# Pier Construction for the S.P. Railroad Bridge Across Suisun Bay

Open Caissons Used in Depths of 143 Ft. Below Low Water—Artificial Sand Islands Within Steel Shells 81 Ft. in Diameter to Be Employed in Sinking Caissons for Eight Piers

By C. R. HARDING

Martinez-Benicia bridge of the Southern Pacific Railroad

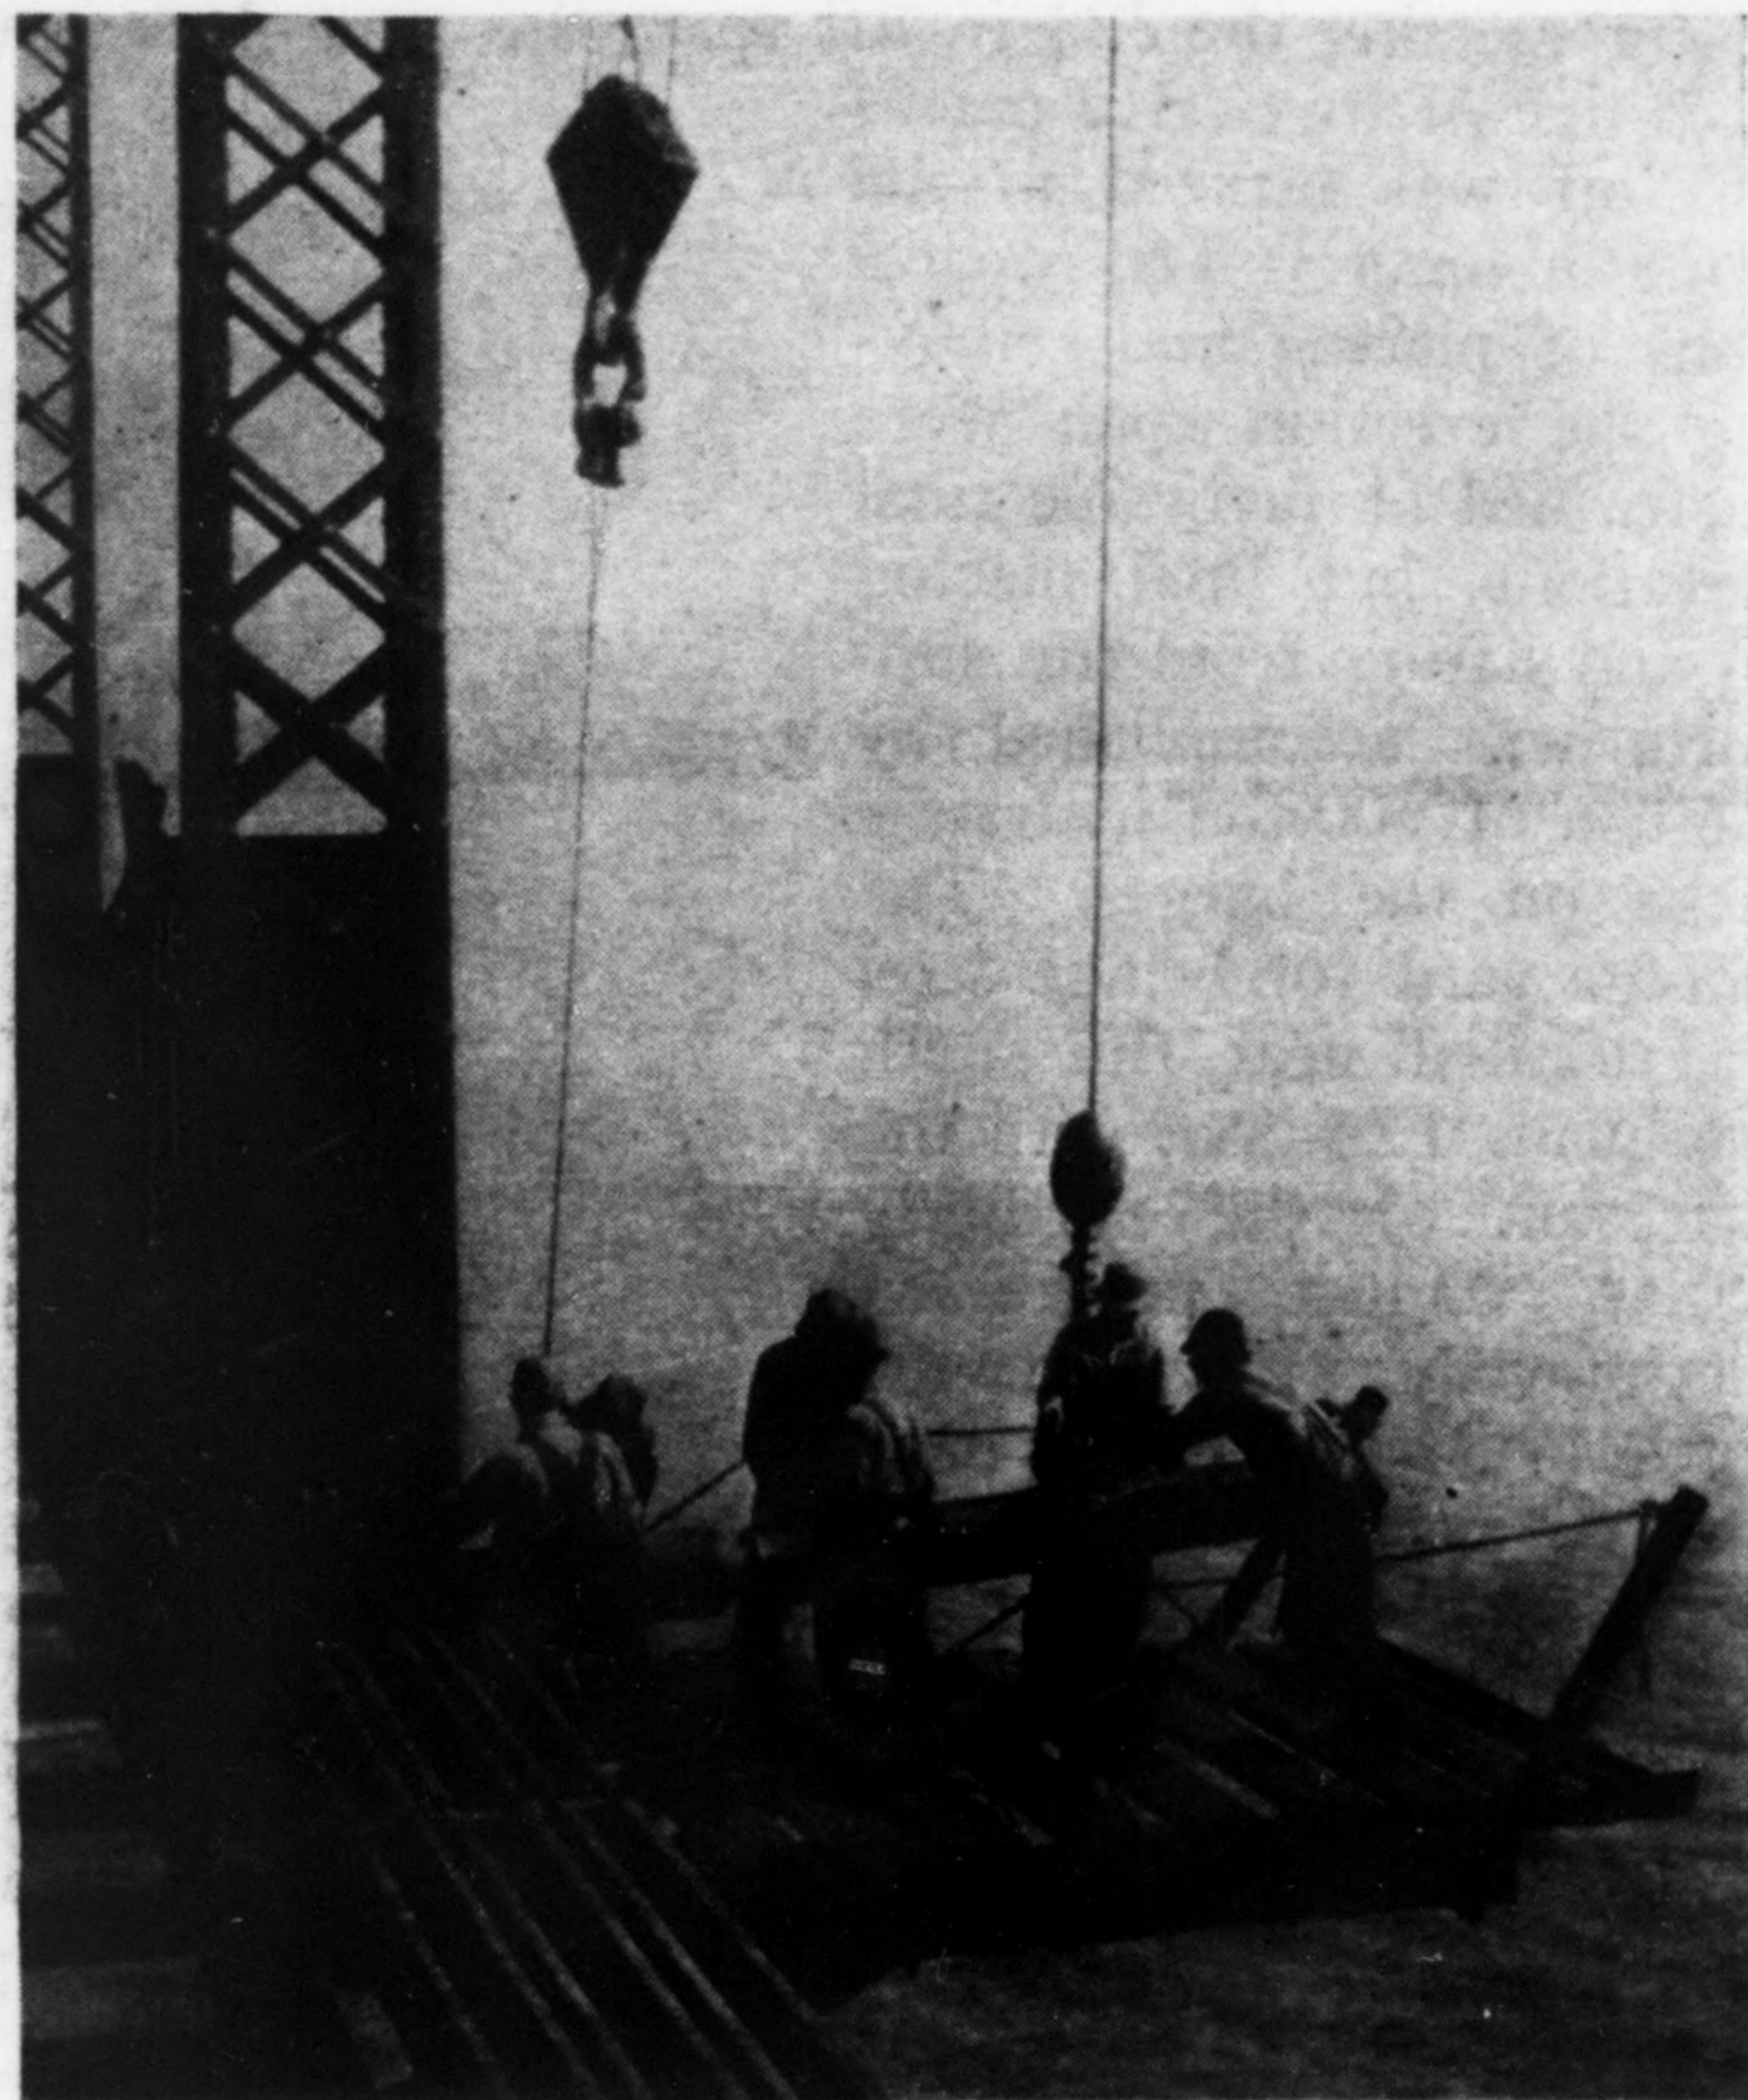
Driving pins in bottom chord

Heat-treated eyebars pretested to full load form the bottom chord.
