NBS MONOGRAPH 127

NBS Papers  
on  
Underground Corrosion of Steel Piling  
1962-1971

# NBS Papers on Underground Corrosion of Steel Piling 1962-1971

**Corrosion of Steel Pilings in Soils,  
Corrosion Evaluation of Steel Test Piles  
Exposed to Permafrost Soils,  
Performance of Steel Pilings in Soils,  
Polarization Measurements as Related to  
Corrosion of Underground Steel Piling**

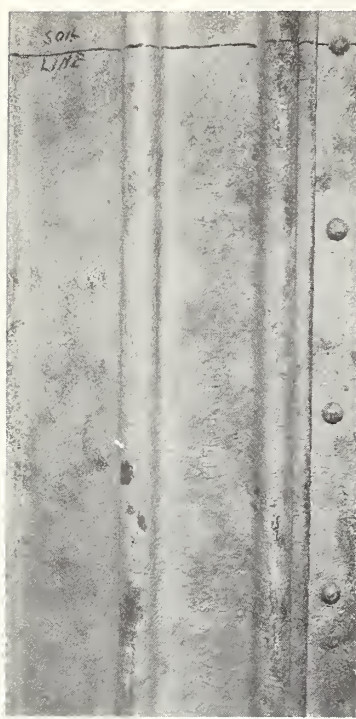
FIGURE 4. A 3-ft section of steel sheet piling exposed below the soil line in a cofferdam structure in the Lumber River near Boardman, North Carolina.

Exposure, 37 years.

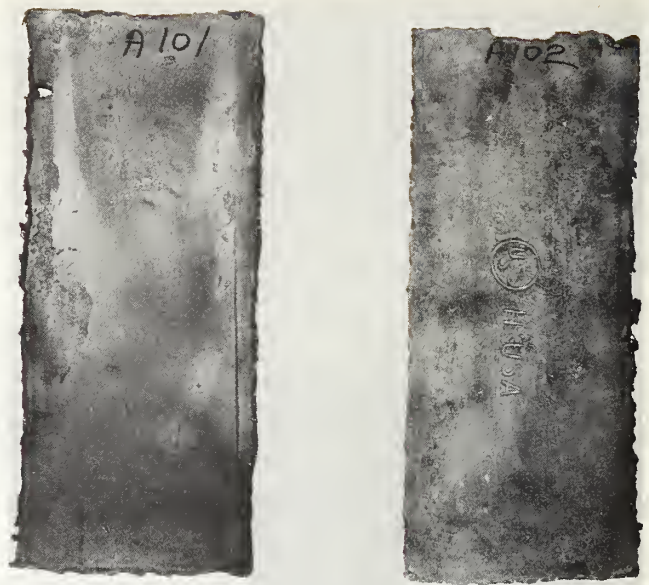
The entire surface of the pilings was in excellent condition. More than 90 percent of the mill scale was intact. There was very slight uniform metal attack in small localized areas. No measurable pits were found on the entire surface. From elevation 218 to the bottom of the excavated pit, the clay adhered very tightly to the piling. On removal, the soil peeled off in layers leaving free water on the steel surface.

A 2 ft by 1 ft section removed from the pile is shown in figure 5.

FIGURE 5. Steel sheet piling sections (2 ft by 1 ft) cut from two locations on the Memphis Floodwall after exposure for 6.3 years.

The sections were cleaned by sandblasting.

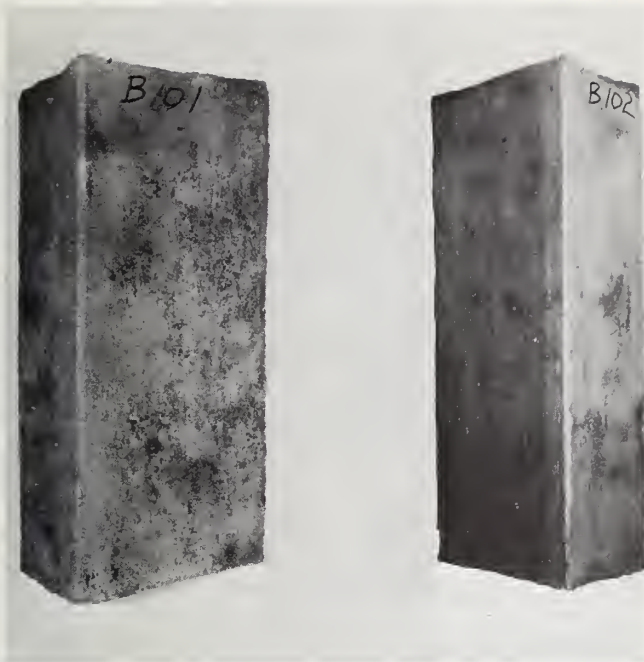
FIGURE 6. Sandblasted sections of Z-type sheet piling cut from two different locations in the Vicksburg Floodwall after exposure for 7 years.

Although cinders were present in the soil at both locations, no significant corrosion occurred.

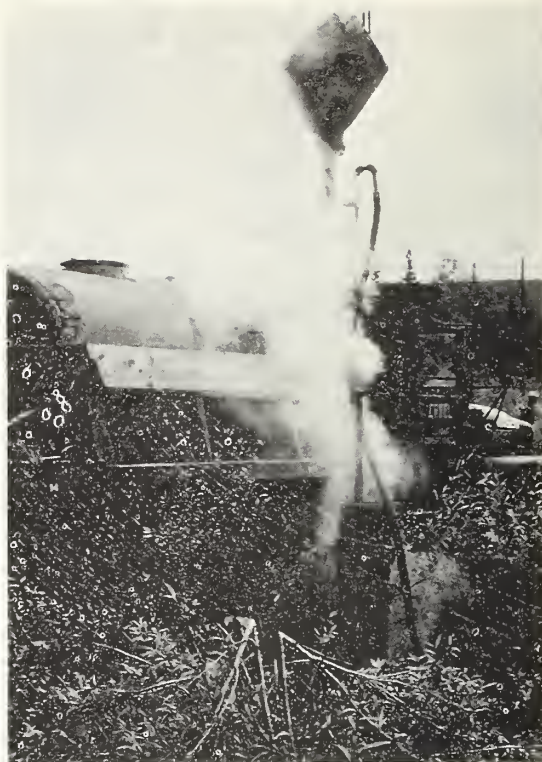
**FIGURE 1 –** Extraction of steel pile in permafrost at Fairbanks, Alaska. Soil was thawed by advancing a steam jet adjacent to and down to the depth of the pile until the pile heaved up.

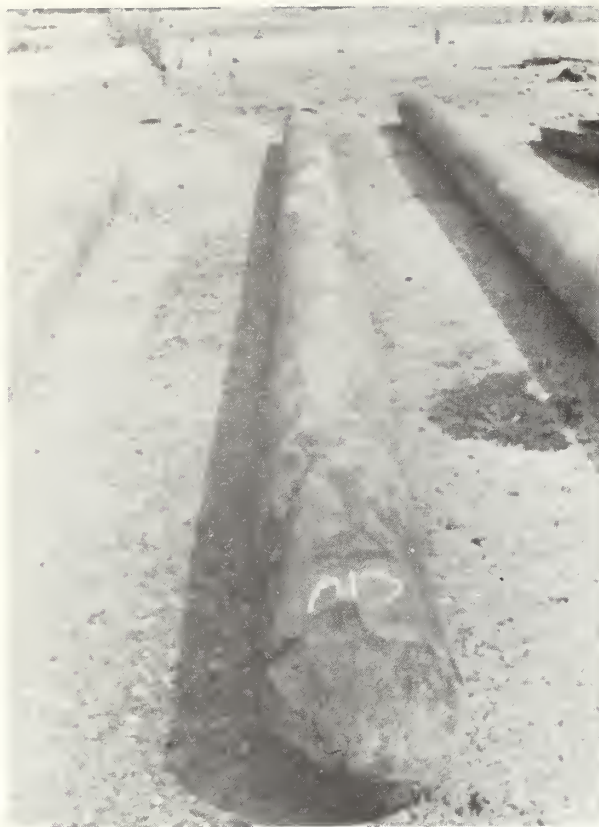
FIGURE 3 - Pipe pile specimen No. A17 prepared for inspection in the field after steam cleaning.

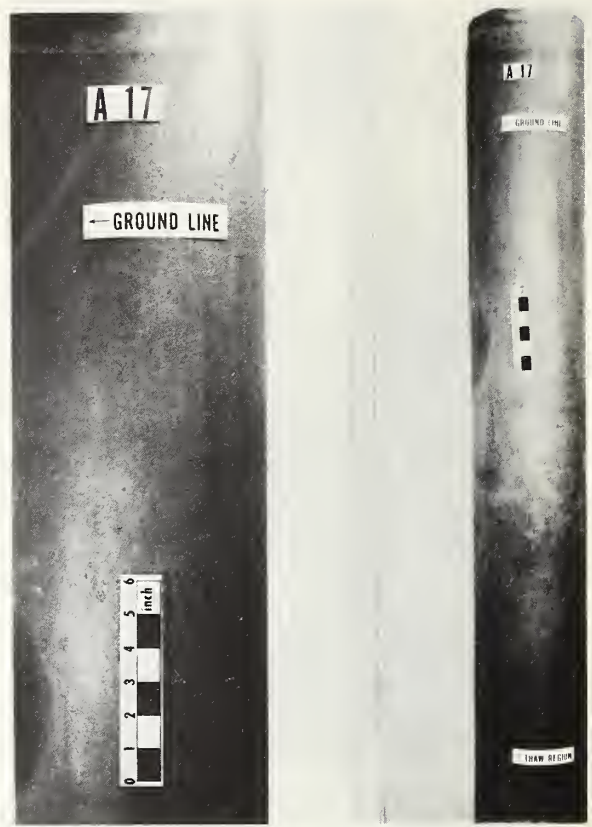
FIGURE 4 - Conditions of sections of pipe pile A17 exposed above the ground line and in the active (thaw) region. Final inspections of these sections were made in the laboratory.

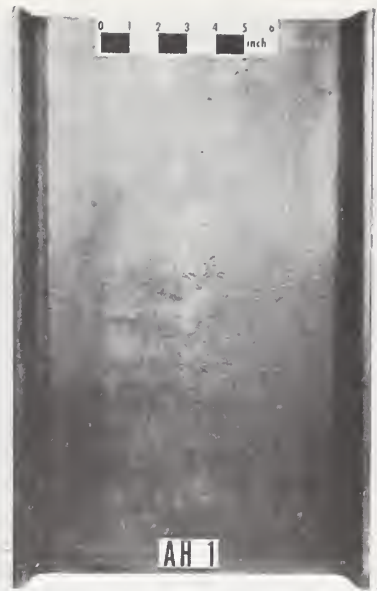
FIGURE 2 — Section of steel I-beam pulled from a pier on Lake Ontario at Olcott, N. Y., after exposure for 50 years. The section was exposed about 2 ft below the mud line and was practically unaffected by corrosion.

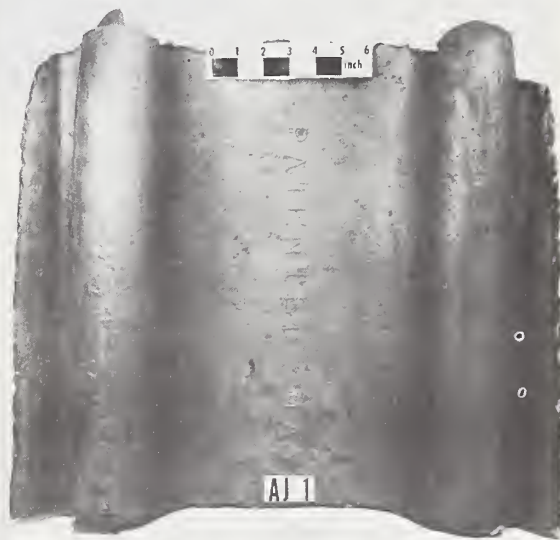
FIGURE 3 — Section of steel sheet-pile pulled from an engineer's slip on the Niagara River at Buffalo, N. Y., after exposure for 36 years. The section was exposed about 8 ft below the ground line in the water table zone.

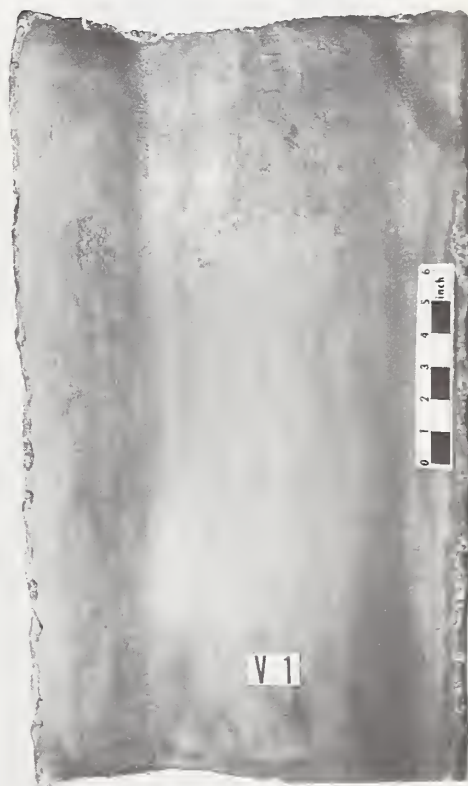
FIGURE 7 — Steel sheet pile section cut from a floodwell at North Little Rock, Ark., after exposure for 24 years. The section was exposed between 3 to 5 ft below the ground line in fill soil underlain by natural clay soil. The depth of pitting did not exceed 50 mils.

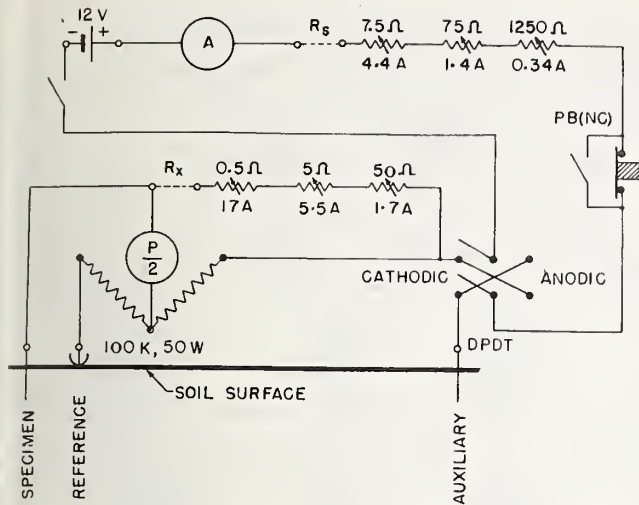
An adaptation of the Holler bridge (fig. 1) was used by the Bureau to obtain the polarization curves. It will be noted that terminals are provided for inserting other control resistors,  $R_s$  and  $R_x$ , should specimen size or environmental conditions make that necessary. For running the curves on the piling, the 0.5  $\Omega$  balancing resistor  $R_x$  was used and the other balancing resistors were set at zero. A 12-volt storage battery supplied the polarizing

FIGURE 1. Circuit used for obtaining polarization curves on piling.

current. A potentiometer was used in the bridge circuit for measuring potentials. The polarization curves were obtained by applying equal increments of current at one minute intervals. The increments were previously determined by the applied current necessary to change the potential from 2 to 10 mV.

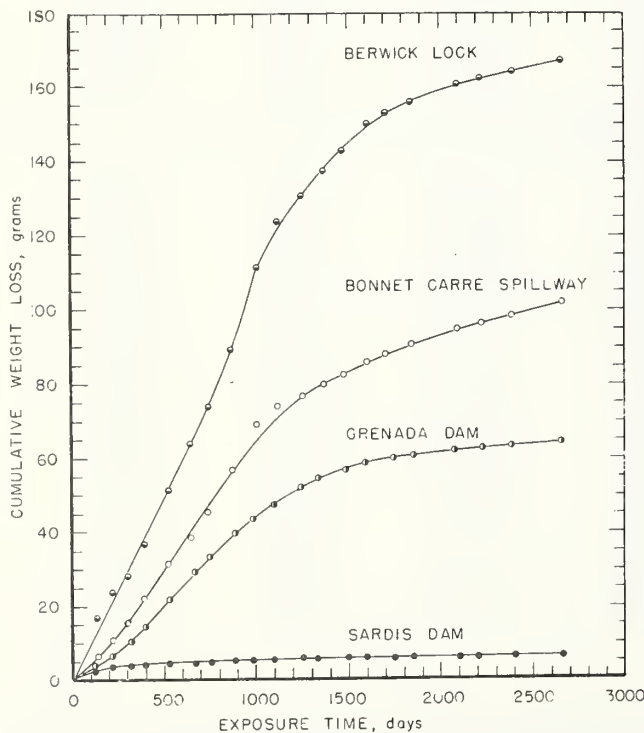
FIGURE 4. Weight loss-time curves, based on polarization curves, obtained on iron specimens (Nos. 8) buried at four back-filled trench sites.
