# United States Patent [19]

[11] Patent Number: **4,729,799**

- [54] **STRESS RELIEF OF SINGLE CRYSTAL SUPERALLOY ARTICLES**
- [75] Inventors: **Robert J. Henricks, Farmington; John J. Marcin, Hartford; Jacqueline B. Wahl, Willington, all of Conn.**
- [73] Assignee: **United Technologies Corporation, Hartford, Conn.**
- [21] Appl. No.: **880,603**
- [22] Filed: **Jun. 30, 1986**
- [51] Int. Cl.<sup>4</sup> ..... **C22F 1/10**
- [52] U.S. Cl. .... **148/13; 148/20.3; 148/404**
- [58] Field of Search ..... **148/13, 20.3, 404**
- [56] **References Cited**

## STRESS RELIEF OF SINGLE CRYSTAL SUPERALLOY ARTICLES

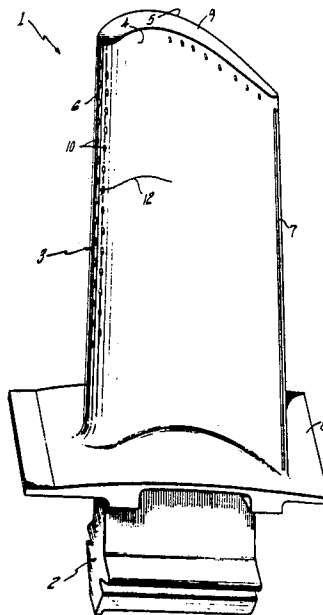
FIG. 1 is a prospective view of a used single crystal airfoil blade, illustrating a typical chordwise crack which developed during exposure of the airfoil blade to a corrosive environment.

mersed in boiling HCl to remove the coatings. After coating removal, the blades were inspected and a significant number found to be damaged beyond repair by cracks which initiated in the corrosive environment of the acid bath. Of 53 articles exposed to the acid, 26 developed chordwise cracks, for a 49% failure rate. Such a high rate of failure results in significant increases in the cost of overhauling gas turbine engines which utilize single crystal articles. Consequently, a need arose to determine the cause of the cracking problem and to define proper procedures to prevent damaging the single crystal superalloy airfoil articles during refurbishment.

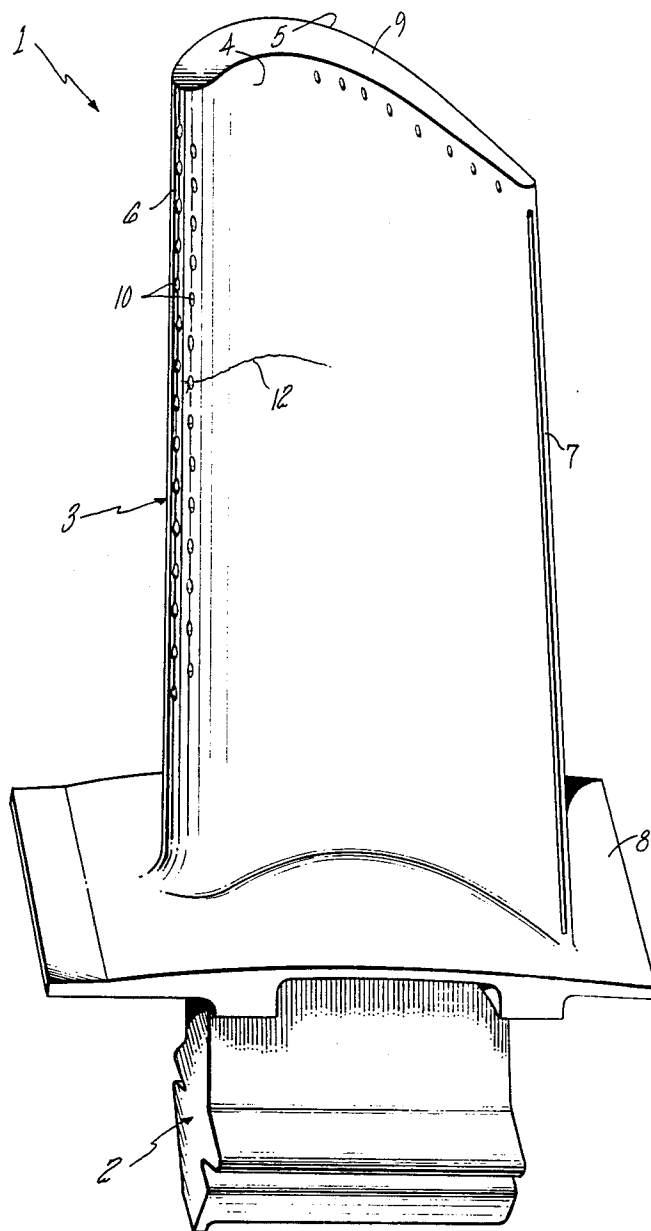
Referring to FIG. 1, a used single crystal airfoil blade 1 is shown. The blade 1 includes a root 2 and an airfoil 3 having a concave surface 4, a convex surface 5, a leading edge 6, a trailing edge 7, a platform 8, and a tip 9. The blade 1 also includes internal cooling passages 10 which direct relatively cool air through the blade to allow operation at high temperatures. The blade 1 also previously included a surface coating 11 (not shown) on both the inner and outer surfaces which was removed. The coating may have been either a diffusion or overlay coating such as those described in U.S. Pat. Nos. 3,928,026, 3,544,348 and 4,132,816, or a combination thereof, as described in U.S. Pat. No. 4,005,989, all hereby incorporated by reference. The blade 1, as well as those other blades and vanes to which the present invention applies, are of the type used in the turbine section of a gas turbine engine, and are composed of single crystal nickel base superalloys, such as that disclosed in U.S. Pat. No. 4,209,348 to Duhl et al.

In particular, coated nickel base superalloy single crystal turbine airfoil blades, which are subject to gas turbine engine operation for 2000 to 10,000 hours, can crack from a stress corrosion mechanism when exposed to certain corrosive media. Bulk spanwise residual tensile strains of 1,000 to 1,500 microinches per inch were sufficient to create chordwise cracks at airfoil locations in 26 of 53 parts exposed to boiling hydrochloric acid. Spanwise strains are developed as the airfoil is subject to centripetal forces during engine operation. These strains within the superalloy are measured from the root platform 8 to the blade tip 9 by positioning a number of strain gauges about the article, slicing through a portion and measuring the strain relaxation. Referring to FIG. 1, a typical chordwise crack 12 is shown on a nickel base single crystal superalloy airfoil blade, the crack being perpendicular to the spanwise strain.
