The Morgan Hill, California, Earthquake of April 24, 1984

U.S. GEOLOGICAL SURVEY BULLETIN 1639

Seena N. Hoose, Editor

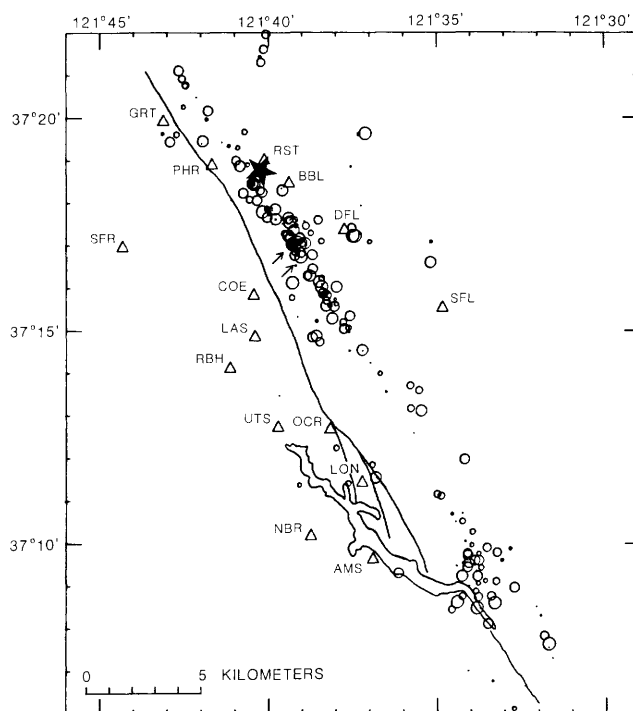
Figure 4.1. Sketch map of earthquake source region, showing locations of main-shock epicenter (star), GEOS stations (triangles), epicenters of events of $M \geq 1.5$ recorded by one or more GEOS stations (circles, size proportional to magnitude), and approximate surface trace of the Calaveras fault (heavy diagonal line). Arrows point to epicenters of two events for which source parameters were calculated.

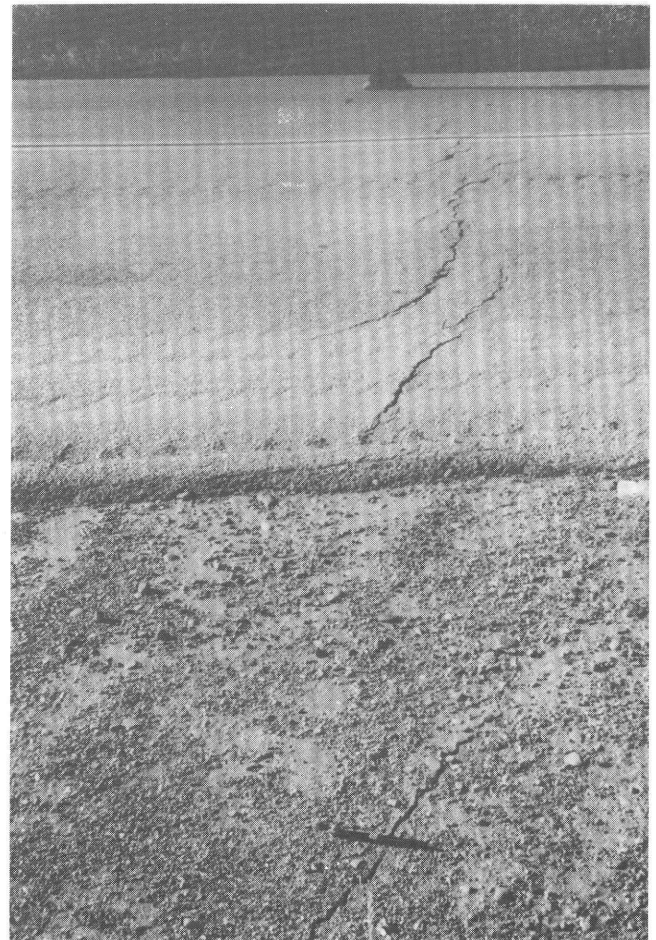
Figure 7.2. Calaveras fault at Shore Road on April 25, 1984. Left-stepping echelon cracks appear in the asphalt and also in the dirt.

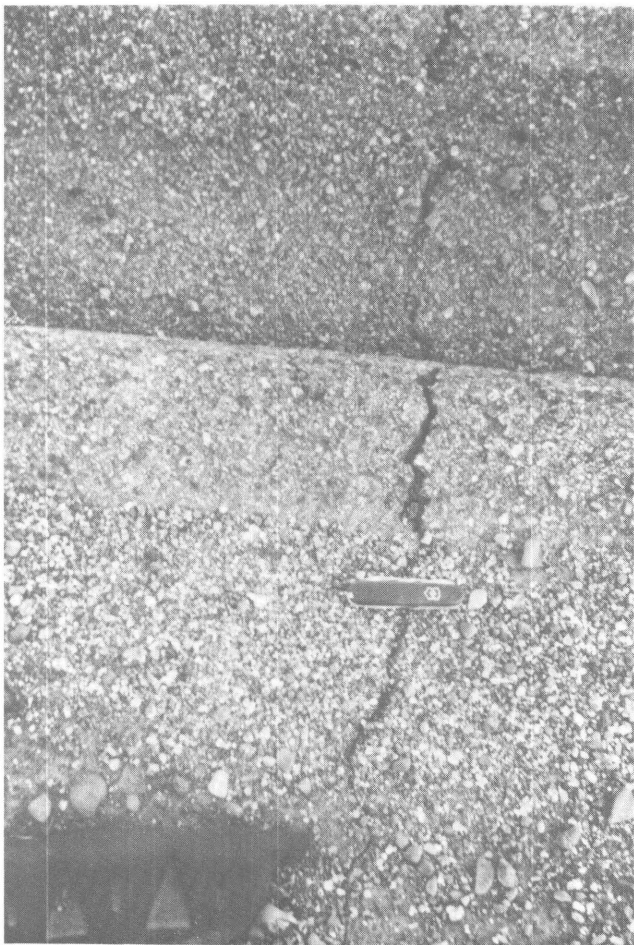
Figure 7.3. Calaveras fault at California Highway 152 (Pacheco Pass Road) on April 25, 1984. Crack in darker upper part of photograph is in asphalt of the road. Crack in lighter middle part above knife is in road curb, which is offset about 1 cm right laterally. Crack beneath knife in foreground, in dirt alongside the road, also shows right-lateral offset.

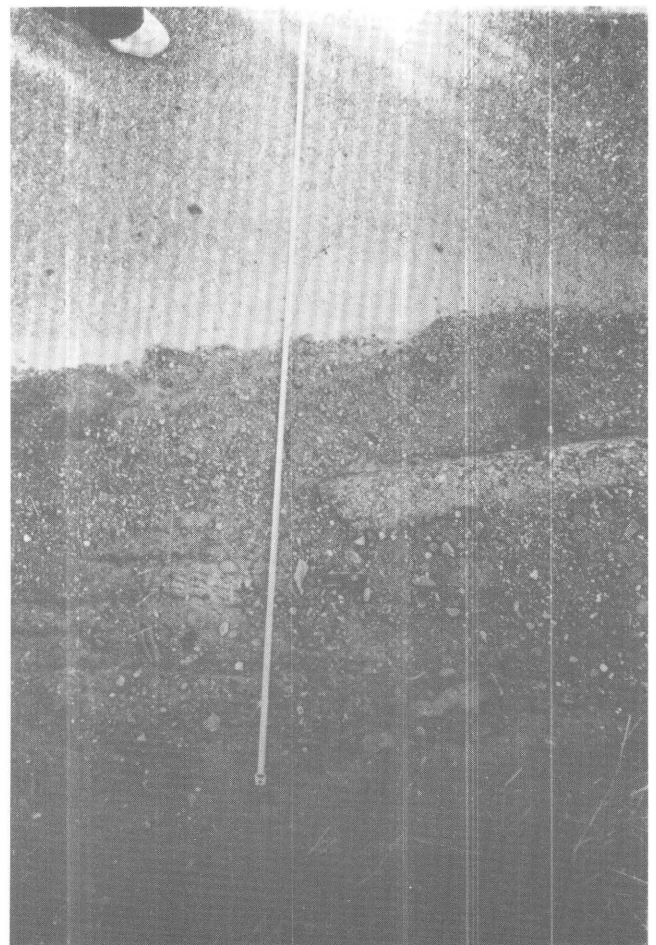
Figure 7.4. Calaveras fault at California Highway 152 (Pacheco Pass Road) on April 25, 1984. Crack is northeast of the one in figure 7.3. Crack in lighter upper part of photograph to right of tape is in asphalt. Crack in darker lower part is in dirt and runs from underneath knife downward and underneath tape, about 1.5 knife lengths from end of tape.

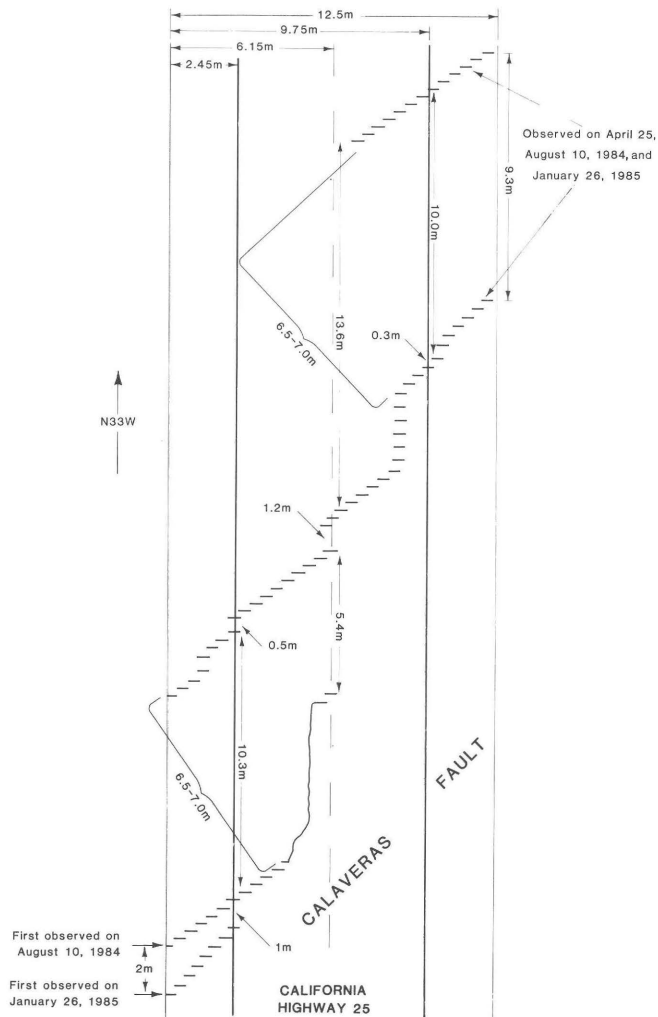
Figure 7.5. Sketch map of four traces of Calaveras fault crossing California Highway 25 in Hollister area on January 26, 1985.

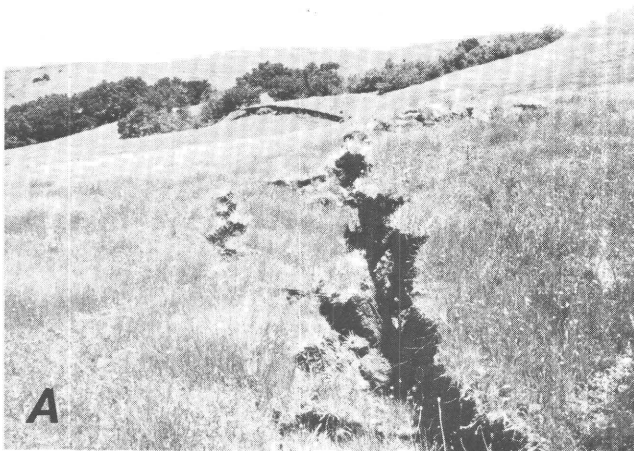
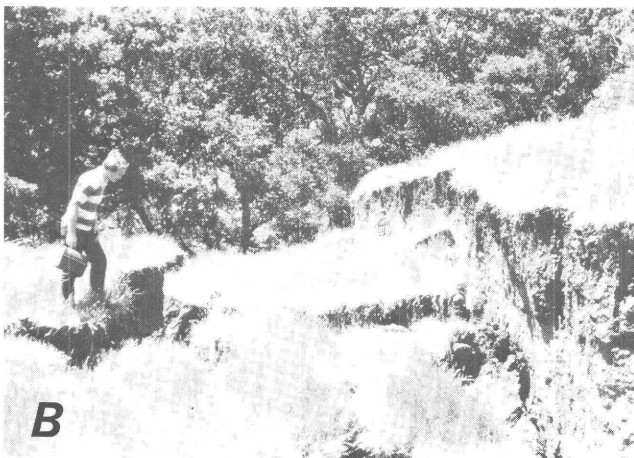
Figure 8.2. Landslide at La Honda, Calif., probably triggered by the earthquake. **A**, Scarp along northeastern part of landslide. View northward. **B**, Graben at head of landslide. Measurements across graben show 1.2 m of displacement toward the southwest.

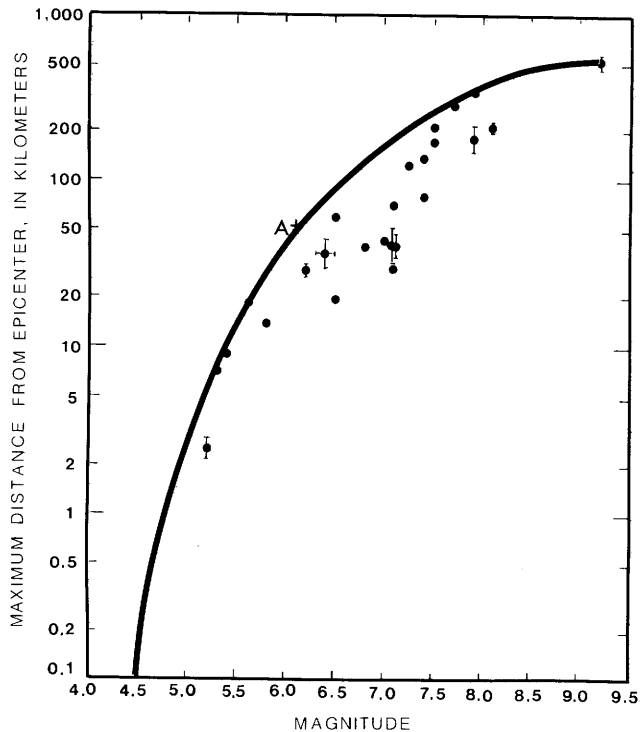
Figure 8.6. Maximum epicentral distance for block slides and related landslides as a function of earthquake magnitude for historical earthquakes. Dots represent historical earthquakes compiled by Keefer (1984). Solid line is approximate upper bound enclosing all historical data, as determined by Keefer (1984). Point A represents distance of landslide at La Honda from epicenter of April 24, 1984, Morgan Hill earthquake ($M_s=6.1$).

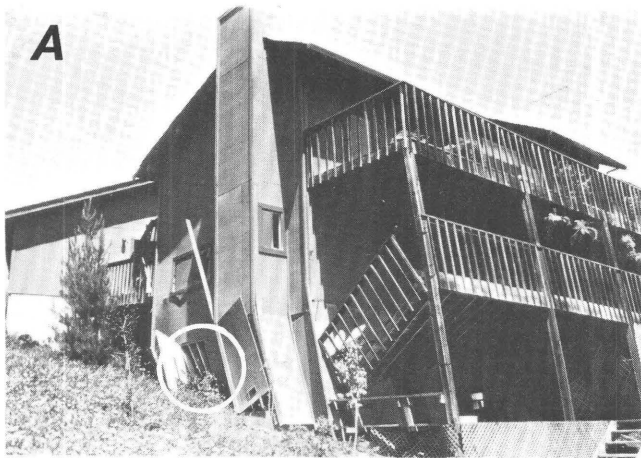
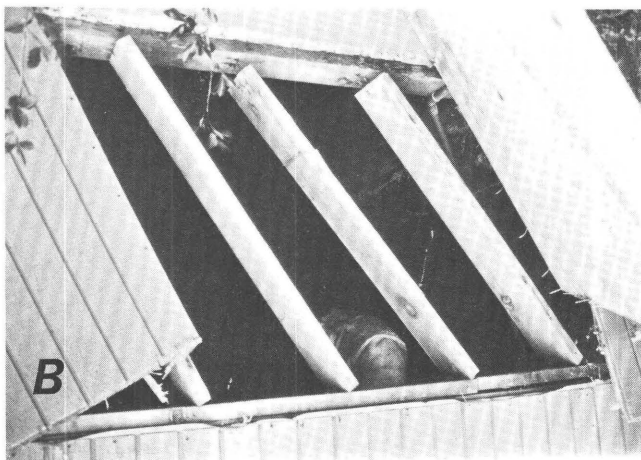
Figure 10.2. A house described as "off its foundation" in Morgan Hill. Perimeter and interior footings of house are intact and were undamaged by the earthquake. Lateral displacement of house and consequent damage was due to shear deformation within wall immediately above foundation. **A**, View of house from a distance, showing damage and distortion to structure. Unbroken rotated shear panels appear to have provided little shear protection. **B**, Closeup of circled area in figure 2A, showing skewed studs and siding ("shear panels") that pulled off from wall as the structure deformed.

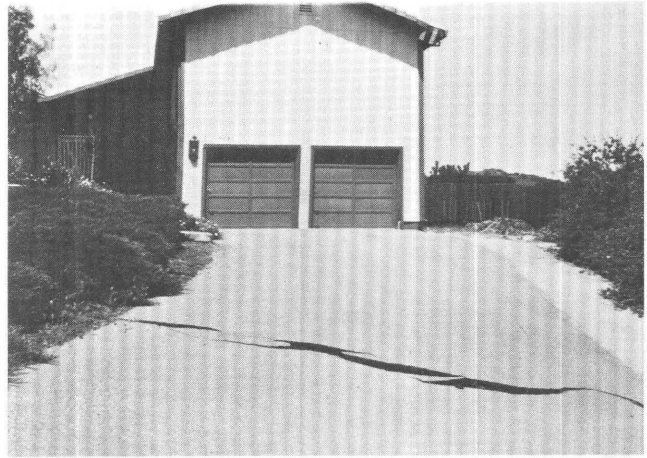
Figure 10.3. Conspicuous fissure in a driveway near crest of hill above house shown in figure 10.1. Fissure was caused by local ground displacement, probably an incipient slope failure, but had no direct influence on damage to houses in the area.

Several houses were damaged in the Jackson Oaks area on the southwest side of the Anderson Reservoir (see chap. 10). A conspicuous east-west fissure along Oak Ridge Court cracked driveways and the street, and broke pipes. Although this fissure

probably marked the head of an incipient slope failure, the fissure had no detectable direct influence on the damage to houses in the vicinity. Damage to the Cochrane Bridge across the Anderson Reservoir may have been caused by deep-seated landslide movement. Dunne Road was damaged by landslides. Details of the various cracks are described in chapter 6. Liquefaction effects were found at only one locality on the east shore of the Anderson Reservoir, where sand boils and fissures a few centimeters wide occurred.

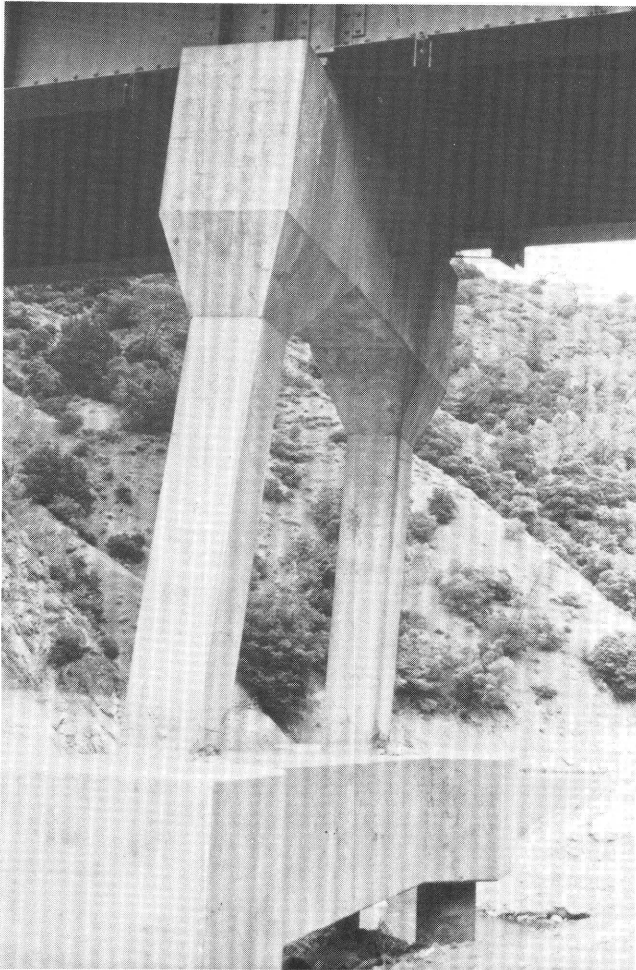
Figure 10.4. Tilted and fractured bent of the Cochrane Bridge. Tilting and fracturing of bent were possibly caused by deep-seated movement of a landslide that pushed or carried pier supporting bent toward the Anderson Reservoir (to left).

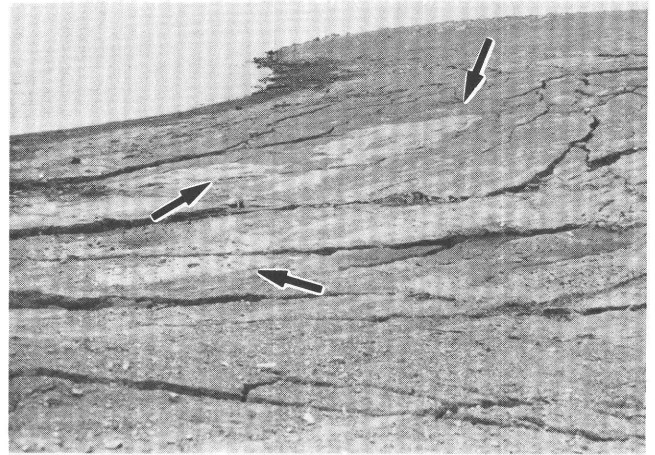
Figure 10.5. Sand boils (arrows) and fissures near shoreline on east side of the Anderson Reservoir. Liquefaction and minor lateral spreading caused these features.

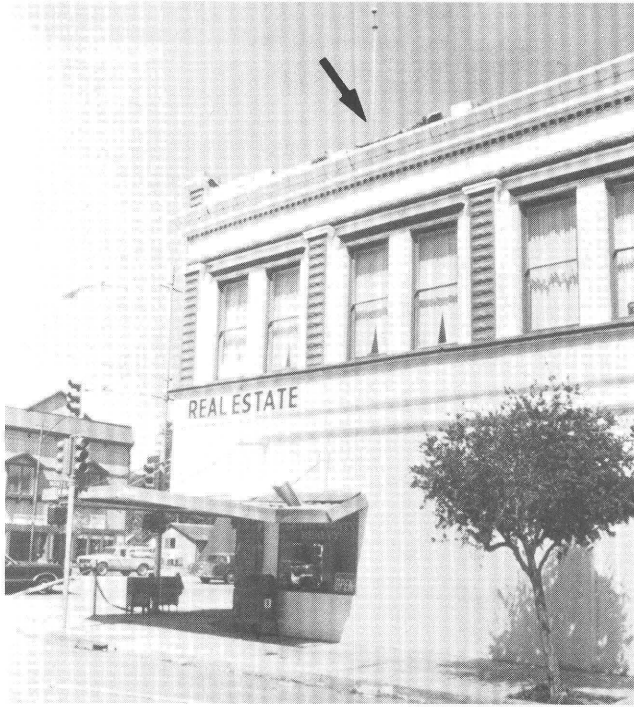
Figure 11.3. The 1905 or South Coast Realty Building (loc. 1, fig. 11.2). Tumbled part of roof cornice fell to north (arrow). Note partly collapsed awning near left corner of building that was struck by a heavy object, possibly a block from the cornice. View northwestward.

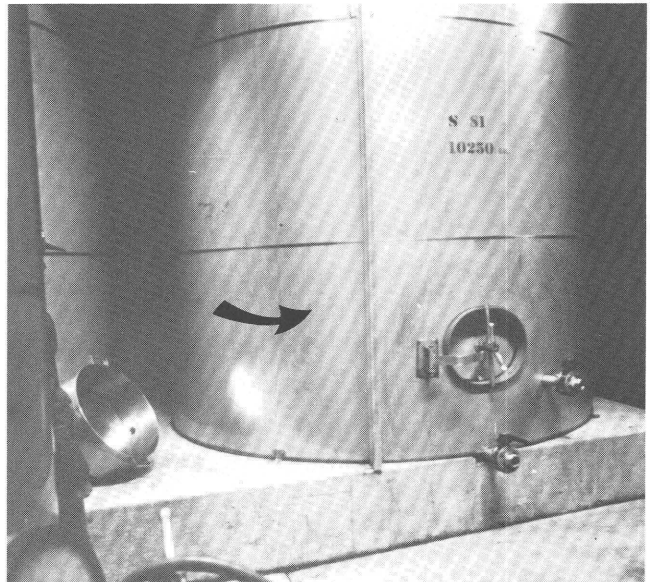
Figure 11.6. Inside of the Emilio Guglielmo Winery (loc. 4, fig. 11.2), showing 10,250-gal storage tank welded to a catwalk support, which, in turn, was bolted into the concrete pad. This stainless-steel tank rotated 2.5 cm counterclockwise (to right in direction of arrow), and the catwalk was twisted. The tank was empty. Tanks that were filled to capacity developed "elephant toe" bulges while shifting on the same concrete pad. View west-northwestward.

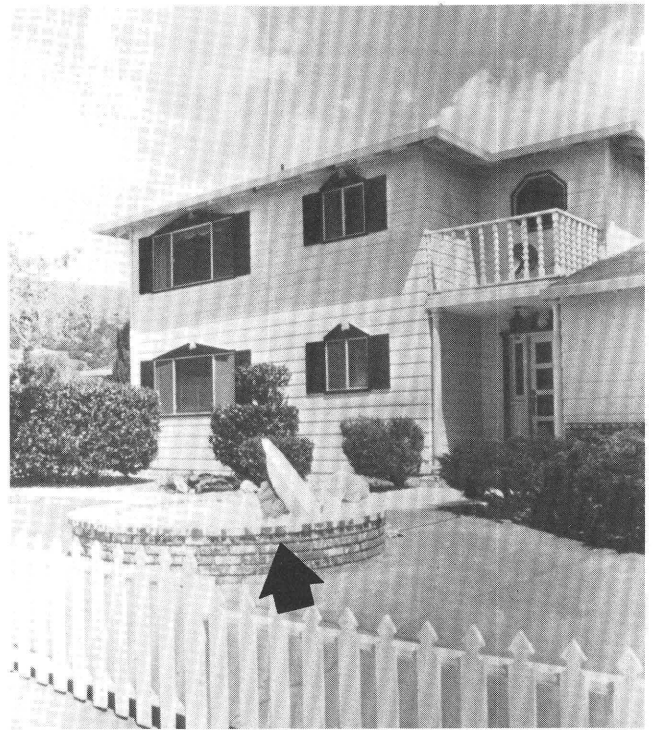
Figure 11.9. Fountain toppled in front yard of house in Jackson Oaks subdivision west of area shown in figure 11.8. View southeastward.

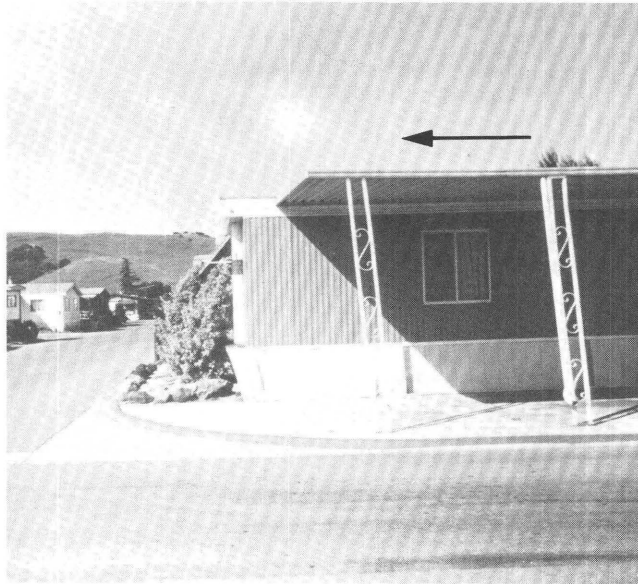
Figure 11.11. Partly collapsed mobile home in Madrone Mobile Home Estates (loc. 7, fig. 11.2). Carport supports were perpendicular to ground before the earthquake. Arrow shows direction of motion. View westward.

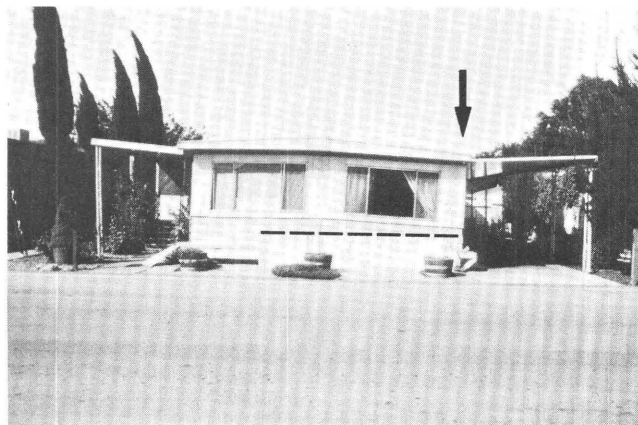
Figure 11.12. Completely collapsed mobil home in Madrone Mobile Home Estates (loc. 7, fig. 11.2). Carport roofs, which sloped away for drainage before the earthquake, now slope toward trailer. Bottom of trailer was at level of top of skirt (dashed line). Arrow shows direction of collapse. View westward.

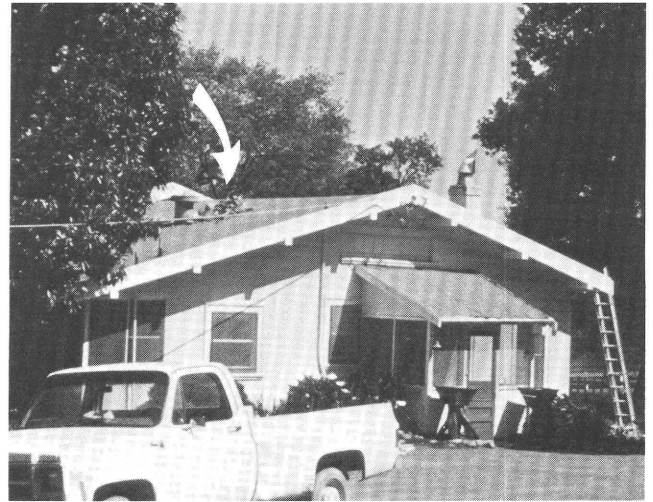
Figure 11.15. Damaged wood-frame house (built about 1914) in the San Felipe Valley. Chimney toppled (arrow) and stemwall cracks developed in perimeter foundation. View east-southeastward.

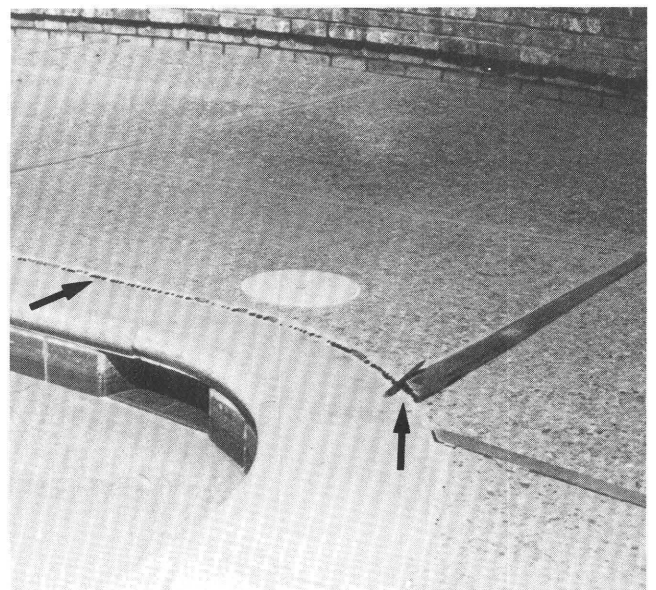
Figure 11.16. Concrete swimming-pool apron in the San Felipe Valley (loc. 9-west, fig. 11.14) that has settled differentially owing to minor lateral spreading of Holocene and late Pleistocene stream deposits. Arrows show different levels of slab surfaces and stretched caulk material.

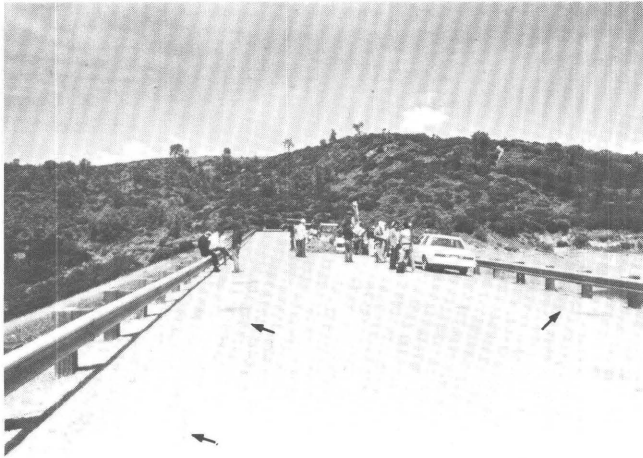
Figure 11.19. Longitudinal cracks developed along crest of the Anderson Dam (loc. 22, fig. 11.7). Trench used to investigate behavior of cracks at depth was excavated parallel to longitudinal upstream crack at right center. Arrows point to crack sets. Upstream is to right. View north-northwestward.

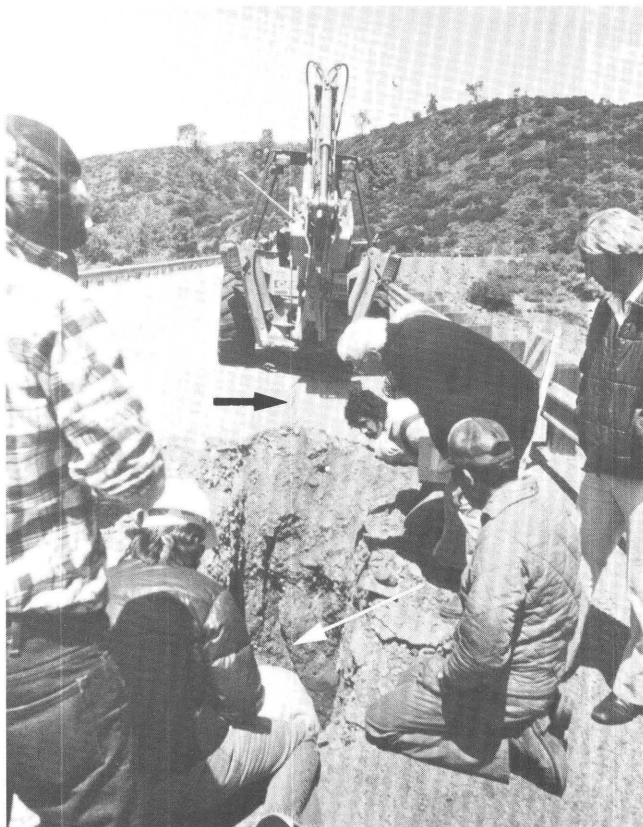
Figure 11.20. Soil-pit-type trench through crest of the Anderson Dam (loc. 22, fig. 11.7). Crack in pavement, visible in north vertical trenchwall, appears to curve outward toward upstream face of dam, to right near bottom of excavation. Arrows point to cracks at surface and at depth. View north-northwestward.

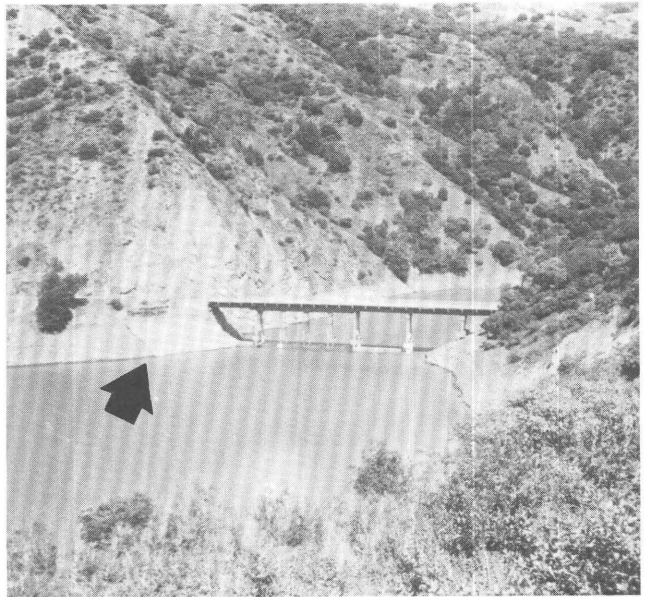
Figure 11.21. Cochrane Bridge over the Anderson Reservoir (loc. 25, fig. 11.7). Bridge has been shortened by telescoping of timbers that support paved roadbed. Rock fall (arrow) covers East Dunne Avenue east of the bridge. View east-southeastward.

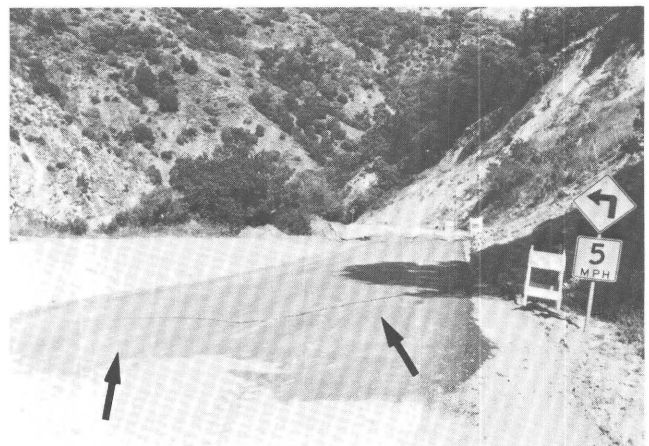
Figure 11.22. Large complex landslide within 0.2 km of the Cochrane Bridge disrupts East Dunne Avenue right-of-way (adjacent to loc. 24, fig. 11.7) and obscures trace of the Calaveras fault. Arrows point to crack caused by landslide. Note repeated patching of pavement. Rock fall at left is same one shown in figure 11.21. View southeastward.

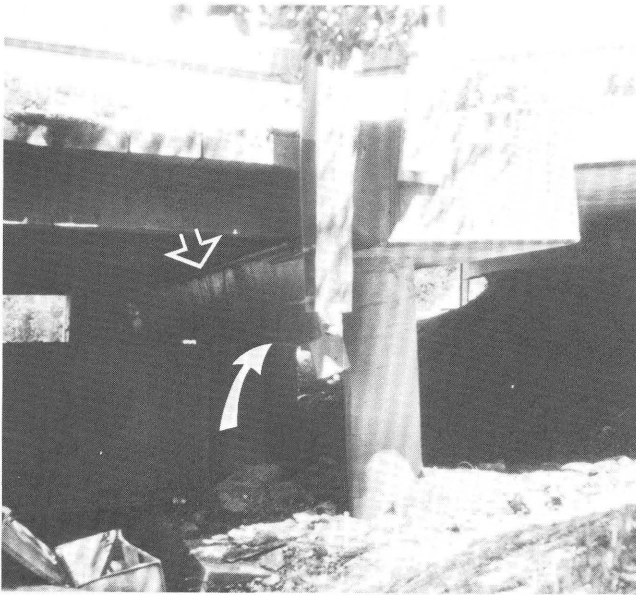
Figure 11.23. Rotated I-beam beneath the Cochrane Bridge (loc. 24, fig. 11.7) and bridge-support timbers (see arrows). Rivets were torn out in several places. View eastward.

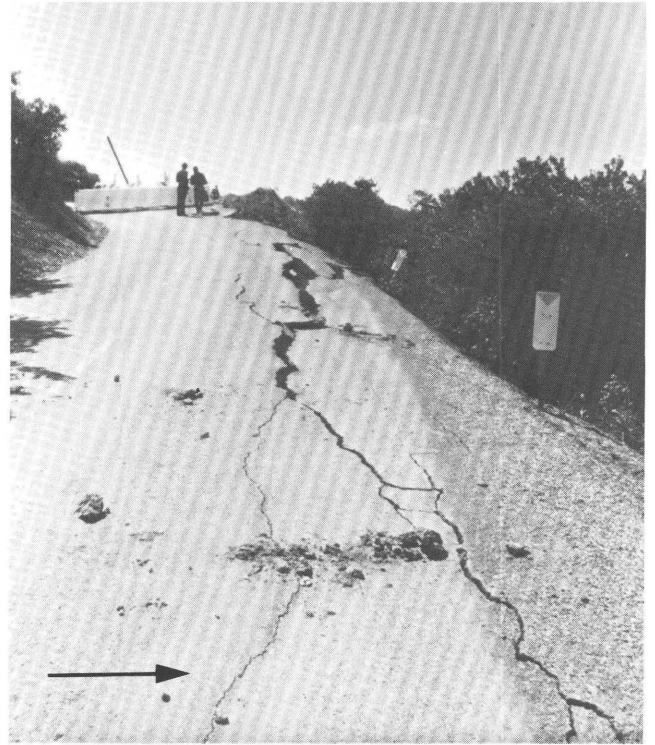
Figure 11.25. One of many fill failures along East Dunne Avenue within 0.8 km of the Cochrane Bridge (west of loc. 24, fig. 11.7). These failures were typically down toward reservoir, to right (arrow). View northwestward.

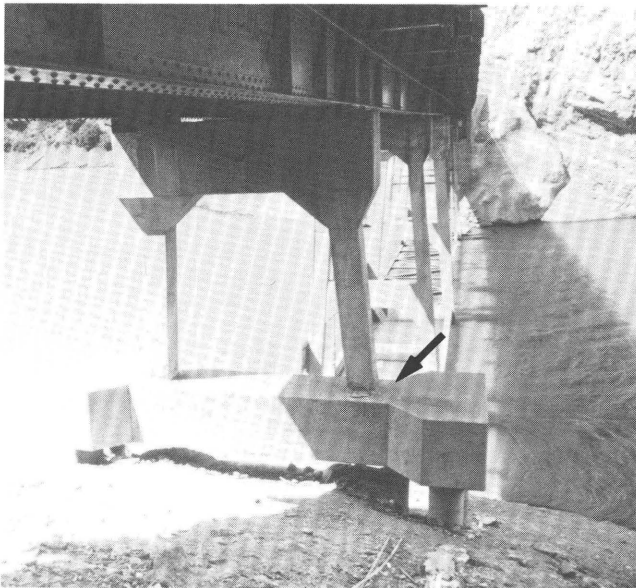
Figure 11.24. Bent bracing, added years ago to strengthen the Cochrane Bridge (loc. 24, fig. 11.7) after distortion of bridge by either fault creep or landslide displacement was discovered. Bent pillar bases (arrow) spalled during main shock. View northward.

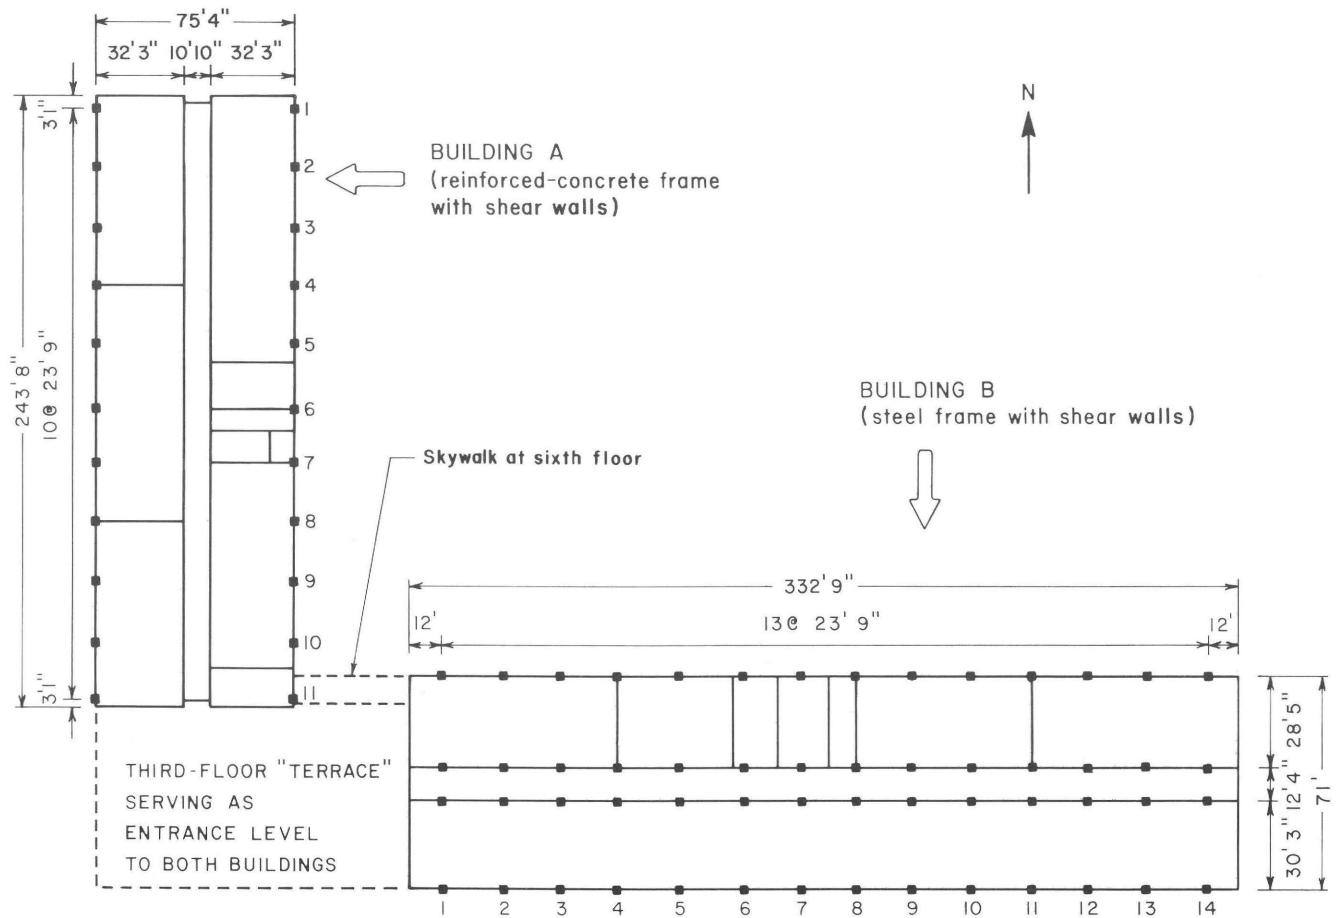
Figure 12.1. Typical plan view of fourth floor and above floors for buildings A and B. Not to scale.

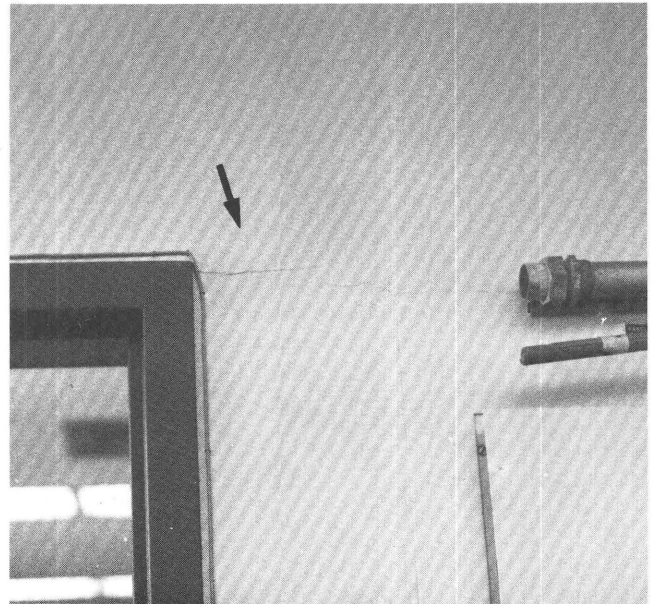
Figure 12.3. Typical nonstructural cracks in walls of building A.

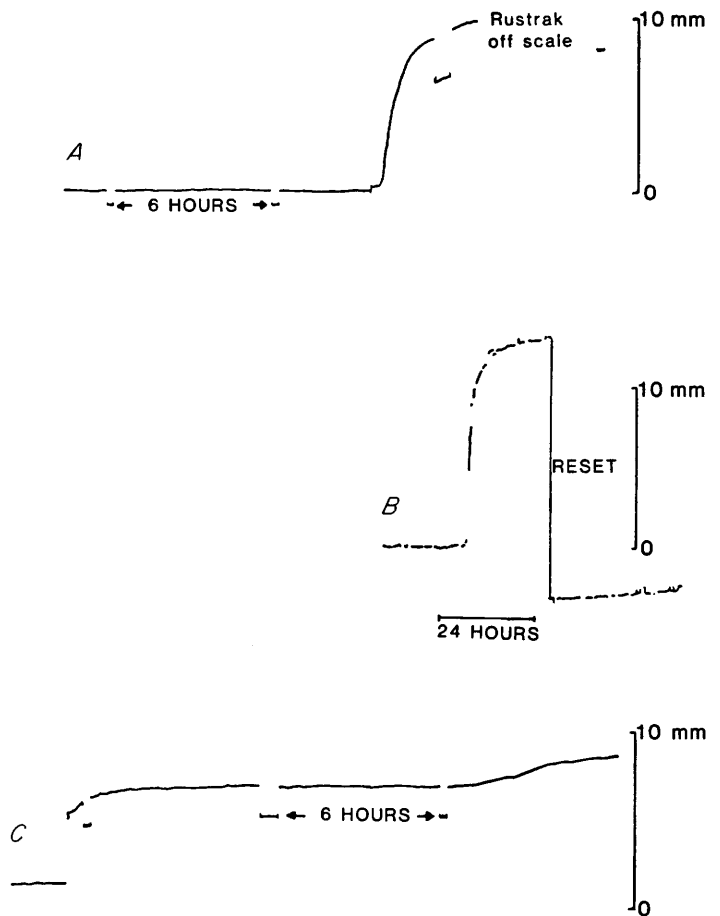
Figure 13.2. Records of the April 24 earthquake. *A*, Rustrak trace showing station SHR1's response to the April 24, 1984, Morgan Hill earthquake. A 0.11-mm coseismic step was followed within 23 minutes by 12.0 mm of afterslip over the next 18 hours. Recorder went off scale after 4 hours. *B*, Telemetry trace showing entire event (10-minute samples). Left-lateral step was due to mechanical reset on April 25 to prevent instrumental range being exceeded. *C*, Rustrak trace showing station SHR1's response to the August 6, 1979, Coyote Lake earthquake. A 4.2-mm coseismic step was followed by 4.1-mm of afterslip in two events over the next 24 hours.

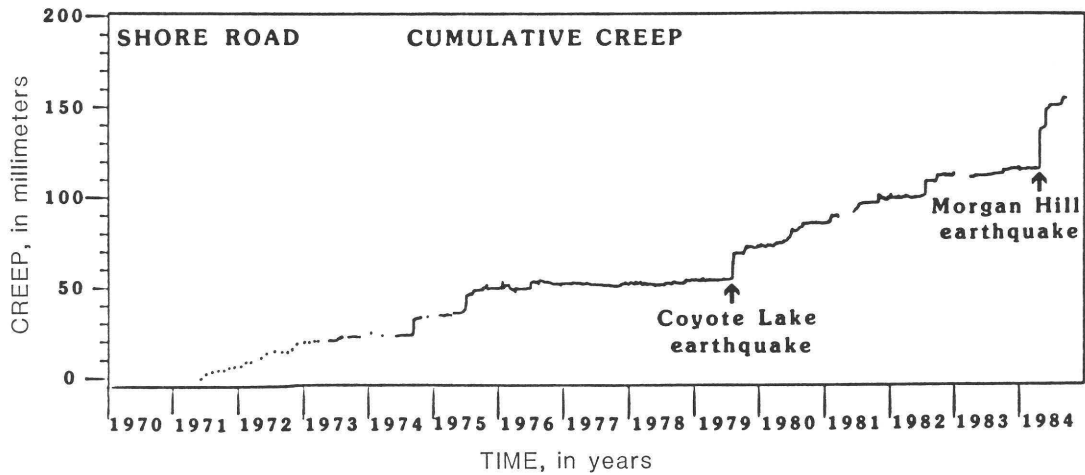
Figure 13.3. Long-term cumulative creep recorded at station SHR1. Step that begins at time of the Coyote Lake earthquake consists of four separate events over a 5-day period.

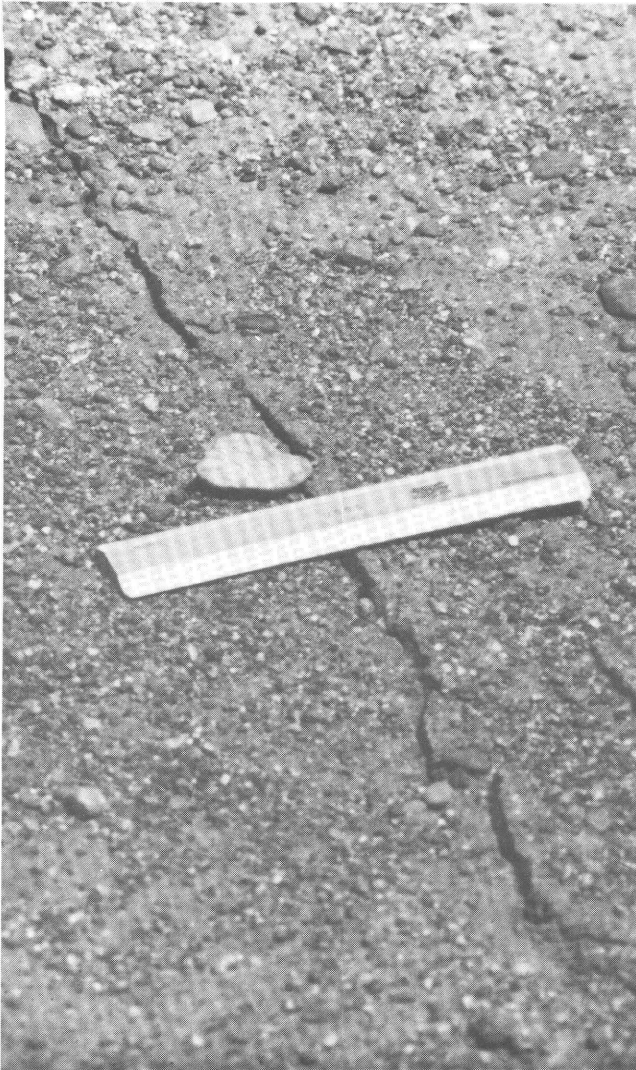
Figure 13.5. Closeup of fresh crack, 1 m long by as much as 0.5 cm wide, beside Shore Road. Scale is 15 cm long.

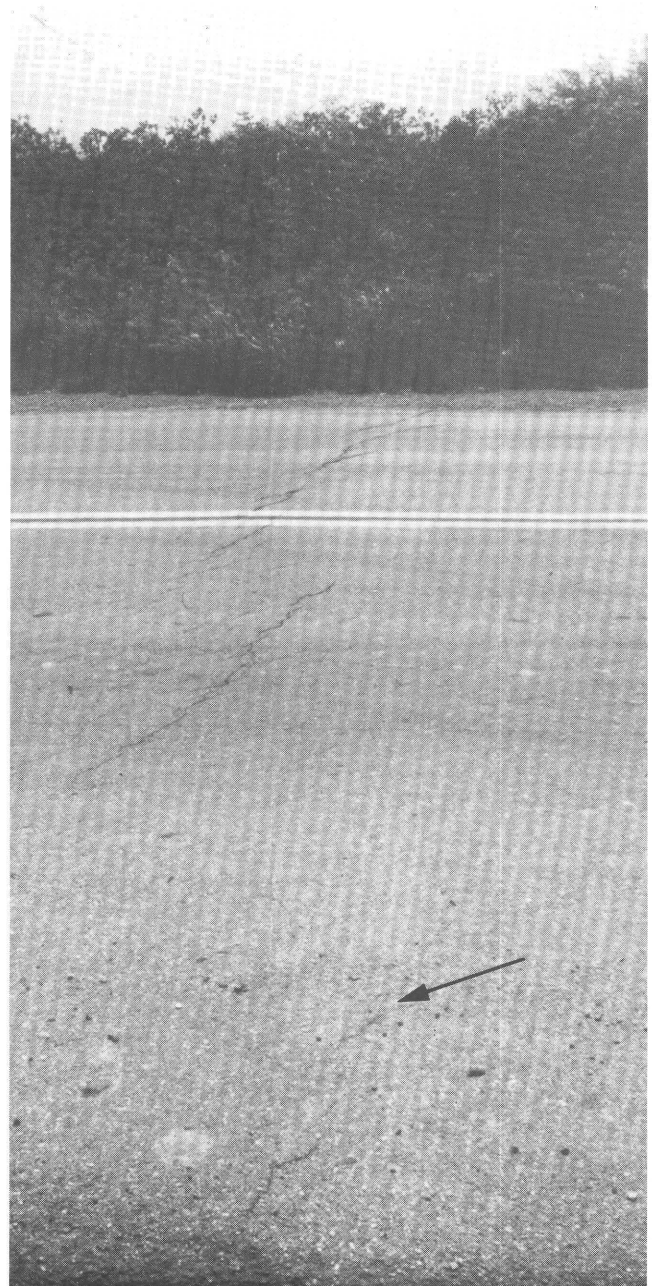
Figure 13.6. Calaveras fault trace at Shore Road. Station SHR1 is in shoulder in upper left center. Arrow denotes hairline crack extending from dirt shoulder into roadway. View southeastward.

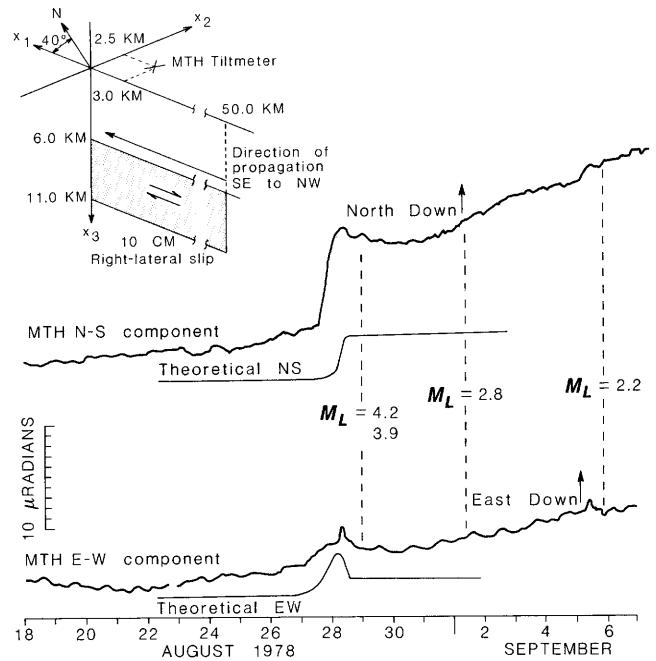
Figure 16.2. Short-term tilt signals recorded by the Mount Hamilton tiltmeter (MTH) before the August 29, 1978, earthquake pair and September 5 aftershock, in comparison with theoretical tilt waveforms generated by propagating-slip model shown in upper left. Tilt components are sampled every 10 minutes; curve MTH N-S. component has been smoothed with a six-point running mean to eliminate noise. From Mortensen and Iwatsubo (1980, fig. 2).

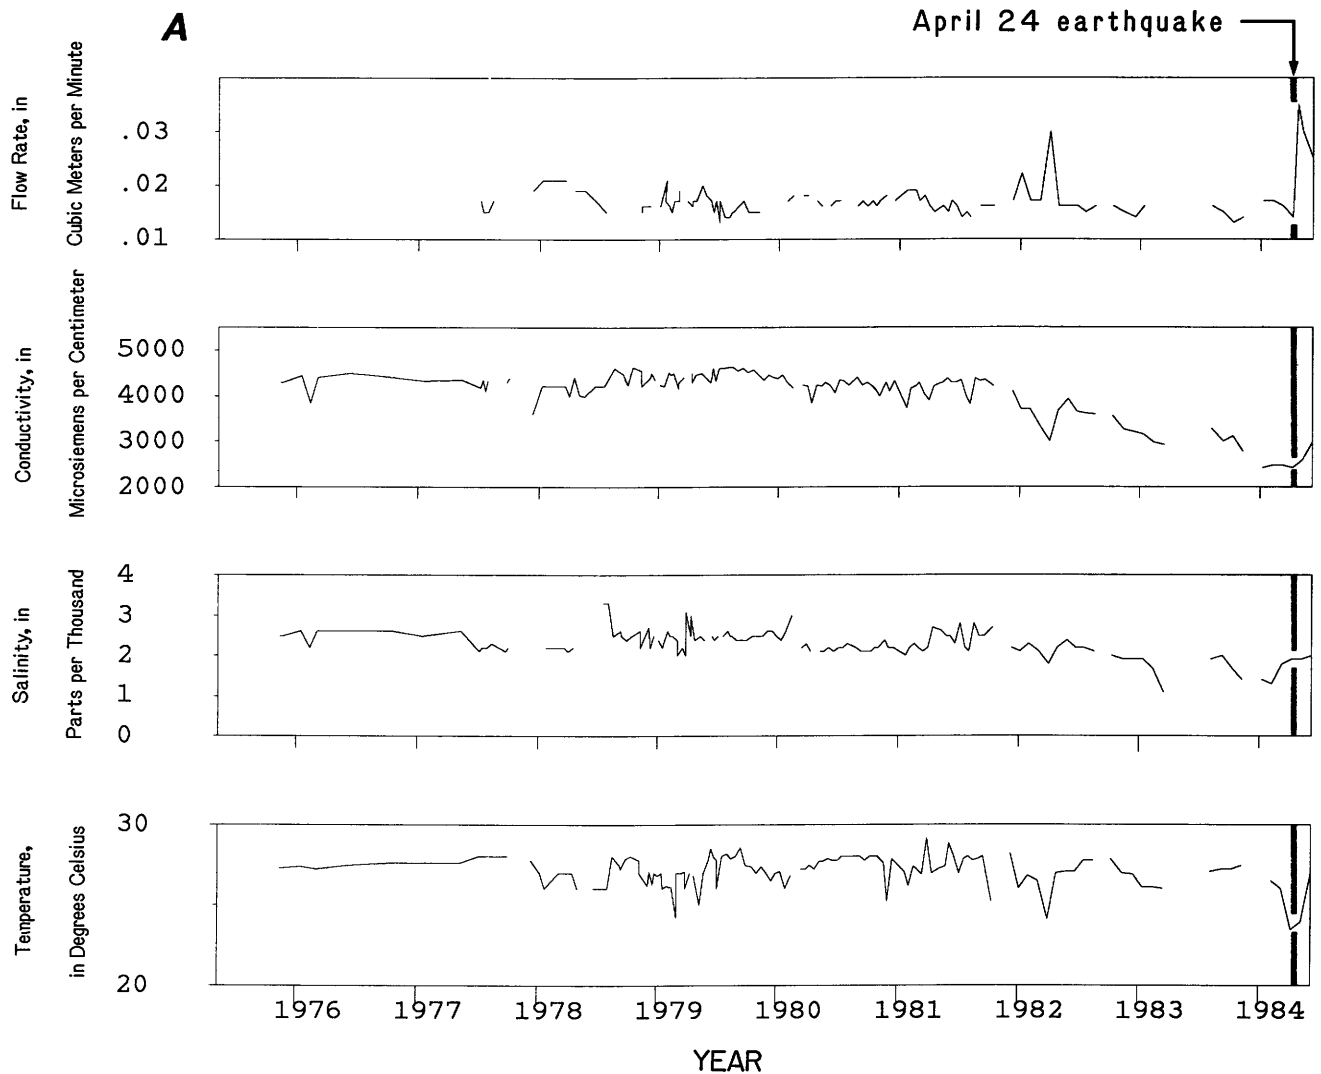
Figure 18.2. Flow rate, conductivity, salinity, and temperature data from two springs in Alum Rock Park. A, Sulfur Spring 11. B, Sulfur Spring 4.
