Chapter 3 Field Survey Report on the 2004 Indian Ocean Tsunami along the Southwestern Coast of Sri Lanka

3.1 Introduction

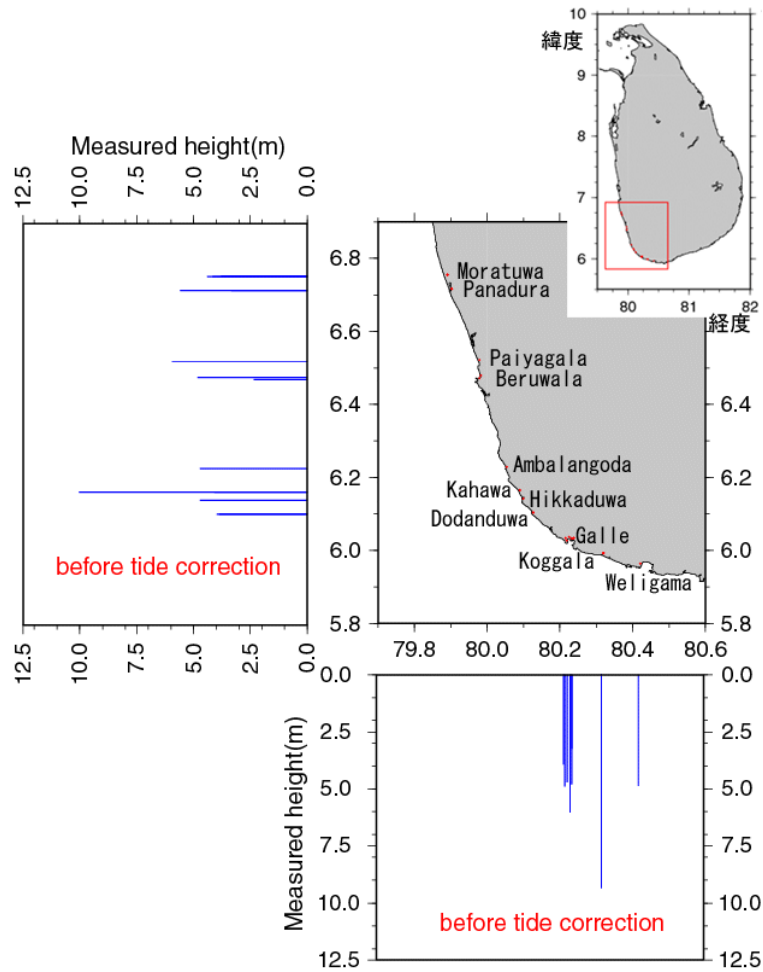
Figure 1 Distribution of Tsunami Trace Heights in southwest Sri Lanka

From these tables and figures, it is obvious that the tsunami trace heights were 6m in the Galle port and 10m in the Kahawa district, which is located 90km to the south of Colombo. However in the Beruwala district, which is located 53km to the south of Colombo, the tsunami trace heights were about 5m, and only 2.5m inside the fishing port. This suggested the effect of the wave-break and sea wall here reduced the tsunami attack. Details about this phenomenon are described in 3.3.2. It is indicated that the typical tsunami trace heights along the coast in the southwest of Sri Lanka were about 5m by the field survey, except for two points: Koggala Airport and Kahawa.

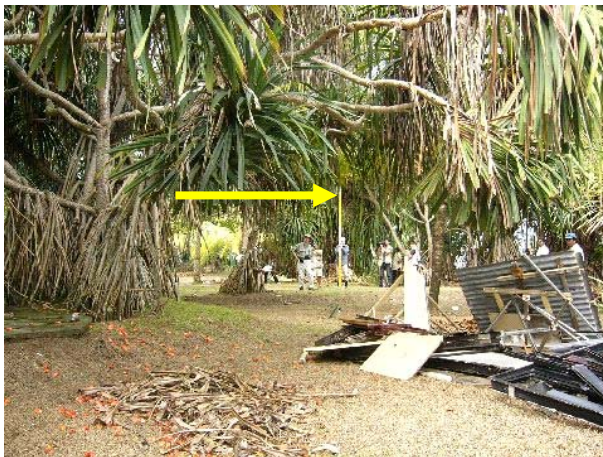
Photo 1 Tsunami trace in Koggala district

Koggala, where the airport is located, is 10km to the east of Galle. And its average altitude is only 3.6m above sea level. The distance from the beach is 100m, where many trees were damaged by seawater. The measured heights are about 9m as shown in Photo 1. Because the flat land continues inland, the inundation area was large. The tsunami trace of 15cm height was found on the exterior wall of a house located 300m from the shoreline. A chain link fence 200m from the shore was crushed as shown in Photo 2, suggesting a powerful wave force acting on the wall.

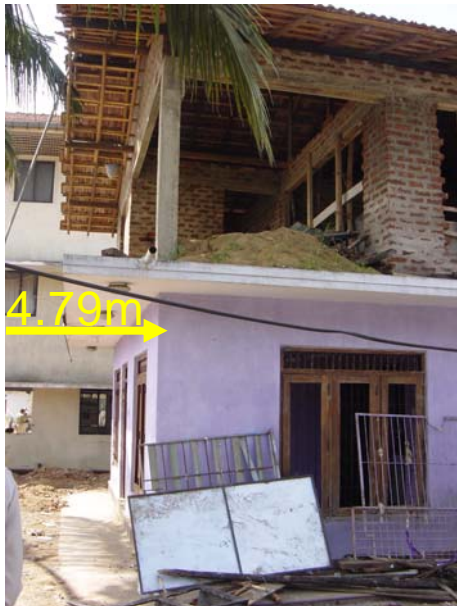
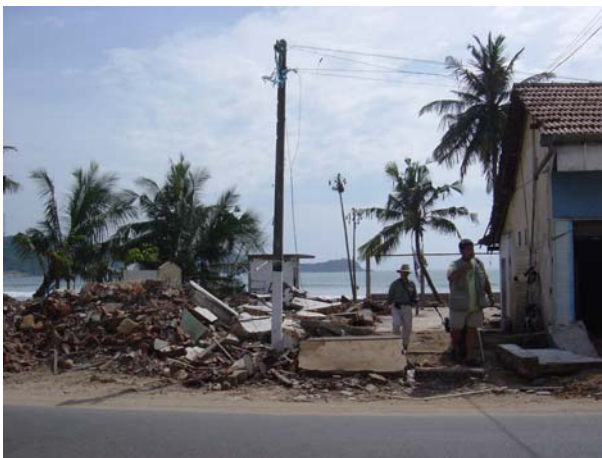
Photo 3 Tsunami inundation level (upper) and destroyed beachfront house (lower)

In the coastal areas there are two types of houses where the heights of tsunami traces on the walls were different. For the first house, the tsunami inundation height on the ground was largely 2.6m and the trace heights were 4.8 m, where the brick house at the front facing the coast had been completely destroyed as shown in Photo 3. On the other hand, the tsunami inundation heights on the second typed house was only 0.6 m and trace height was 3.2 m, where a house at the sea side was damaged but barely remained as shown in Photo 4. The inundation/trace heights of a tsunami are influenced by the situation such as existed house/building/green on the coast, so that we should carefully report this after the investigation and it is important to obtain the distribution of tsunami heights on the land in order to look at the effects.

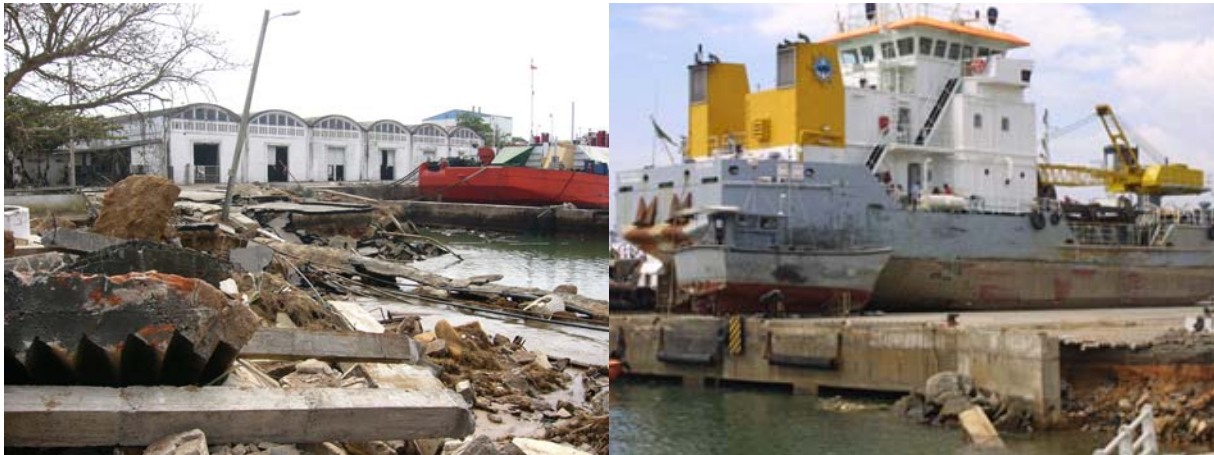
Photo 5 Damage on the quay at the Galle Port Photo 6 Dredger ship carried onto the quay

Tsunami traces were found on the wall of the warehouse and of the office building located at the entrance of the inland. The trace heights above the mean sea level were 5m and 6m respectively. Though breakwater was not severely damaged, the quay was destroyed as shown in Photo 5 and the port was not running when we visited after the tsunami attack. The dredger was carried onto the quay, as shown in Photo 6.

At Galle Port, the height of the tsunami trace was about 5 m, and there was damage to the quay, scouring of the quay foundations by the undertow, a dredger was lifted up onto the quay itself, and the first floors of harbour buildings were inundated. Even though the damage was not catastrophic the port stopped running. And the influence and impact on not only the rehabilitation and reconstruction but also on the local society became significant.

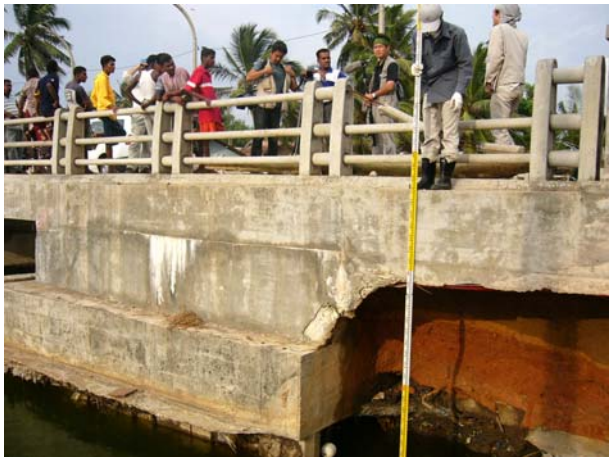
Photo 7 Damaged concrete handrail of the bridge

In Dodanduwa, which is 12 km in north of Galle, there is a concrete bridge constructed at the river mouth. It appears to have been built recently. The concrete handrail of the bridge, which has a thickness of about 20cm had broken. The handrail was 3.9m high. It was partially damaged as shown in Photo 7. It is explained from the situation that a broken fishing boat as shown in Photo 8 has been scattered that drifting debris collided. The people at this village told us that some of them were washed away by the tsunami flood though they evacuated across the bridge. Two people who had taken a motorcycle onto the bridge were also washed away by the tsunami..

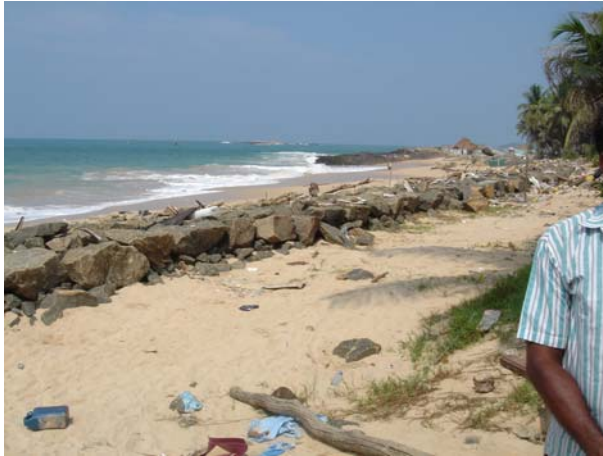
Photo 9 Erosion countermeasures

In Ambalangoda, which is about 80km to the south of Colombo, the tsunami trace was found to be 4.7m high on the exterior wall of an inundated house. Photo 9 shows coastal erosion countermeasures, consisting of stones of about 500kg in weight. It seems that the houses on the seafront were not destroyed because of the rubble revetments. However, the foundations of the railway line inland behind the village were severely scoured by the tsunami that propagated into the river, as shown in Photo 10. It is suggested that the horizontal vortex that formed after passing the river mouth would have caused the severe erosion.

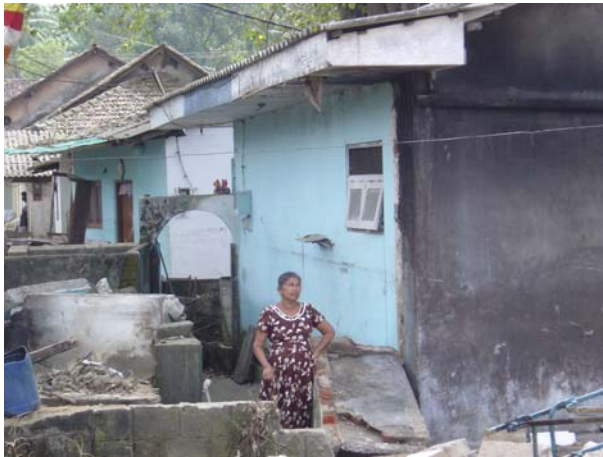
Photo 11 Barely damaged houses behind the Beruwala fishing harbour

In the Beruwala district, which is located 53km to south of Colombo, the tsunami trace height outside the fishery harbor exceeded 4 m, though it was only 2.3m from the sea. The houses had not been destroyed behind the fishing port, as shown in Photo 11, it is thought that the tsunami power was reduced by the breakwaters in the harbour. A lot of fishing boats were washed away from the harbor by the tsunami back current, and were carried along the coast by the following tsunami attack, as shown in Photo 12.

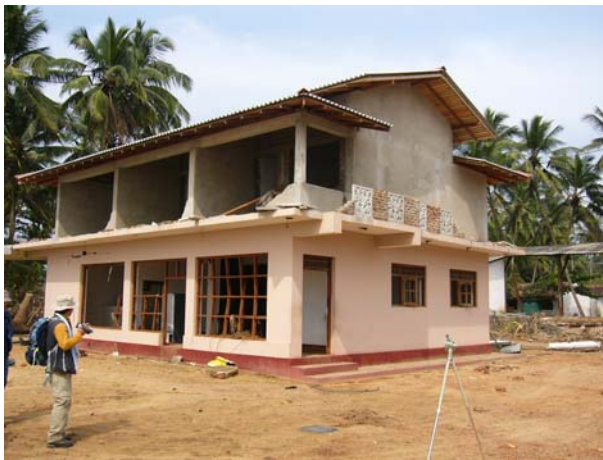
Photo 13 Barely damaged building made of concrete

In Paiyagala, which is 48km to the north of Kahawa, there was a tsunami trace which was about 6m above the mean sea level. This inundation level was 4.2m inland. Photo 13 shows that only the doors and windows of concrete houses were damaged.

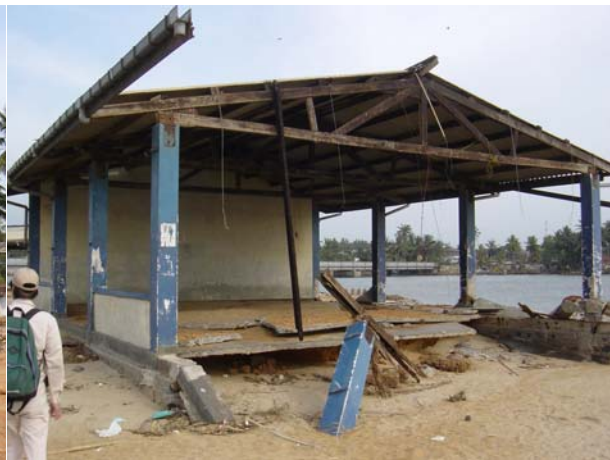
Photo 14 Concrete floor damaged by the tsunami lifting force

The Panadura district, which is 25km south of Colombo, is located between a river and the sea. It is indicated that the damage was caused by both the tsunami surging up the river and coming in from the sea. The impact of the tsunami, especially the lifting force, was able to destroy the concrete floor and roof of the building shown in Photo 14.

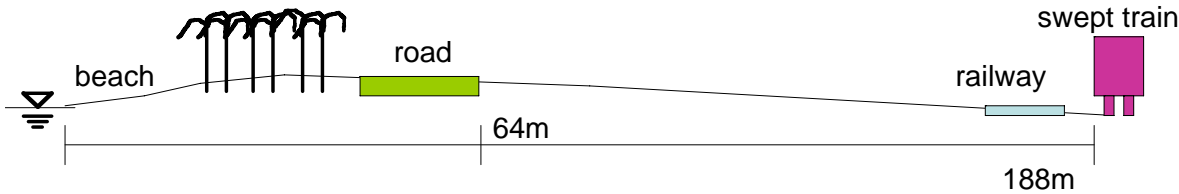
Figure 3 Cross section of the damaged area, Kahawa, where the train was washed away

At Kahawa a nine-car train was damaged, killing about 1,500 of its passengers. This train happened to have stopped while passing this point when the first wave of the tsunami struck. The first wave submerged the land to a depth of about 1m, not causing any damage. The land along the shoreline is a little lower than the coast road (Figure 3), so water brought by the first wave was retained there.

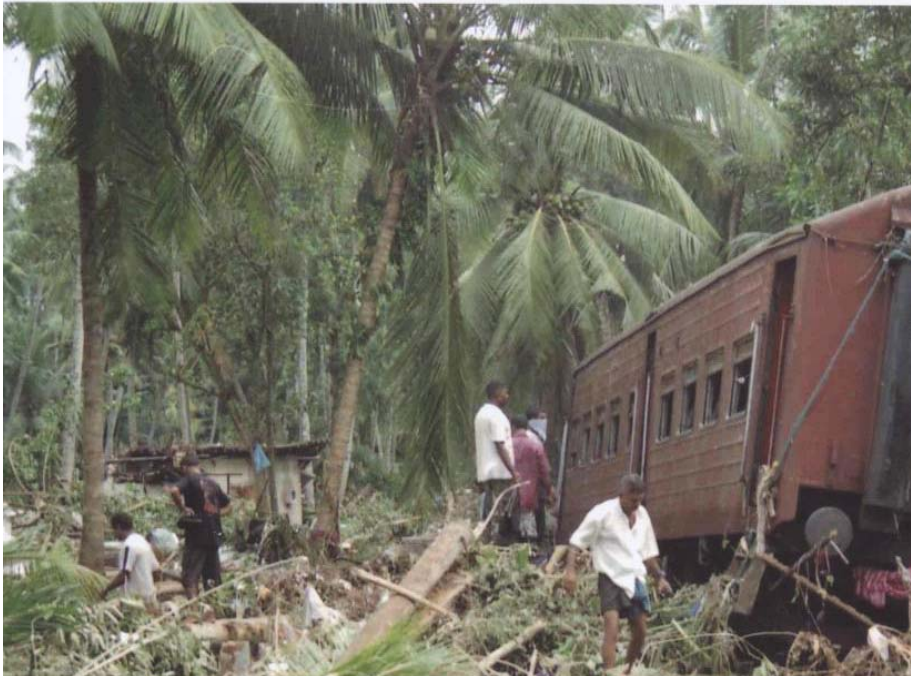
Photo 15 View of the Overturned Railway Train

The residents of the district saw the disaster and began to flee inland. Some of them sought refuge on the stopped train. Generally railway cars are stronger and higher than automobiles etc., so the residents probably thought they were safe. This would be why not only passengers but also residents died in the train cars. But the second wave that struck 30 to 40 minutes later, or about 15 minutes later according to other witnesses, engulfed the train, as shown in Photo 15.

The traces of the second tsunami revealed a submersion depth of about 5 m, and sometimes up to 10 m. The railway cars were not severely damaged, but were filled with sea water that drowned almost all of the passengers and residents who could not escape. It is a tragedy caused by the tsunami that struck in an instant. People started to evacuate after the first tsunami, but lost their lives by seeking refuge inside the train.

Actually, there was school building about 50m from the railway which survived the tsunami. It is important to evacuate people to such a building. When a tsunami strikes, in principle, people should evacuate to a high refuge instead of a place far from the shoreline. In a district where flat ground spreads inland, a usable evacuation site such as a school or building must be prepared in advance.
