# Montlake Landfill Information Summary

January 1999

## **The Montlake Landfill Work Group**

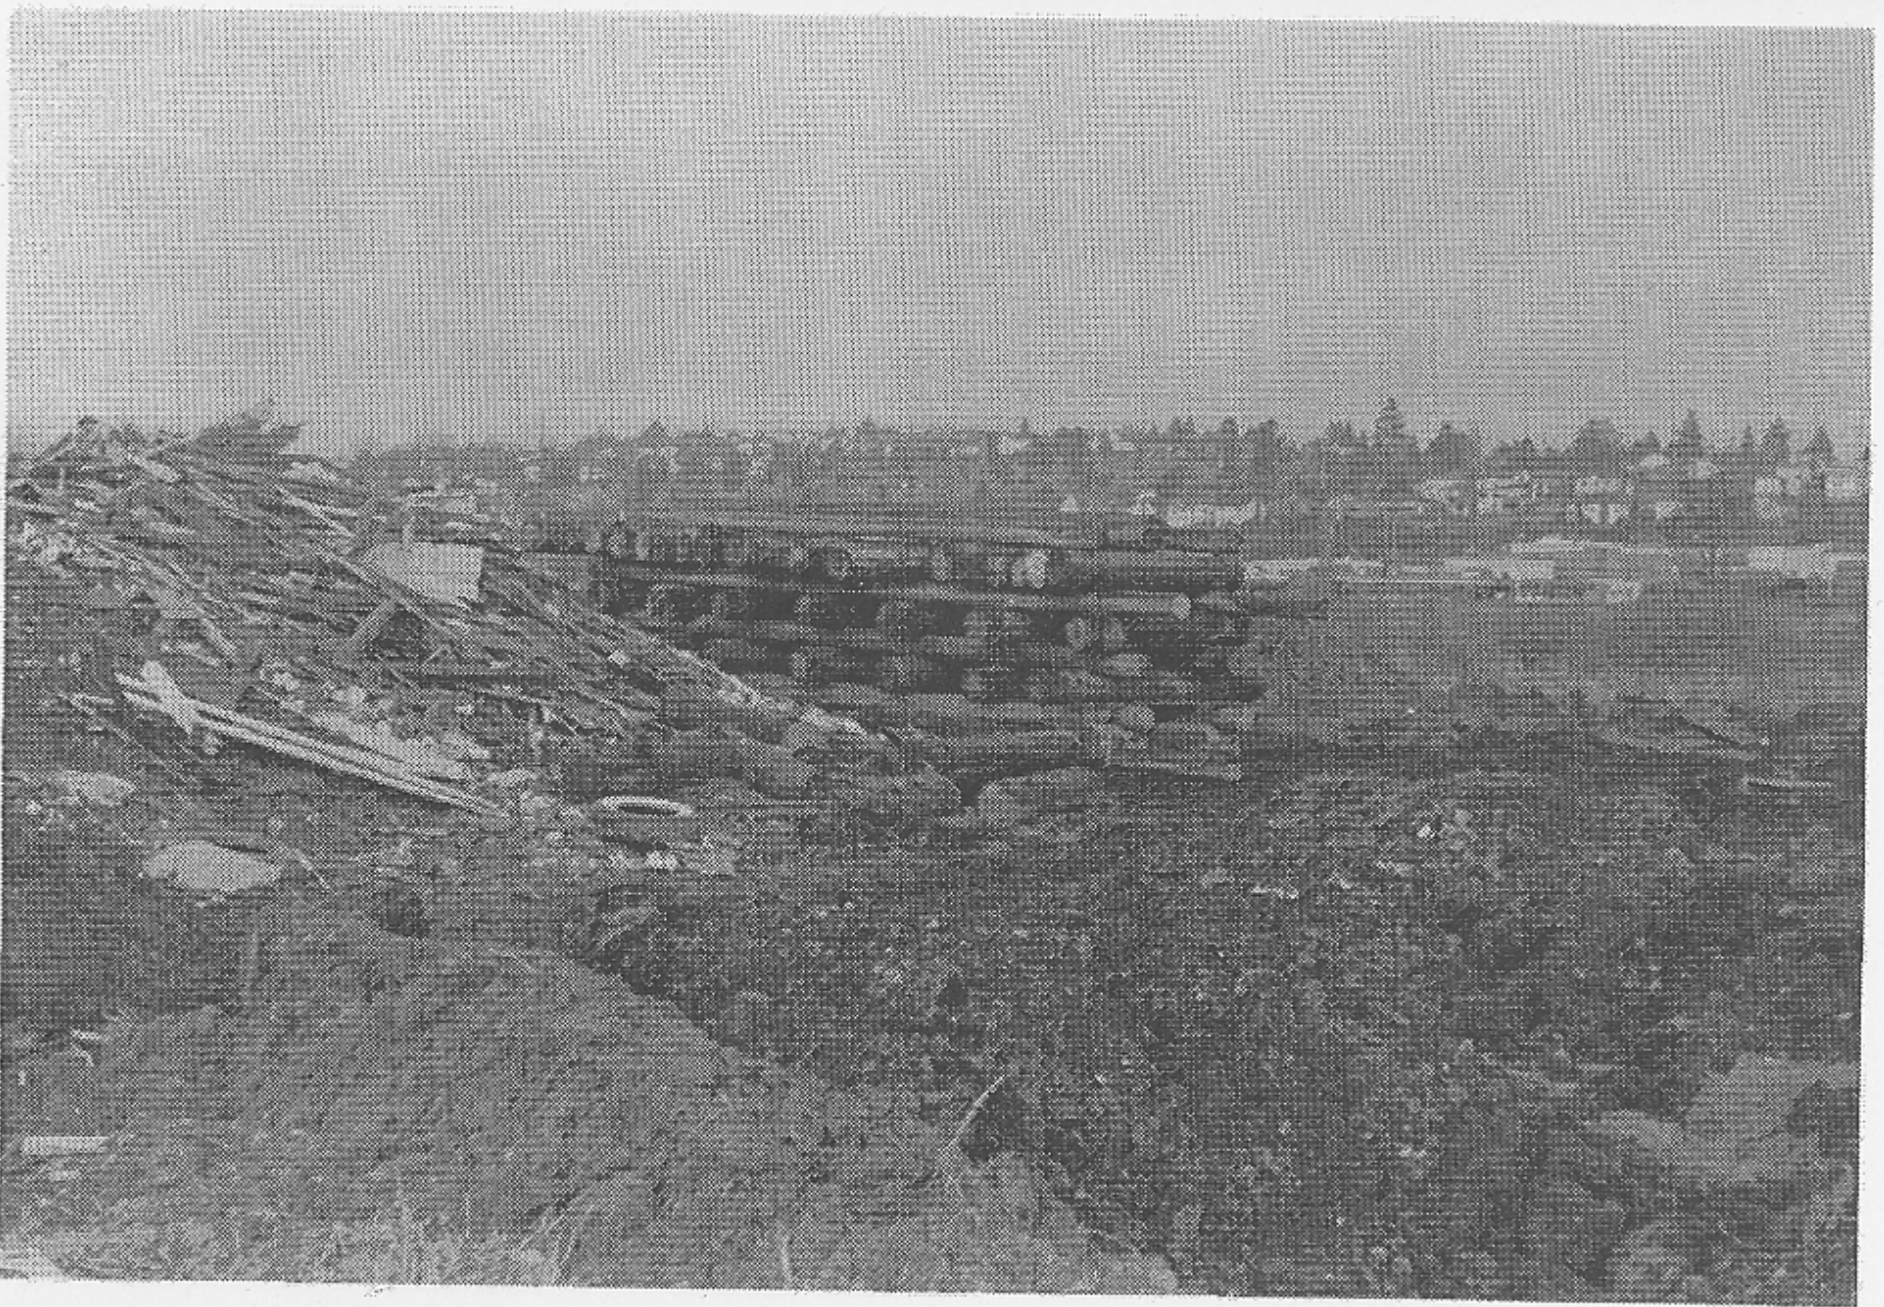
Figure 22: Picture of timber dikes in Montlake landfill January 1960

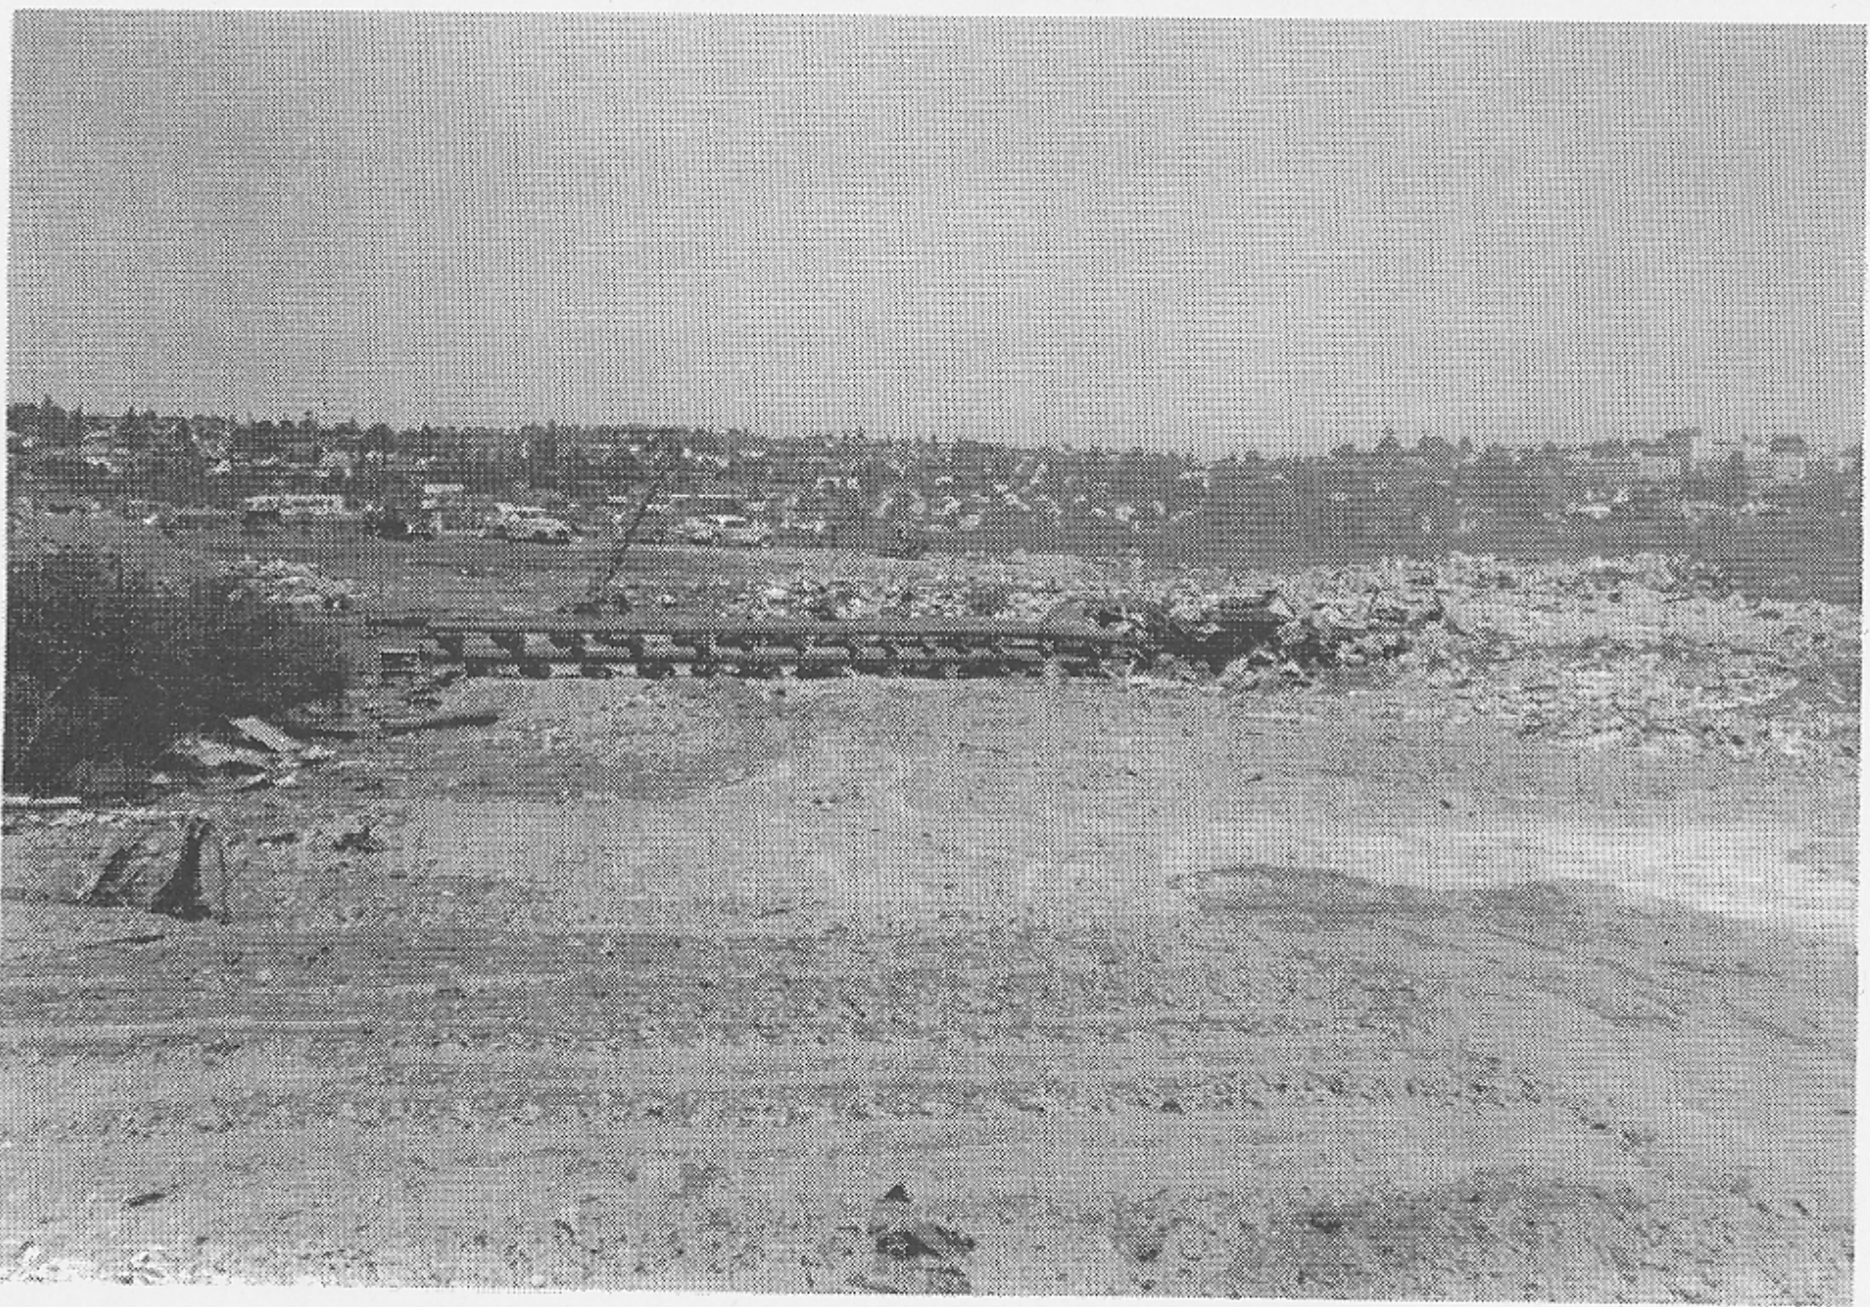
Figure 23: Picture of timber dikes in Montlake Landfill July 1961
