**UNITED NATIONS
ECONOMIC COMMISSION
FOR LATIN AMERICA
AND THE CARIBBEAN –
ECLAC**

LC/MEX/L.367
14 April 1999

**HONDURAS: ASSESSMENT OF THE DAMAGE CAUSED
BY HURRICANE MITCH, 1998**

*Implications for economic and social development
and for the environment*

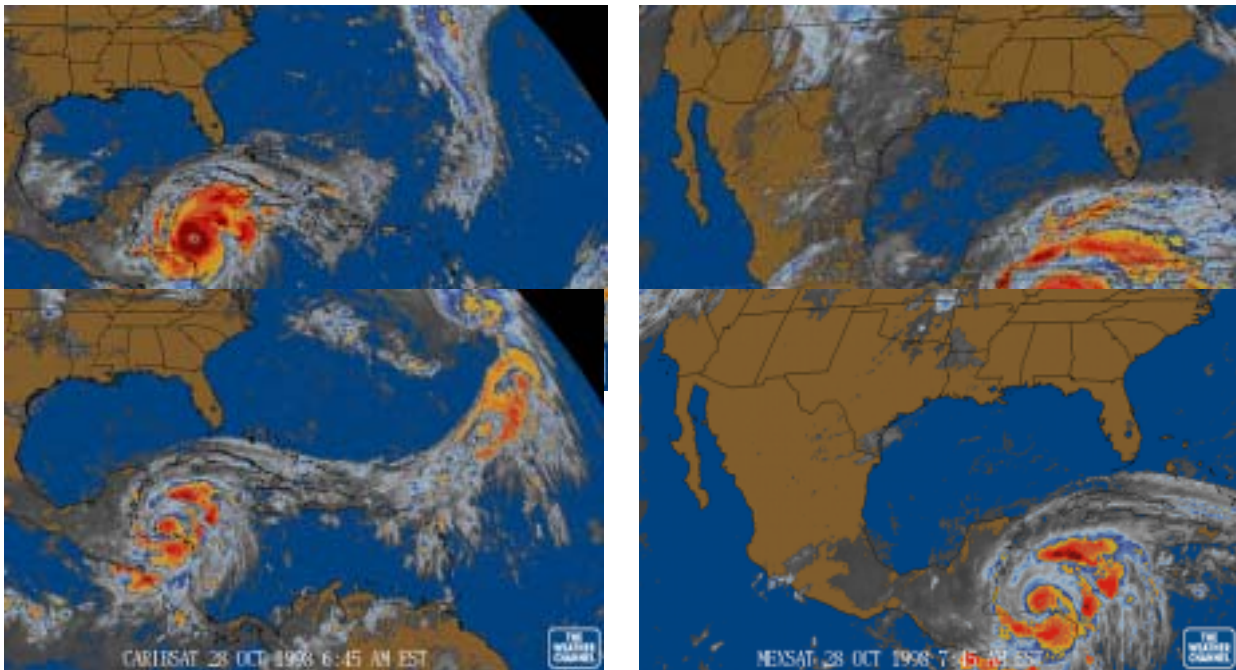
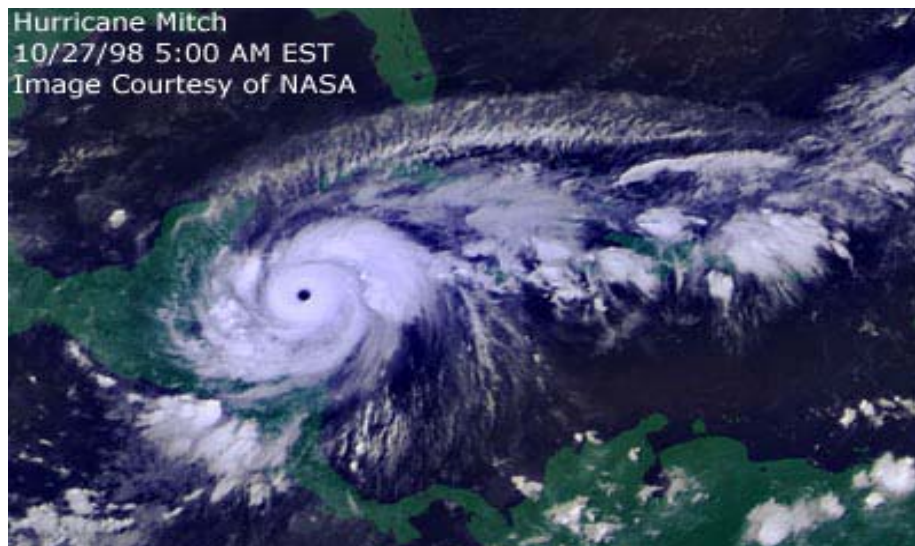
Figure 1

IMAGES OF THE PATH TAKEN BY HURRICANE MITCH

(Between 26 and 28 October 1998)

On Thursday, 22 October, it was upgraded to a tropical storm (named Mitch); its centre was located 704 kilometres south-east of the Nicaraguan city of Bluefields, with steady winds of 72 km/h and gusts of more than 90 km/h. From that time on, it followed an apparently erratic path, varying in intensity and changing course several times between 23 October and 4 November (see Table 2 and Figures 1 and 2).

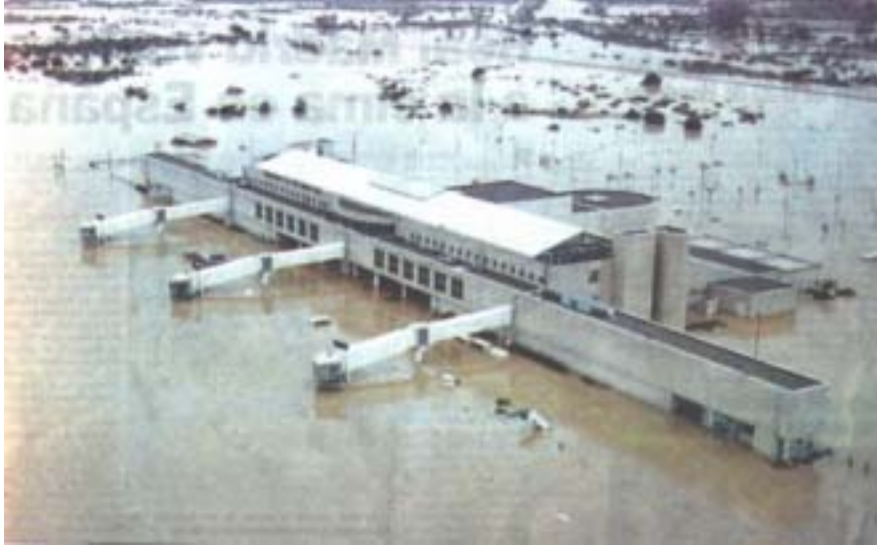
Photo 1. Airport in San Pedro Sula. Damage to facilities and suspension of services.

In its path, the extraordinary amount of rainfall caused rivers to overflow to an extent unprecedented in this century, with very serious flooding on the coastal plain, such as in the suburbs of San Pedro Sula, where several neighbourhoods and the international airport were flooded with mud that damaged housing, road, street, drainage and basic service infrastructure, as well as the radionavigation equipment and facilities in the country's newest air terminal.

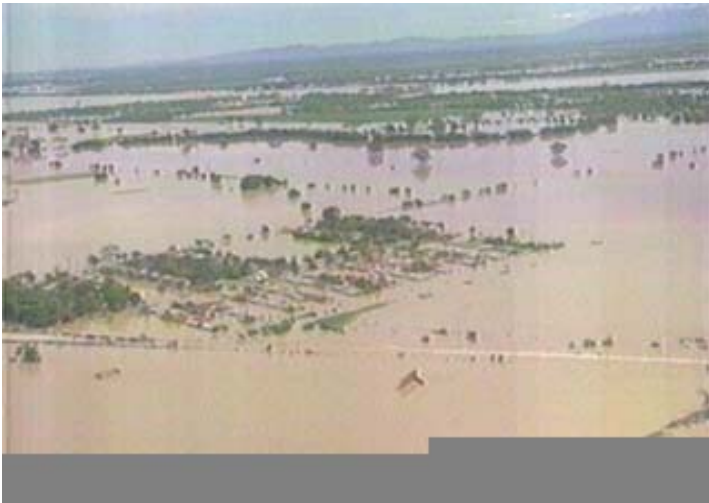
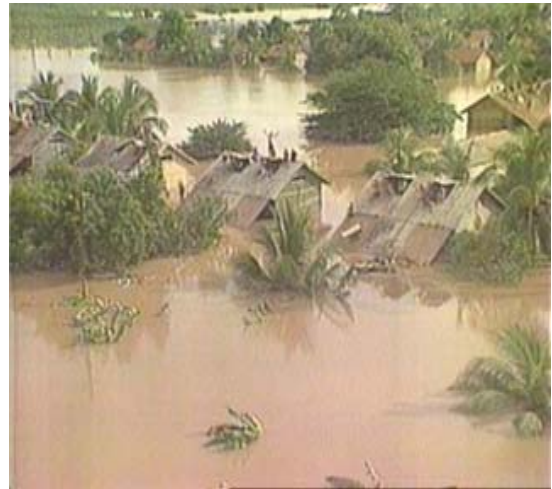
Photos 2 and 3. Flooding in the Aguán valley: waterlogging and damage to housing, communications and power lines.

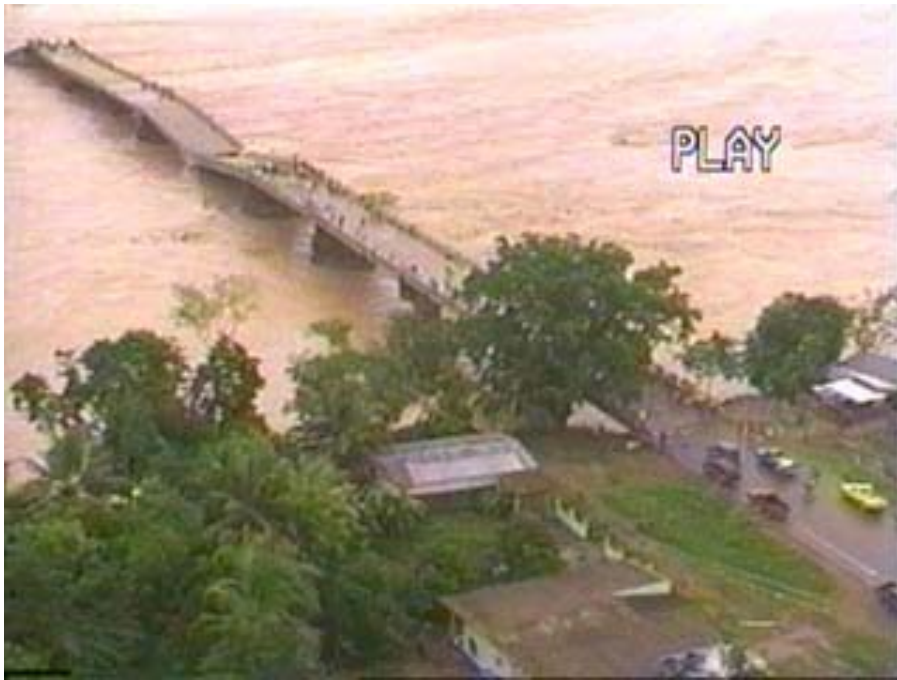
Photo 4. Destroyed bridge in the department of Colón.

As the hurricane reached the steep mountainous areas of Honduras, it caused mud and landslides on the slopes and raging river rapids that swept away bridges, highways and infrastructure of all kinds. The capital in particular was hit by the flooding of the Grande de Choluteca and Chiquito rivers which, on sweeping through built-up areas, rose more than 10 metres above their riverbeds, causing devastation and death. The enormous amount of rocks, vehicles, tree trunks, furniture and all types of debris swept along by the current formed a dam that held back the waters and debris, blocking drains in the area of La Isla.

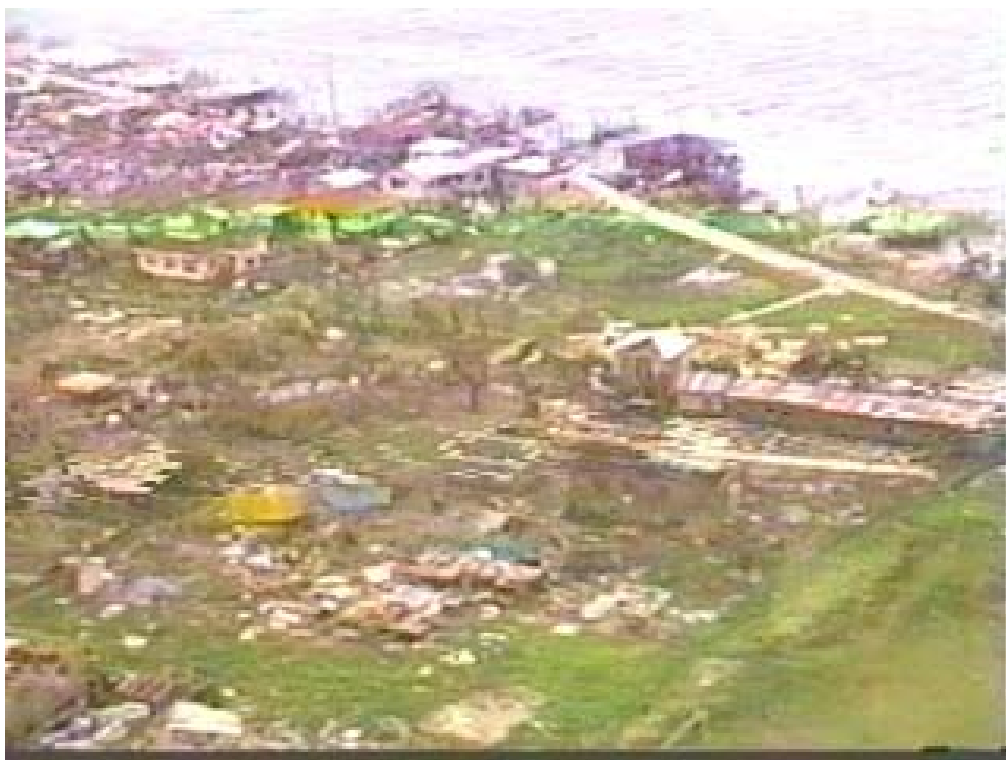
Photo 5. Devastation caused by high winds on Guanaja Island.

At its greatest intensity, the hurricane passed over Guanaja island. At midday on 27 October, the pressure at the centre reached 906 millibars, as it moved along the northern coast of Honduras and slowly advanced southwards, going inland.

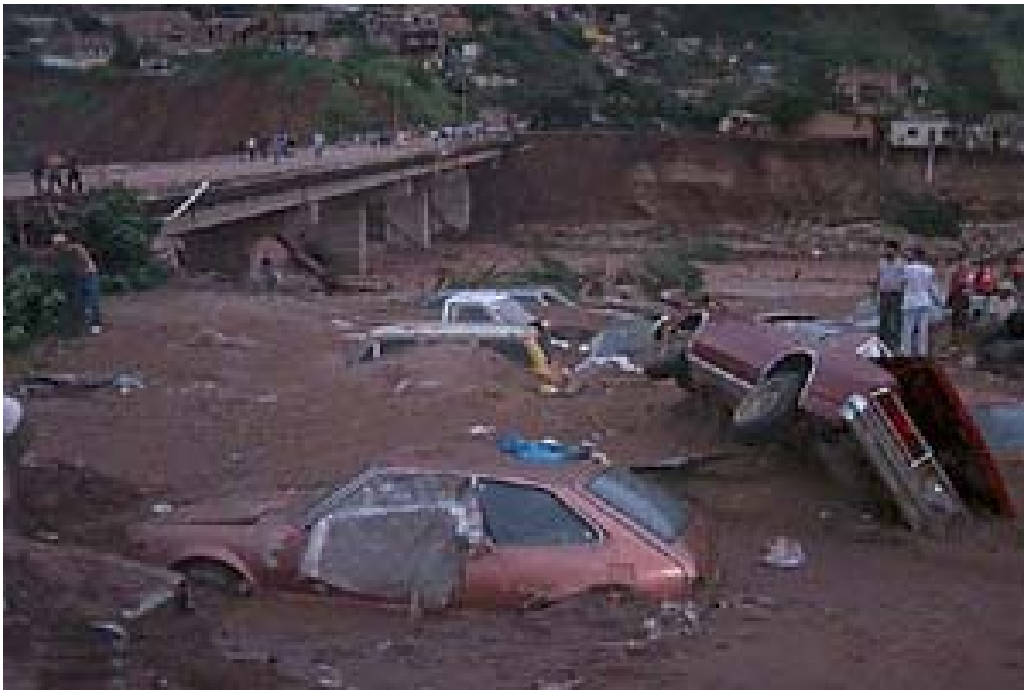
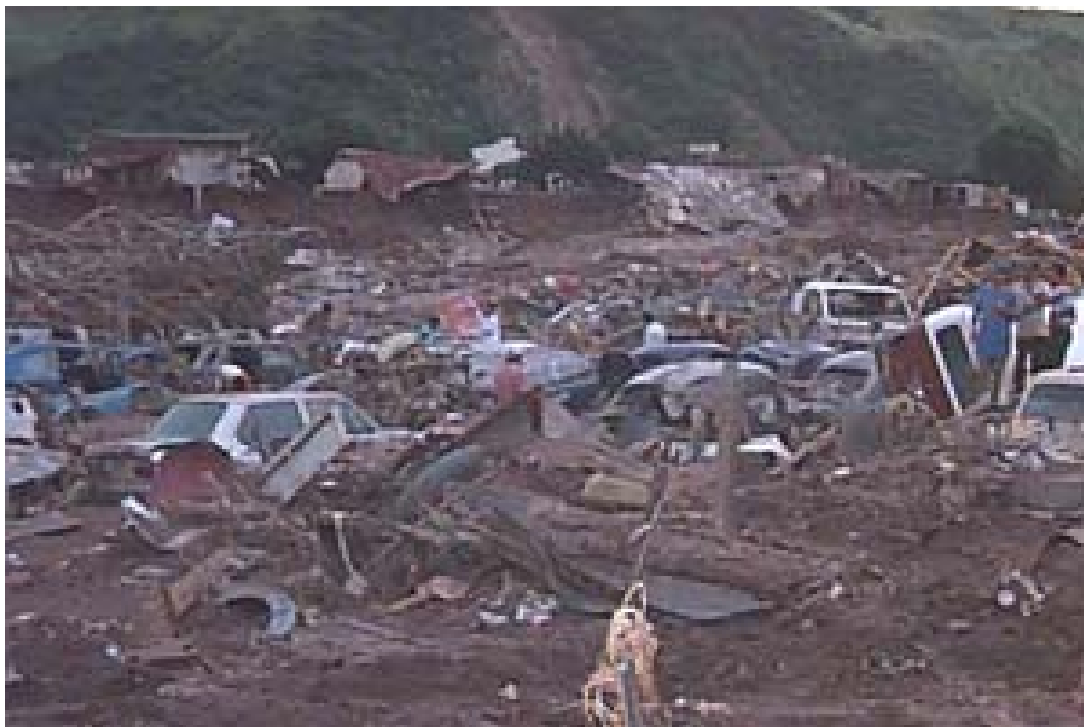
Photos 8 and 9. Effects of overflowing and waterlogging in Tegucigalpa.
