# SURVEY OF THE DECEMBER 26<sup>TH</sup> 2004 INDIAN OCEAN TSUNAMI IN SRI LANKA

## SUMMARY

An International Tsunami Survey Team (ITST) consisting of scientists from the U.S., New Zealand, and Sri Lanka evaluated the impacts of the December 26<sup>th</sup> 2004 transoceanic tsunami in Sri Lanka two weeks after the event. Tsunami runup, height, inundation distance, morphological changes, and sedimentary characteristics of deposits were recorded and analyzed along the southwest and east coasts of the country. Preliminary results show how local topography and bathymetry controlled the limits of inundation and associated damage to the infrastructure. At some sites, human alterations to the landscape increased damage caused by the tsunami.

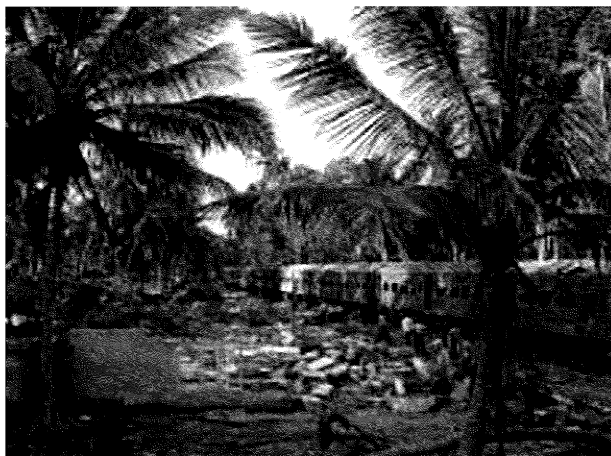
**Figure 8.** Peraliya: “Queen of the Seas” train remains after being placed back onto the tracks (photo from Synolakis et al., 2005).

Damage from the tsunami was more marked at sites where there had been some degree of human disturbance of the environment. In the case of Peraliya (Figure 8), illegal coral mining has been shown to have created “low resistance” pathways that allowed focussed flow and intensified destruction (Fernando *et al.*, 2005).
