Effects of the December 2004 Indian Ocean Tsunami on the Indian Mainland

The 26 December 2004 tsunami significantly affected the coastal regions of southern peninsular India. About 8,835 human lives were lost in the tsunami in mainland India, with 86 persons reported missing. Two reconnaissance teams traveled by road to survey the damage across mainland India. Geographic and topological features affecting tsunami behavior on the mainland were observed. The housing stock along the coast, as well as bridges and roads, suffered extensive damage. Structures were damaged by direct pressure from tsunami waves, and scouring damage was induced by the receding waves. Many of the affected structures consisted of nonengineered, poorly constructed houses belonging to the fishing community.

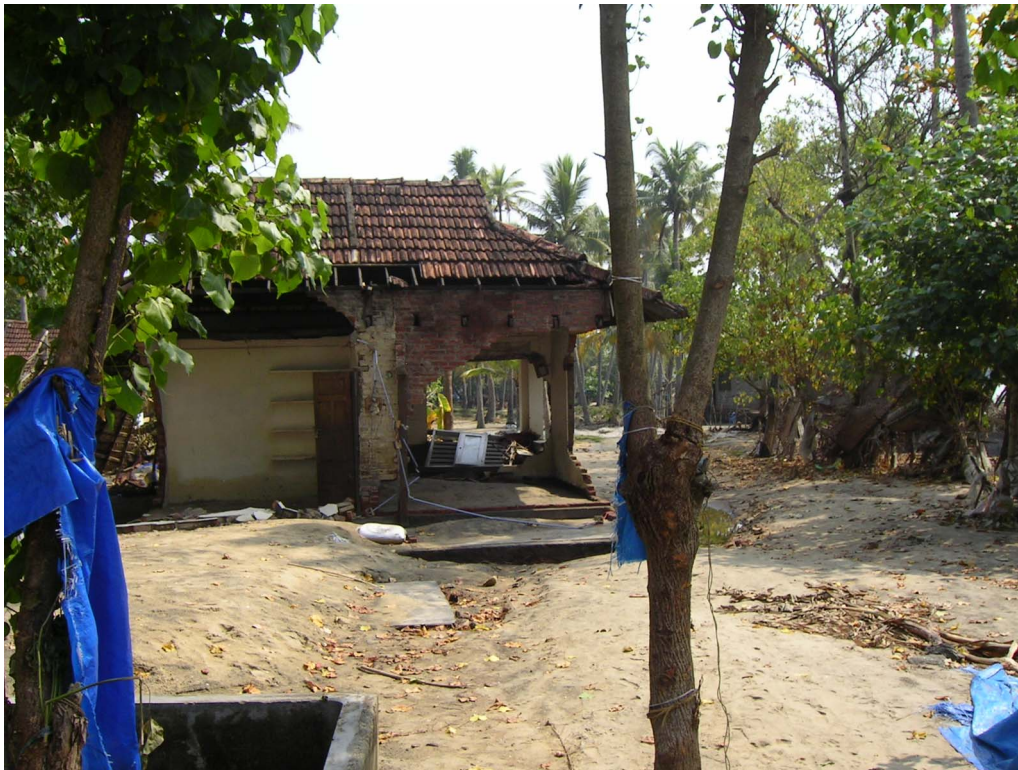
Figure 8. Damaged house in Edavanakkad (photo: A. Sheth).

which triggered collapse of the walls and subsequent failure (Figure 8). However, masonry structures with RC roofs and better integrity performed well even when on the shore (Figure 9), although they too suffered foundation scouring.

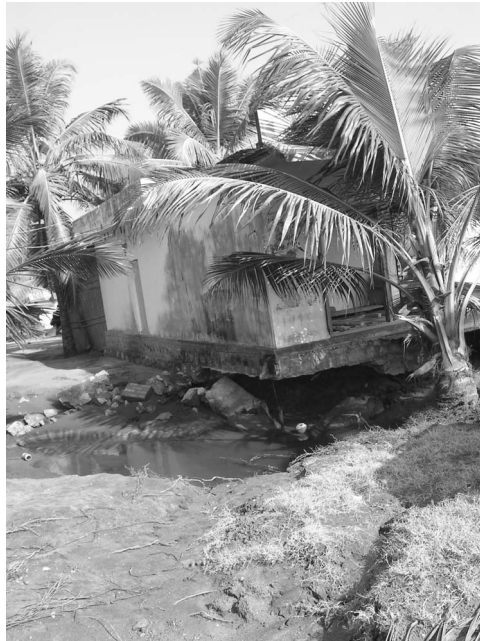
Figure 9. Scouring in Allapuzha—houses were 4–15 m from the shoreline (photo: A. Sheth).

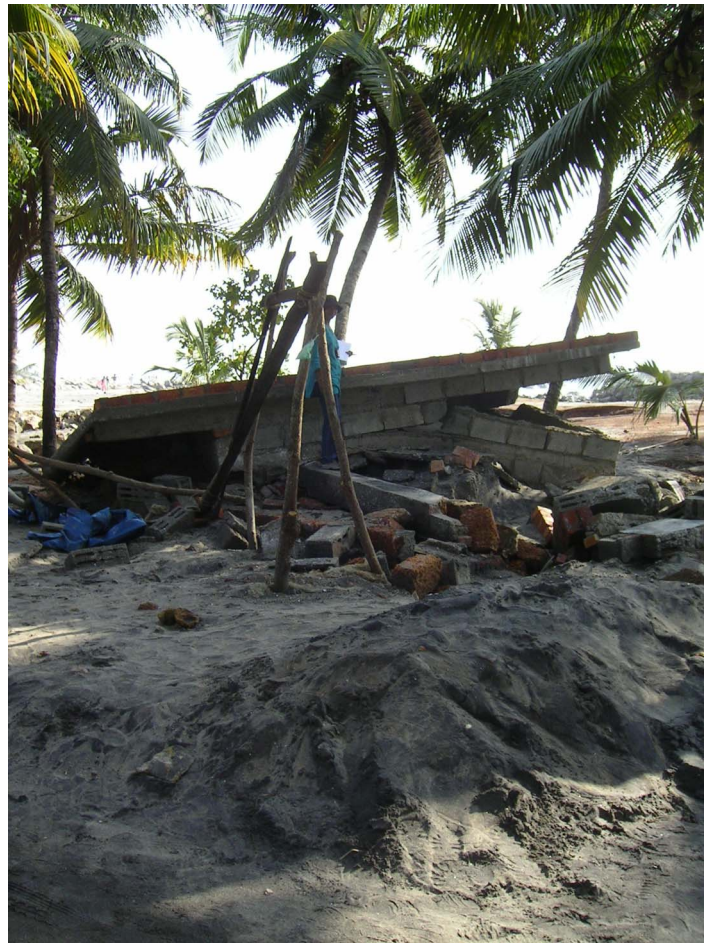
Figure 10. Destruction in the Allapad *panchayat*—a concrete block house with a reinforced concrete (RC) roof (photo: A. Sheth).

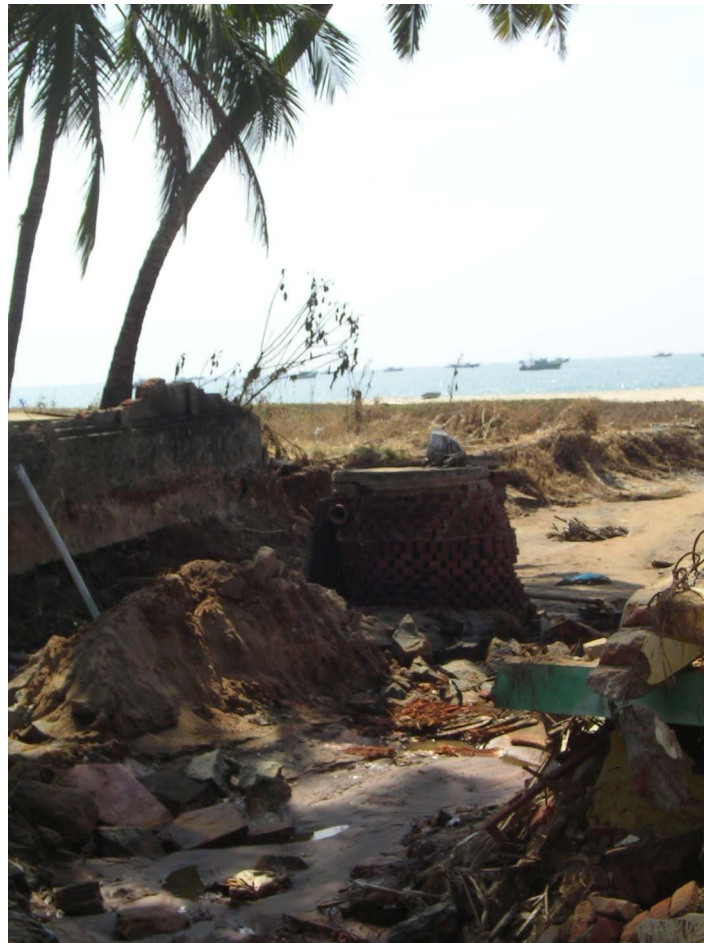
Figure 11. The tsunami carved new waterways—a soak pit was exposed by tsunami waves in Kolachel (photo: A. Sheth).

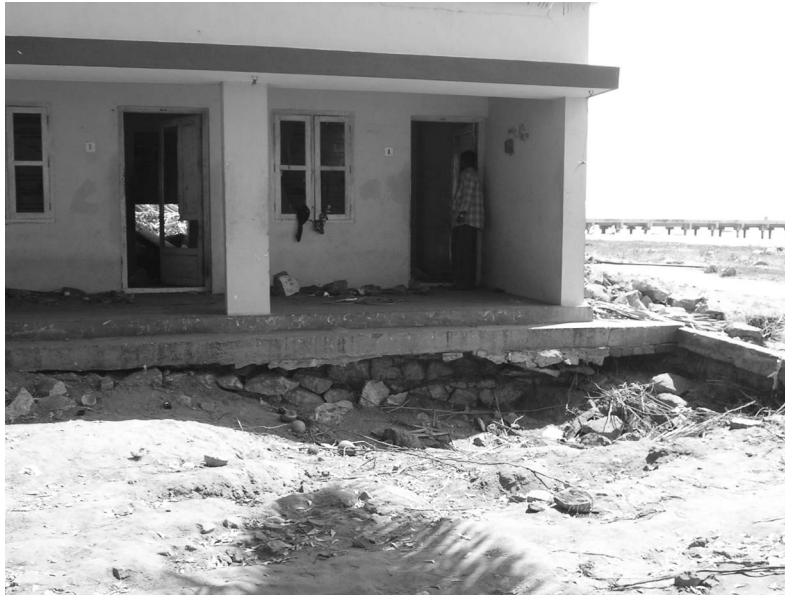
Figure 12. The runup height at Kolachel Beach was 2.6 m, as shown by the watermarks (photo: A. Sheth).

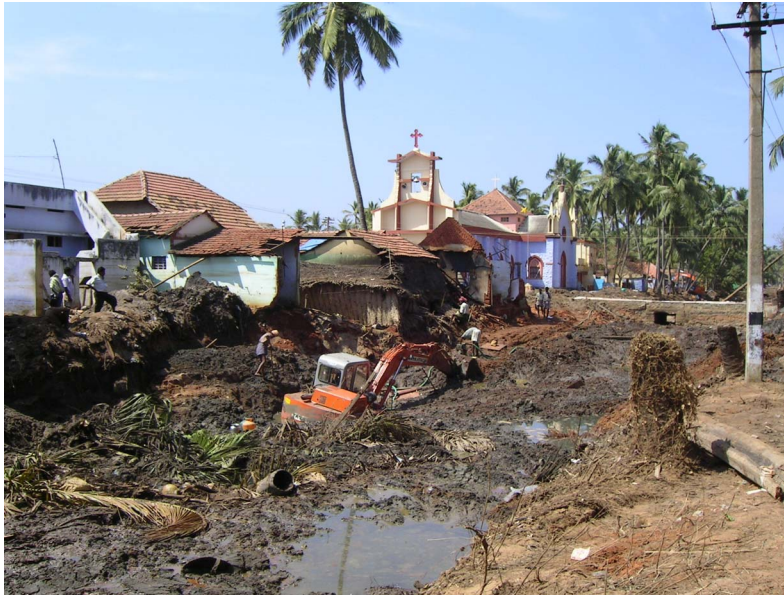
Figure 13. The AVM channel in Kolachel, which became a death trap; more than 300 bodies were found in the slush of the AVM channel and open trenches (photo: A. Sheth).

One of the most affected areas in the district was Kolachel and the surrounding villages, located 30 km west of Nagercoil, which is the capital of the Kanyakumari district. The land near the coast is flat and is at sea level, and no seawall was visible. Water traveled inland by more than 300 m. New streams and estuaries were carved out by incoming waves (Figure 11). When the waves receded, they deepened these features further by scouring. The town and neighboring villages recorded more than 500 fatalities, of which more than 50% were children. The wave height was reported to be 5 m, and the runup height was 2.6 m (Figure 12). A large number of deaths were triggered by the human-created topology of this town. Harbour Road, which experienced the maximum number of casualties, had a long, open, dry channel called the Ananda Victoria Marthandam (AVM) Canal (Figure 13). This canal is more than 2.5 m deep and 6 m wide, running parallel to the shore. The canal was meant to bring in fresh water but was not in use. Besides this canal, there were numerous open trenches laid parallel to each other (Figure 14) that catered to the special needs of the coir-making industry, which is the main means of livelihood in this region besides fishing. These trenches were about 1.5–2 m deep, 15 m long, and 4 m wide. They were used to soak the coconuts and separate the

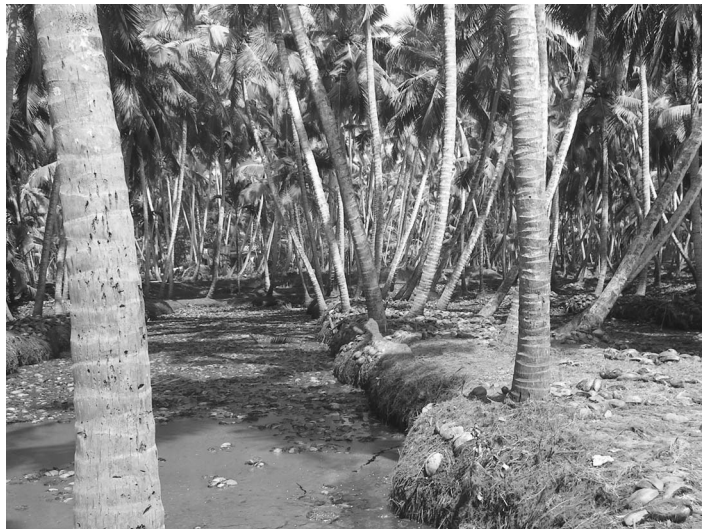
Figure 14. Open trenches for making coir. As with the AVM channel, these trenches also became death traps (photo: A. Sheth).

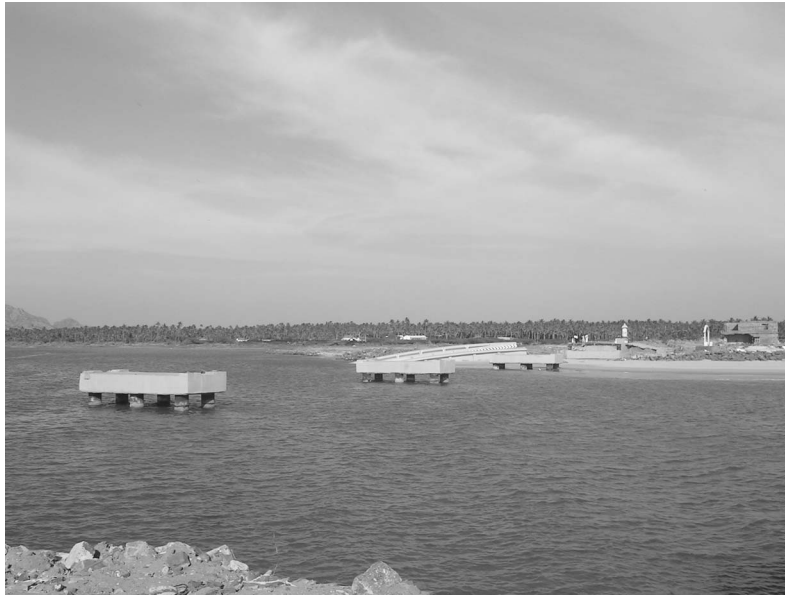
2002 to connect the villages of Melamanakudi and Kelamanakudi on opposite banks of the Pazhyar River. The bridge went missing after the tsunami (Figure 15). It was originally built with four spans, all of which were washed away by the tsunami. The two end spans traveled upstream by 100 m and were beached on the banks; the central spans were not visible, apparently having sunk into the waters. The substructure appeared to be intact except at the apron. There were no restraints between the superstructure and the foundation. Melamanakudi is a prosperous and picturesque hilly village built on the waterfront. A road from the village of Palam to Melamanakudi was reportedly built by leveling the sand dunes in the region, in violation of the coastal regulation zone (CRZ) rules. Numerous houses were built on the seashore not more than 50 m from the shoreline, apparently after the leveling of sand dunes. These houses suffered complete devastation (Figure 16). Structures 250 m from the shoreline suffered little or no damage, because the land sloped upward. About 150 people died at Melamanakudi.

Figure 15. All spans of the Melamanakudi Bridge came off their bearings. The end spans drifted upstream, while the middle spans sank into the river (photo: A. Sheth).

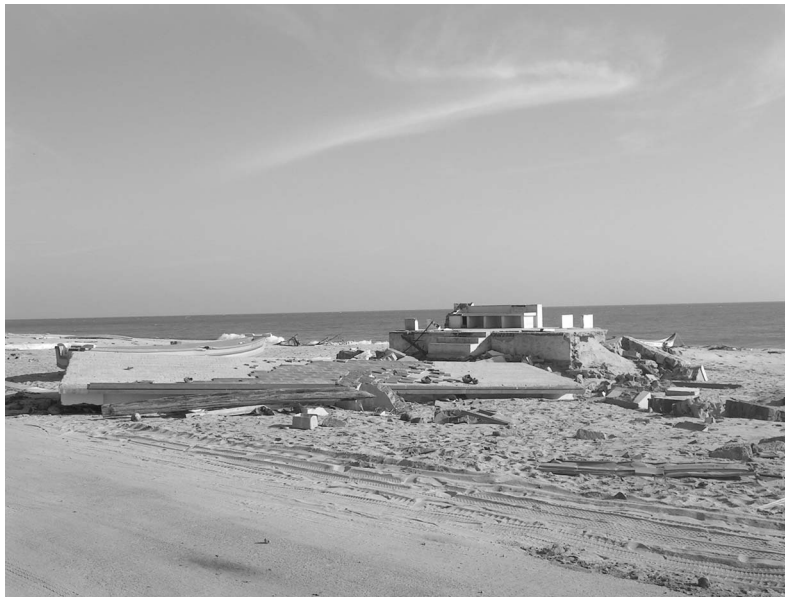
Figure 16. Some homes at Melamanakudi were within 6 m of the shoreline. This photo shows a fallen RC roof slab (photo: A. Sheth).

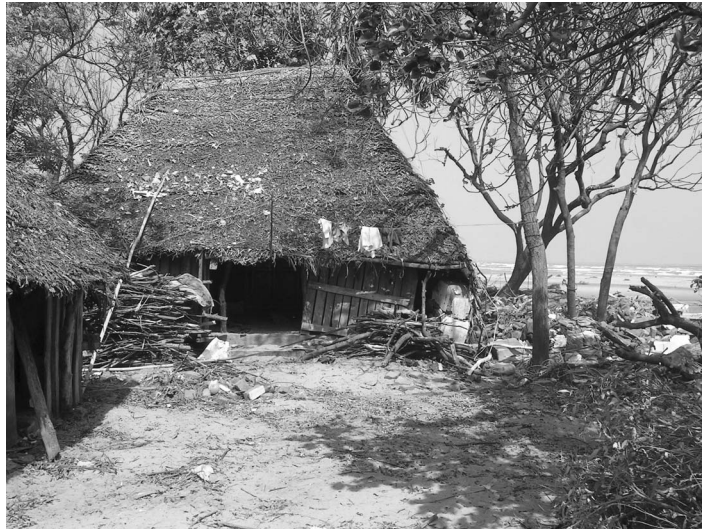
Figure 18. Houses in Seruthur, the village neighboring Velankanni, were not significantly affected, due to a higher plinth (photo: A. Sheth).

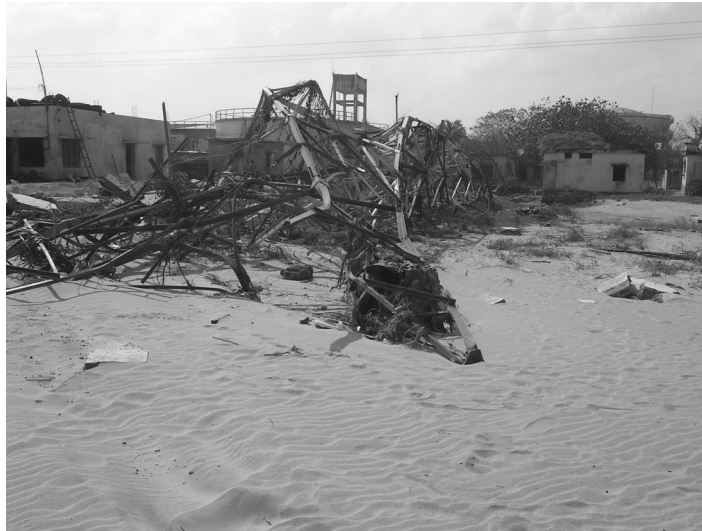
On Ariyanattu Street, a communications tower (Figure 19) and control room (Figure 20) had toppled, while in adjacent Naliyanthottam, a godown (warehouse) storing gas cylinders was destroyed, with all cylinders being swept away by the tsunami. The godown was more than 800 m from the shoreline.

Figure 19. Damaged communication tower on Ariyanattu Street (photo: A. Sheth).

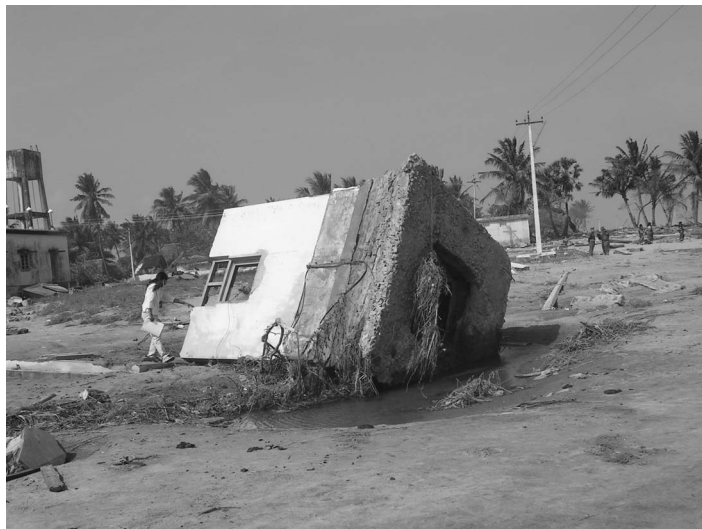
Figure 20. Toppled control room on Ariyanattu Street (photo: A. Sheth).

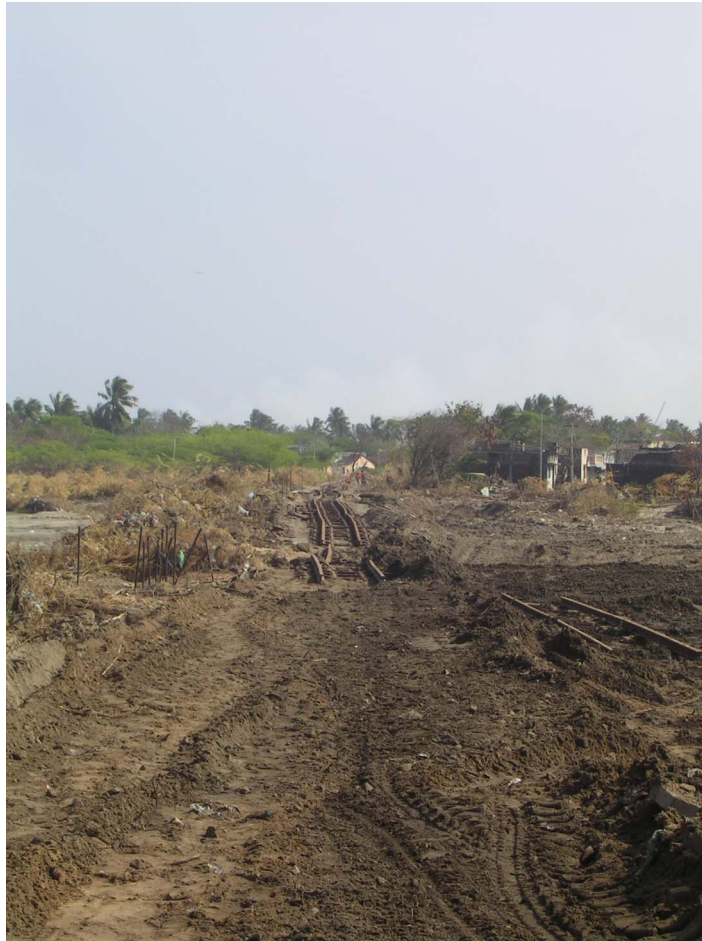
No damage was reported at the oil jetty at Chennai Petrol Chemicals Ltd. at Nagore, primarily because of the high elevation, more than 3 m from sea level. However, 1,200 houses were destroyed or damaged. Water entered almost 1,000 m inland. The rail link to Nagore, a pilgrim town, was cut off as a 7-km meter-gauge track between Nagapattinam and Nagore was completely damaged (Figure 21).

Figure 21. Damaged railway line between Nagore and Nagapattinam (photo: A. Sheth).

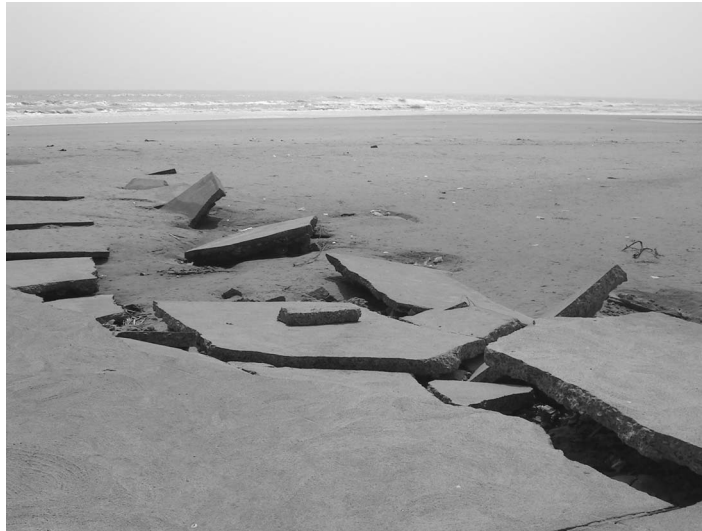
Figure 22. Tsunami waves washed away the newly built roads at Silver Beach, Cuddalore (photo: A. Sheth).

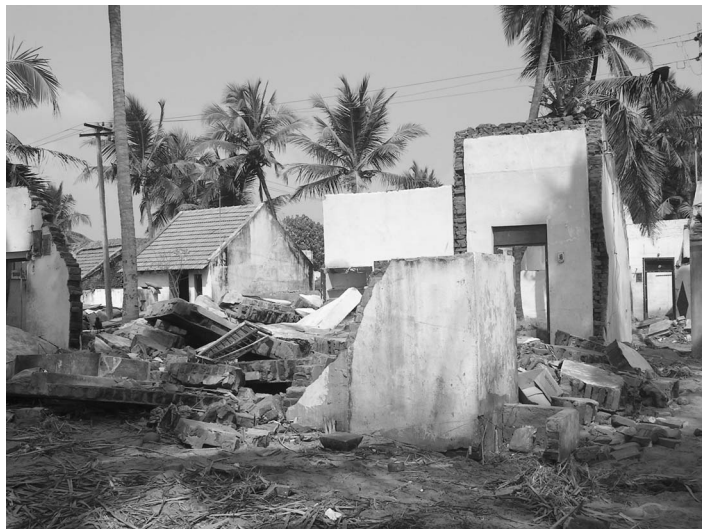
This is a coastal fishing village not far from Silver Beach, built barely 50 m from the shoreline at sea level. Unsurprisingly, houses were significantly damaged (Figure 23).

Figure 23. Houses in Devanampattinam were barely 50 m from the shoreline (photo: A. Sheth).

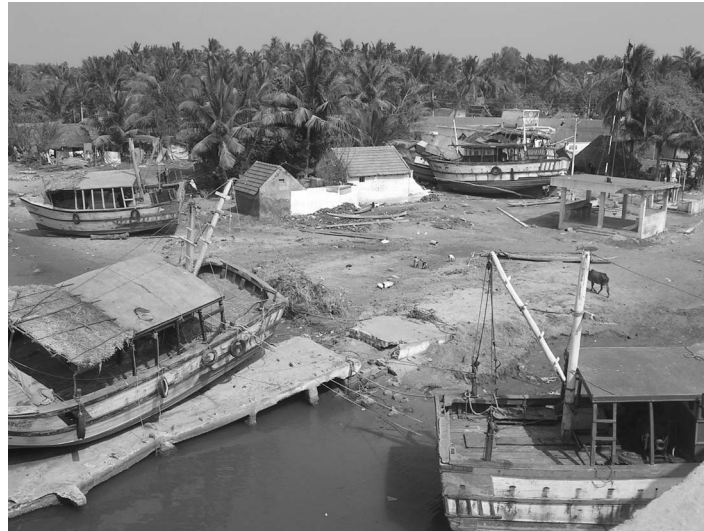
Figure 24. At Singarathop, the bridge from which this photo was taken is much higher than the town and served as a refuge (photo: A. Sheth).

Singarathop was a fishing village with a flowing river. A new bridge connects the town of Cuddalore to Singarathoppu. The tsunami, coupled with the high tide level of the river, caused a severe rise in water level, and the whole town was submerged. The recently constructed bridge had a very high elevation, and residents rushed to this bridge, thus saving their lives (Figure 24).

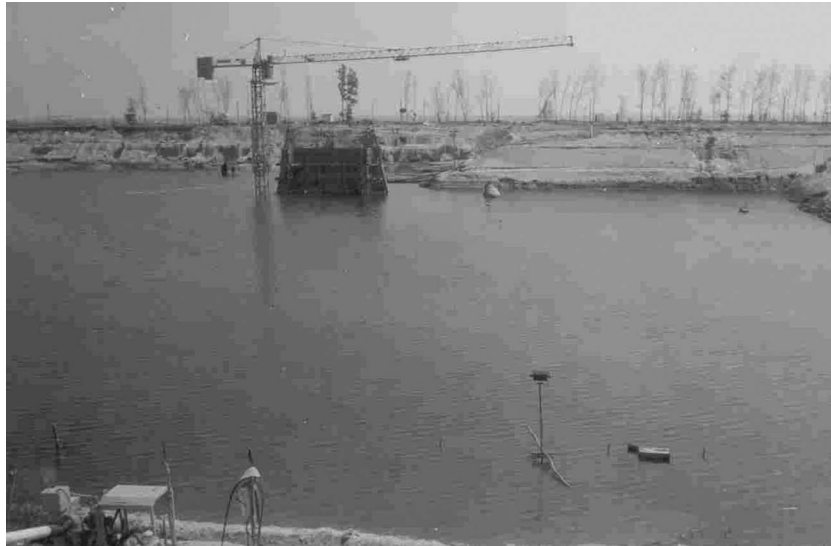
Figure 25. The foundation pit of this 500-MW reactor was inundated by 6 m of water (photo: P. Gandhi).

A foundation of 100×100 m for a 500-MW fast breeder reactor was being constructed about 500 m from the sea. The foundation's pit, which was 20 m deep, was inundated by 6 m. From an observation post, a vigilant project officer had seen the tsunami wave striking the compound wall and warned the 180 people in the pit to immediately evacuate; as a result, there were no casualties. Also, the people had enough time to escape because of the time required for the water to fill the foundation pit (Figure 25).

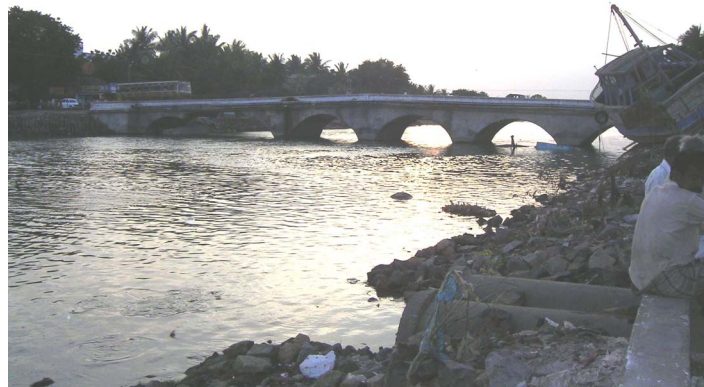
Arasalar Bridge connects the north and south of Karaikal. Tsunami waves traveled through the Arasalar River about 500 m beyond the bridge into the mainland. In essence, water went inland 2.5 km from the shoreline. A pier gave way, causing the collapse of two adjacent arches of the bridge, but the Indian Army put up a temporary Bailey bridge in under six hours. This Bailey bridge was further extended across the entire bridge (Figure 27). A helipad washed away on the south side of a backwater, along with a wooden army jetty. The wave height, according to eyewitness accounts, was about 10 m and was the color of black mud. The runup height was 2.4 m.

Figure 27. Arasalar Bridge—the two southern arches of this bridge collapsed in the tsunami, but a temporary Bailey bridge was erected by the Indian army within six hours (photo: A. Sheth).

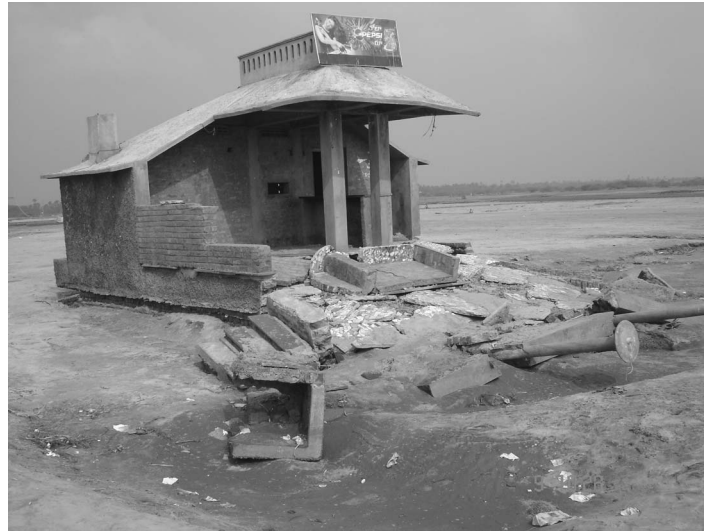
Figure 28. A damaged refreshment center on the beach at Machalipattanam, Andhra Pradesh (photo: A. Jaiswal).

According to narratives of the local residents, the tsunami water came like a running wall at Machalipattanam Beach. It pounded on existing structures such as refreshment kiosks (Figure 28), and it scoured the shallow foundations and washed beach vendors away. The giant waves also left remains of dead deep-sea turtles and completely destroyed a beach children's park.

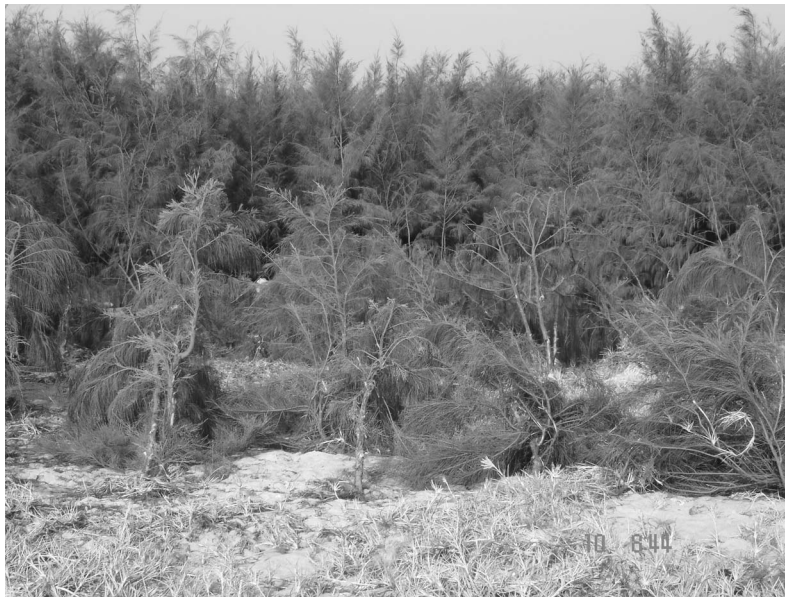
Figure 29. Casuarina trees tilted in the direction of the onslaught of the tsunami waves in Singraikonda (photo: A. Jaiswal).

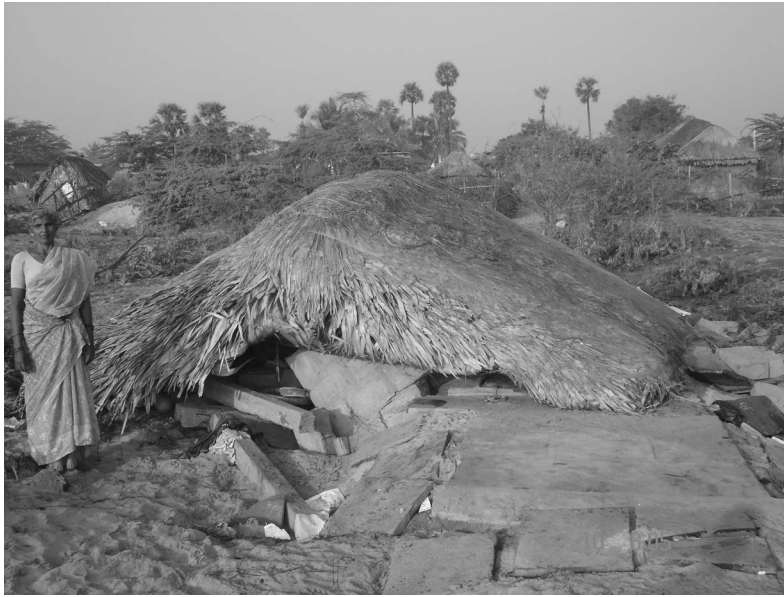
Settlements away from the casuarina shield and within 700 m of the coastline suffered the most damage. Fishermen's huts made of sun-dried adobe and mud-plastered walls with thatched roofs were razed (Figure 30).

Figure 30. Fishermen's huts of adobe and mud plaster walls were razed at Prakasham (photo: A. Jaiswal).

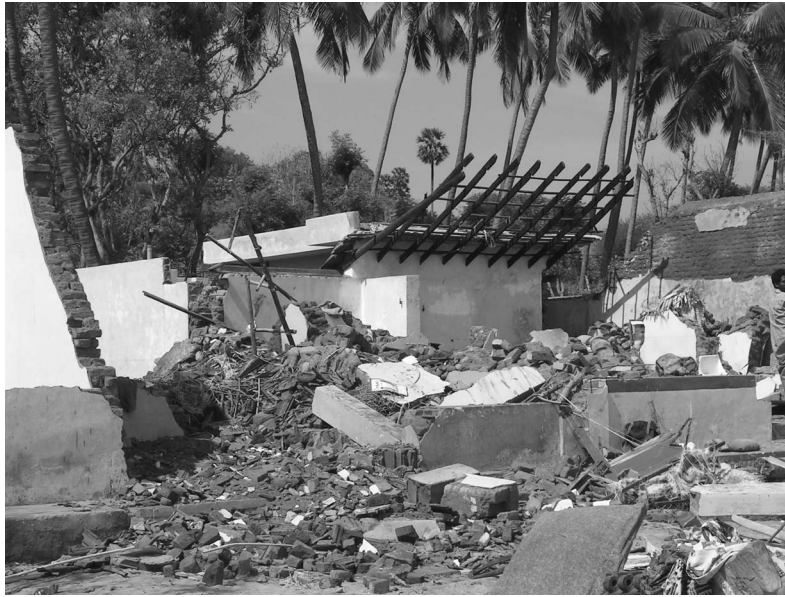
Figure 31. In areas with deeper foundations, masonry superstructures failed first (photo: A. Sheth).

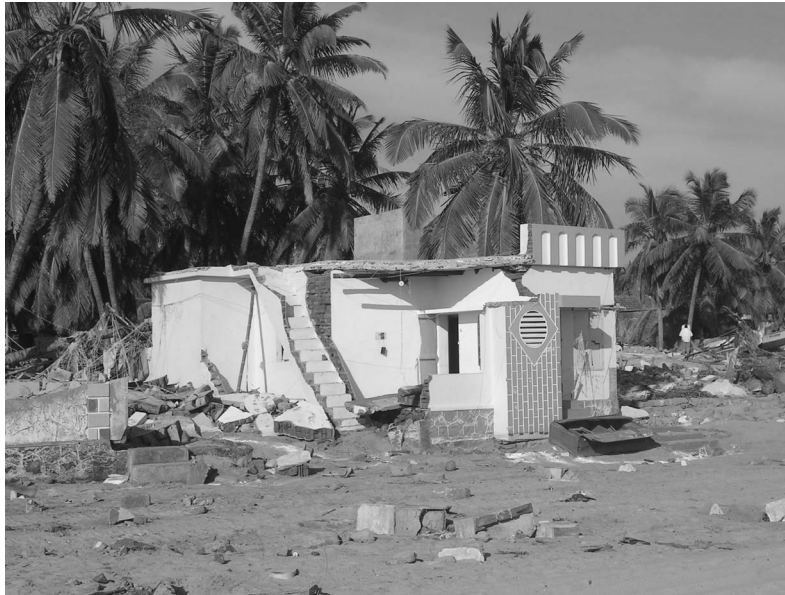
Figure 32. The lack of structural integrity caused failures to trigger at the corners of structures (photo: A. Sheth).

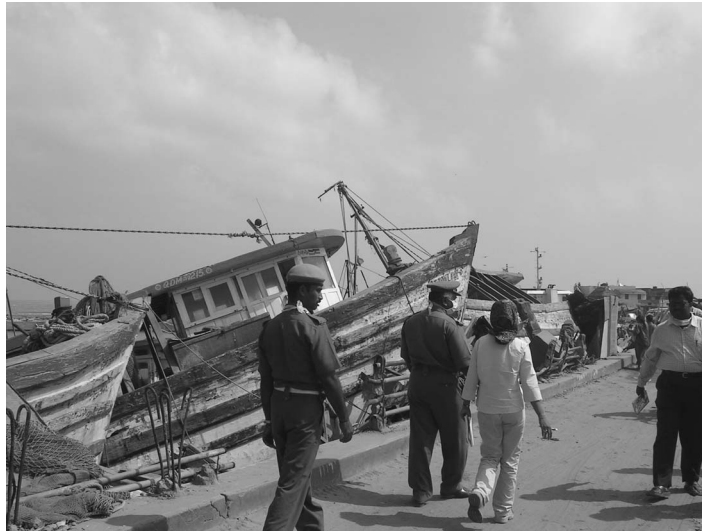
Figure 33. Large boats broke their moorings and damaged a bridge at Akkaraipettai (photo: A. Sheth).
