Congested Corridors Project

Woodhaven Boulevard, Queens

Queens Boulevard to Liberty Avenue

New York City Department of Transportation

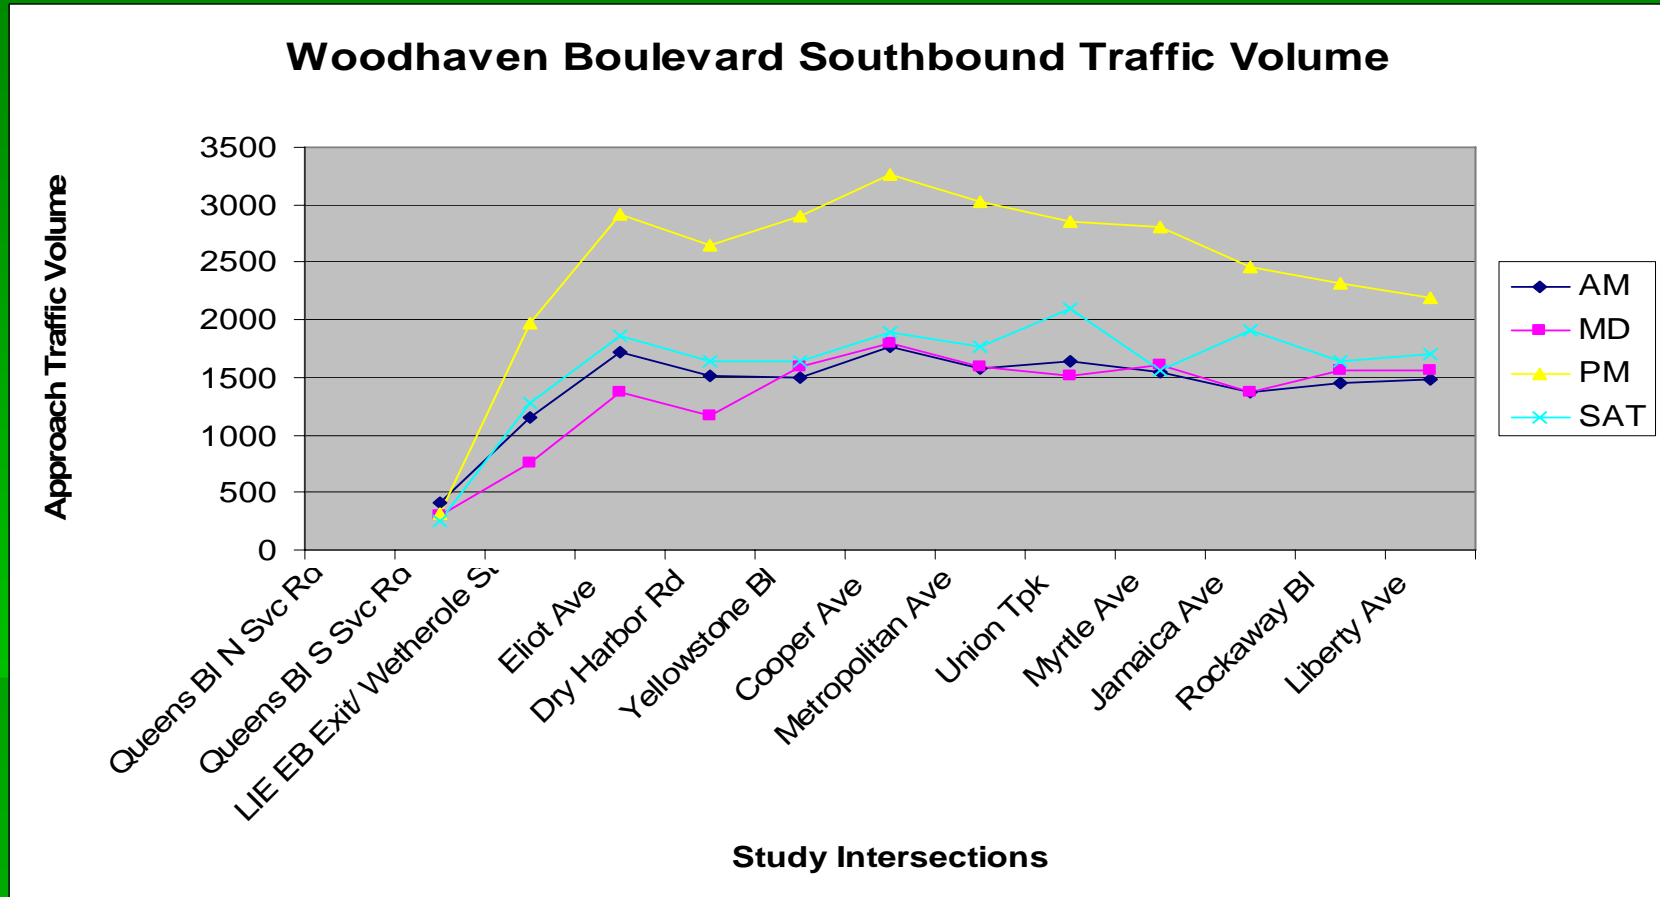
Corridor Traffic Patterns

- Southbound volumes increase significantly at the LIE interchange
- PM volume is significantly higher in the southbound direction

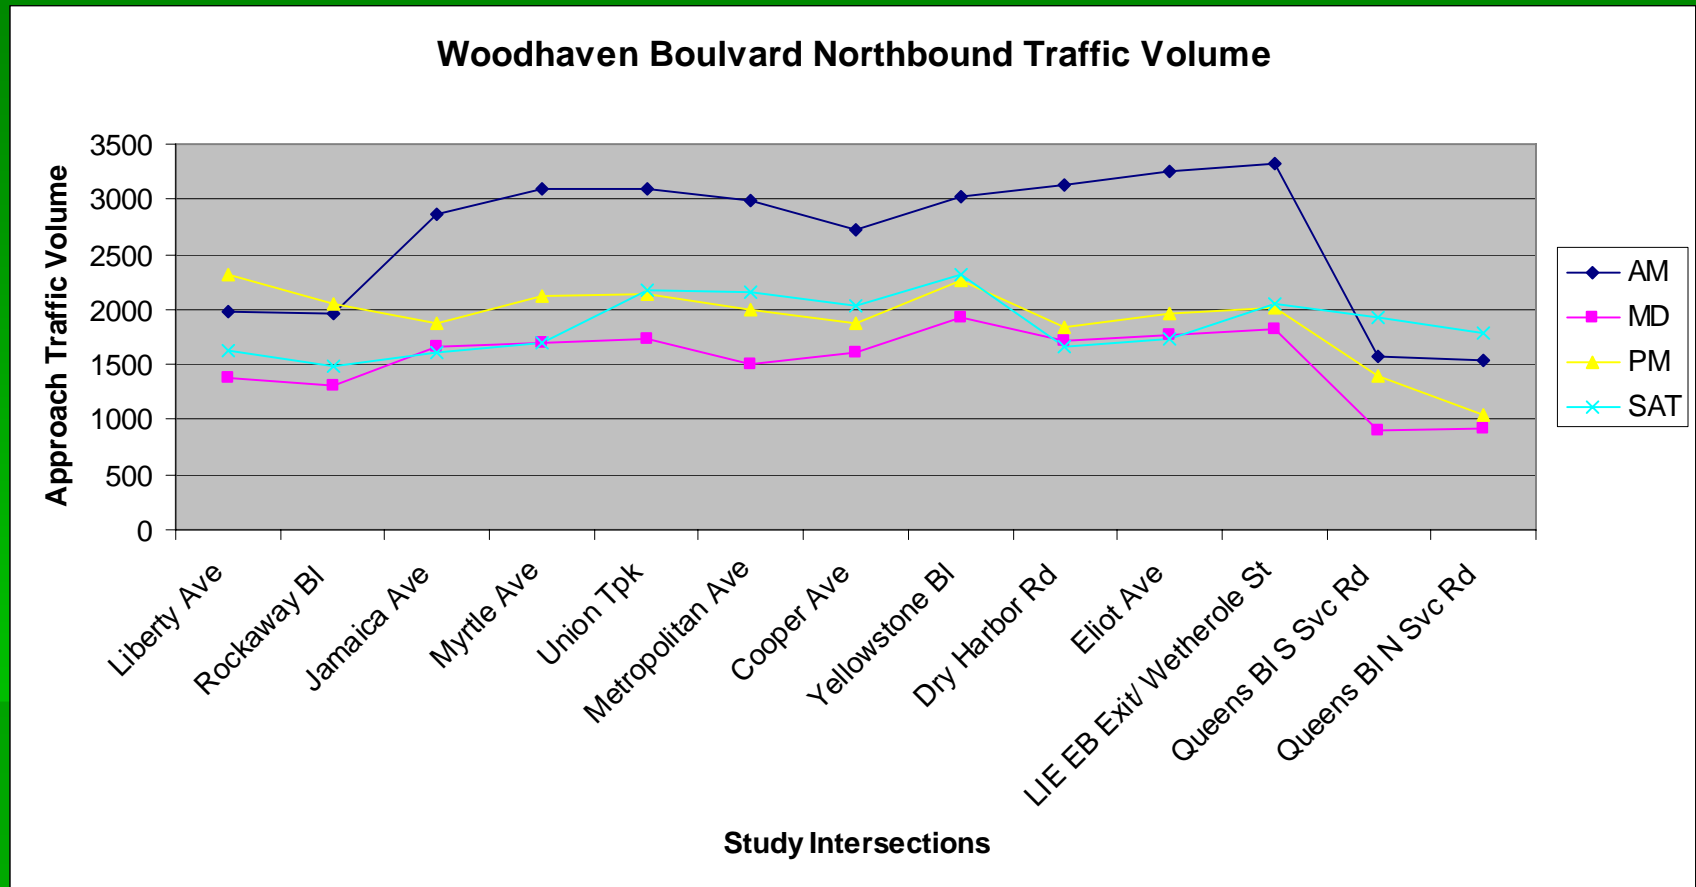
Corridor Traffic Patterns

- Northbound volumes decrease significantly at the LIE interchange
- AM volumes are higher than other peak hour volumes

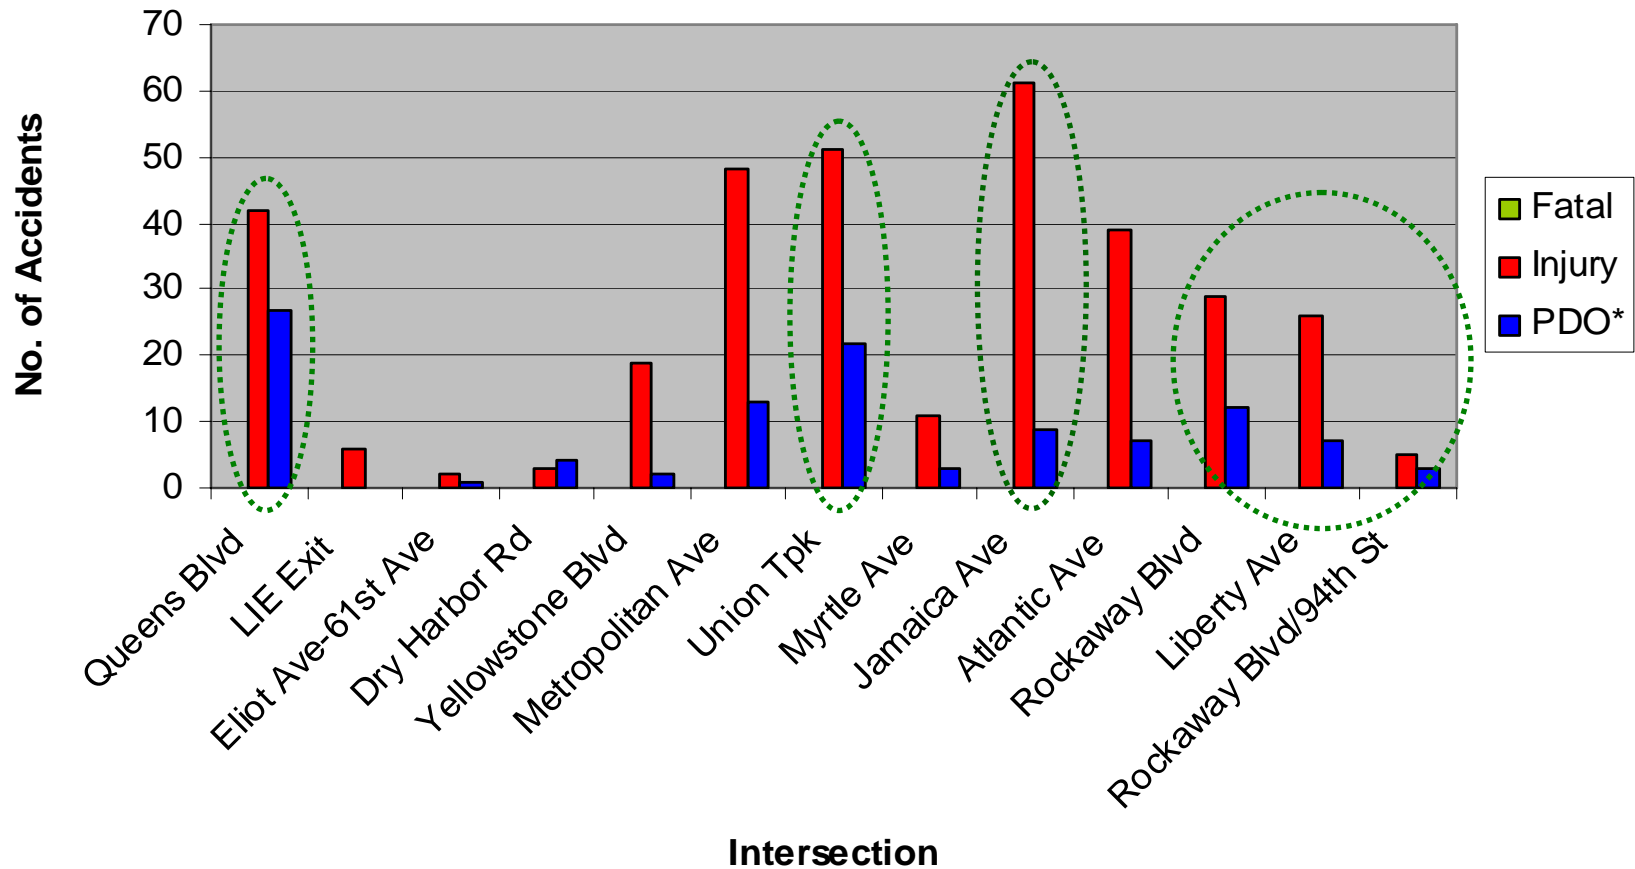
Accidents By Severity at Woodhaven Blvd Study Intersections

Year	2004	2005	2006	3-Year Total
No. of Reportable Accidents	136	162	197	495

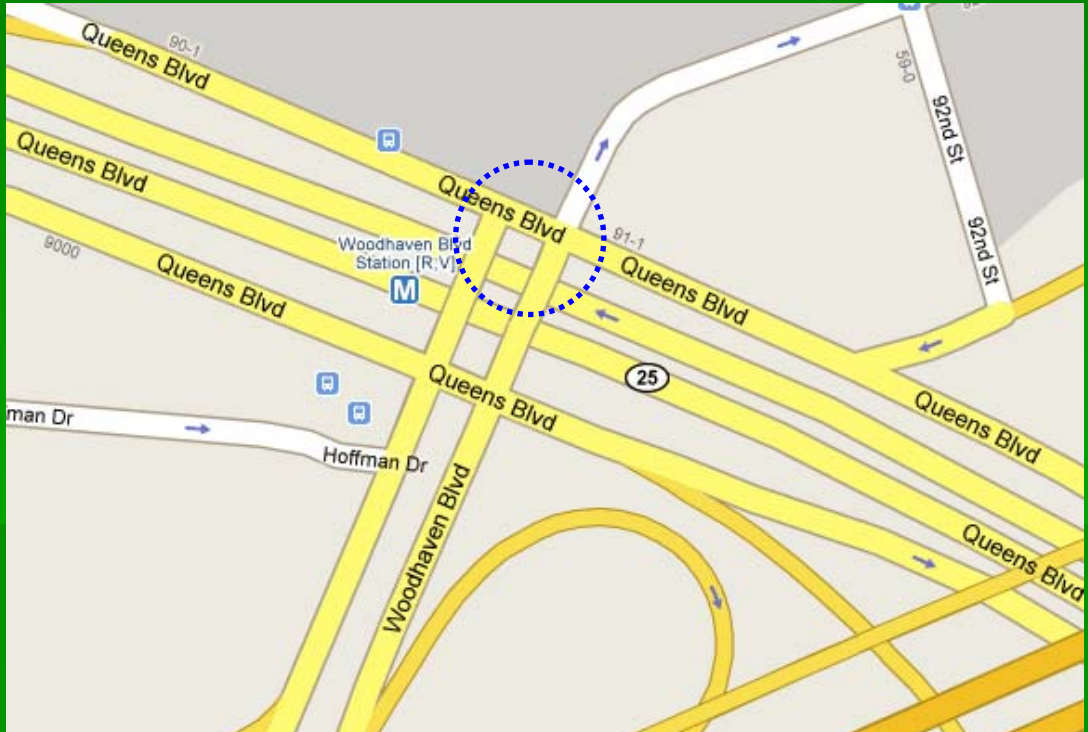
Heaviest Pedestrian Volumes (Peak Hour)

- Queens Blvd
No. Service Rd
(PM): 5,400 total
pedestrians
- Queens Blvd
No. Service Rd
(AM): 3,500 total
pedestrians

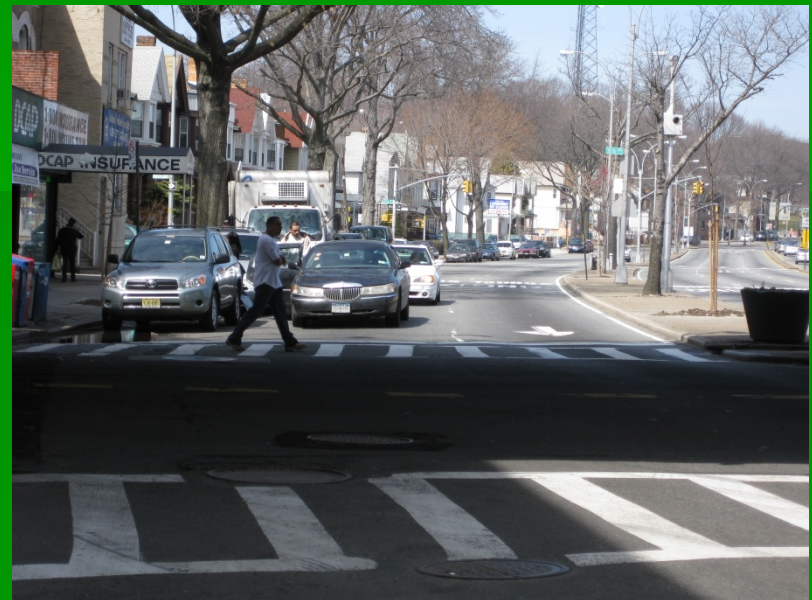
- Complex Intersection Geometries
 - Mainline & service roads
 - Closely-spaced Intersections
 - Lane continuity & alignment (e.g. Union Tpk)
 - No crossovers between mainline & service roads

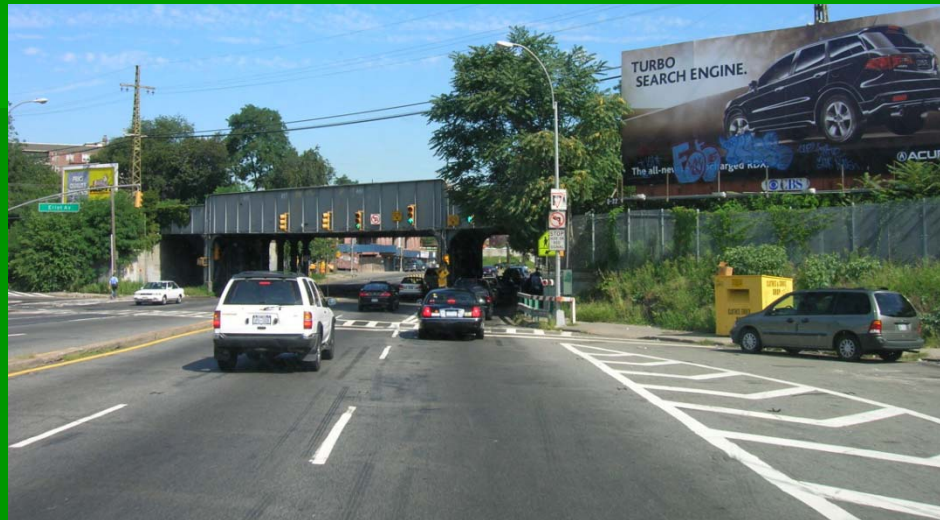
- Discontinuous Service Roads
 - Between Union Tpk and Metropolitan Ave
- Bottleneck at the LIRR Overpass
 - Lane reduction in both directions
 - Highly-trafficked area due to LIE

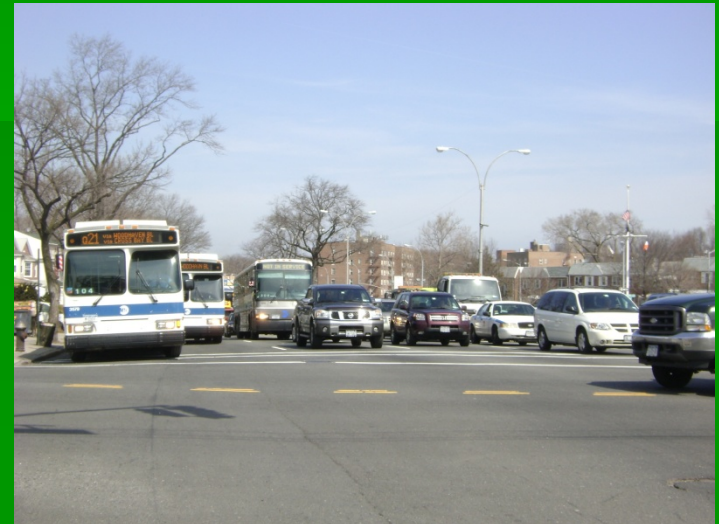
- Transit
 - Local (3), limited-stop (1) and express (4) bus routes serve the *entire* corridor
 - Buses operating in mixed traffic
 - Bus-pedestrian conflicts
 - Locations of bus stops

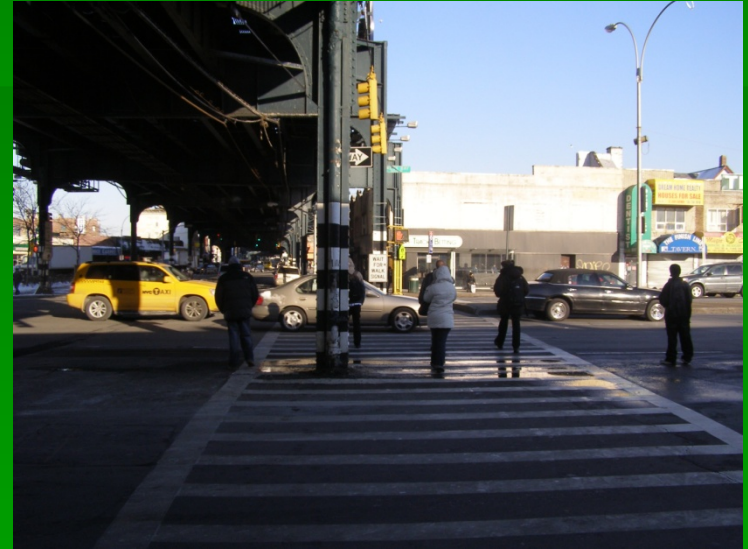
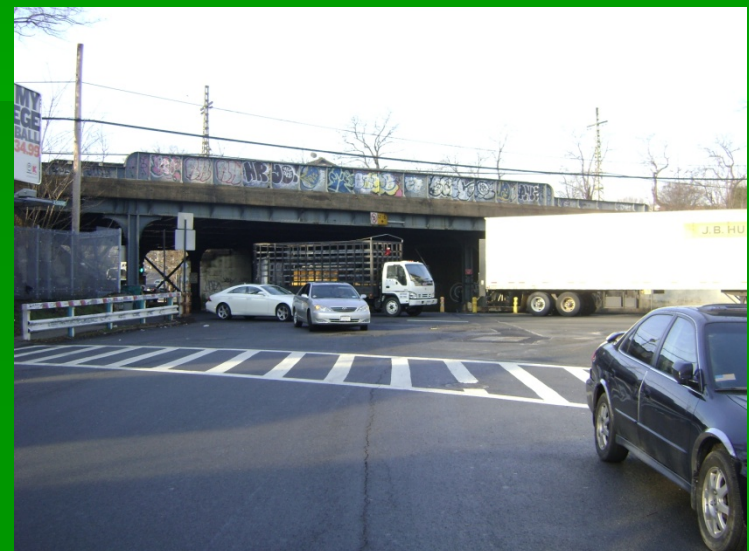
- Lack of Pedestrian Amenities
 - No preferential treatments for crossing pedestrians
 - Pedestrians exposed to high volume of conflicting turning vehicles
 - Poor visibility of pedestrians to drivers
 - Narrow sidewalks at LIRR overpass
 - Long crossing distances across Woodhaven Boulevard

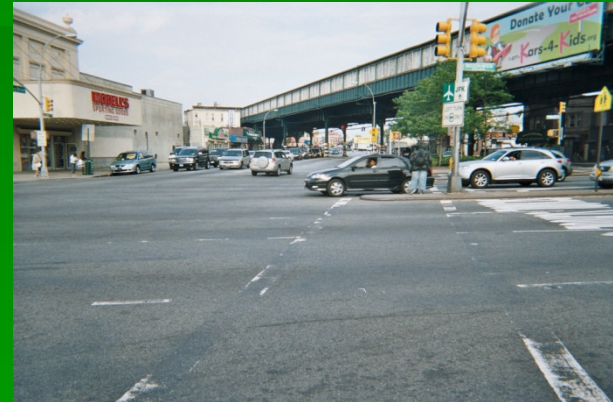
- Modify signal timings
- Restripe / Revise pavement markings
- Add Left turn lanes/phasing
- Localized parking restrictions
- Turn restrictions

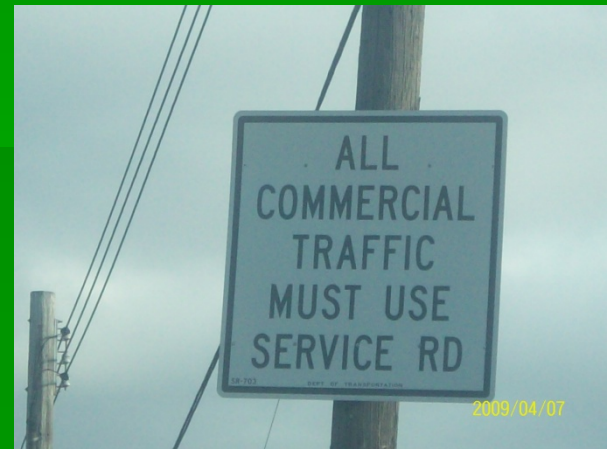
- Lane usage signs
- Way-finding signs

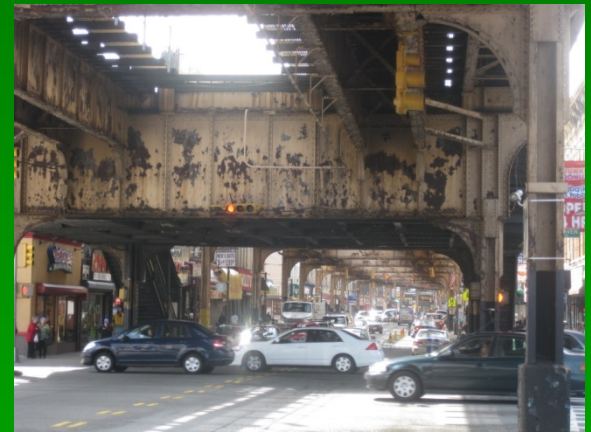
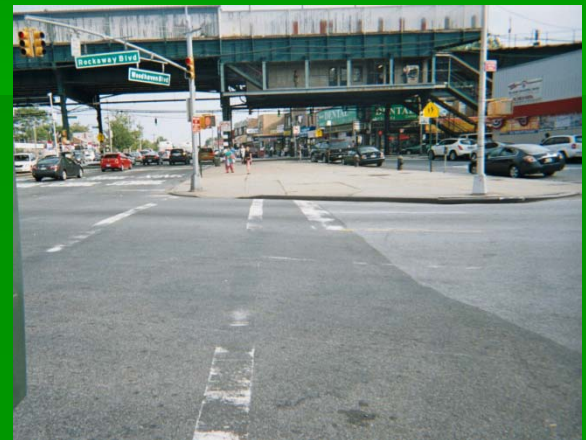
- Pedestrians
 - Improve/install refuge islands
 - Modify signal timings
 - High-visibility crosswalks

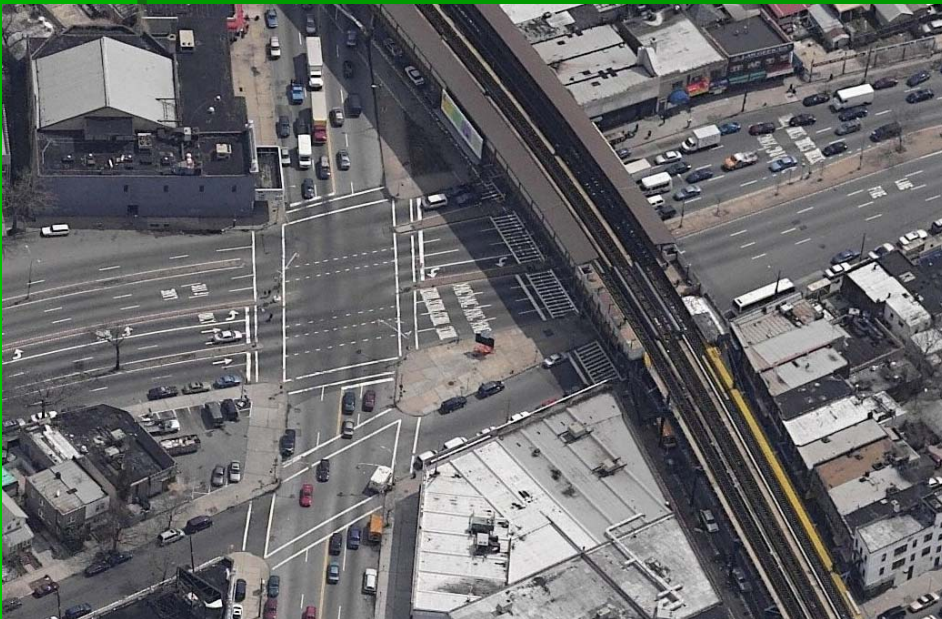
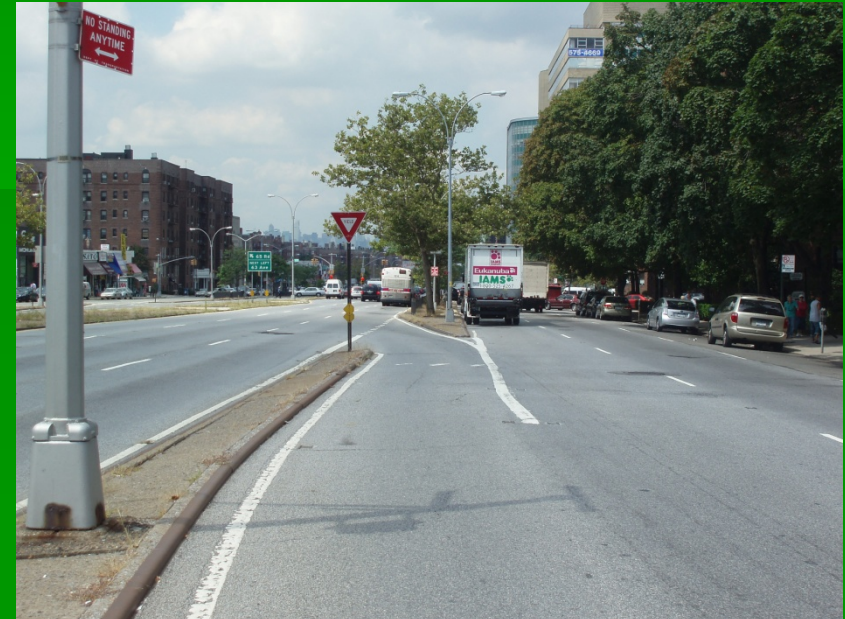
- Reconfigure intersections
- Install crossovers between mainline and service roads
