RUACANA POWERLINE MINE CLEARING

**Contributing Parties: Namibian Defence Force
Windhoeker Maschinenfabrik 1998
RONCO
Force XXI
Military International Limited**

**Report compiled by: Johan Dippenaar – MIL
Date: November 2000**

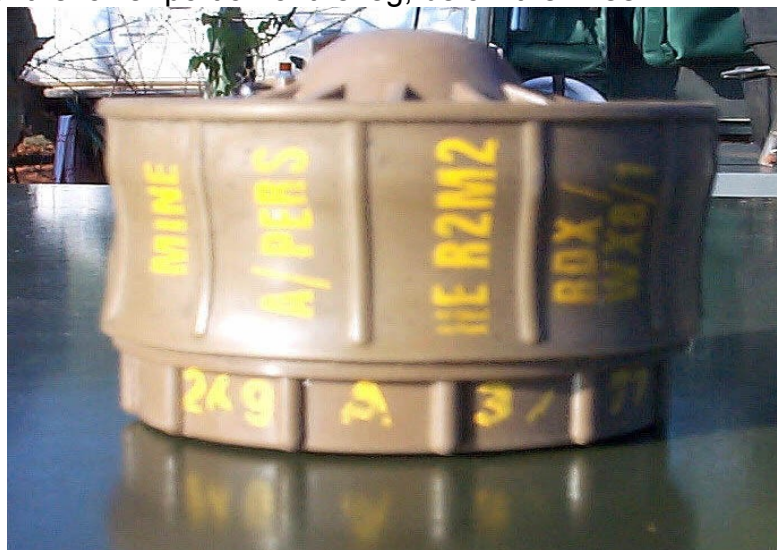
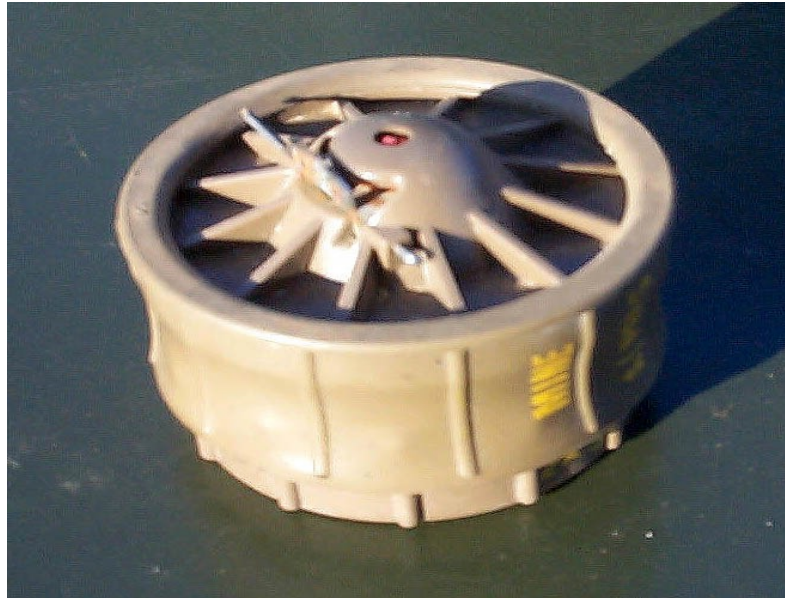
For this purpose the SADF used two types of anti-personnel mines. Firstly they used the R2M2 mine, which is a blast mine containing about 50 grams of RDX in a plastic housing. The R2M2 has virtually no metal content (apart from a small needle-like firing pin), which makes it very difficult to detect with conventional handheld mine detectors. The R2M2 is pressure detonated by about 5 pounds of pressure on the detonator. The R2M2 will not kill its victim but serious injury will definitely occur with possible loss of the leg in question and definite loss of the lower portion of the leg, below the knee.

R2M2 AP mine with safety pin in place over the detonator.

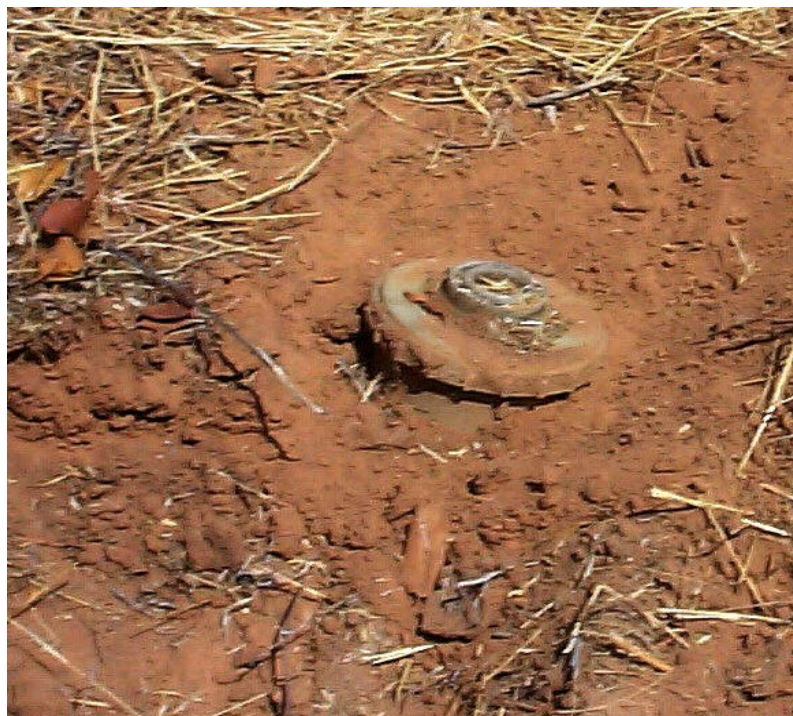
Actual J69 AP Mine uncovered under one of the pylons. These mines are too unpredictable and lethal to handle and was therefore destroyed in-situ.

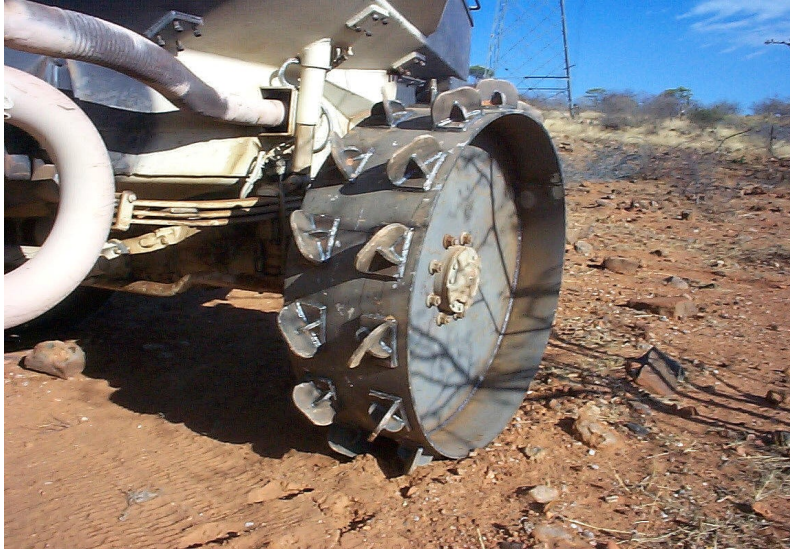
Detail of steel wheel construction.

- The design of the protrusions on the steel wheels should be revised. The protrusions have an unduly high profile. They work very well as they almost seem to plough the soil over, yet they also increase the rolling resistance of the axle unnecessarily. They will do the job equally well, even if shortened by half the present height. All you need is the ground pressure to detonate any mines; you don't need to unearth the mines as well. Anyway, the increased rolling resistance could contribute to the universal joint failure.

- The outside diameter of the steel wheels is not the same as that of the normal rubber road wheels. This could also be a factor since the vehicle was fitted with rubber wheels on the rear axle. The possible problem here is the fact that the output ratio from the transfer gearbox is constant, but the roll radius of the 2 axles are different due to the different diameter wheels. This could cause the front axle to wind up after prolonged use with the resulting universal joint failing under stress, it being the weakest link in the drive train.

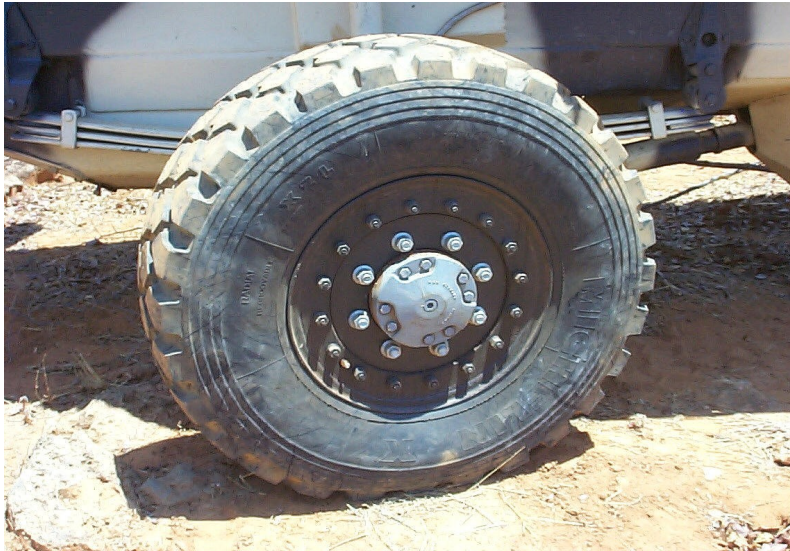
Detail of run flat tyre.

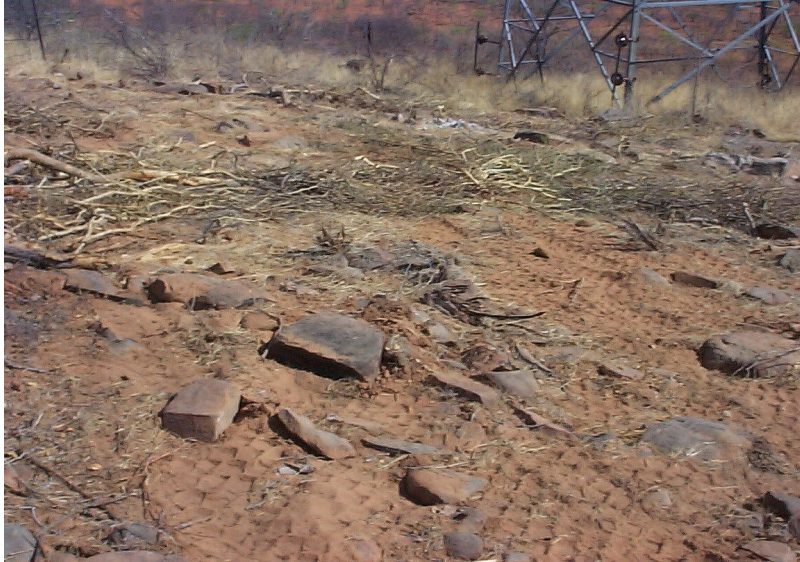
Detail of how the vehicle worked pylon # 1.

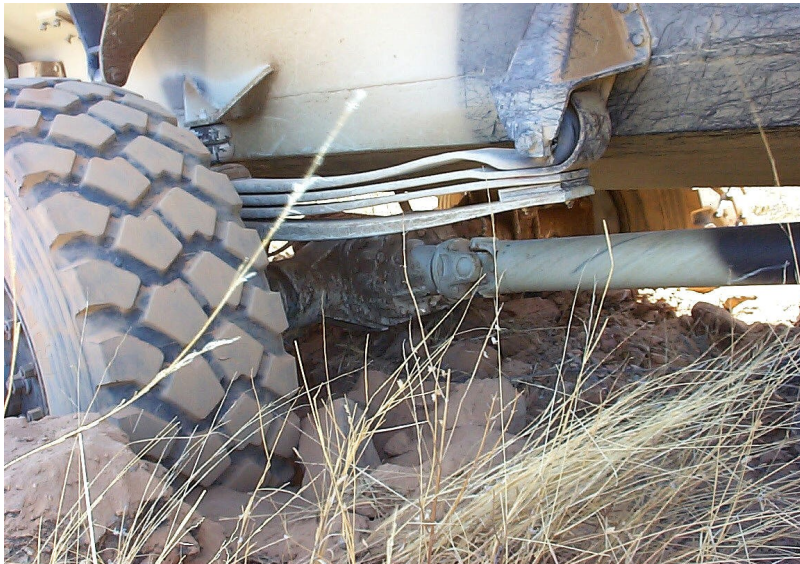
The 1st pylon was cleared 100%, but unfortunately the vehicle broke down just as the job was completed. The universal joint on the final drive hub of the right front wheel shattered. The vehicle lost traction and as a result the rear wheels dug in. the vehicle had to be recovered by the Freight Carrier.

The rear wheels dug in when the front axle broke down.

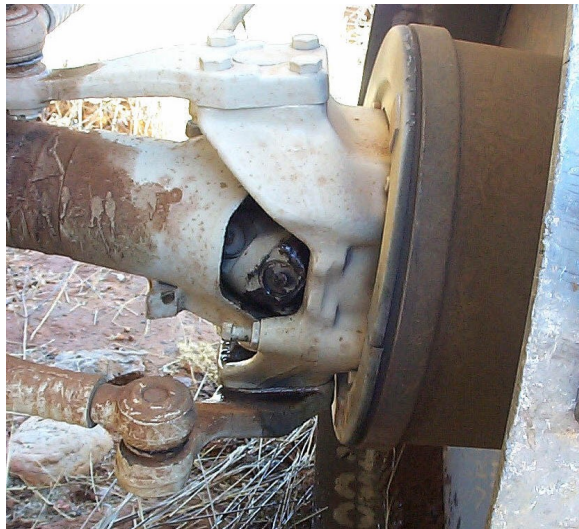
The damaged universal joint.

It is not entirely clear why the universal joint shattered. The vehicle was not working exceptionally hard at the time of the failure. In fact, the vehicle handled the terrain with ease and did not seem to experience any kind of difficulty during the day.

One point of speculation is the fact that the axle was MKI status. This was the reserve axle that was fitted in India after the blast trials were concluded. These axles were used in other vehicles before being shipped to India and hence their status in terms of wear and tear was unknown. We do know however that these axles worked extremely hard in India after the blast trials when they concluded the automotive trials. This extensive wear and tear could have been a factor, especially when linked to the other possible contributing factors outlined below.

These other factors, which could also play a significant role, include:

The entire day was spent in getting a new axle in from Windhoek and in changing the axles. The damaged axle could not be repaired on site and hence a new one was fitted. The damaged axle can however readily be repaired in a workshop with appropriate facilities.

WMF would need to investigate this failure and determine the true and exact cause for rectification on future similar applications.

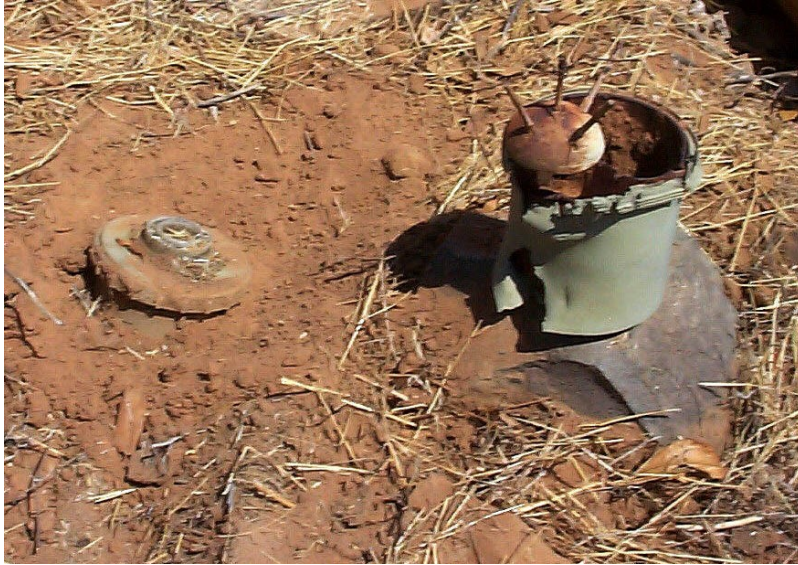
J69 without detonator buried on the left. Expired J69 housing and detonator on the right.

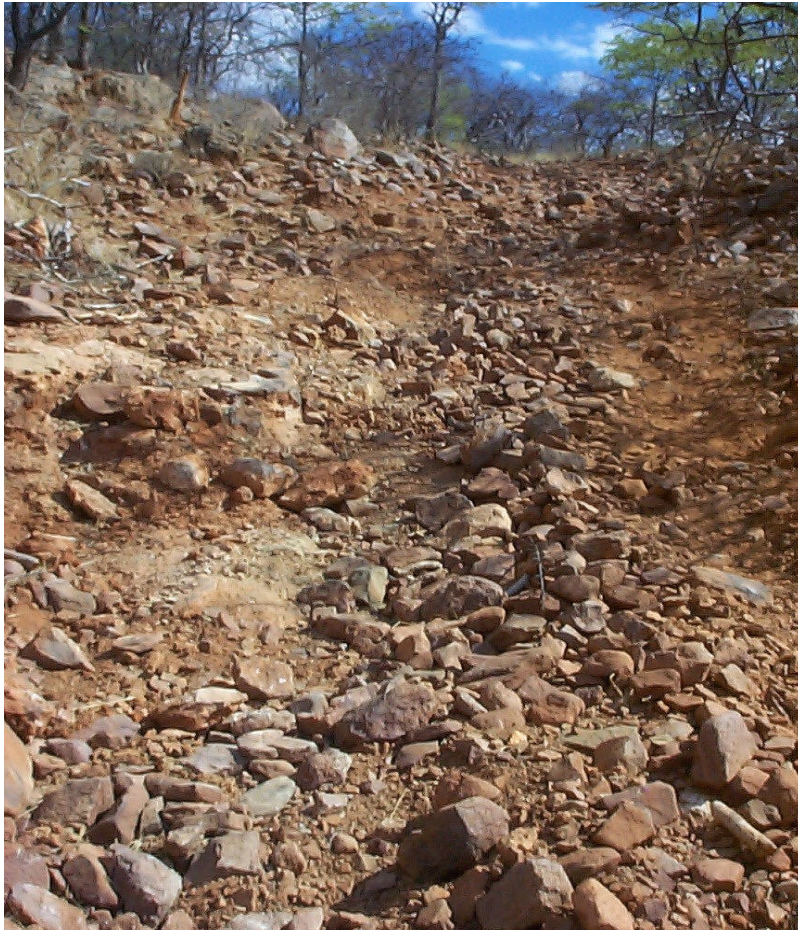
The universal joint shattered in identical fashion whilst traversing up a ravine. This failure is a mystery, which I cannot explain readily. Admittedly, the ravine was not the easiest of slopes to negotiate, but I was inside the vehicle at the time of the failure and it was definitely not struggling. The front axle was MKII status and brand-new. The axle had also not worked with any steel wheels fitted to it. This ravine was traversed by normal 4x4 commercial vehicles on a regular basis without experiencing any problems. I can therefore not offer any possible reason for this failure, which I am sure, will be fully investigated by WMF 1998 and rectified, if necessary.

The section of the ravine where the axle failure occurred.

The entire day was spent in getting 2 new axles up from Windhoek and in replacing both the front and rear axles with new ones. We wanted to stop the project before the new axles were sent up because we didn't know why they were breaking. Will Haynes convinced us however to get the new axles and complete the job.

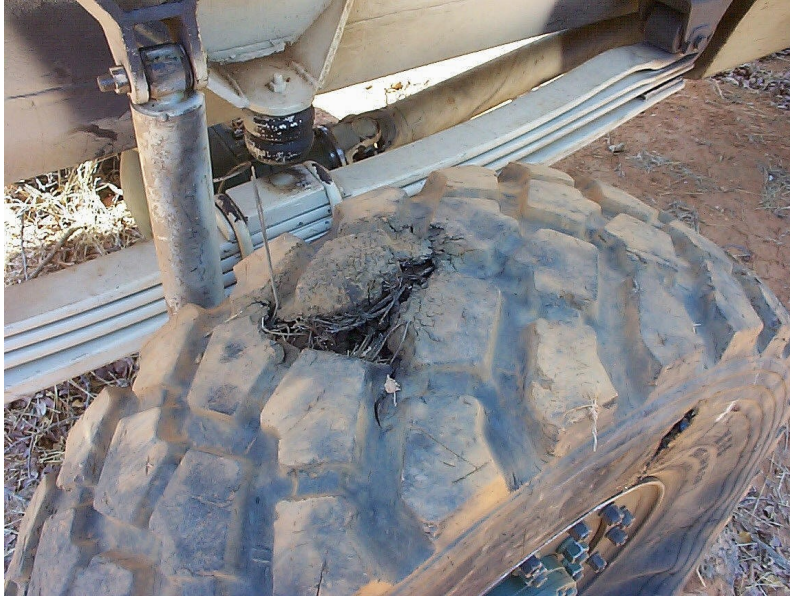
Whilst clearing pylon # 4 we did simulate some AP mine detonations to test the effect on the run flat tyres and to get some suitable video footage. The damage to the tyre was minimal and the vehicle could continue to operate as planned for some considerable time before we replaced the wheel.

Damage to the run flat tyre after an AP mine detonation.
