Historic Environment Survey for the National Trust Properties on the Northumberland Coast

Buston Links, Alnmouth

Report No: 0058/1-09

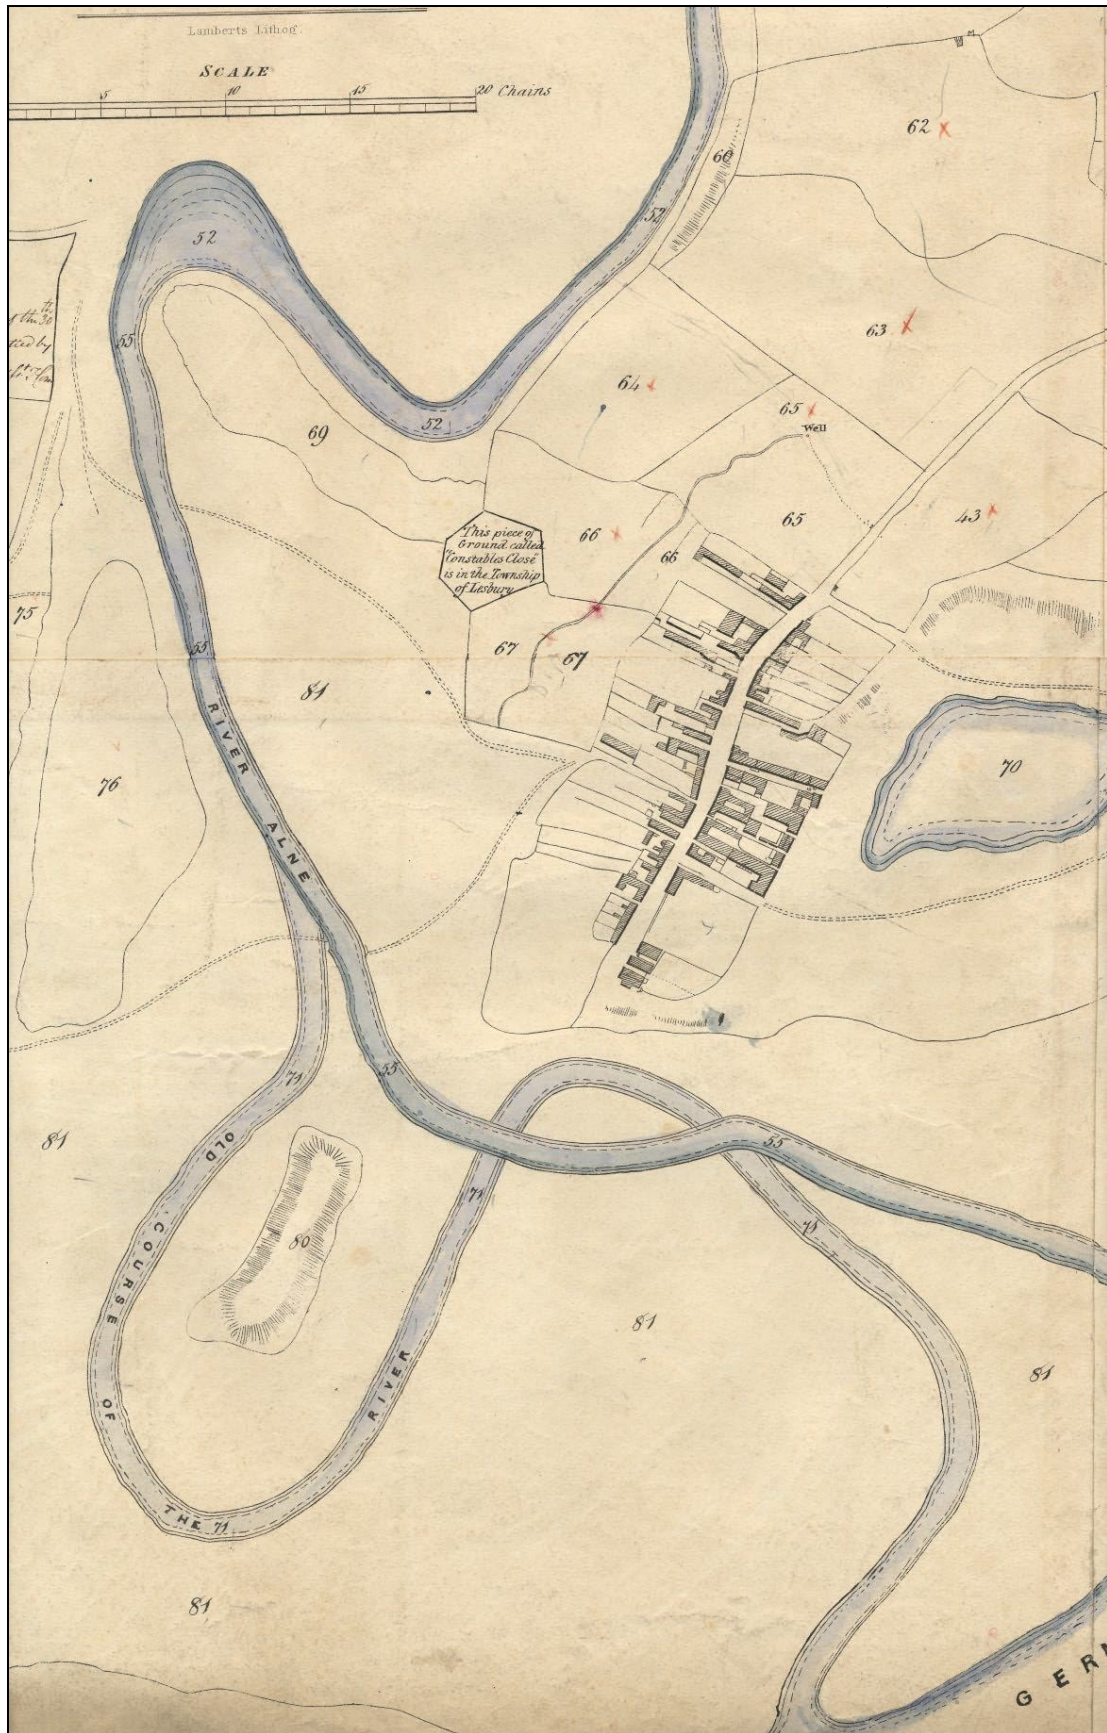
Figure 6. Tithe map of Almouth dating to 1843 showing Church Hill and the old course of the river. The medieval layout of the village shows up particularly well here.

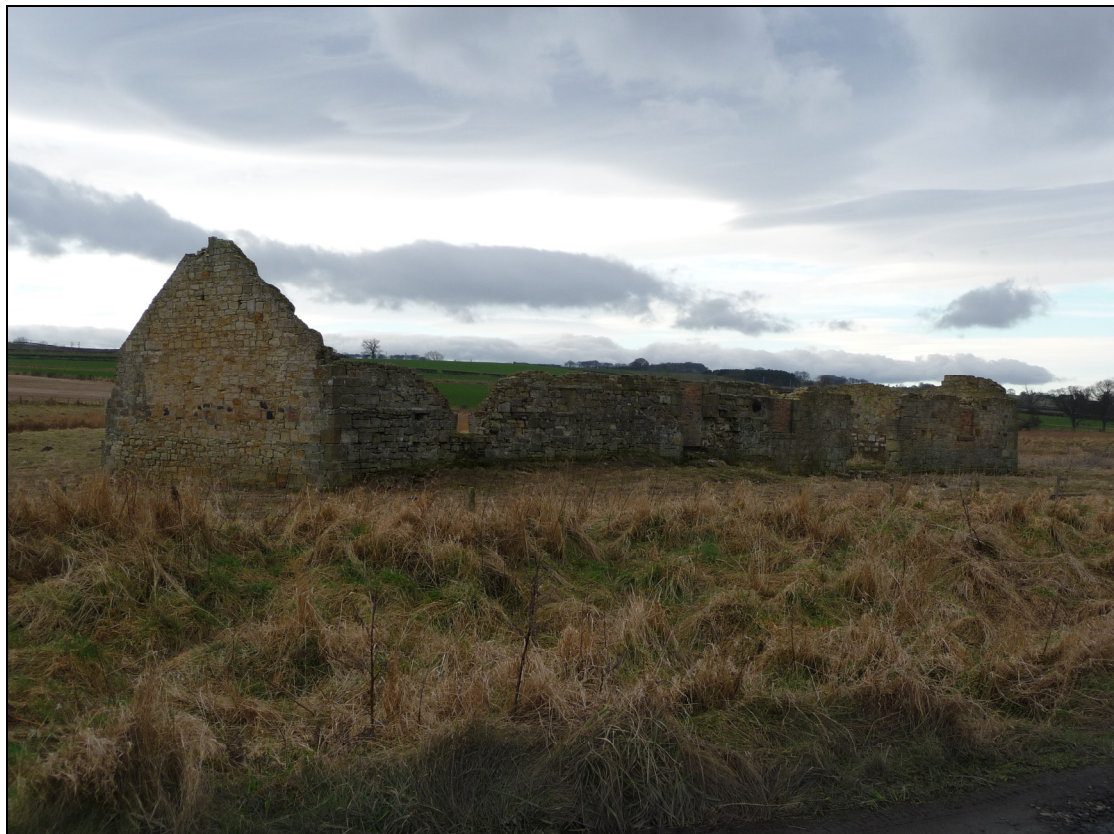
Plate 4. The 'guano shed' at Buston Links (outside NT land)

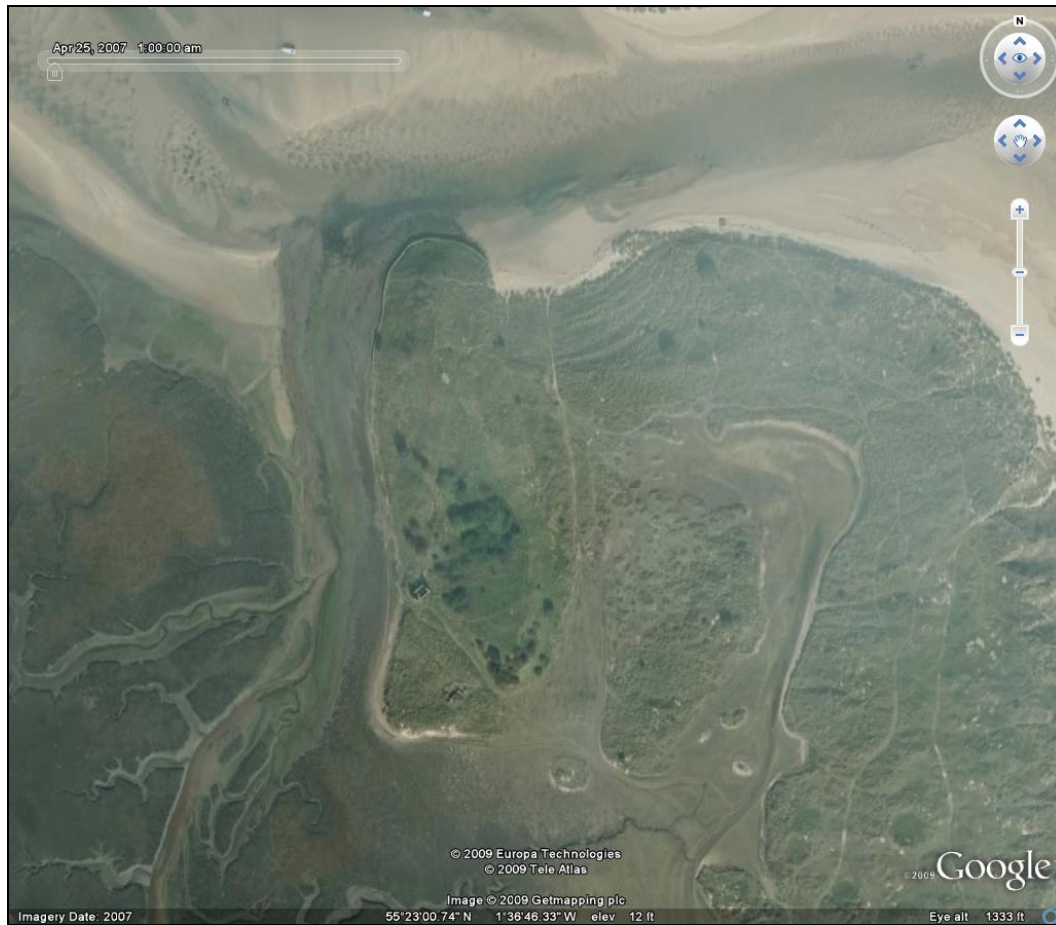
Plate 5. Church Hill from Google Earth. Photo taken in 2007. The mortuary chapel and cottage are visible on the south west corner of the hill.

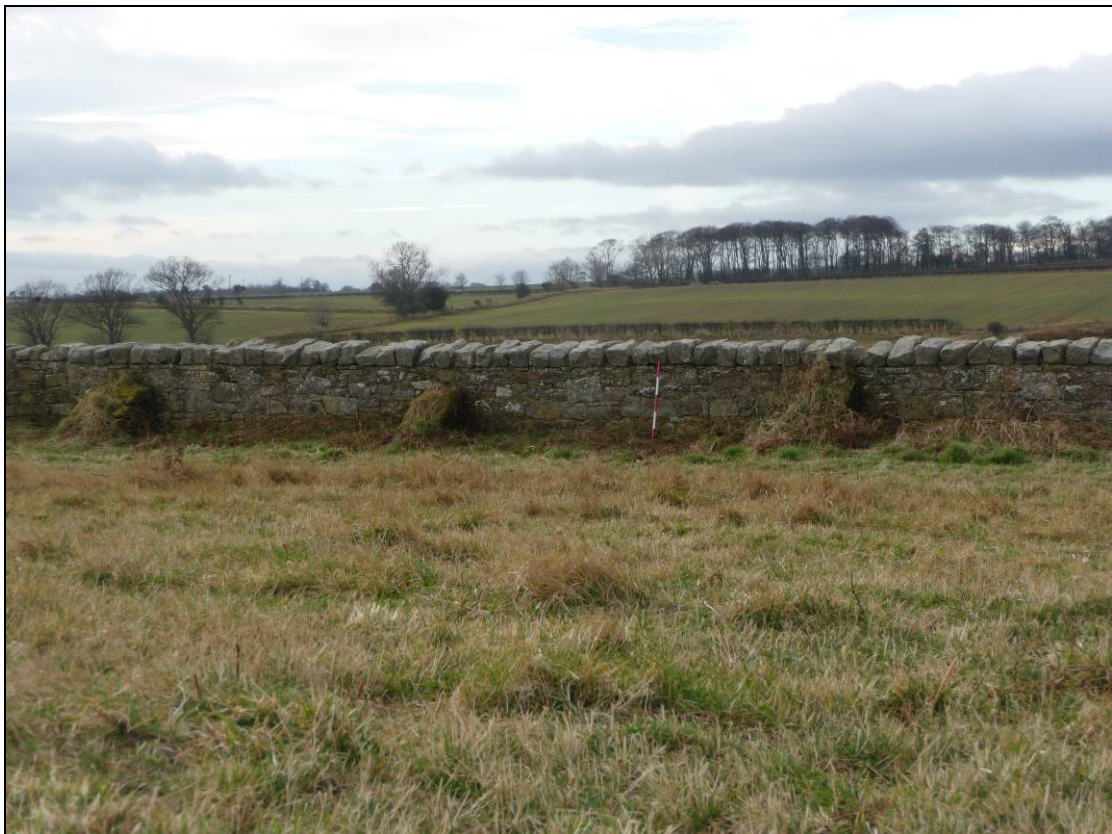
capstones and a small wrought iron entrance gate (NT SMR 14596) survives at NU 24963 08746. This gate is only suitable for pedestrian access. The wall has been reinforced with hedging (NT SMR 14598) on the east side managed in the traditional laying technique in the past, but no longer managed at all. Its survival is very patchy and limited to only a few areas around NU 25040 08549. The wall has also been reinforced, presumably later when slumping became apparent, with a line of four buttresses at NU 25082 08411.

Plate 6. 18th or 19th century wall with buttresses (NT SMR 14595)

Close to this area there is also a join where two parts of the wall abut on a different alignment. Although the majority of the wall is on good condition, large sections have collapsed or are without their capping stones.

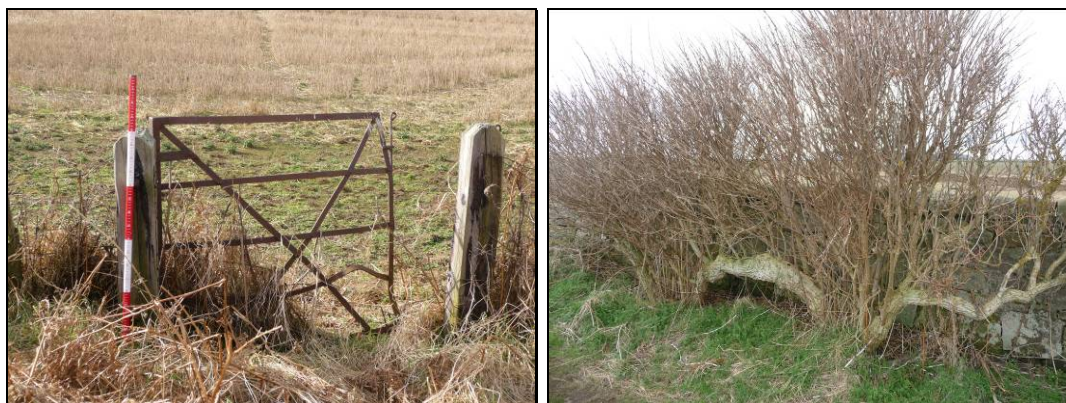
Plate 7. The pedestrian gate (NT SMR 14596) in to the enclosure (NT 14595) and the remnants of a 'laid' hedge (NT SMR 14598)

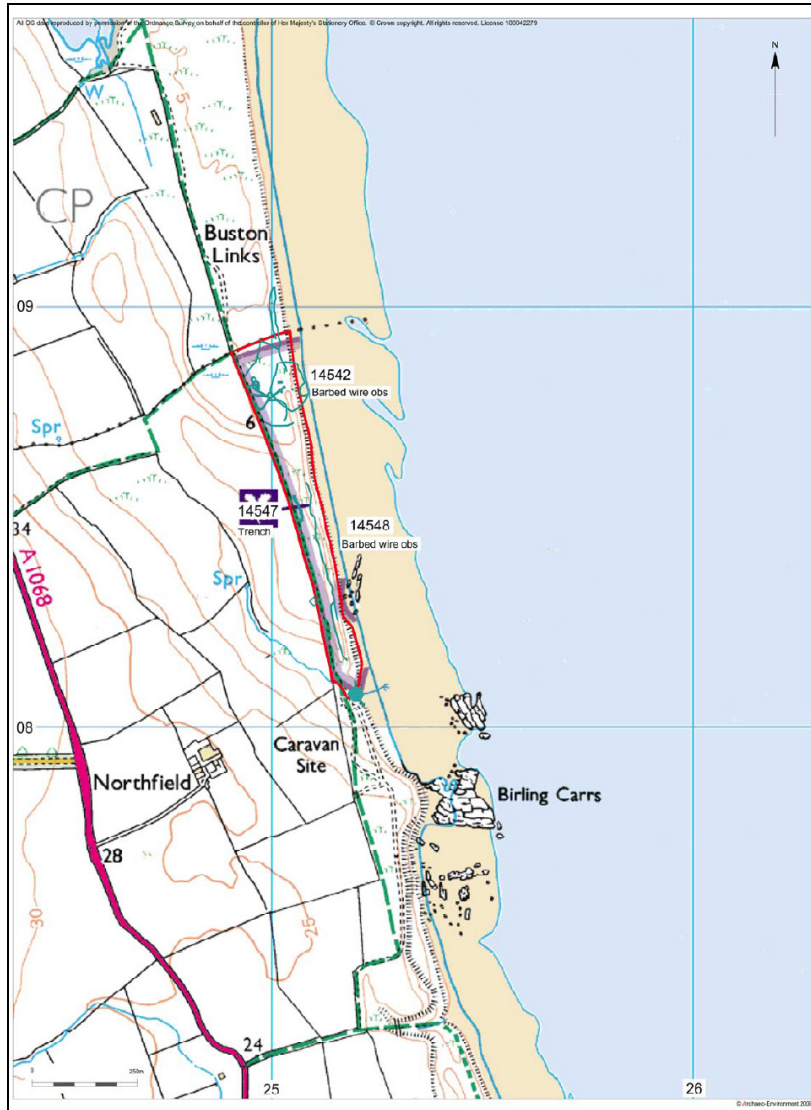
Figure 11. Location of Second World War features from the Rapid Coastal Zone Assessment

There is evidence from elsewhere (see NT land at Druridge Bay) that the ditches were supplemented by scaffolding on the east (seaward) side and the Rapid Coastal Zone Assessment has depicted lines of barbed wire along the dune tops (NT SMR 14542, 14548). No remnants of barbed wire or scaffolding were seen during fieldwork.

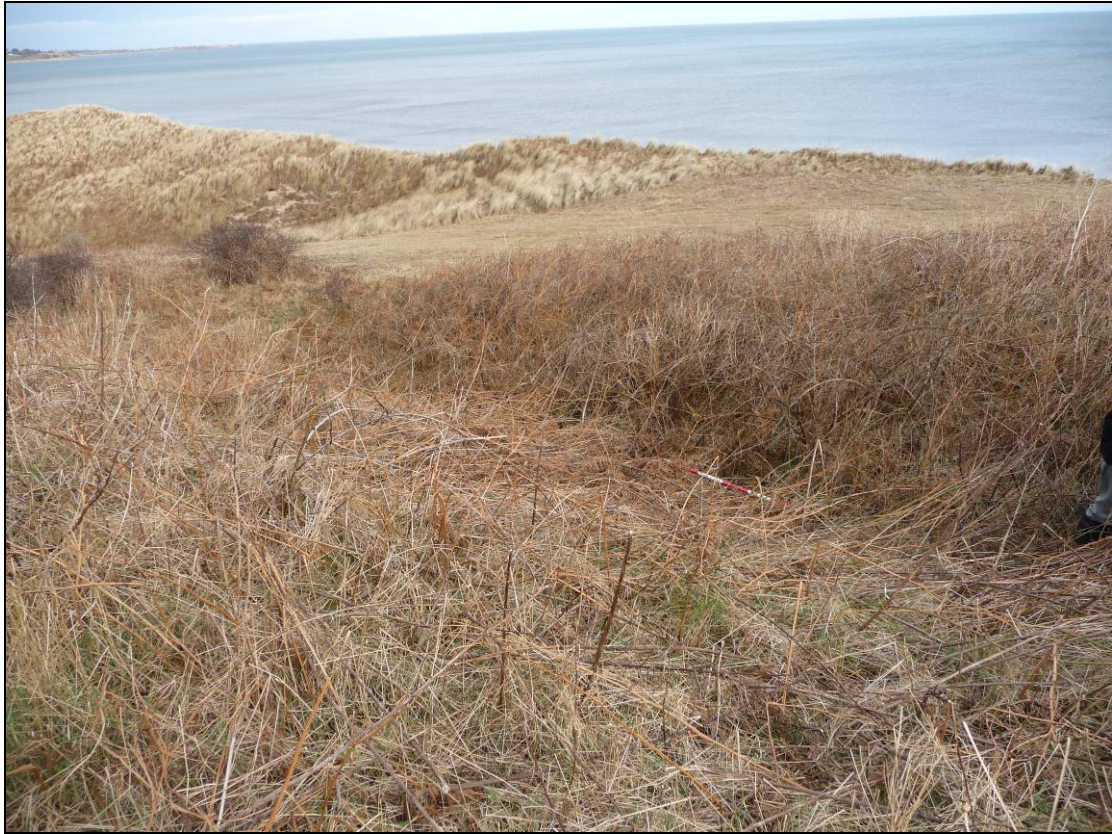
Originally, anti-tank ditches were either V-shaped, square sided or asymmetrical, and were designed to immobilise the tank by confronting it with an unclimbable vertical face or (in the case of V-shaped ditches) to trap the vehicle nose down. The recommended dimensions for the V-shaped variant (the most likely shape at Buston given that they were being excavated into sand) were 18ft (5.49m) wide by 11ft (3.35m) deep (CBA 1996, 87). At Buston the sand has since filled all of the anti-tank ditch which once ran along the back of the dunes (NT SMR 14547) and it is no longer visible, however there is a small possible remnant at NU 25022 08626, close to the footpath.

Plate 11. The possible surviving stretch of anti-tank trap – the ranging pole points along the base of the ditch

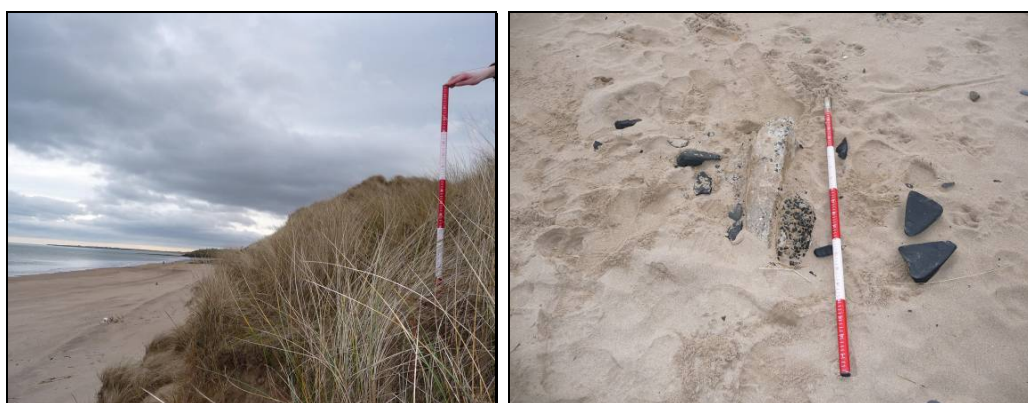
Plate 12. The site of the pillbox seen on 1946 aerial photographs is now on the dune edge overlooking the foreshore and may already have been swept out to sea (left). 200m south on the foreshore are the fragmentary remains of concrete filled sandbags

The base of the pillbox on Church Hill can still be discerned, but the one example recorded within the National Trust landholding is no longer visible

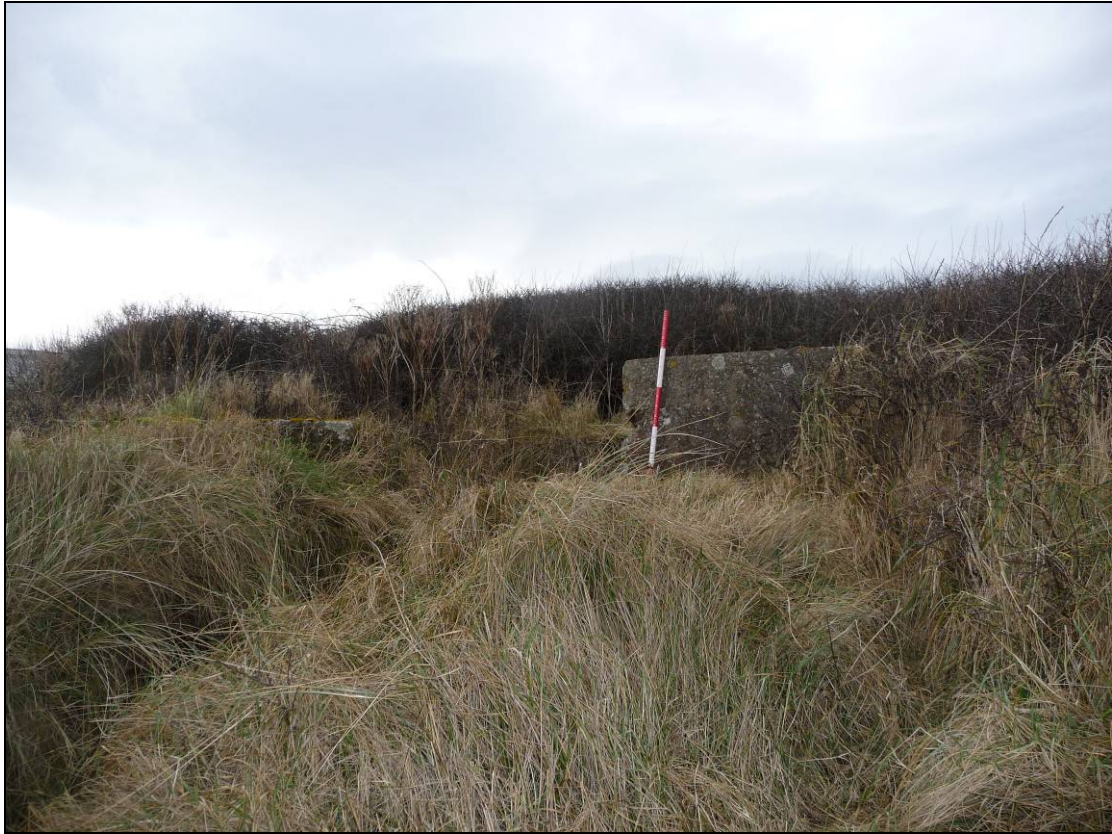
Plate 13. Two anti-tank cubes near the caravan park (NT SMR 14549)

Two small groups of anti-tank cubes can be found at the southern end of the landholding near the caravan park and Birling Carrs. The first group of two are set on top of the dunes and partially hidden from view by grass and a backdrop of thorn bushes. The second group consists of four cubes sitting on the high tide line and showing signs of having been shifted by wave action; one in particular is eroded. The vegetation growth on top of three of the cubes suggests that they have been buried beneath the dunes until relatively recently.

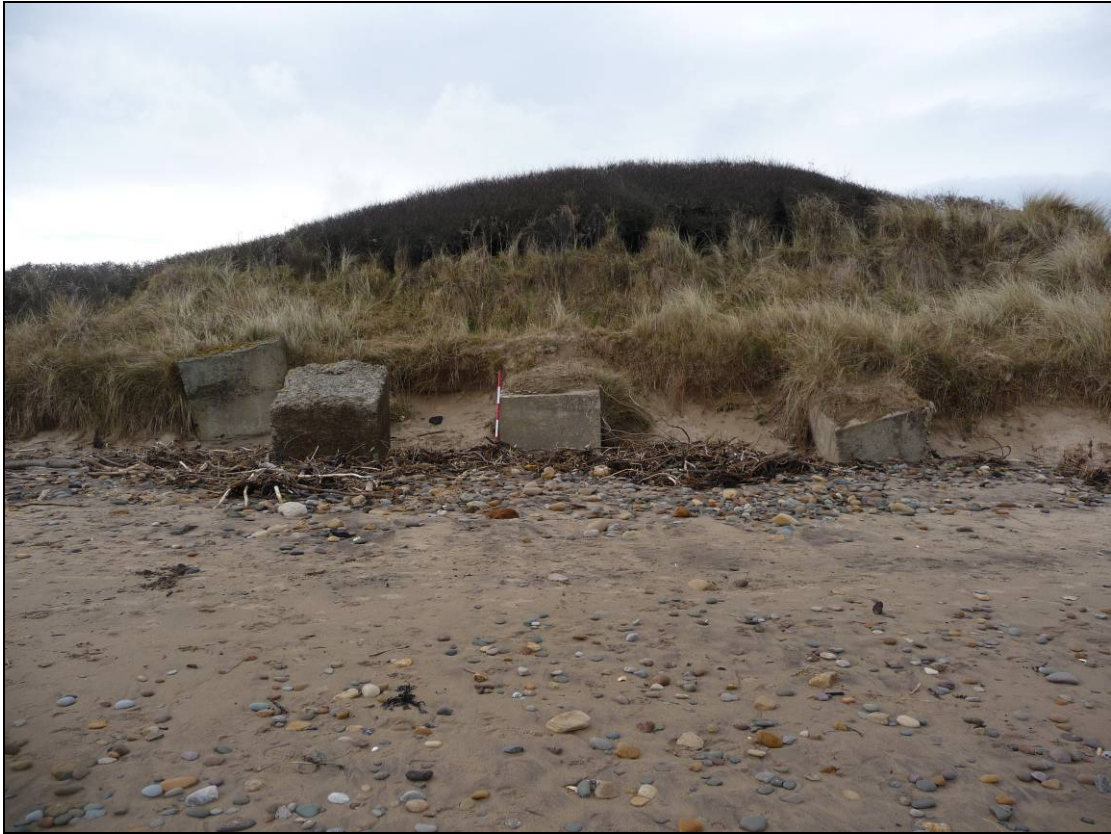
Plate 14. Group of four anti-tank cubes on the high tide mark north of the caravan site.

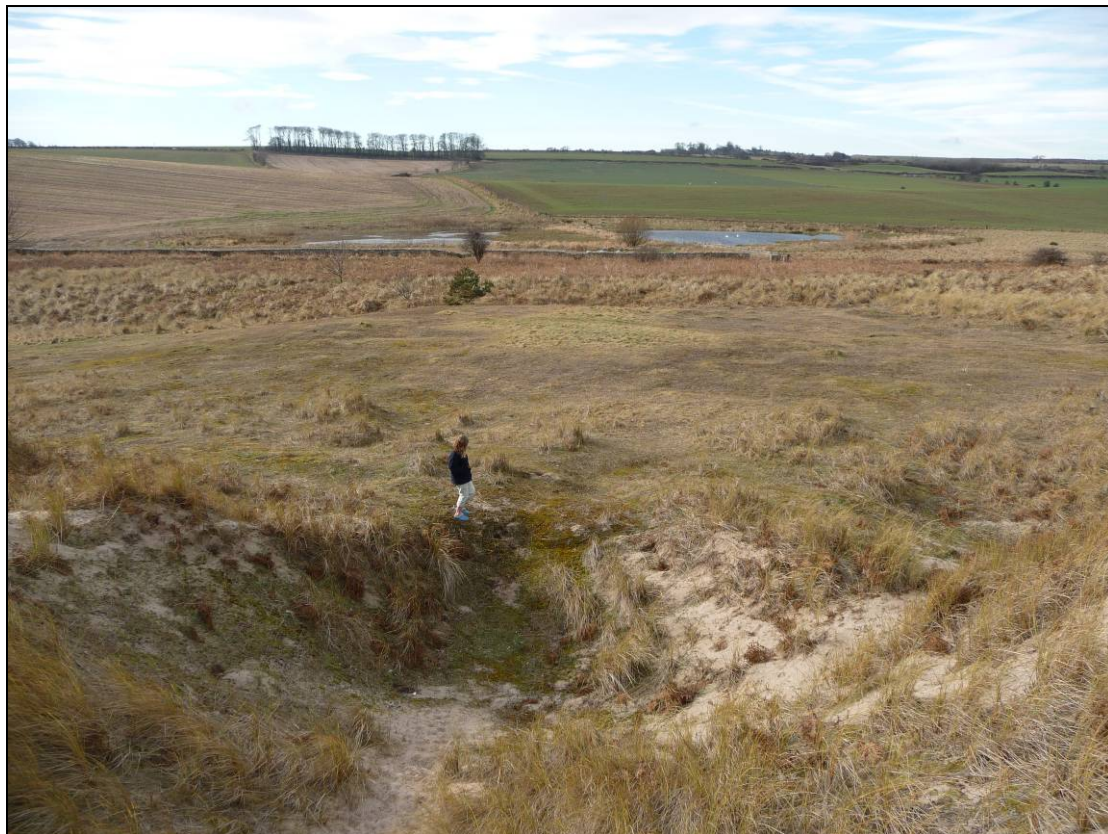
Plate 15. Large flat area behind the dune system – this might be the site of the 19th century sand pit, perhaps reused as the site of the Second World War Nissen hut.
