Northern Sumatra Field Survey after the December 2004 Great Sumatra Earthquake and Indian Ocean Tsunami

A field survey of earthquake and tsunami effects was conducted in the region around Banda Aceh in northern Sumatra. The field data included visual observations of watermarks, which were located via handheld GPS units and then photographed. Where possible, watermarks were surveyed along cross-shore profiles to determine runup height. Additional information on wave arrival and behavior—including the timing and the number of waves—was collected through interviews with witnesses and survivors and from video recorded during the tsunami event. These data were used in conjunction with satellite imagery obtained before and shortly after the earthquake to describe the effects of the tsunami and earthquake in terms of runup height, inundation distance, flow depth, levels of structural damage, shoreline erosion, and earthquake-related subsidence. This data set is far from complete, and additional information is needed to fully assess the tsunami effects in northern Sumatra. [DOI: 10.1193/1.2206793]

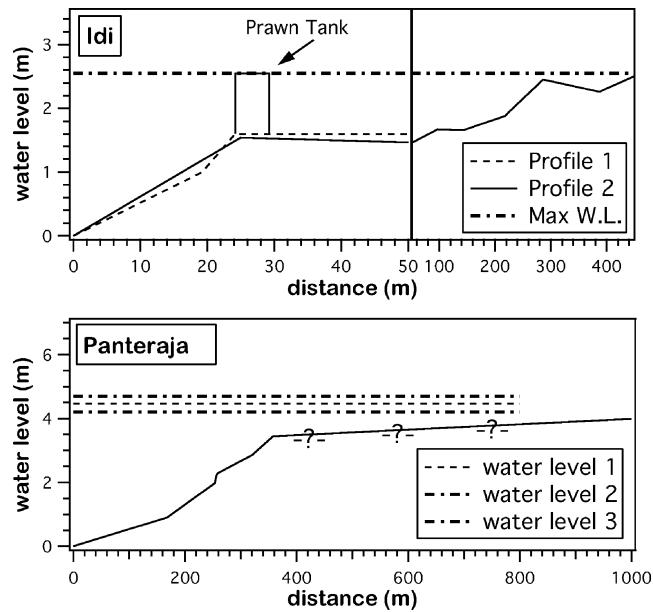
Figure 2. Cross-shore profiles at Idi and Panteraja. The question marks on the Panteraja profile indicate that this was not directly surveyed; however, the land was made up of relatively flat agricultural fields, and the inundation distance was on the order of 1 km.

Continuing north along the coast, we observed the damage at Panteraja. Residents stated that the shaking lasted for approximately 10 minutes. The shaking was severe in this area: residents reported not being able to walk or even squat during the shaking, and that they were knocked to the ground. They also described two shaking episodes, the first with a horizontal east-west-oriented back-and-forth motion and the second feeling more “up and down.” Earthquake damage to structures in the area was reported to be minor. The tsunami effects were more severe here than at Idi. The tsunami attack began with an initial withdrawal about 30 minutes after the earthquake. Local residents reported three waves, with the third being the largest. The wave penetrated up to 1 km inland and attained a height of 4.2–4.7 m above sea level at the time of the tsunami (Figure 2, lower panel).

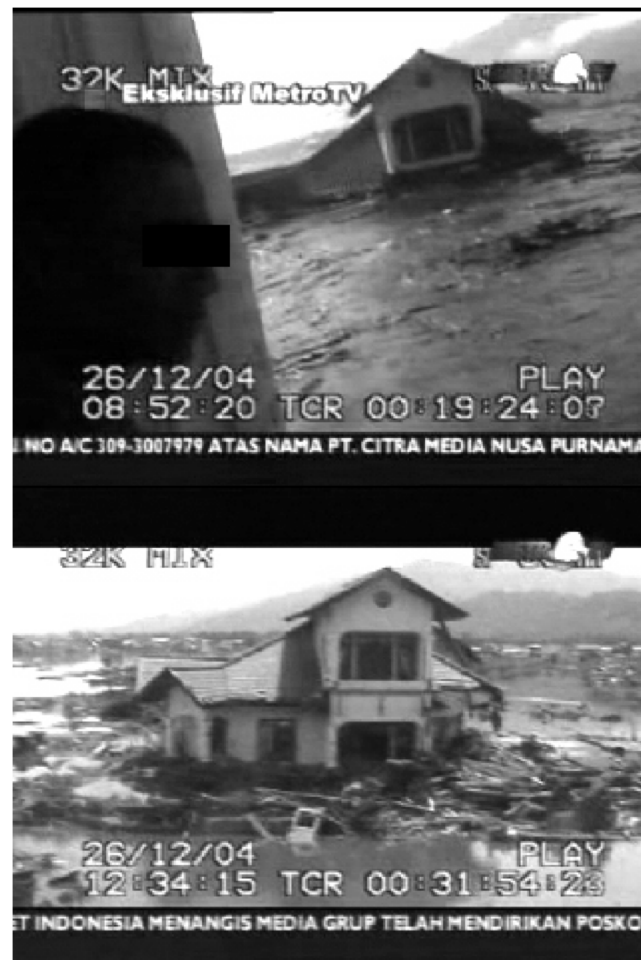
Figure 7. Still frames from a video that was recorded at location B in Figure 3, looking west. The upper frame shows the tsunami attack; the lower frame shows the post-tsunami damage. The flow is 2–3 m deep, as indicated by the water level at the house.

Video images recorded before, during, and after the tsunami attack reveal many notable features of the event. By comparing features and landmarks in the background of the videos, we were able to precisely locate where each video was recorded. Figure 7 shows a house during and after the tsunami; the house is near location B in Figure 3. A sustained flow depth of approximately 2.5 m is clear from this image. Figure 8 shows

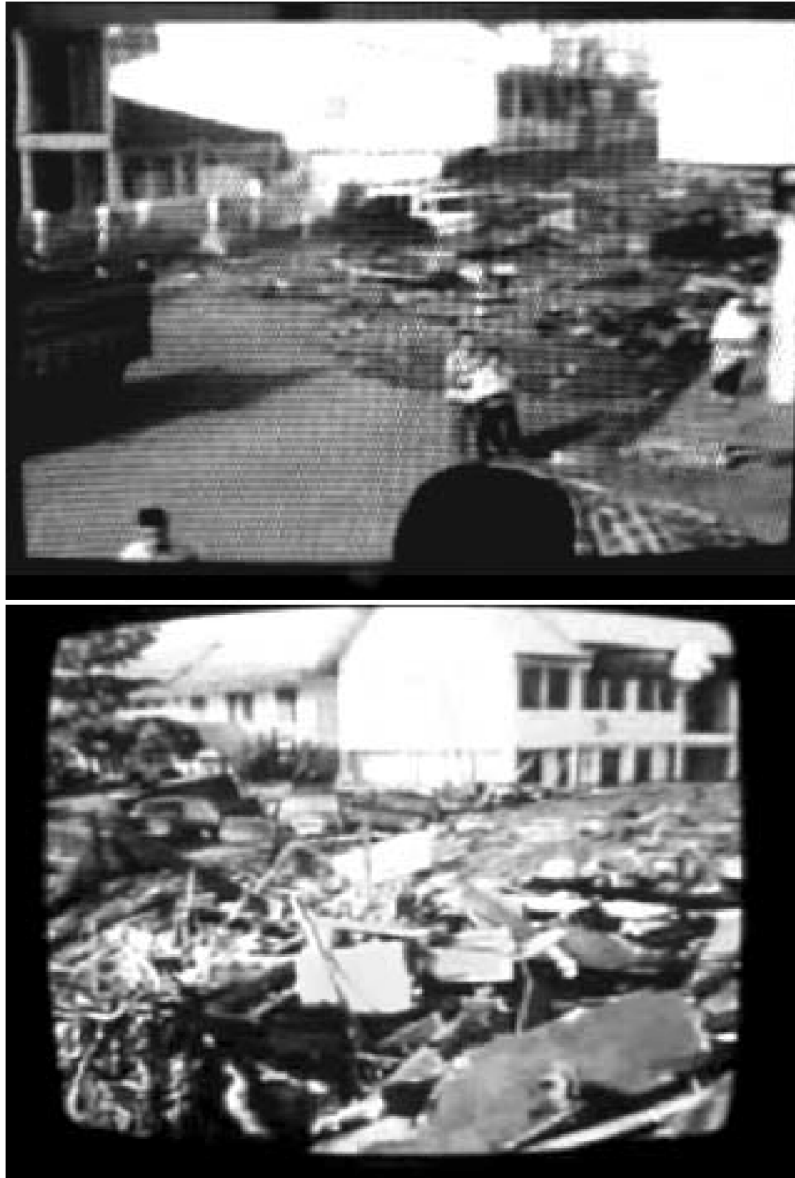
Figure 8. Still frames from a video recorded at the grounds of the Grand Mosque. The upper panel shows the leading edge of the tsunami wave as residents run to escape. The lower panel shows the same location moments later, as the debris-laden tsunami inundation moves through the street. From the video, flow velocities were estimated to be on the order of 15 m/sec.

two frames from a video recorded near the Grand Mosque in the center of Banda Aceh. At this location, the effects of the flow being channeled through narrow city streets can be seen. Flow speeds of 10–15 m/sec. were estimated from tracking single particles over a set distance in the video frame. The video from the city center location clearly shows that the flood depth did not reach the level of the second floor in these buildings. Figure 9 shows what this street corner normally looks like. A detailed analysis of the flow characteristics at different locations on the basis of video imagery is currently under way.

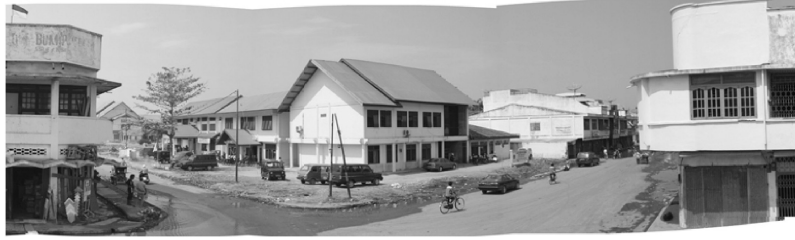
Figure 9. A panoramic photo of the street corner shown in Figure 8. This photo was taken from the precise location used by the videographer in Figure 8.
