## Chapter 4 Field Survey and Numerical Simulation on the 2004 Off-Sumatra Earthquake and Tsunami in Thailand

### 4.1 Introduction

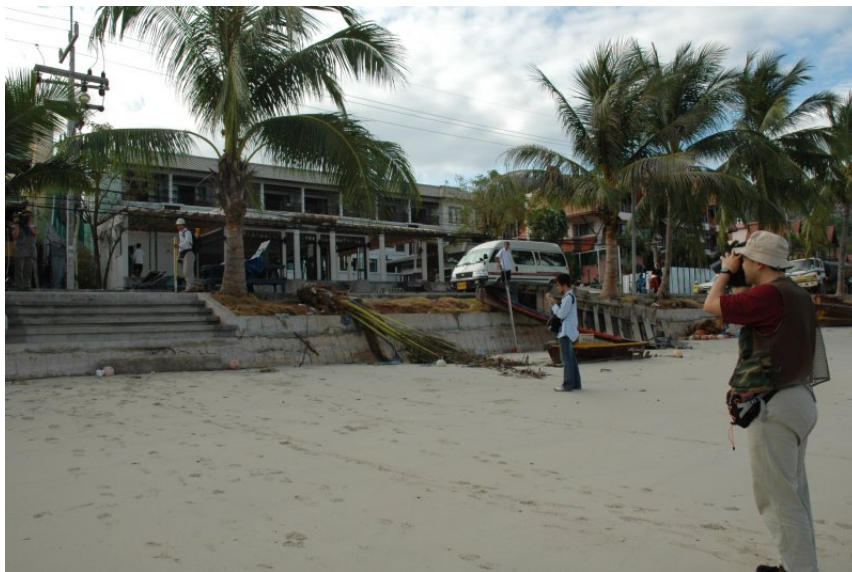
Photo 4.3 The measurement of tsunami height with the laser distancemeter

We carried out tsunami-trace measurements and interviews with residents, as shown in Figs. 4.3 and 4.4. The tsunami traces, driftage and debris, inundation lines on walls, withered plants, etc. were probed as shown in Fig. 4.7. We took several traces to determine the typical tsunami height in the region. When a trace height was low, we confirmed it by interviewing residents. For accurate measurement of tsunami heights and distances from the shore, we used a laser distancemeter and an optic prism.

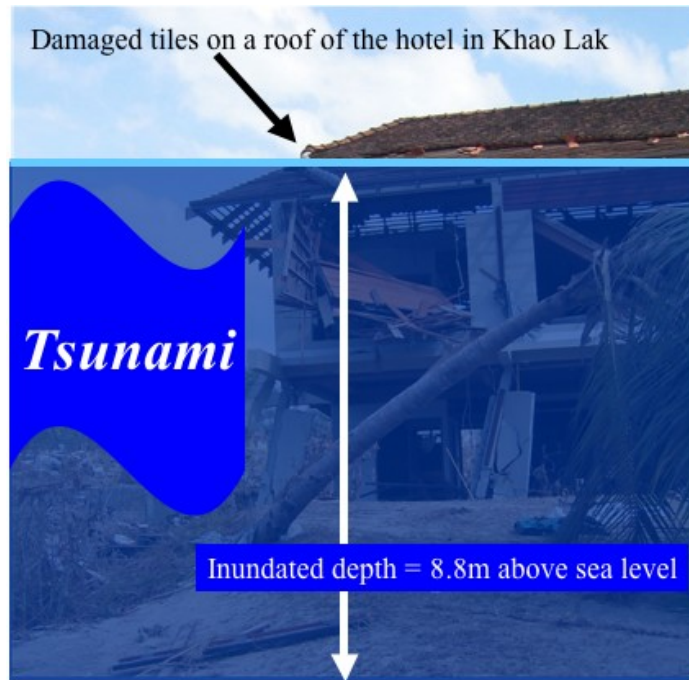
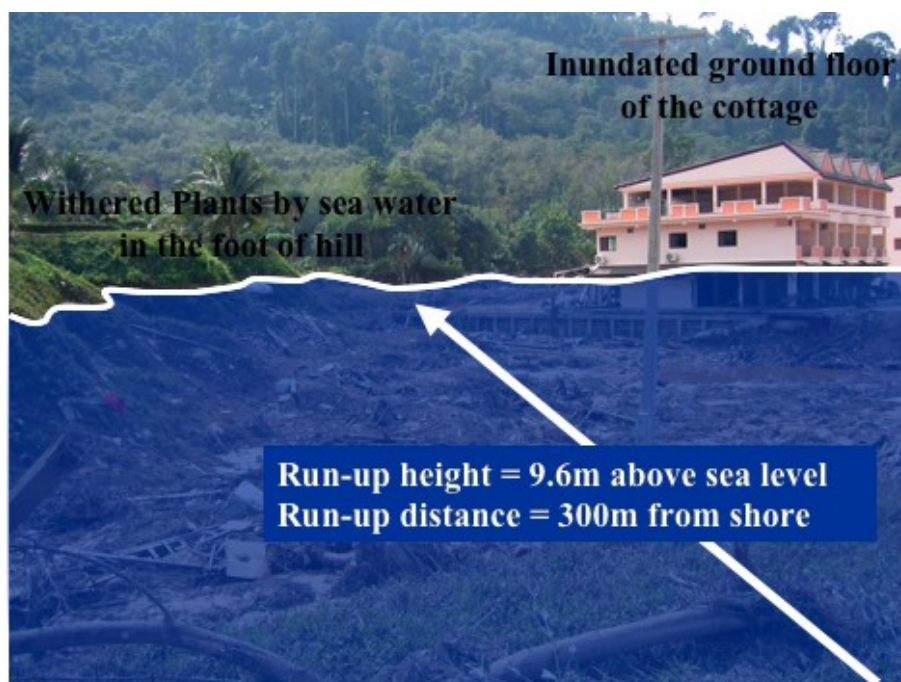
Fig. 4.7 Examples of tsunami trace discrimination

(a) Inundated depth

(b) Runup height and distance from shore

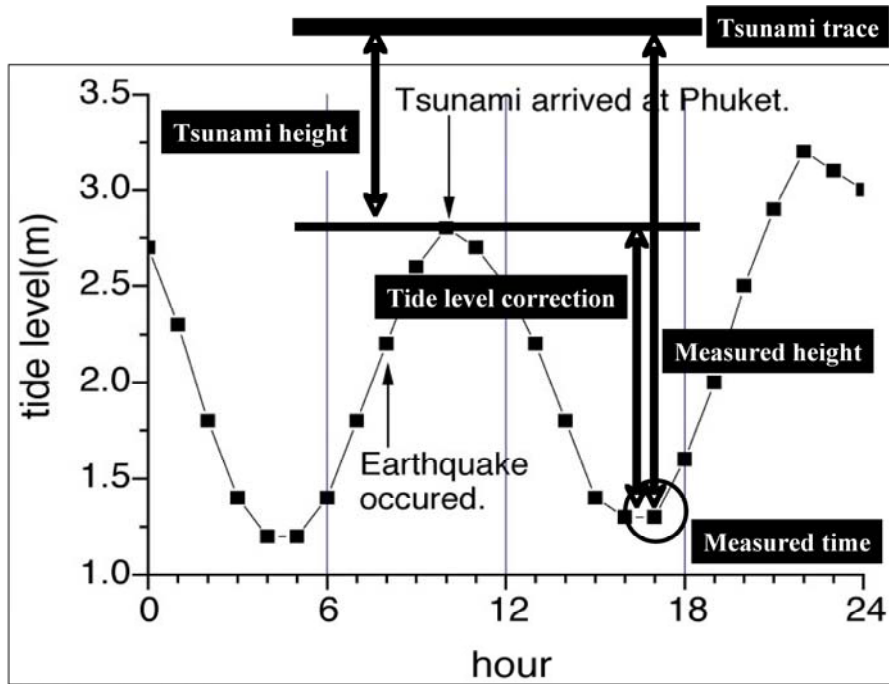
Fig. 4.8 The method of tide level correction

Because of the difference in tide levels between when the tsunami arrived and when our measurements were made, the measured tsunami heights were corrected by the method shown in Fig. 4.8. The tsunami arrival times were assumed to be a uniform 10:00 am local time.

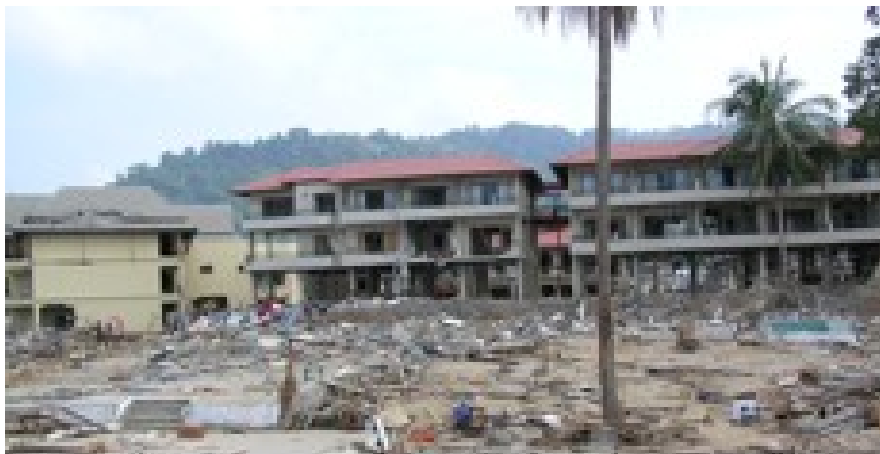
The largest tsunami in Thailand hit this area. Some tsunami heights were higher than 10 m and the inundated depths were 4 to 7 m in the south of Khao Lak. Photo 4.5 shows that the tsunami inundated the third floor of a hotel. The tsunami heights in Khao Lak were much higher than Phuket Island. The reason for this difference seems to have been caused by the local bathymetry off Khao Lak (Suzuka, 2005) and the generation of soliton fission. Some photos and video tapes suggested there was soliton fission. Photo 4.6 and 4.7, for example, show two lines of the wave breaking at a short interval.

Photo 4.5 The tsunami inundated the third floor of a hotel (left building in photo) in Khao Lak

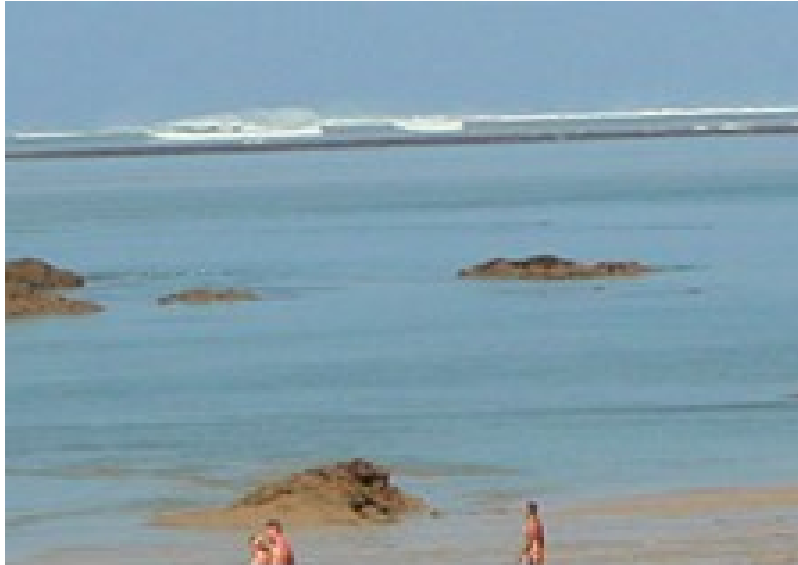
Photo 4.6 The tsunami hits Khao Lak (BBC, 2005)

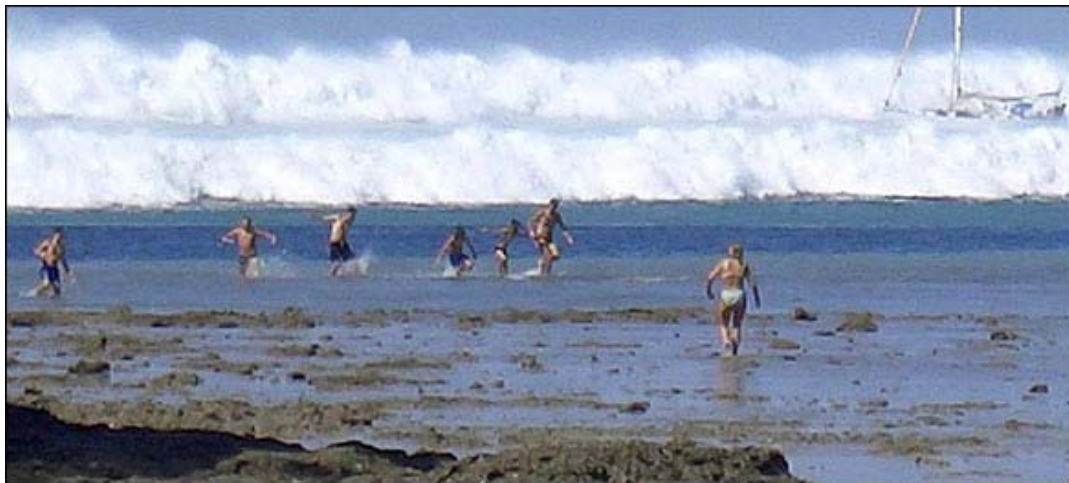
Photo 4.7 The tsunami hits Khao Lak (Amateur Asian Tsunami video Footage, 2005)

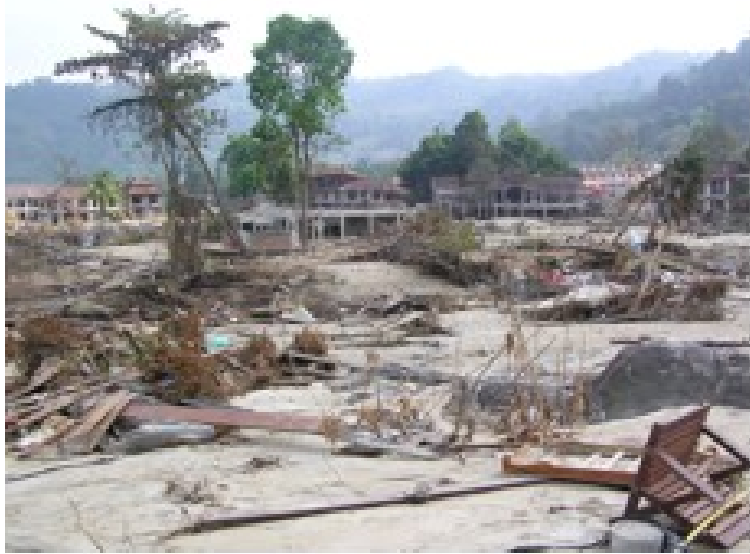
The velocities were 6 to 8 m/s and the drag forces were 3.8 to 6.7  $\text{tf/m}^2$  ( $3.7$  to  $6.6 \times 10^4$  Pa) in the inundated area estimated from the inundated depths in the south of Khao Lak (Matsutomi et al., 2005). This area was a new tourist place and there were many hotels and cottages. Those cottages and two-storied houses close to shore were totally destroyed. In the mid-area of the inundation, their walls and pillars were

partially flushed away. The two-storied houses consisted of floors and pillars made of reinforced concrete, and walls made of brick and mortar, but their roofs were made of tinplate and brick. Photo 4.8 was taken of the damage in the tourist place.

Photo 4.8 Heavily damaged hotels in Khao Lak

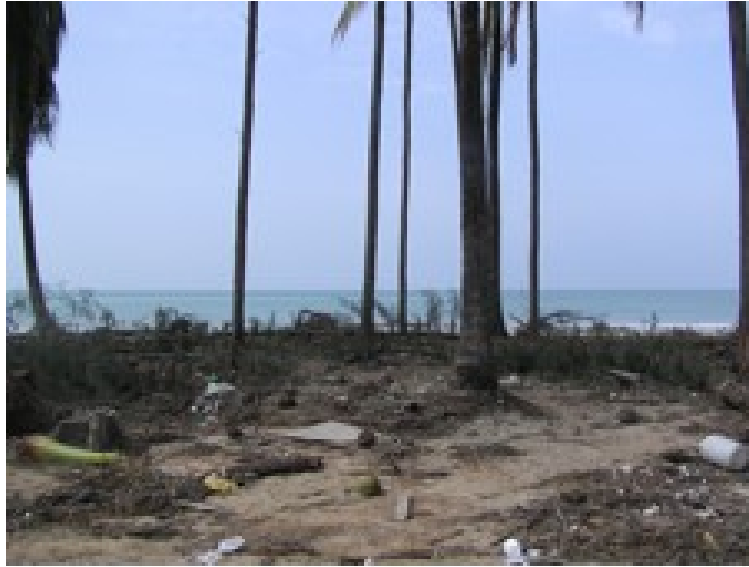
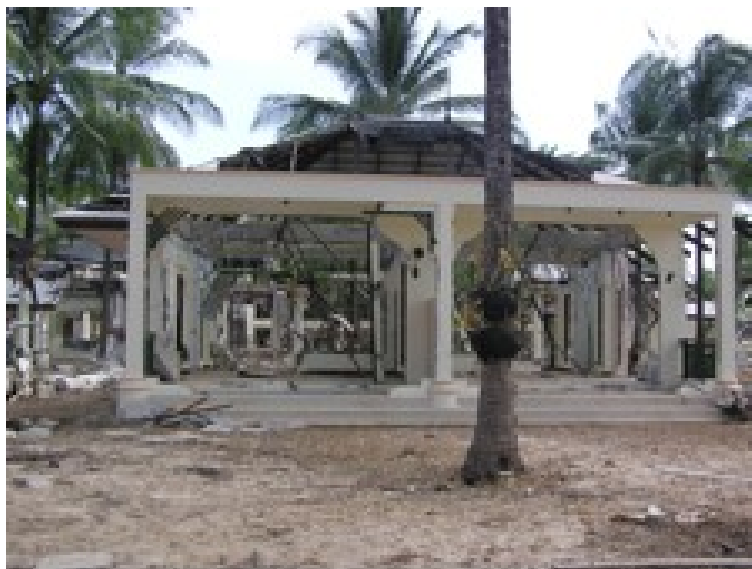
The effect of energy dissipation on the tsunami due to vegetation could be confirmed in Khao Lak (Matsutomi et al., 2005). Figs. 4.9 and 4.10 show vegetation facing the sea and houses at the back of the vegetation. A distance of both places was about 150 m along the coast and the place in photo 4.10 located the north. The vegetation decreased inundated depths from 4.9 m to 4.6m.

(a) Vegetation facing the sea

(b) A house at the back of the vegetation

Photo 4.9 An example of energy dissipation of the tsunami due to vegetation in Khao Lak

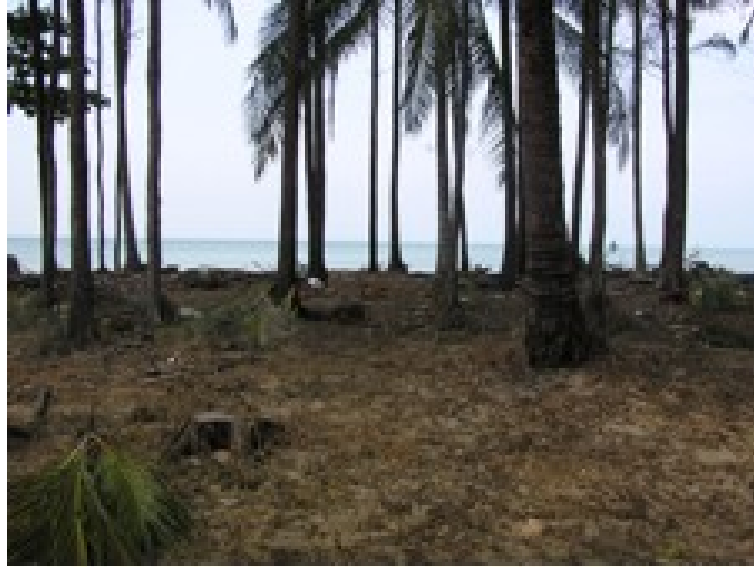
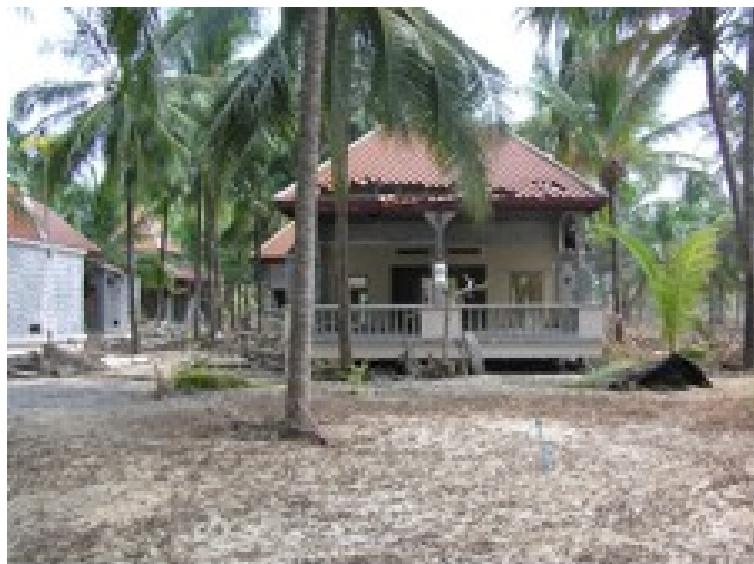
(a) Vegetation facing the sea

(b) A house behind vegetation

Photo 4.10 An example of energy dissipation of the tsunami due to vegetation in Khao Lak

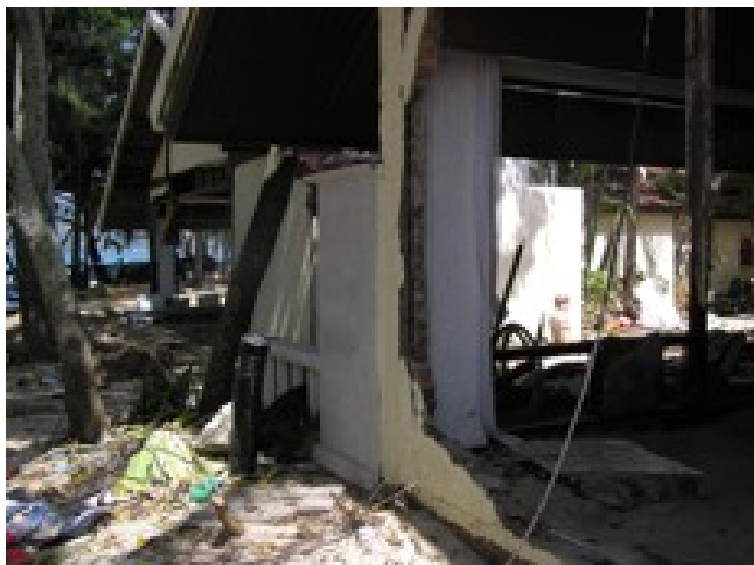
On Patong Beach on the west coast – the most popular tourist place in Phuket – the tsunami heights were 5 to 6 m and the inundated depth was about 2 m. The velocities were 3 to 4 m/s and the drag forces were 0.9 to 1.7  $\text{tf/m}^2$  ( $0.9$  to  $1.7 \times 10^4$  Pa) in the inundated area as estimated from the inundated depths (Matsutomi et al., 2005). In the event of an inundated depth of about 2 m, Japanese wooden houses would show "very heavy damage" or "substantial to heavy damage". On Patong beach, however, there were many houses built of brick and "substantial to heavy damage" was predominate, as shown in Photo 4.11.

Photo 4.11 The broken wall of a house built of brick at Patong beach

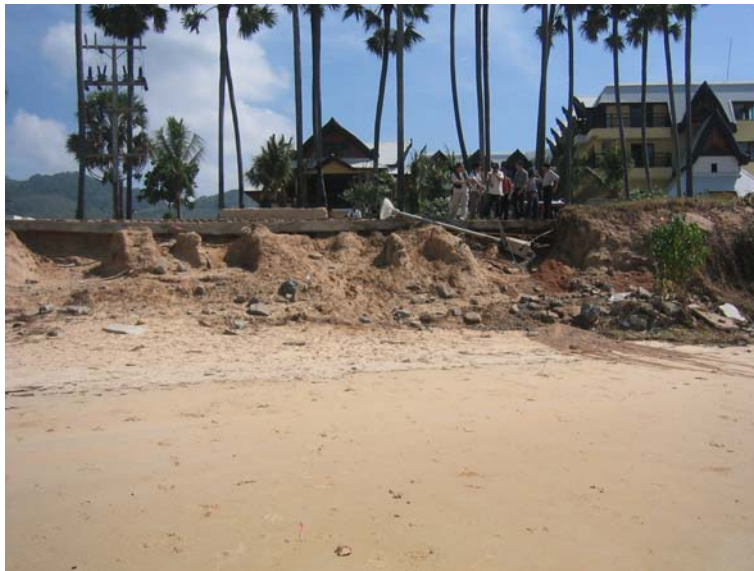
On Karon beach on the west coast, the coastal road was built higher than the shore and it acted as a seawall, protecting a hotel which was behind it, as shown in Photo 4.12. At the southern end of Karon beach, the road was not raised and hotels were damaged.

Photo 4.12 Karon Beach. The high road reduced the tsunami by acting as seawall

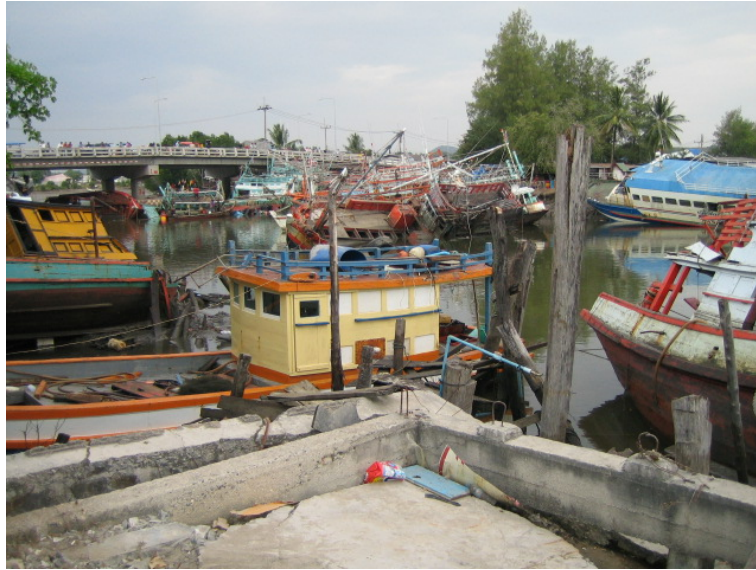
On the east coast of Phuket Island, which was not facing the tsunami source, the tsunami height was about 2 m. In one river mouth, many boats were damaged, as shown in Photo 4.13. Fortunately, concrete bridge piers were not damaged. The tsunami propagated anticlockwise around Phuket Island, as was the case at Okushiri Island in the 1993 Hokkaido Nansei-ok Earthquake Tsunami.

Photo 4.13 Damaged boats in a river in the east of Phuket Is.

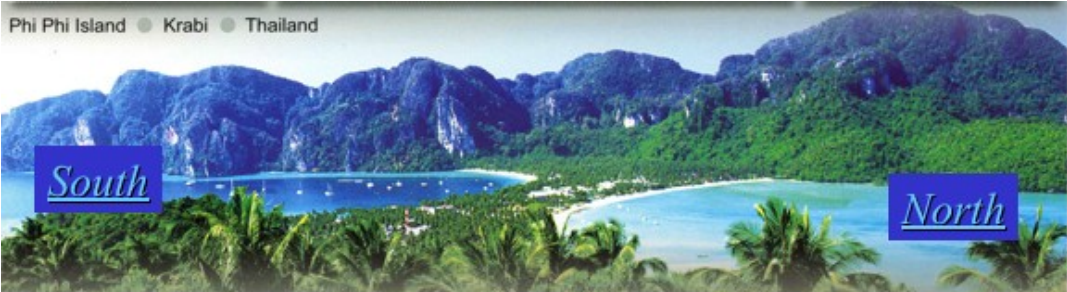
The shape of Phi Phi Don Island is similar to the letter "H" in shape. There are a bay on the north coast and a bay on the south coast, as shown in Photo 4.14. Photo 4.15 shows the north bay, which is shallow and had a beautiful beach. Photo 4.16 shows the south bay, which is deep and had a port.

Photo 4.14 The north and the south bays of Phi Phi Don Islands.

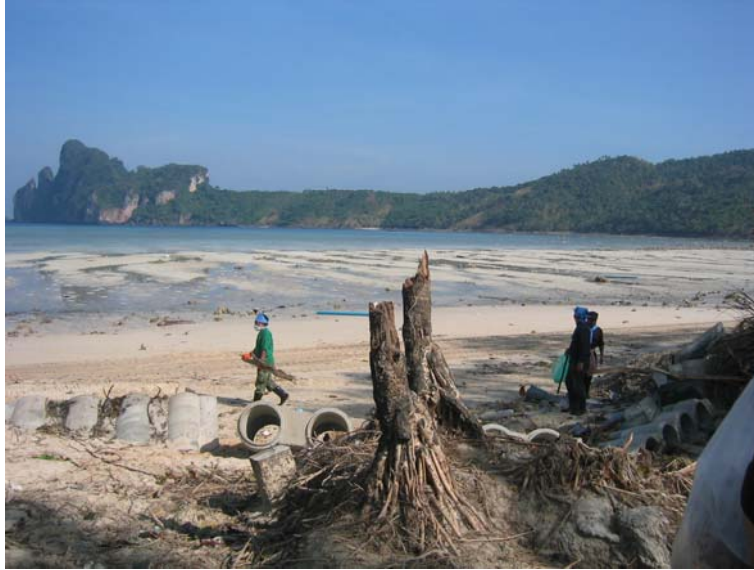
The north bay opens to the northwest, thus it faced in the direction that the tsunami came from. The measured tsunami height on this beach was 5.8 m. On the other hand, the south bay opens to the southeast.

Photo 4.15 The north bay on Phi Phi Don Island.

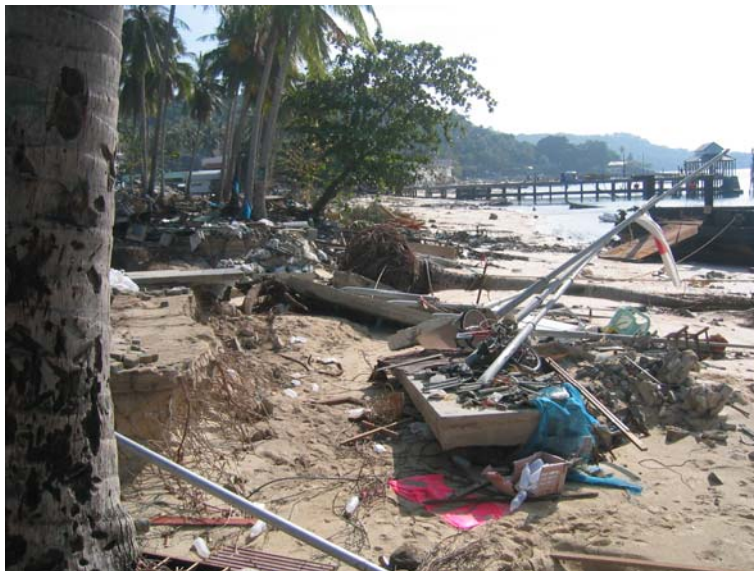
It faces in the opposite direction to which the tsunami was propagated. Further, Phi Phi Le Island shields the port of Phi Phi Don Island. The measured tsunami height, however, was 4.6 m in this port. It indicated that the tsunami propagated around the islands.

Photo 4.16 The south bay which was used as a port on Phi Phi Don Island.

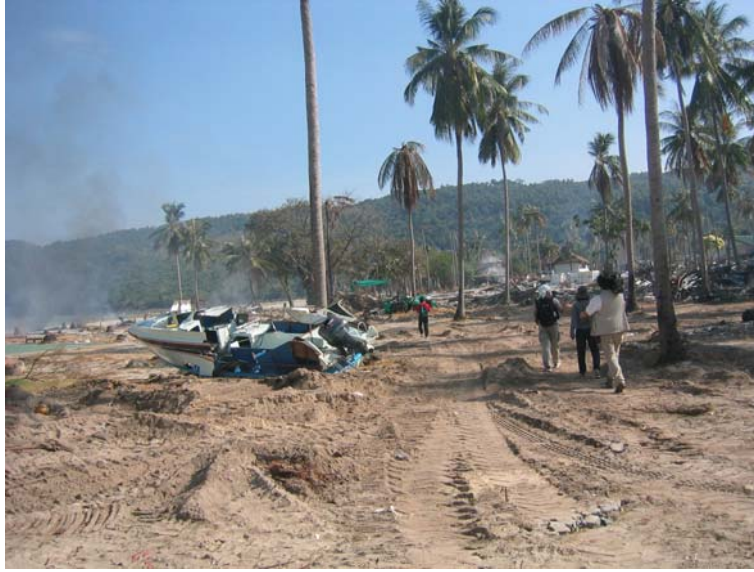
According to some eyewitnesses accounts, the tsunami came from the north and south, and totally washed the central area away. The ground level here was about 2 m above sea level, but there were many cottages and hotels. Therefore, the tsunami waves from the north and south destroyed this area, as shown in Photo 4.17.

Photo 4.17 The central part of Phi Phi Don Island.

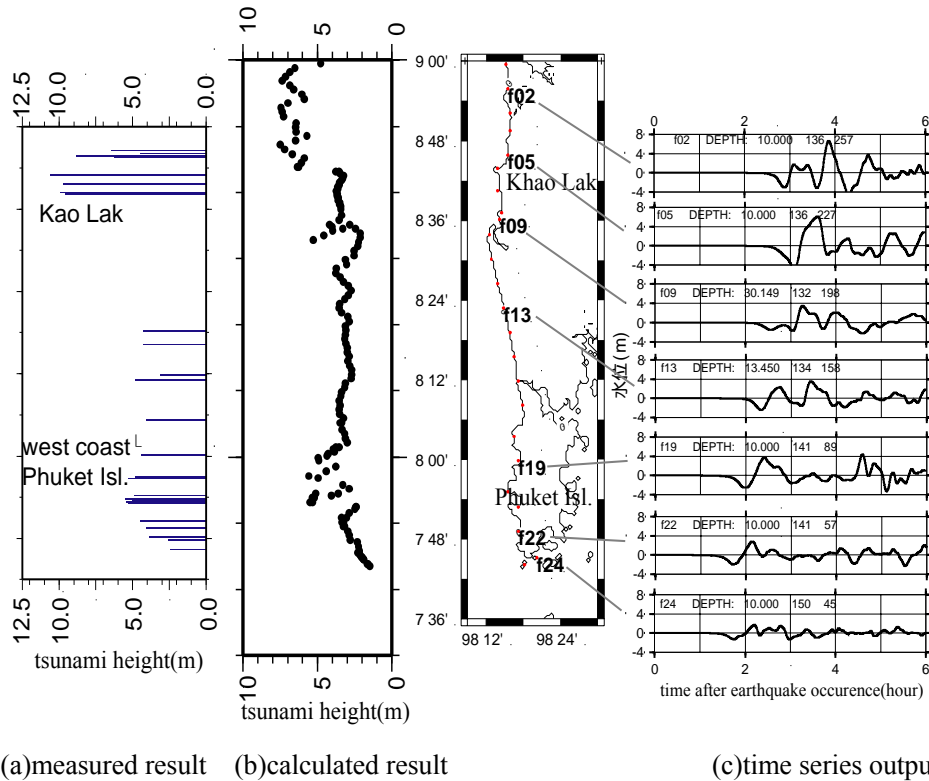
Fig. 4.16 shows distributions of measured and calculated tsunami heights along the coast of Thailand. The maximum calculated height on Phuket Island is about 6m and similar to the measured height. On Khao Lak, the maximum calculated height is about 8m, and the measured height was a little larger, which ranges from 9 to 10m. However calculated result describe the difference between heights in Phuket and at Khao Lak, as shown in measured distribution. Therefore both results are harmonious, and this indicates total energy of two fault models is acceptable for tsunami heights in Thailand.

Fig. 4.16 Comparison between calculated and measured tsunami height distributions in Thailand, and time series output by calculation along shore

Fig. 4.16 also shows time series output along the coast of Thailand. The tsunami arrived at the southern part of Phuket Island at first. It took 90 minutes to propagate from the tsunami source. Water surface descended first and ascended after half an hour. The tsunami arrival ran to the north direction along the coast of Thailand. Witnesses confirm this feature of the tsunami arrival time. The tsunami arrival time at Khao Lak was an hour later than on Phuket Island. The maximum height was recorded by the second or later ascent wave at four points. Especially maximum height at f19 appeared four and a half hours after the earthquake.

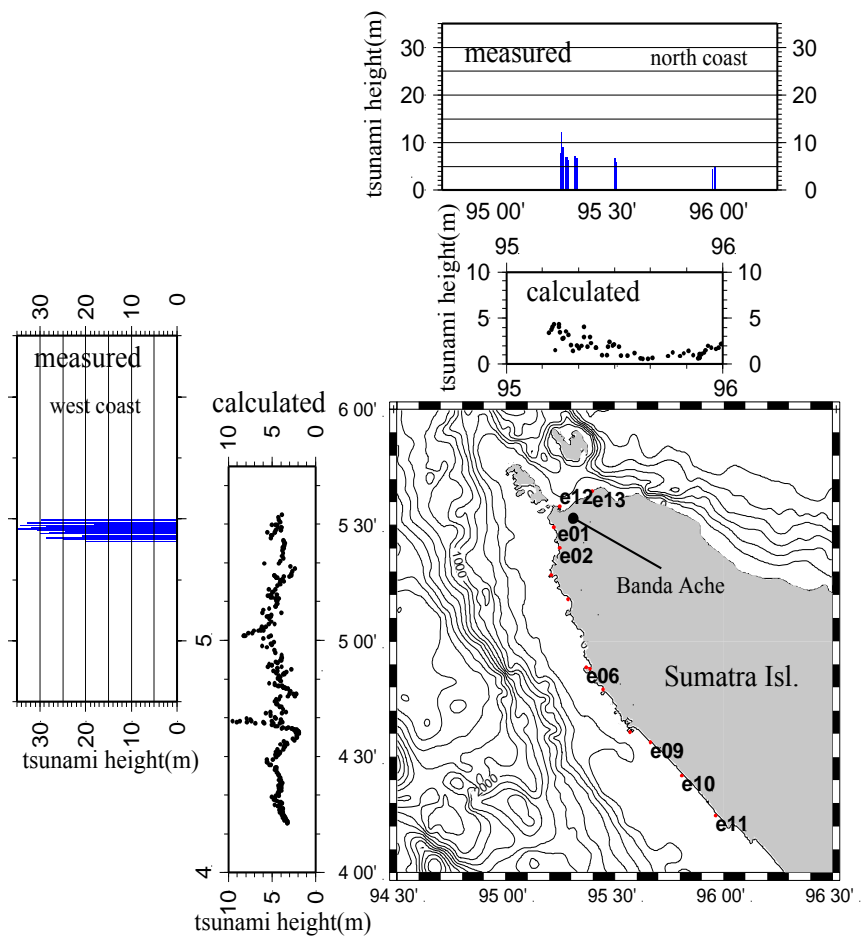
Fig. 4.17 shows distributions of measured and calculated tsunami heights on Sumatra Island. Along the northern coast of Banda Ache, tsunami height by calculation was a maximum of 4m and decreased farther to the west. Calculated heights ranges from 40 % to 50% of measured ones. Along the western coast of northern Sumatra, the tsunami height maximum was 10m, and about 5m at the same coast region of measurement. Measured heights are much larger than calculated ones. The reason for the difference between

calculated and measured results is uniformity of two assumed fault models. That is, real fault movement has plural asperities, and it caused a giant tsunami, which hit to the west coast of northern Sumatra Island.

Fig. 4.17 Comparison between calculated and measured tsunami heights distributions in northern Sumatra.
