PERFORMANCE OF THE NEW ENGLAND  
HYDRAULIC DREDGE FOR THE  
HARVEST OF STIMPSON'S SURF CLAMS  
(*Mactromeris polynyma*)

Jean Lambert and Patrice Goudreau

1996

Canadian Industry Report of  
Fisheries and Aquatic Sciences 235

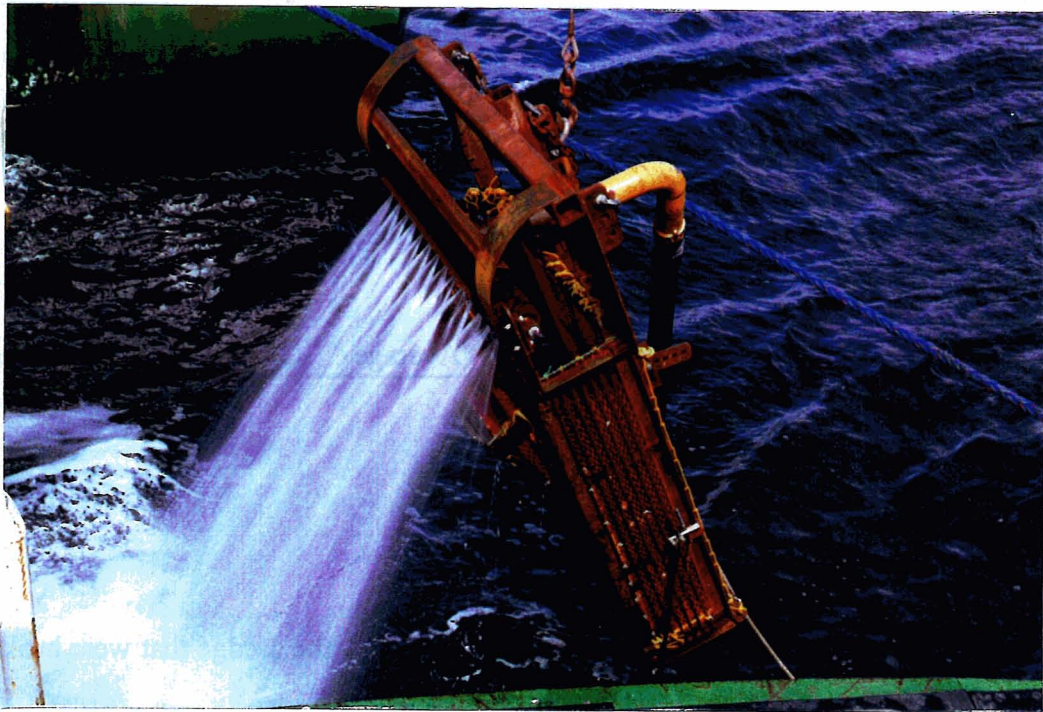
Figure 1. New England type hydraulic dredge.

The study was carried out in two parts. The first was undertaken in 1993 aboard a commercial fishing vessel and the second in 1994 aboard a DFO (Department of Fisheries and Oceans) research vessel. A New England hydraulic dredge (Figure 1) was used on both vessels.

The first part of the study, on the *Brigitte Susan*, took place from 6 to 10 July 1993. The vessel measures 12.57 m (41 ft, 3 in) and has a 125 horsepower diesel engine. The dredge used had a total length of 2.13 m (7 ft), a basket height of 43.2 cm (17 in), and a total width of 1.52 m (5 ft), of which 1.22 m (4 ft) was the width of the blade. At the time of this experiment, the blade height was 15.2 cm (6 in). The space between the rods of the basket measured about 2.5 cm (1 in). Twelve water jets were directed at the base of the blade. The hydraulic pump, with a capacity of 4091 liters per minute (900 imperial gallons per minute), was connected to an 80 horsepower diesel motor. The diameter was 12.7 cm (5 in) at the pump entry and 10.2 cm (4 in) at the exit. A 10.2 cm diameter hose joined the pump to the entry of the dredge's jets. A constant pressure of 4.2 kg per cm<sup>2</sup> (60 lbs per in<sup>2</sup>) was maintained at the pump exit for each tow.

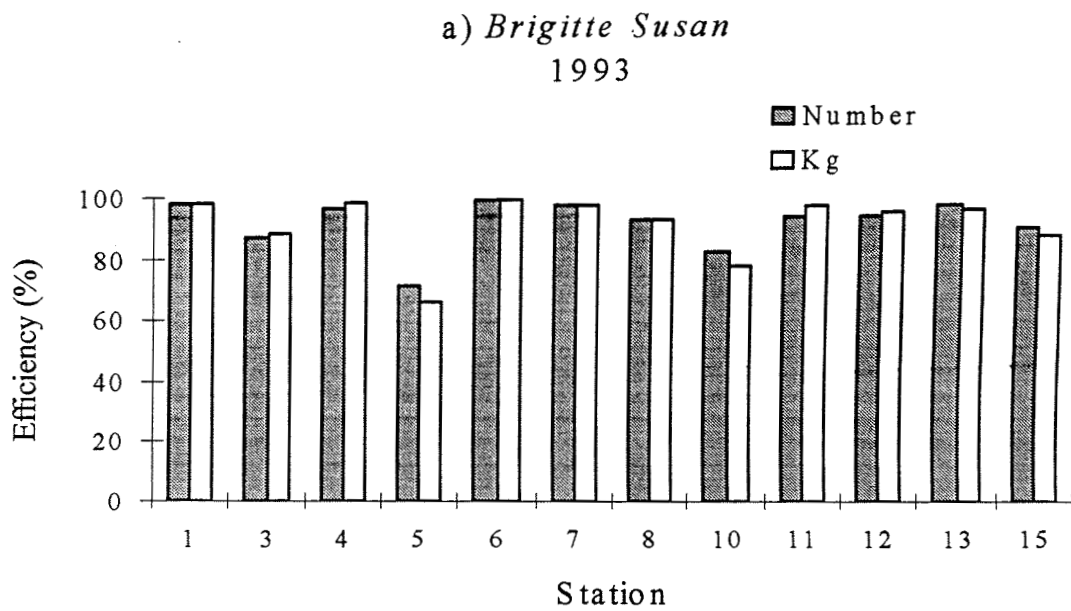
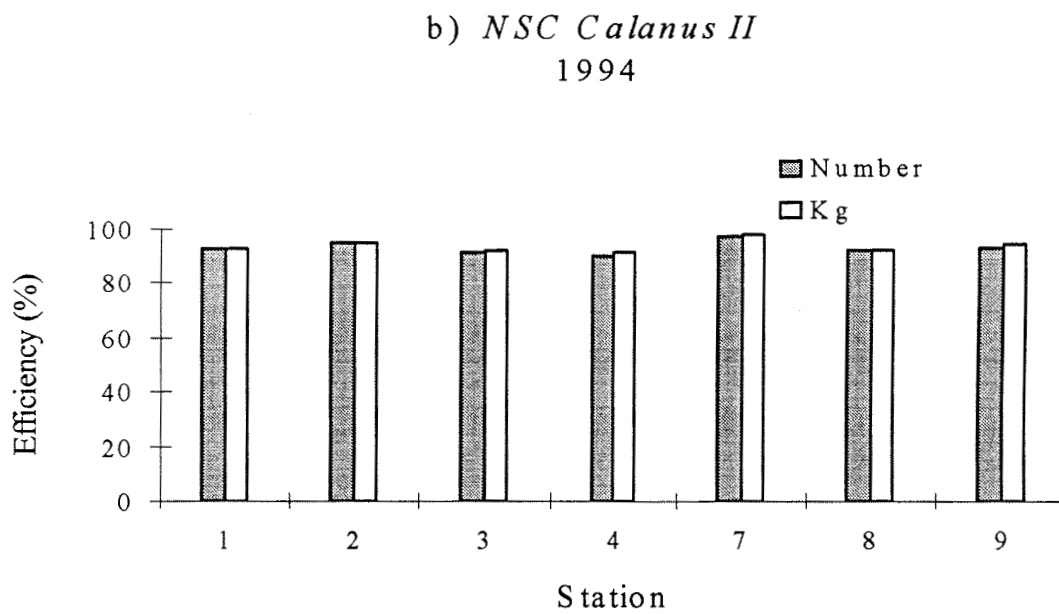
Figure 2. Efficiency of the hydraulic dredge (a) in 1993 on the *Brigitte Susan* and (b) in 1994 on the *NSC Calanus II*.

In seven of the ten tows conducted by the *Brigitte Susan* with the unlined dredge, the dredge efficiency was greater than 90% and attained nearly 100% at certain stations (Figure 2a). Only the tow at station 5 resulted in an efficiency less than 80%. At this station, the divers noted a strong current flowing perpendicular to the dredge's pass. The tows made with the lined dredge resulted in efficiencies of 95% at station 13 and 86% at station 15. It is important to note that the sampling of station 14 was not completed because the divers noted many molluscs left on each side of the lined dredge's traces. There are several possible explanations for this apparent anomaly in dredge performance: the dredge may have been moving sideways or a hard bottom under a sandy layer could have caused the jets of water to rebound and displace the clams outside the path of the dredge. It is also possible that an accumulation of rocks and organisms inside of the lined dredge could have hindered the crosswise penetration of water and subsequently impeded the collection of the clams. This last hypothesis seems the most likely considering observations by the divers for this station and area.

All of the tows conducted on the *NSC Calamus II* resulted in a collection efficiency equal to or greater than 90% for Stimpson's surf clams (Figure 2b). A maximum efficiency of 97% was obtained at station 7. It was observed that these stations, characterized by relatively flat sandy sediments, were favorable for the proper maneuverability of the dredge.

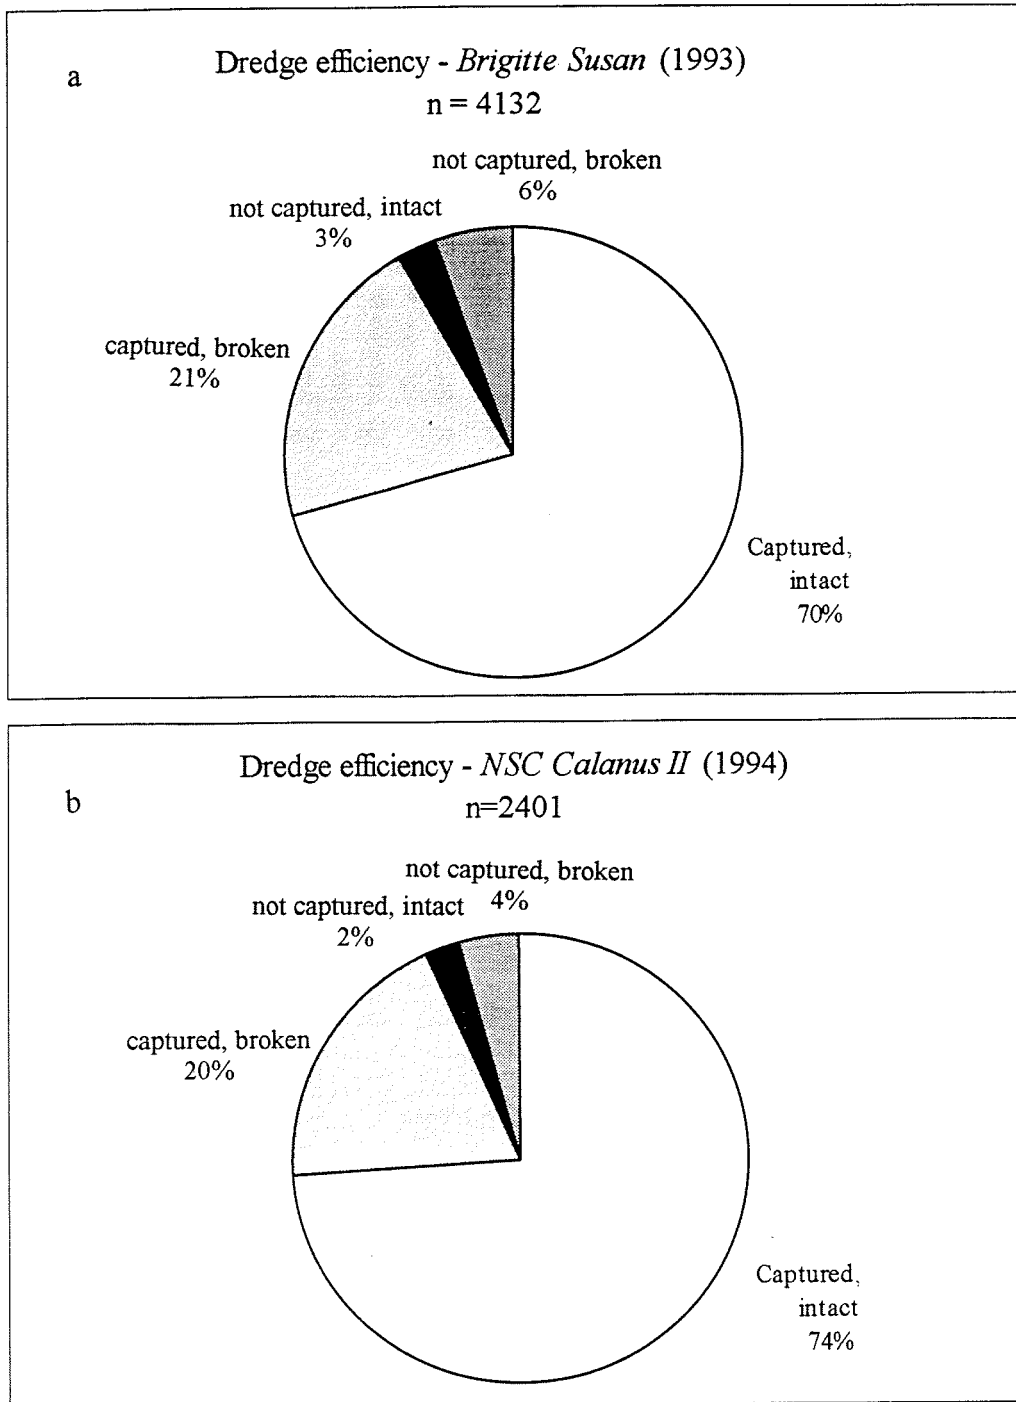
Figure 7. Percentages of Stimpson's surf clams, intact or broken, that were captured by the dredge or collected by divers in (a) 1993 or (b) 1994.

Among the Stimpson's surf clams not collected by the dredge and subsequently collected by the divers, 67 and 63% were broken in the first and second parts of the study respectively (Tables 5 and 6). It is important to emphasize that these high percentages of damaged individuals represent a small proportion (less than 10%) of this species present on the site prior to the passage of the dredge. Damages ranged from breakage of one shell to nearly complete crushing of the entire shell, which sometimes hampered identification of the species. It was also not possible to verify if there was a relationship between the size of the clams and the relative damage caused since it was usually impossible to measure the broken clams.

Stimpson's surf clams collected in the dredge were also found to be damaged. An average of 23% of the clams collected during the 12 tows on the *Brigitte Susan* were broken between the moment of capture and final deposition on the bridge of the boat (Table 7). For the seven tows conducted with the *NSC Calanus II*, 21% of the clams retained in the dredge were found to be broken at the time of their examination on the bridge (Table 8). The highest rates of damage to the clams retained in the dredge in 1994 were at stations 1 and 3, where the lowest water pressure ( $3.2 \text{ kg/cm}^2$  or  $45 \text{ lbs/in}^2$ ) was used. These two tows were also conducted at the highest operational speeds, 19 and 25 m/min., and with a blade height of 17.8 cm. The lowest percentage of damaged clams was found at station 8, where a water pressure of  $4.2 \text{ kg/cm}^2$  ( $60 \text{ lbs/in}^2$ ), a speed of 16.6 m/min., and a blade height of 22.9 cm were used. The numbers of broken shells obtained in this study are on the same order of magnitude as those found for other studies. For example, in a study in the Bering Sea, Kauwling and Bakus (1979) noted that 16% of the Stimpson's surf clams were damaged during collection. Roddick and Kenchington (1990) indicated that 27.6% of Stimpson's surf clams were damaged following scientific collections made near Nova Scotia. These numbers are of importance considering that the majority of damaged Stimpson's surf clams collected as part of the commercial fishery in Québec are thrown back and thus not counted in official catch landings.

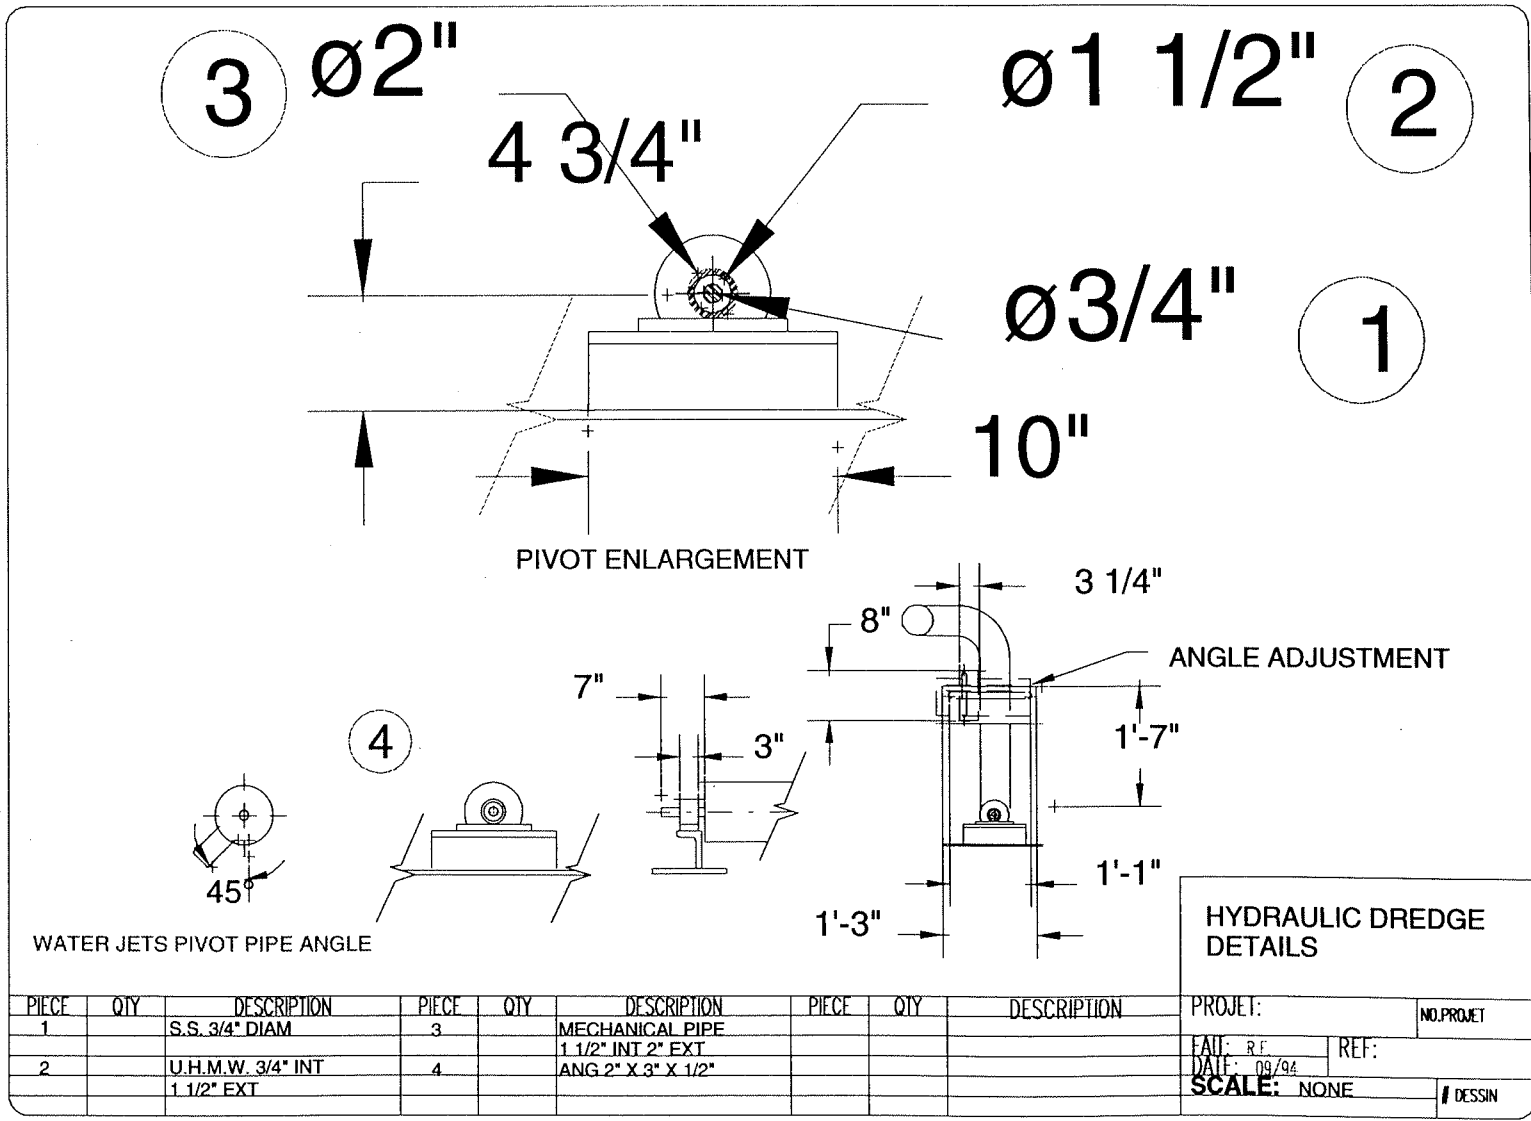
Annex 1. (continued)

UPPER VIEW

SIDE VIEW

FRONT VIEW

HYDRAULIC DREDGE WATER JETS DETAILS	
PROJET:	NO. PROJET
FAT:	REF:
DATE:	
SCALE: NONE	DESSIN
