Tsunami heights and damage along the Myanmar coast from the December 2004 Sumatra-Andaman earthquake

The tsunami heights from the 2004 Sumatra-Andaman earthquake were between 0.4 and 2.9 m along the Myanmar coast, according to our post tsunami survey at 22 sites in Ayeyarwaddy Delta and the Taninthayi coast. Interviews to coastal residents indicate that the tsunami heights were lower than high tide level in rainy season, probably by storm surge. They also testified that the arrival times were between 2 and 5.5 hours after the earthquake but the reliability may be low because nobody felt ground shaking. Much smaller tsunami than the neighboring Thai coast, where the tsunami heights were 5 to 20 m, explains relatively slighter tsunami damage in Myanmar; the casualties were reported as 71, compared to about 8300 in Thailand. The smaller tsunami was probably due to the fact that the main tsunami source did not extend to Andaman Islands. The tsunami travel times and maximum heights computed from a 700 km long source are basically consistent with the observations. For a nearby tsunami source, the tsunami hazard would be more significant in Myanmar, because coastal houses are unprotected

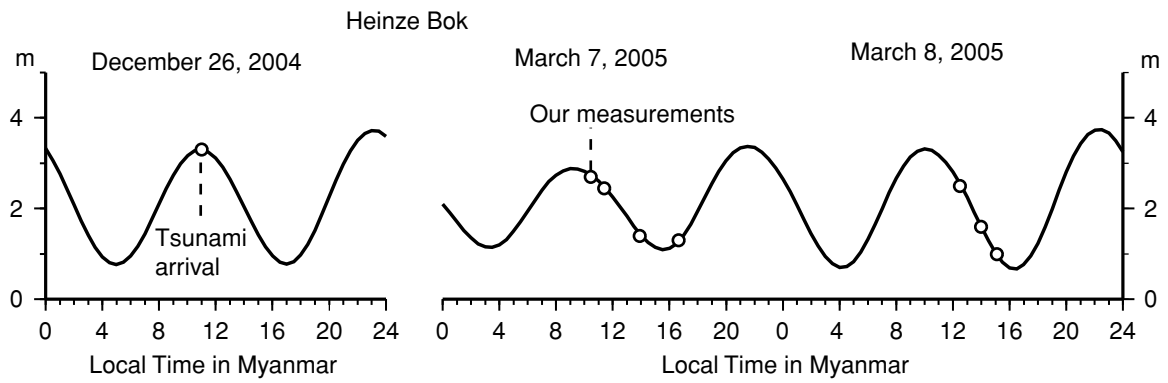
Fig. 4. Predicted astronomical tidal changes at Heinze Bok (Long Island), near Dawei. (a) Tidal change on December 26, 2004. An open circle on the curve shows the time of the tsunami arrival. (b) Tidal change on March 7–8, 2005. Circles on the curve show times of our measurements.

The tide levels at the times of tsunami arrival and the measurement were computed on the basis of astronomical tides, by using computer program WXTide 32 release 4. The maximum differences of the predicted tides with a tide table (United Kingdom Hydrographic Office, 2004) are within 70 minutes and 50 cm at ebb/flood times. For Ayeyarwaddy Delta, tide was calculated based on predicted tides at Bassein River, Diamond Island (15°52.0'N, 94°17.0'E). For Dawei coast, the tide was calculated at Heinze Bok, Long Island (14°24.0'N, 97°47.0'E). For Mergui measurements, the tide was calculated at Mergui (12°26.0'N, 98°35.9'E). For the measurements around Kawthaung, tide was calculated at Pulo Basin (9°59.0'N, 98°29.0'E).

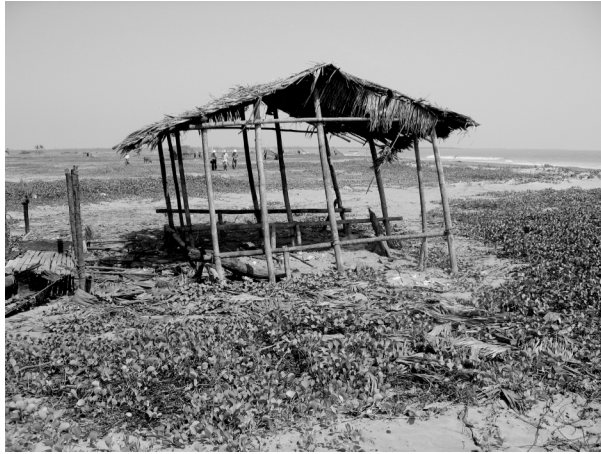
Fig. 6. Damaged hut in Kapyet Thuang Village.

At Layyin Kwin Village (loc 17), 16 huts out of 20 were washed away and one person was perished by the tsunami (Fig. 6). According to an eyewitness, the tsunami arrived at 11:45, when the tide was low, in four waves. The inundation depth was about 20 cm. Our measurement indicated that the tsunami level was 0.7 m above the sea level, or 0.6 m after the correction for tide.

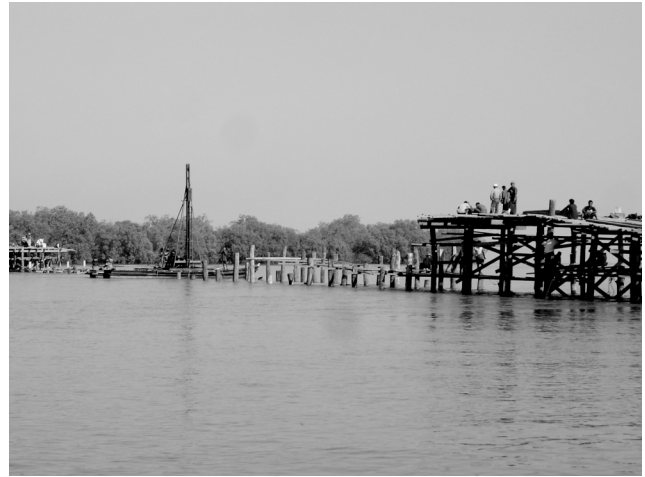
Fig. 7. Destruction of wooden bridge to Plautonton Island.

bridge. The central part of the bridge was destroyed by the tsunami (Fig. 7). Measurement was taken at Plautonton Village (loc 08) on the island. Most houses of the village are built on a mudflat, raising floor level up to one or two meters above the sea surface. Watermark was observed at the interviewee's house. A housewife told us that the tsunami arrived at 10:30 am in three waves with 15 minute intervals. An owner of a grocery store said that two waves with 10–15 minute interval arrived. Because the tsunami arrived during low tide, there was no severe damage to buildings, but some household wares (rice bags, cloths and TV sets, etc) were flooded. One person died in this village. Our measurement indicated that the tsunami height was 1.8 m above the sea level, or 2.5 m after the correction.

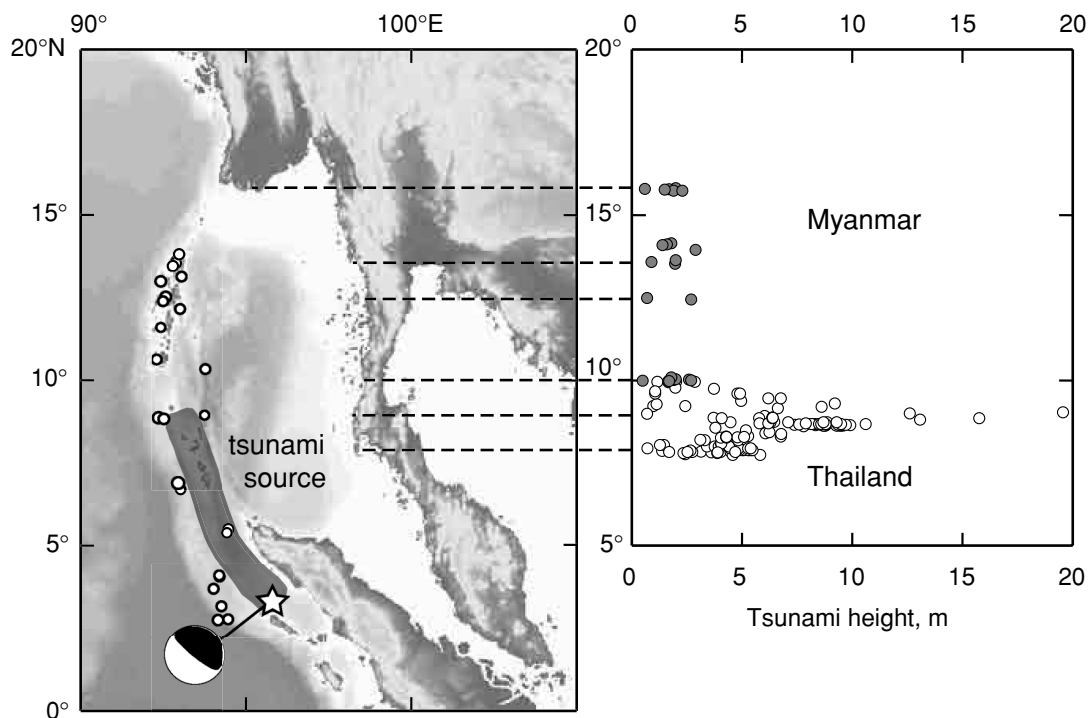
Fig. 9. Comparison of tsunami heights along the Myanmar and Thai coasts. The tsunami heights along the Thai coasts were surveyed by Matsutomi *et al.* (2005), Satake *et al.* (2005), and Tsuji *et al.* (2006). Inferred tsunami source area is shown.

The tsunami height was much smaller than those of the neighboring Thai coast (Fig. 9). The tsunami heights along the Thai coast were measured by three Japanese parties (Matsutomi *et al.*, 2005; Satake *et al.*, 2005; Tsuji *et al.*, 2006). From south to north along the Andaman Sea, the reported tsunami heights are about 5 m in Phuket, more than 10 m around Khao Lak where thousands of European tourists lost their lives, and nearly 20 m at Ban Thung Dap, then are smaller toward the Myanmar border. The relatively smaller tsunami heights in Myanmar explain why the tsunami casualties, as reported as 71, were much smaller than those of Thailand. One of the reasons for the smaller tsunami may be due to the fact that some coast of Taninthayi Division was protected by offshore islands of the Myeik Archipelago trending in the north-south direction.
