# 33 PRESERVATION BRIEFS

## The Preservation and Repair of Historic Stained and Leaded Glass

Neal A. Vogel and Rolf Achilles

National Park Service  
U.S. Department of the Interior

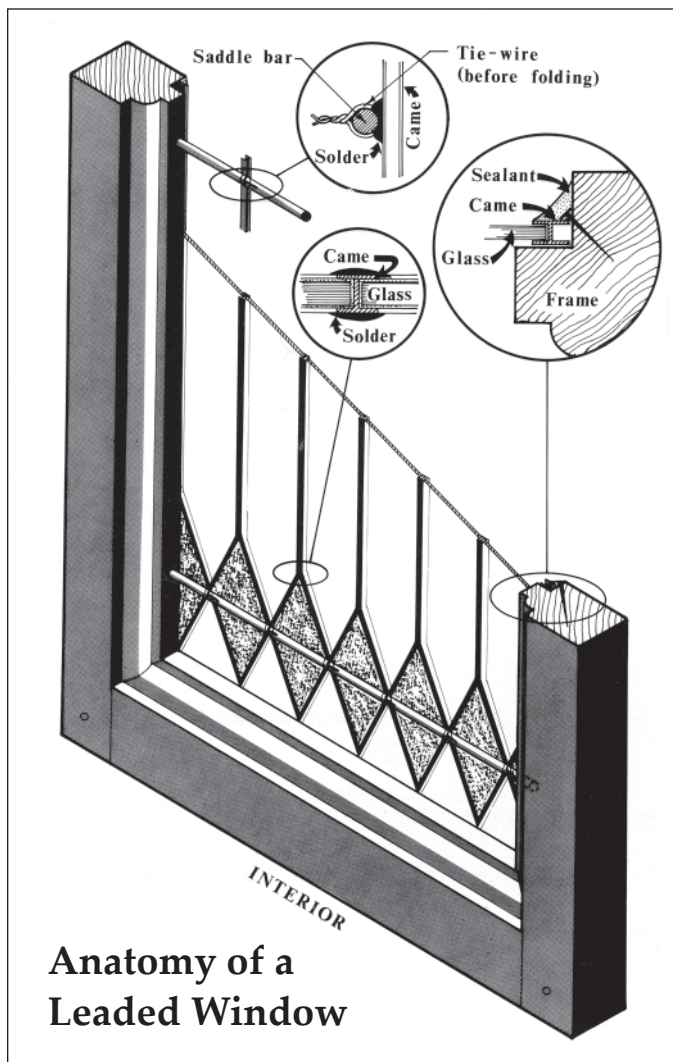
Figure 2. Components of a leaded glass window.

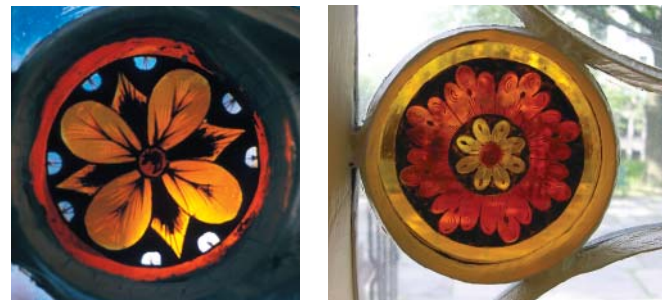
Figure 3. The entrance to the Morris-Jumel Mansion, New York City, is one of the earliest surviving installations of stained glass in the country. It features a fanlight and sidelights of large clear roundels and small bulls-eyes of red and orange glass tinted with silver stains from ca. 1810. Photo: Ken Moss.

from these periods is very significant (Fig. 3). Every effort should be made to document and preserve it.

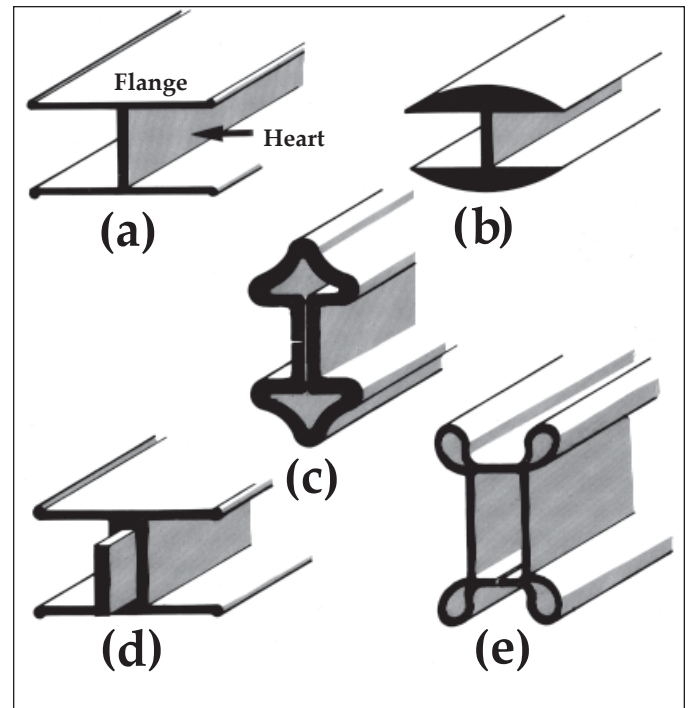
Figure 13. A wide variety of came has been used for ornamental glass in America: (a) flat lead came; (b) round lead came; (c) “Colonial” zinc came; (d) double-heart lead came with a steel core; (e) “Prairie School” zinc came.

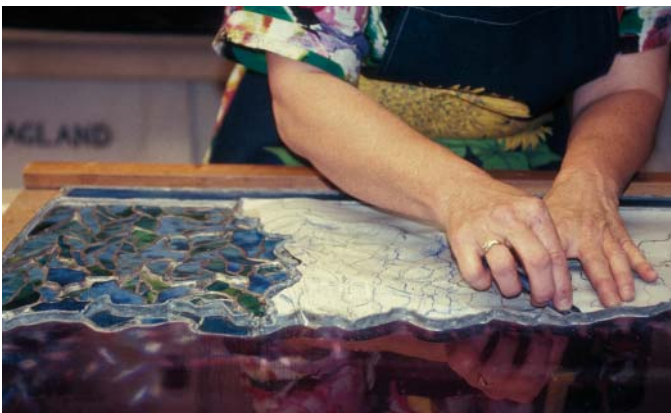
*Figure 14. The external glass plate has been removed to clean the interlayer of this plated Tiffany Studios window.*

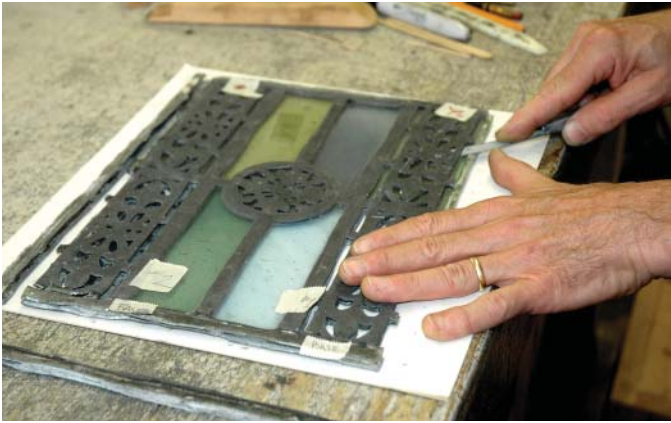
Figure 15. To permit repair of the cracked glass, the original lead overlay is first salvaged from this historic leaded panel of silhouette glass to retain as much of the original work as possible.

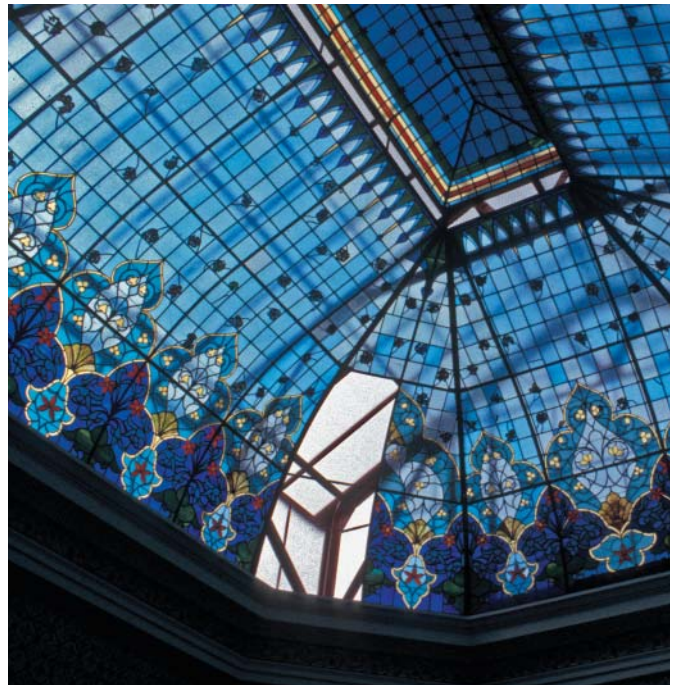
*(a) Stained glass ceilings and domes are often principal interior features of churches, hotels, restaurants, railway stations, and civic buildings. This vaulted ceiling illuminates the Cypress Lawn Memorial Gardens mausoleum in Colma, California. The panel removed reveals the diffusing skylight above.*

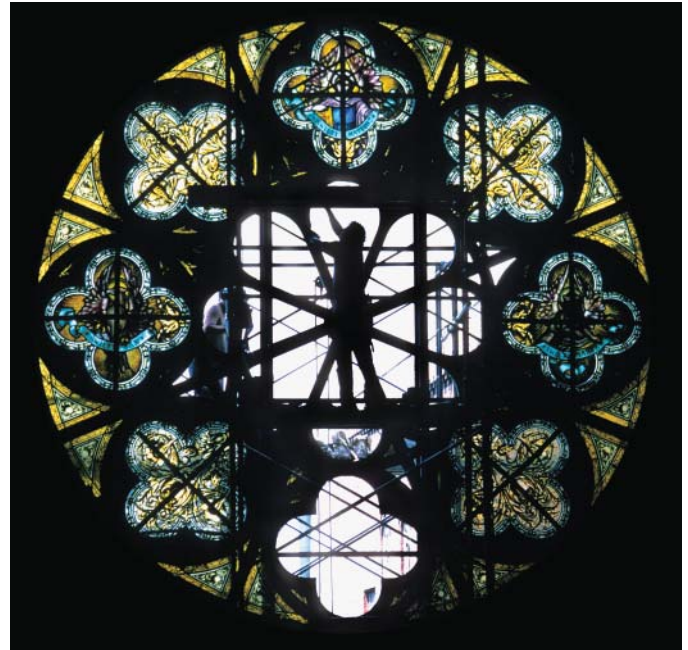
Wooden frame of the rose window undergoing repair (exterior view).
