2.2_Glover Park Site Analysis

Glover Park_Site Analysis

Site Access / Use

Landscape Characteristics

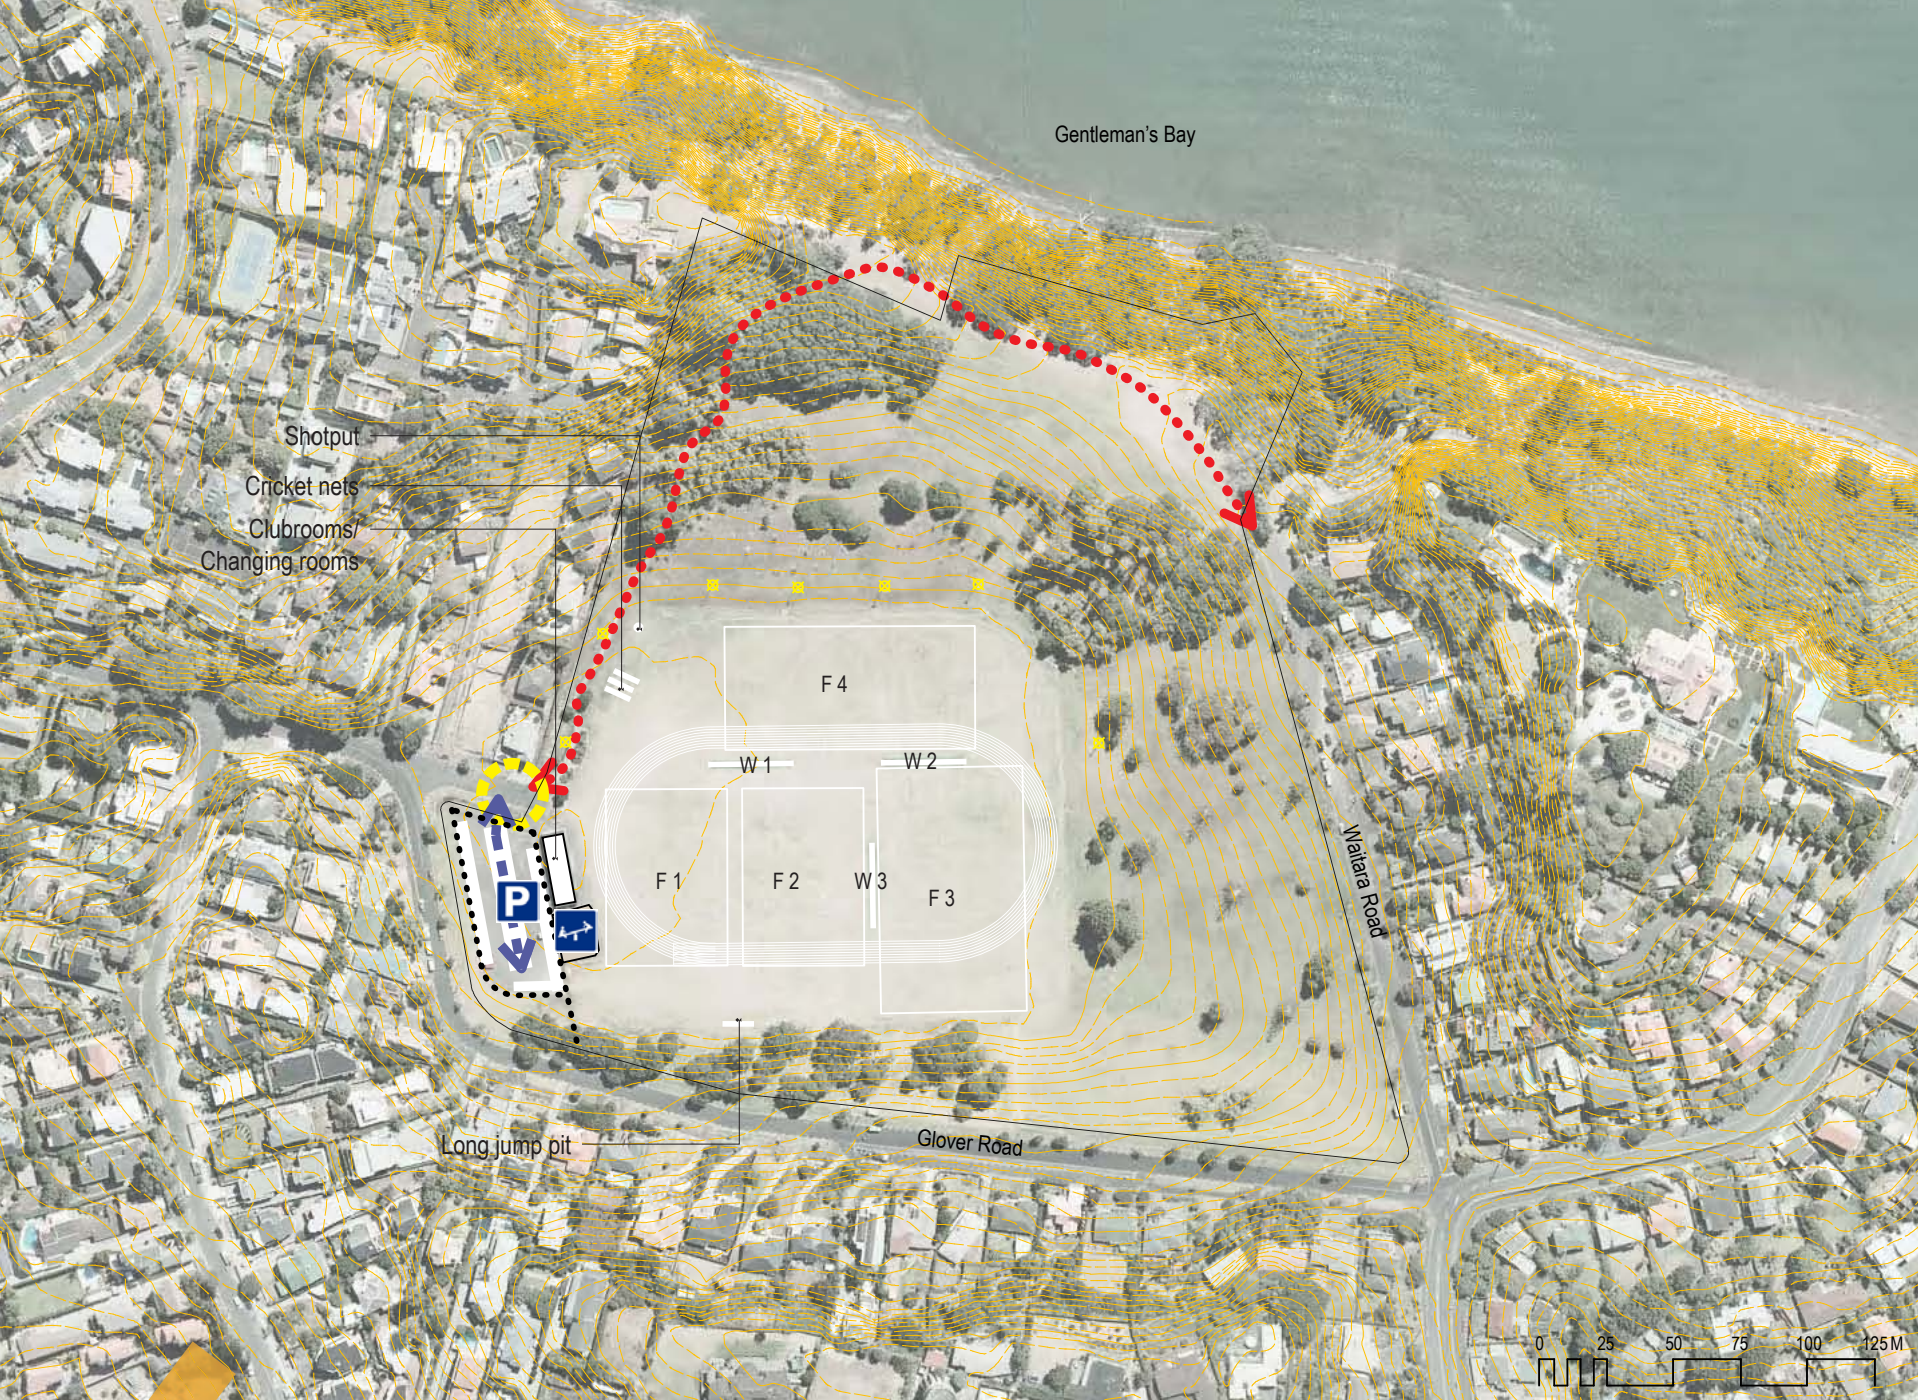
1_Vehicle Entrance and Carpark

The formal park entrance and carpark is located on a flat area at the western end of the reserve. The carpark is characterised by an open expanse of seal with no specimen trees or garden areas to provide any softening or visual relief in this area. The carpark is contained by timber vehicle restraints and sloping grass road berms around the southern and western sides. Immediately to the east of the carpark is a children's playground, changing rooms, athletics equipment storage and public toilet facilities.

2_Central Sportsfields

The central sportsfields occupy the flat central part of the park. In the winter the area has space for four soccer fields. In between these fields are three permanent artificial cricket pitches. Cricket nets are located to the north of the changing rooms and a long jump pit to the south of the field. A 400m athletics track is also marked out during the summer period.

- Athletics track and associated activities (long jump, high jump, shot put, discus etc)
- Playing fields – winter
 - 2 full sized soccer fields and 2 smaller soccer fields
 - OR 9 junior fields
- Junior playground with bark chip surfacing
- Sealed car park accessed off Glover Road (87 spaces)
- On street parallel car parking
- Pedestrian access path to Waitara Road (via the cliff top)
- Off-leash dog exercise area

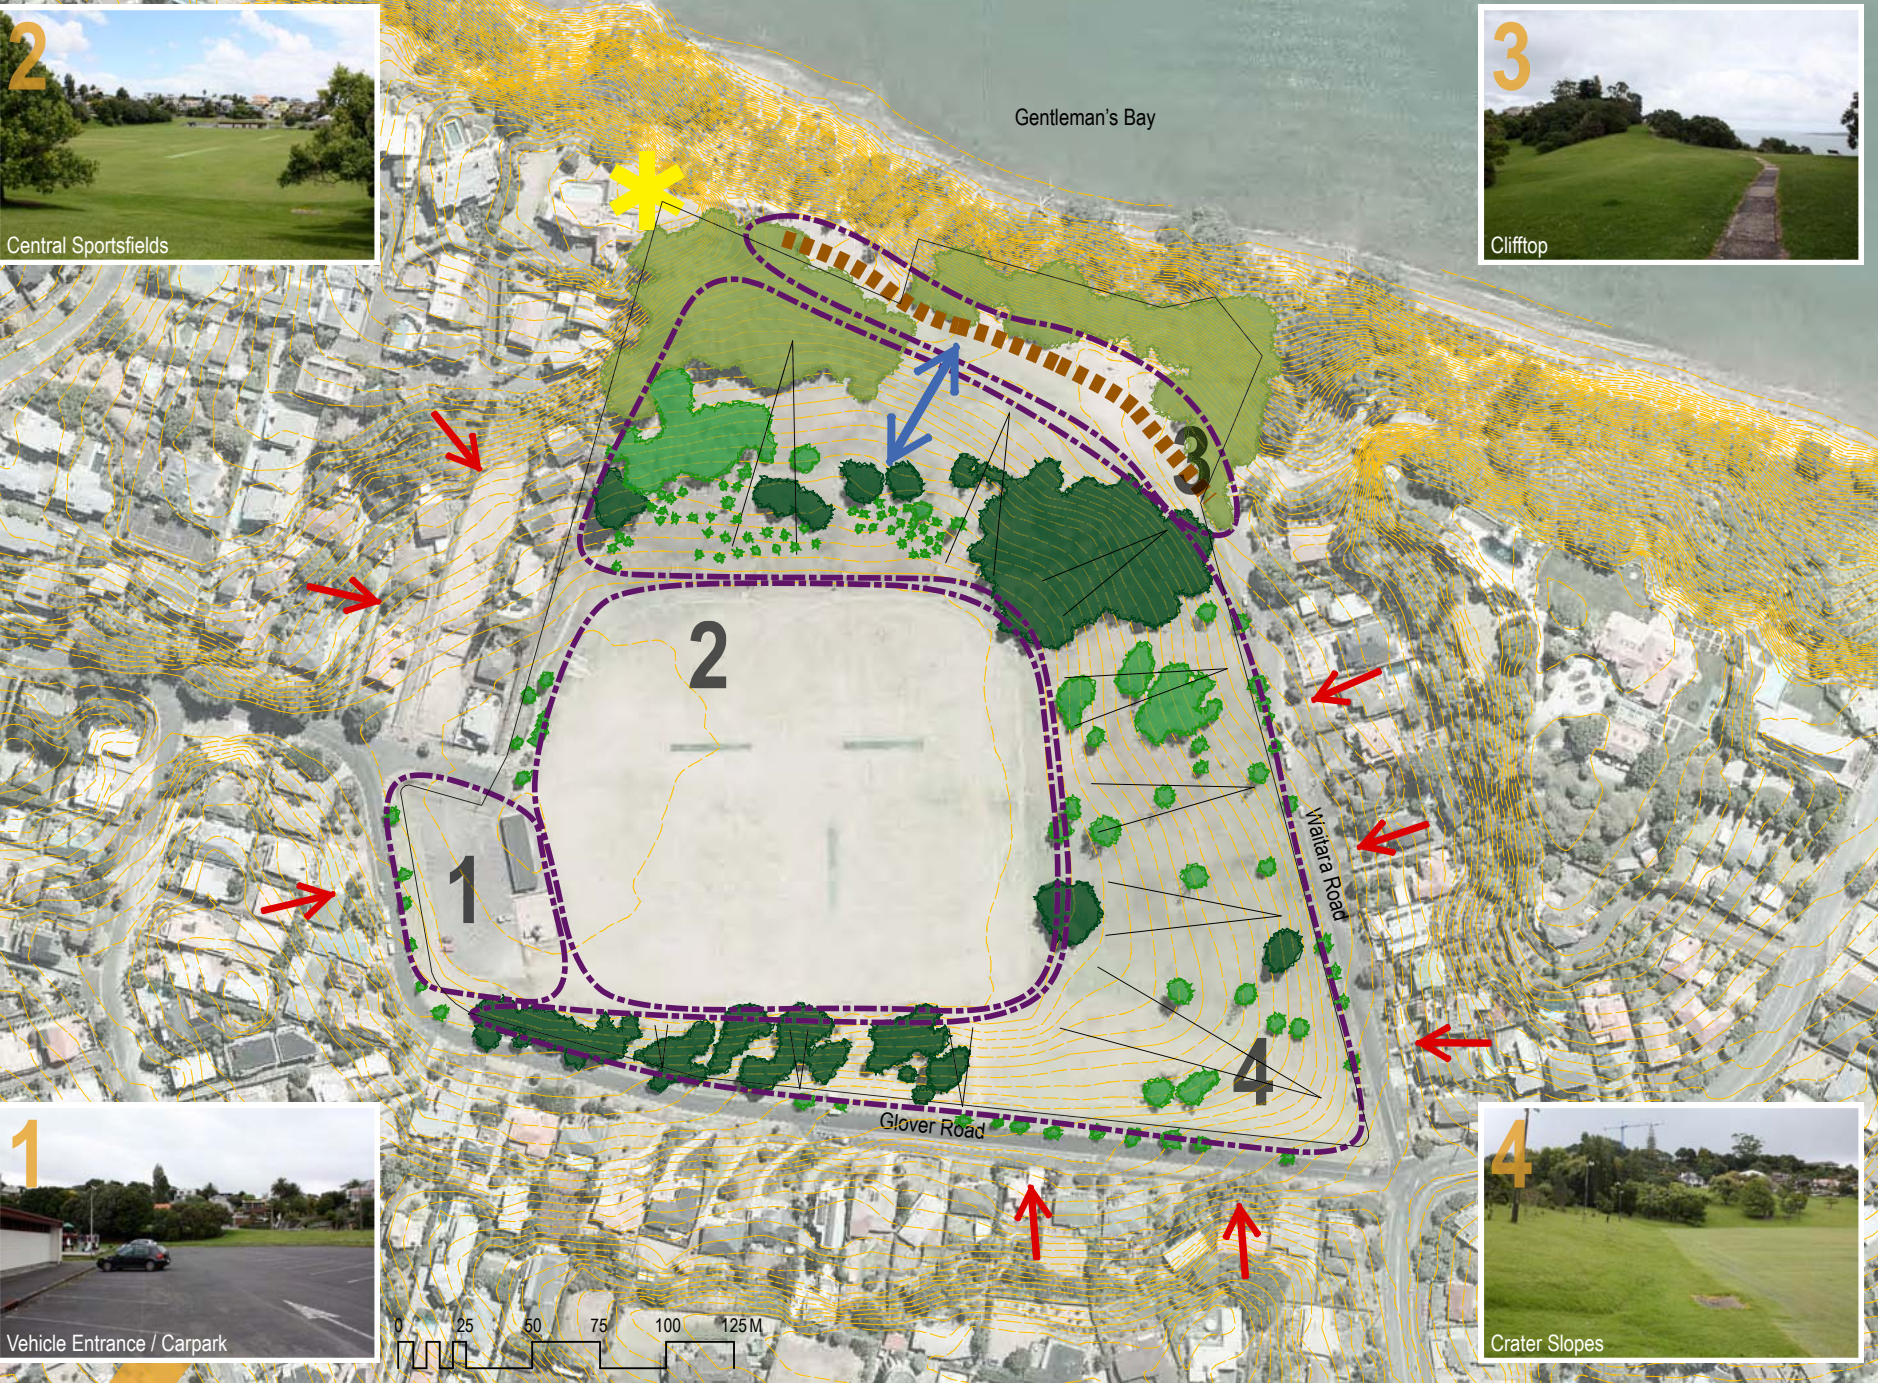
Although significantly modified, the geological origins of the area remain obvious today with the often steeply sloping sides of the crater almost completely encircling the park and providing a strong sense of containment. Today the only area where the top of the former crater remains within the park is along the northern edge of the reserve. Here it forms the top of the cliff line, which falls, steeply toward Gentleman's Bay at its base. The central part of the reserve is characterised by the flat expanse of the playing fields created by the filling of the former crater swamp.

The former crater slopes extend beyond the reserve creating a natural amphitheatre, which is occupied by established residential development. As a result there is comprehensive surveillance of the park from the surrounding area. Similarly, significant views from within the reserve to the surrounding area are limited by this landform, except for the elevated ridgeline above the sea cliff above Gentleman's Bay. This location affords impressive panoramic views out to Rangitoto, Browns and Motuihe Islands and the Hauraki Gulf beyond. In the opposite direction, although somewhat contained, are views back across Auckland toward One Tree Hill/ Maungakiekie.

Although there is relatively extensive planting across the crater slopes, the planting is fragmented and lacks any defined structure or consistency. The species composition is varied with the main trees present including acmena (*Syzygium smithii*), pohutukawa (*Metrosideros excelsa*), Norfolk Island hibiscus (*Lagunaria patersonii*), grevillia (*Grevillia* spp), willows (*Salix* spp), Norfolk Island pine (*Araucaria hetrophylla*), brush box (*Lophostemon conferta*), gums (*Eucalyptus* spp), ornamental cherries (*Prunus* spp) and swamp cypress (*Taxodium distichum*). Many of the trees appear to be struggling with the site conditions.

Native species are more represented on the northern slopes, both intermixed with amenity planting, and in a sizeable grouping in the north west corner of the site. The vegetative composition in this area continues the mix of coastal species commonly found along the sea cliffs locally, with the dominant trees being karaka (*Corynocarpus laevigatus*) and pohutukawa. The understorey in this area is comprised of a mixture of indigenous coastal shrub species mixed with some exotic weeds such as privet, with gorse (*Ulex europaea*) around the exposed edges. Also characteristic of the northwestern boundary are numerous garden escapees and a variety of herbaceous weeds along this edge where the boundary between the reserve and adjacent residential properties lacks definition.
