# Ignition Run-On or Why Won't My Car's Engine Stop Running?

*By Allan Brown*

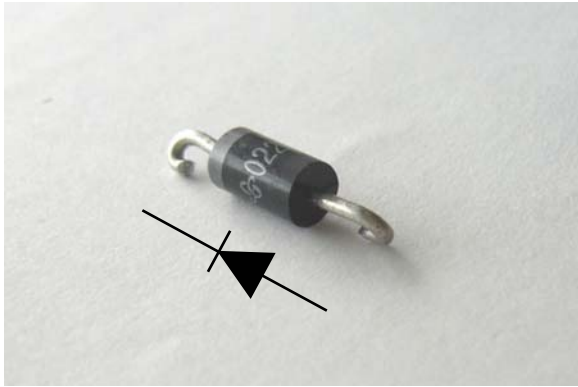
Original Wiring

In 1979, MG incorporated some of these modifications – but *not* the Anti Run-On Valve into the British cars. This is when they discovered the problem. The problem is known as a Sneak Circuit – an electrical circuit that is not always obvious when looking at the schematic. There is (was) a wiring design flaw in the US '77 model year.

What was happening? Depending on the ignition relay tolerances, the alternator, ignition lamp and a few other factors such as the phase of the Moon, weather, day of the week and so on, there may be enough current flowing back thru the charge indicator (ignition warning) lamp after the ignition is turned off to hold the relay on and therefore keep the engine running. Just by changing the relay to another of the same type may fix or partially fix the problem.

To solve the problem completely, you have to add a diode into the Ignition Relay's coil circuit. This is the wire that goes from the alternator negative terminal to the charge indicator (ignition warning) lamp located in the dash (Brown wire with Yellow stripe). You can do this either at the dash end or the alternator end – this being the easiest point to access the wire.

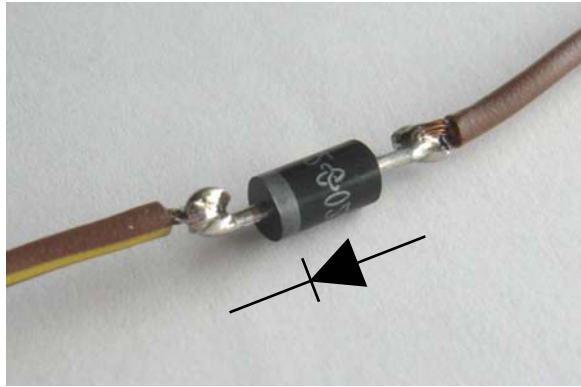
New Wiring

The diode has a band on one end. This corresponds to the Cathode. [See photos below](#). This end should go to the alternator side. If you put the diode in backwards, the lamp will not operate, but no harm will be done.

I chose a low voltage drop Schottky Barrier Rectifier (40V 3A) 1N5822 rather than a regular diode. You can get this diode from Active Components. This diode has a forward voltage drop of about 0.2 V as apposed to the 0.8V for the regular diode and helps to preserve the operation of the alternator sense line.

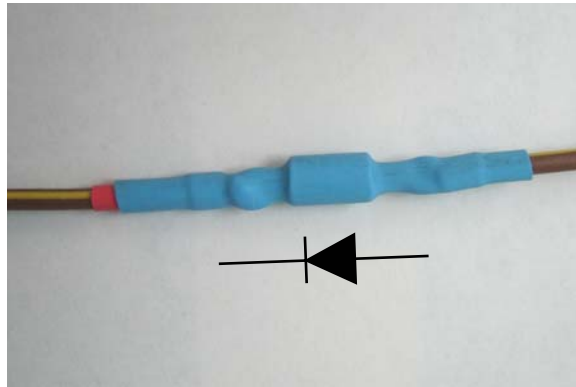
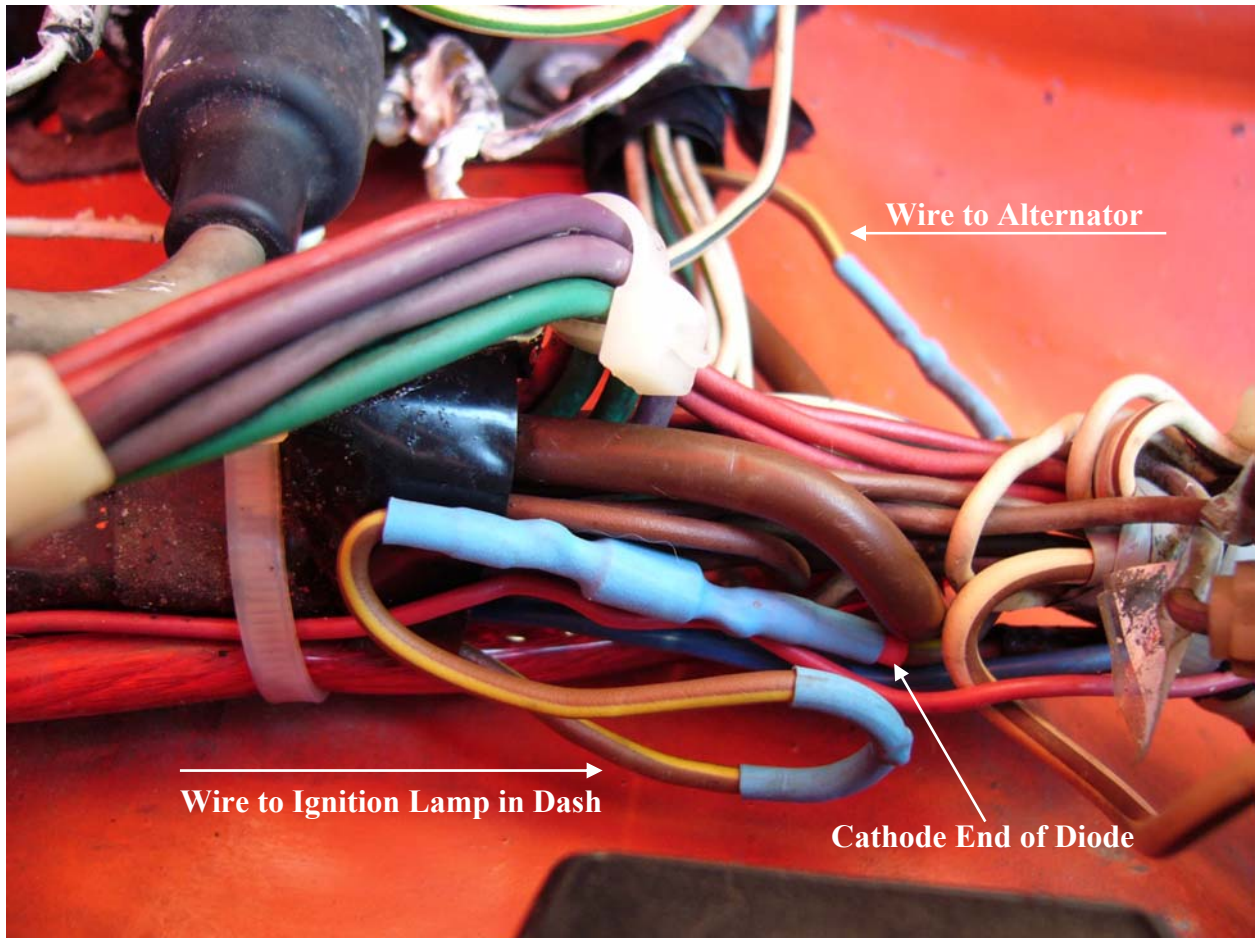
**Diode  
Assembly**

To prepare the diode, I cut and shaped the leads as [shown below](#). I then soldered wires to each end. I happened to have the correct colour of wire from an old harness. Then I placed a piece of red heat-shrink tubing on the cathode end and covered the entire diode with blue heat-shrink, leaving a portion of the red showing. You can use any colour but try to use Teflon heat shrink rather than the PVC. It will stand up to the heat in the engine bay better. Yes, the wire has a PVC insulation but the heat-shrink is different.

You then need to un-wrap the wiring harness going from the alternator to the fender and find the Brown/Yellow wire. Cut this wire and solder in the diode assembly using more of the heat-shrink to cover the joints. Re-wrap the harness.
