# Historical Background Report

## Baltimore and Ohio Railroad, Harpers Ferry Station

HAER No. WV-86

Prepared by: Andrew S. Lee, Archeological Technician

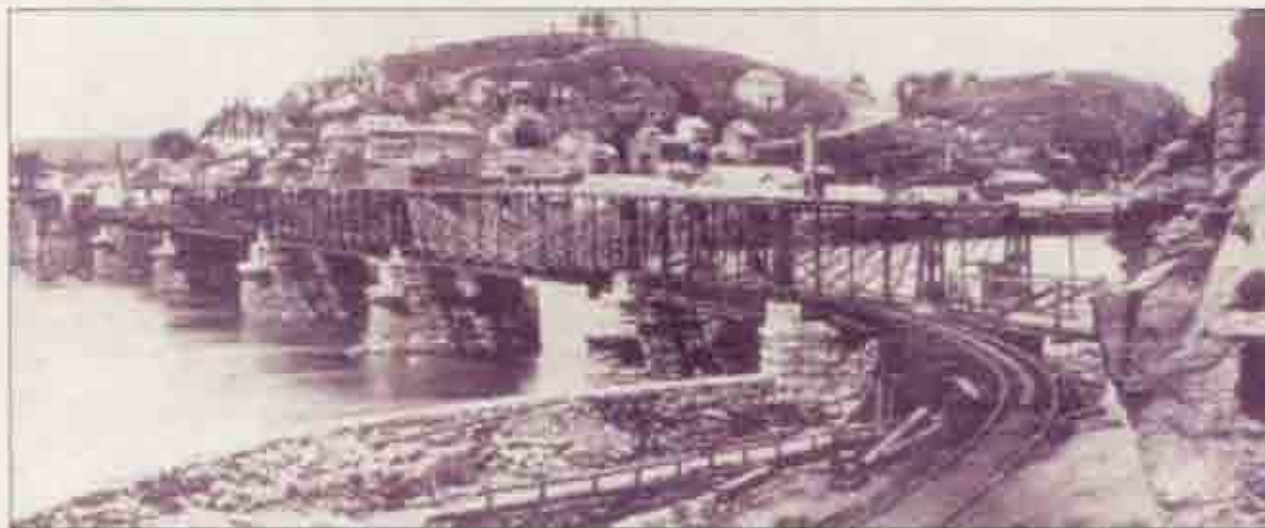
*Figure 3. Railroad, canal, and turnpike competed for limited space on the Maryland end of the bridge. The awkward curve of the railroad track, seen here in 1865, hindered train movements here for years. (NPS photo.)*

The problem facing B&O engineer Benjamin Latrobe, Jr. was a difficult one. Because of a bend in the river, the entrance to the bridge from the Maryland shore had to be placed where the railroad, turnpike, and canal were crowded together on the narrow space below Maryland Heights. This unfortunate geographical arrangement prevented him from designing a gradual curve of the tracks onto the bridge (Figure 3). Because the bridge was practically at a right angle to the river, a fairly sharp curve was the only answer. On the Harpers Ferry side, the goal was simply to align the bridge directly with the grade of the W&P. Little thought was given to how the main line would eventually continue west from there. Ultimately, when the B&O did decide on a course out of Harpers Ferry, the alignment of the bridge proved to be quite unsatisfactory.

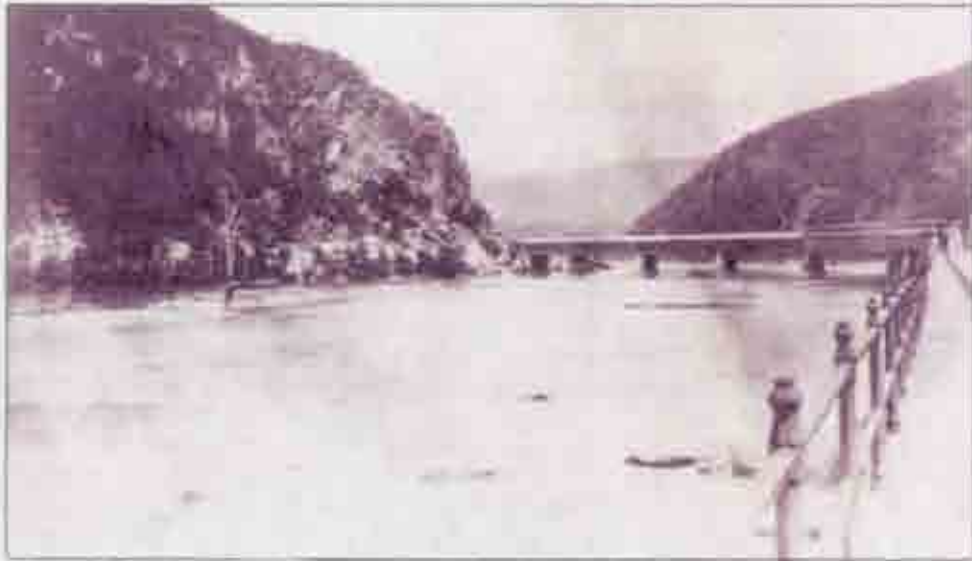
*Figure 7. The junction of the armory trestle and the bridge resulted in a sharp curve. With tight curves at both ends of the bridge, the alignment was far from ideal. (NPS photo.)*

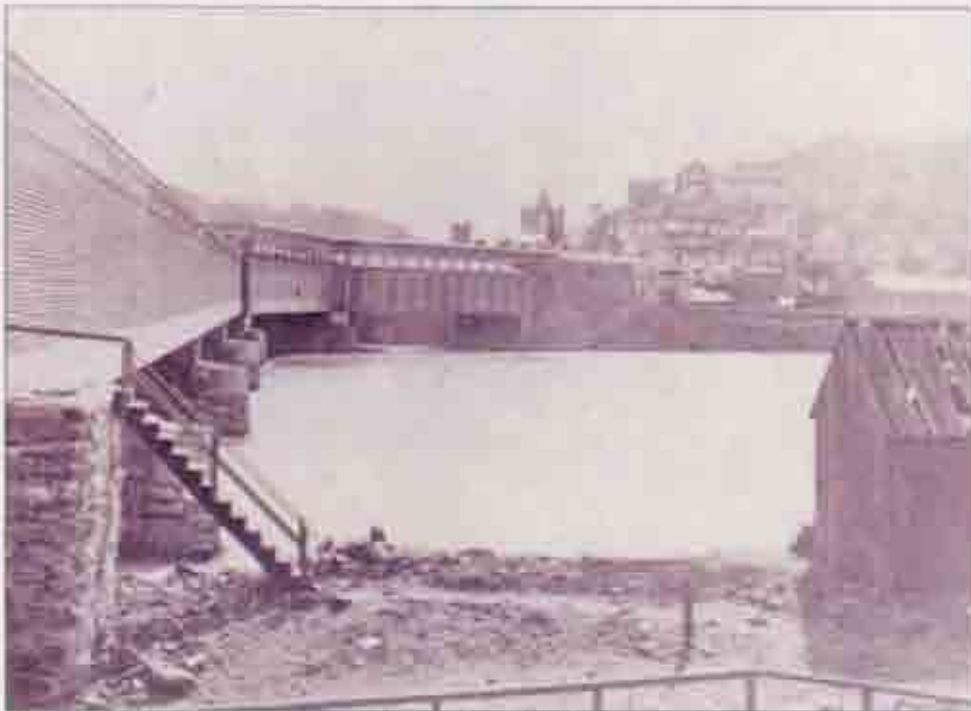
*Figure 8. The requirement to turn the tracks up the Potomac River necessitated rebuilding the Harpers Ferry end of the bridge. There was no room to maintain the junction with the W&P and still make an acceptable turn onto the armory trestle. (NPS photo.)*

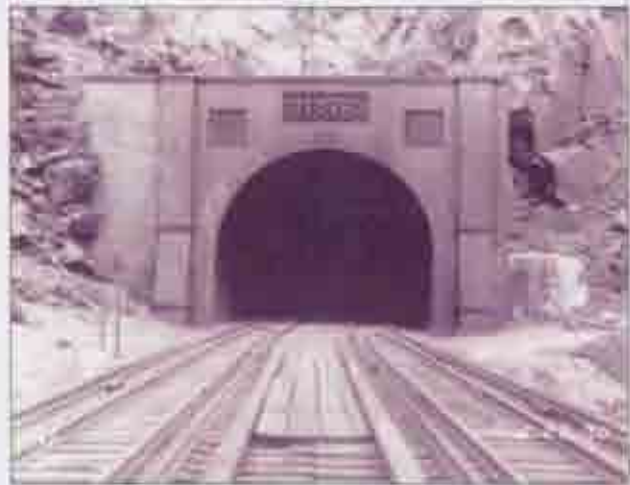
Figure 9. Completed in 1896 with the addition of brick portals, the Harpers Ferry tunnel eliminated the tight curve on the Maryland end of the bridge. (NPS photo.)

After completing the excavation of the tunnel, the rock was stable enough to support itself. Workers lined 80' at the west end and 45' at the east end with limestone masonry walls and a brick arch roof. At first the company constructed limestone portals on both ends of the tunnel, but the deep approach cuts at either end of the tunnel caused immediate problems and new portals had to be built. The steep cuts posed a safety hazard from above, as rocks falling from the cliffs were dangerous to employees and threatened to block the tracks. To remedy the situation, in 1896 construction workers extended the lining of the tunnel over 30' on each end and added sufficient covering over the arch to shield it from falling debris. New brick portals were also built (Figure 9). This lengthened the tunnel to 885'. The tunnel, oriented on nearly an east-west axis, almost completely eliminated the tight turn once required at the east end of the bridge.

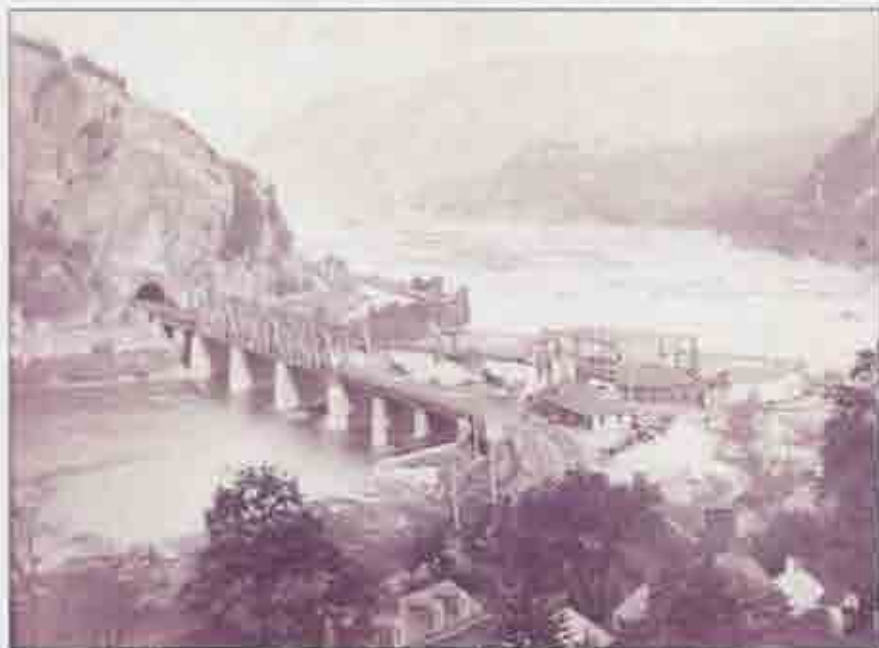
*Figure 10. The new railroad bridge, seen here at left, was a central component of the 1892-94 improvements. (NPS photo.)*

The bridge builders experienced a setback in November 1893 when a shipment of construction materials was sunk during a storm on the Great Lakes, but the new B&O bridge was opened for traffic on April 12, 1894 (Figure 10).<sup>30</sup> Its nine steel spans were a combination of six deck plate-girder spans and three Pratt through trusses.<sup>31</sup> Not only was the bridge designed to handle the heaviest loads of the day, it was also located on a better alignment. The new bridge was between 8 to 11' higher than the old bridge. This not only provided a better gradient, but also made the bridge less vulnerable to floods. The Harpers Ferry end of the 1894 bridge still resembled Latrobe's design of sixty years earlier, but the design incorporated a better junction to the Valley Branch (the former W&P line running along the Shenandoah River). Whereas the old bridge formed a 'Y' with the Valley Branch going straight across and the main line branching off, the new design reversed the order. With the new design, the junction remained over the river, but now the main line remained on a tangent and the Valley Branch curved to meet it (Figure 11). Though not particularly long or massive, the new bridge represented state-of-the-art engineering in the 1890s. Still in use today, the bridge has been called an excellent representative of steel, pin-connected trusses and standardized bridge design of the period.

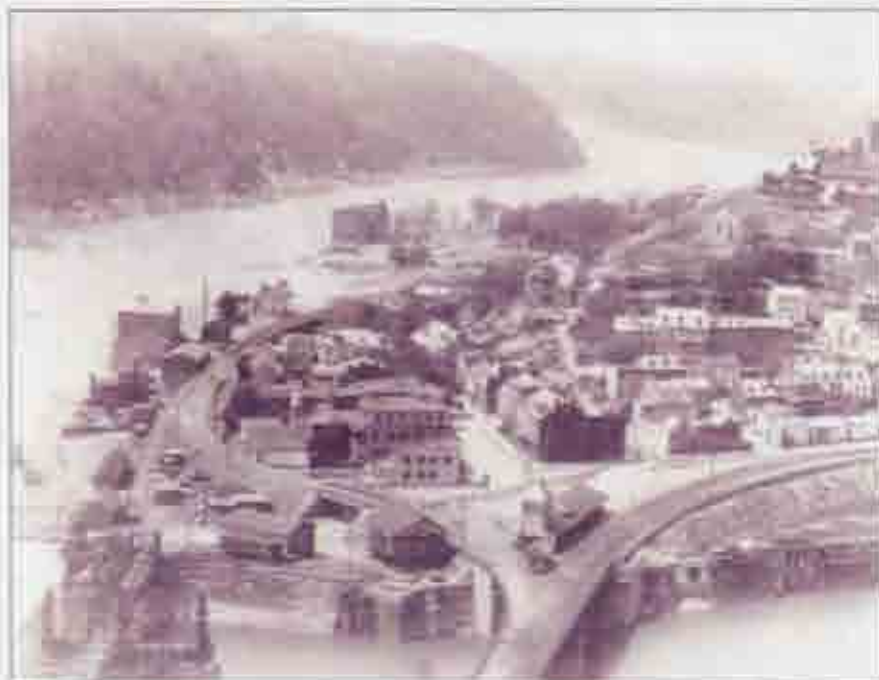
*Figure 11. 1896 photo showing the realigned junction of the Valley Branch and main line. The new design kept the main line on a tangent while the Valley Branch, seen here on the left, curved to meet it. (NPS photo.)*

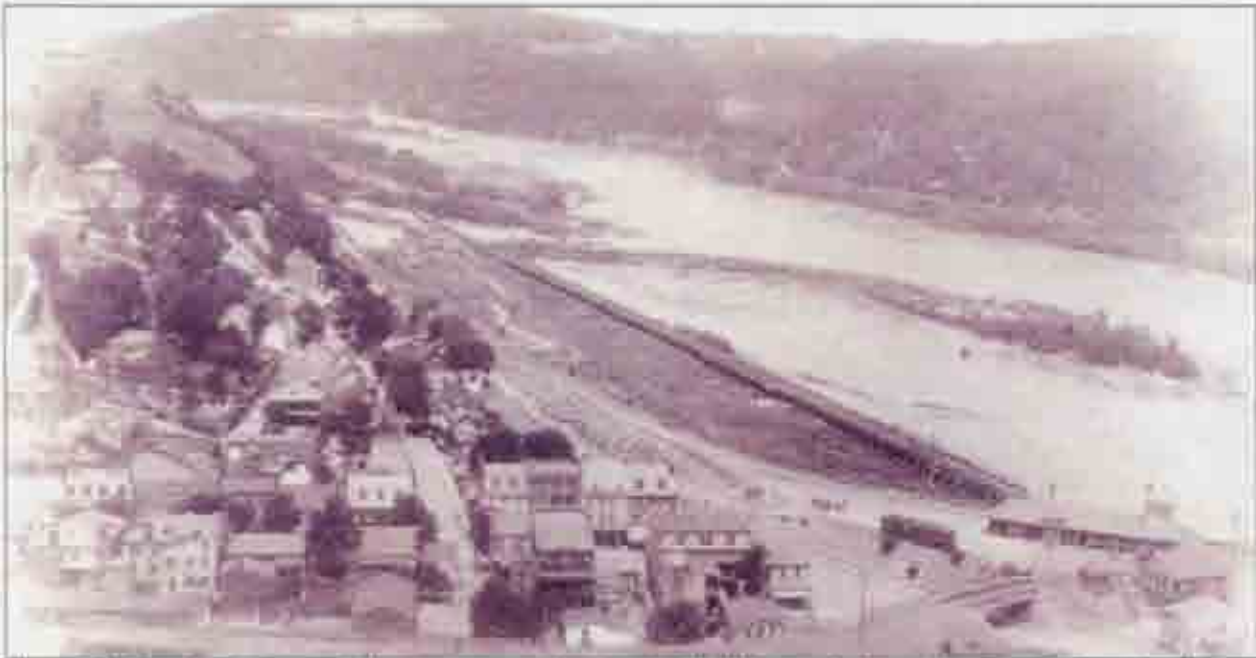
*Figure 12. The abandonment of the armory grounds after the Civil War made the realignment of the railroad possible. The new main line, built atop a 20' high rubble embankment, greatly reduced the curvature of the tracks. The old armory trestle was still in place when this photo was taken in 1896. (NPS photo.)*

The U.S. government's abandonment of the armory grounds after the Civil War made the realignment of the tracks in Harpers Ferry possible. Since the mid-1850s the B&O was forced to run its trains along an iron trestle mounted on top of the stone river wall. The trestle and right-of-way extended 20' into the armory yard from the river wall.<sup>32</sup> In 1892 the B&O finally purchased a new right-of-way through the armory grounds from owner Thomas E. Savery. Armed with a new right-of-way that was considerably more inland, the railroad was free to abandon its original layout along the river wall (Figure 12). Instead they chose to run the tracks through the former armory grounds on top of a 20' high stone and earthen embankment.

By sweeping the tracks broadly around on the town side rather than the river side of the old armory grounds, the result was a much gentler turn coming off the new bridge. This was a great improvement to what had been one of the tightest curves on the B&O's main line. With the need for the elevated trestle thus eliminated, the wood planking, ties, and rails were removed as was a small bridge spanning the armory boatway. The iron framework of the trestle remained in place until around 1898. A small section of the old tracks was maintained as an industrial siding. The siding served Savery's pulp mill located at the end of the former armory grounds.<sup>11</sup>

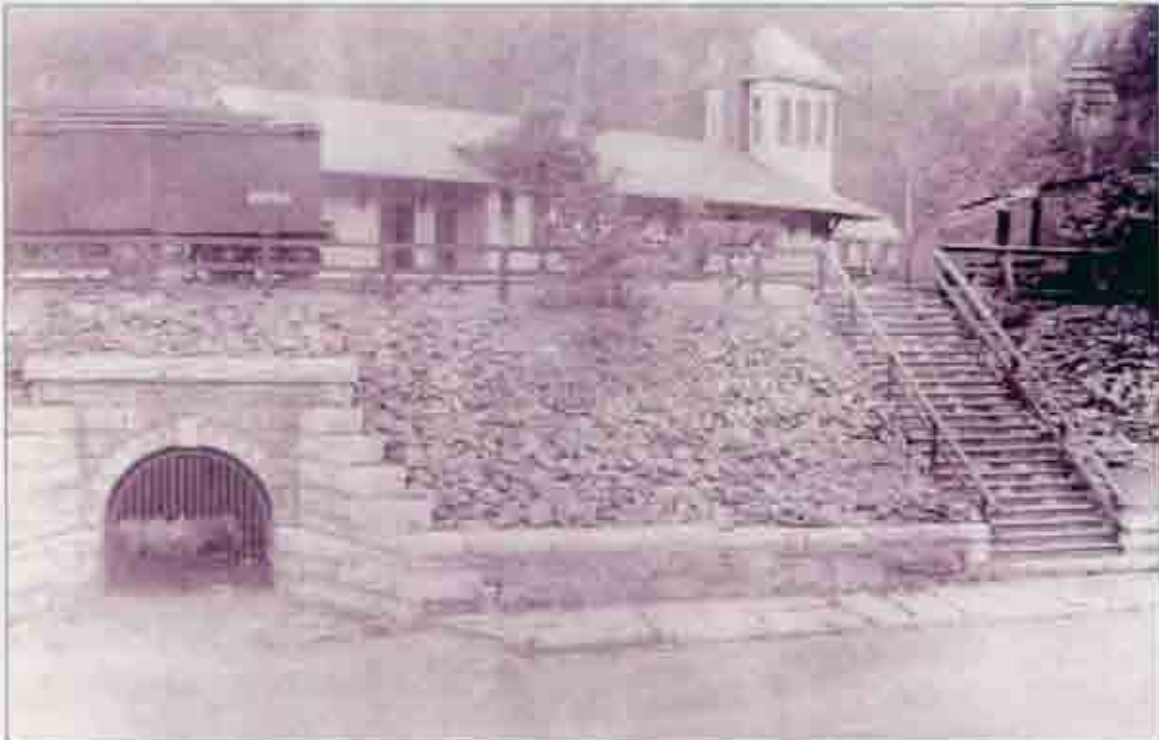
*Figure 14. Ca. 1896 view of the Shenandoah Street drainage culvert. The B&O's new railroad station sits on top of the embankment in the background. (NPS photo.)*

distance of about 800'. The lower end of the street was realigned to pass diagonally under a new overpass constructed as part of the realignment of the Valley Branch approach to the bridge. And because the newly created embankment blocked drainage of water from downtown Harpers Ferry, it was necessary for the B&O to construct a 186' long drainage culvert near the east end of Shenandoah Street (Figure 14).

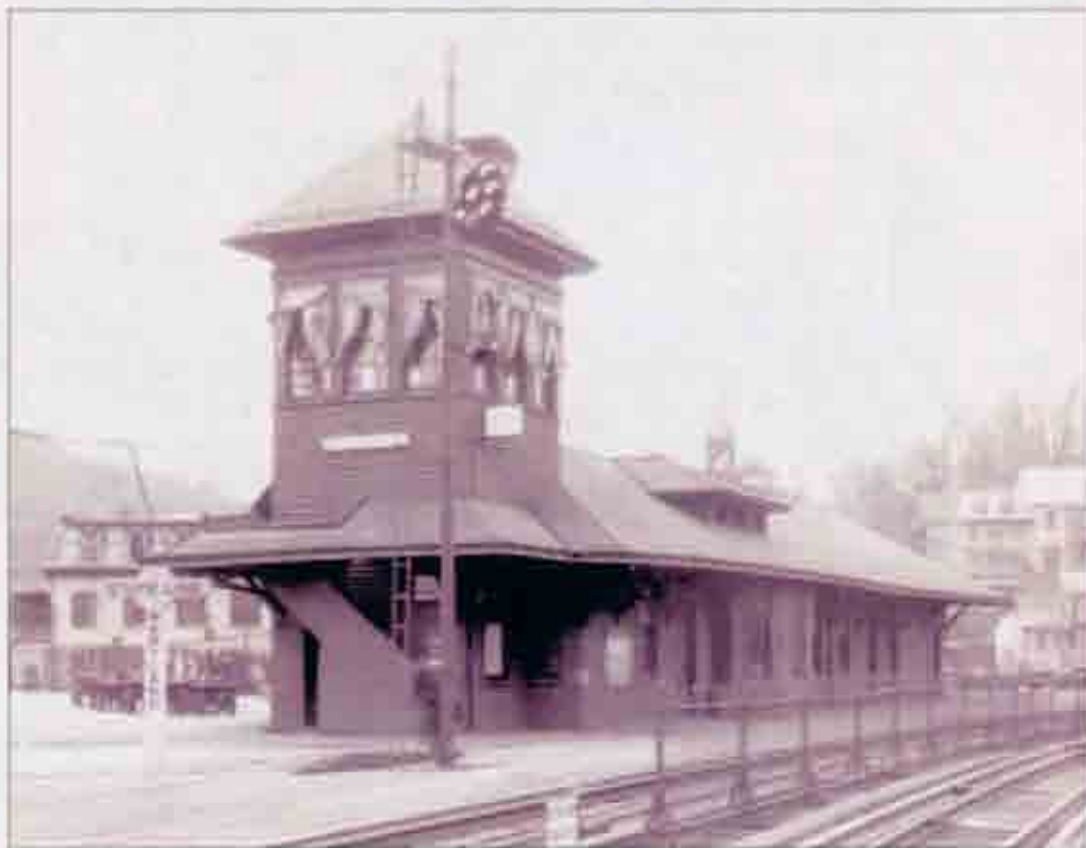
Figure 19. 1930 photo of the Harpers Ferry train station. The two-story signal tower was easily its most distinctive feature. (NPS photo.)

Except for a distinctive two-story tower, it was a rather plain building (Figure 19). The station's tower and its slate-covered, hipped roof were its visually dominant features. The roof covering the single-story portion of the station was low pitched and interrupted only by two hipped dormers, one on each side of the building. The dormers each had three small windows with diamond-shaped glass panes. The tower had a pyramidal roof (also slate-covered) with a slightly steeper pitch. The slates, light gray in color, were hung in a staggered shingle pattern. Pole gutters funneled water from the roof into box-protected downspouts all around the building. A number of large decorative brackets beneath the overhang also tended to emphasize the roof. The walls were covered with horizontal clapboard siding and painted. A 1915 newspaper item

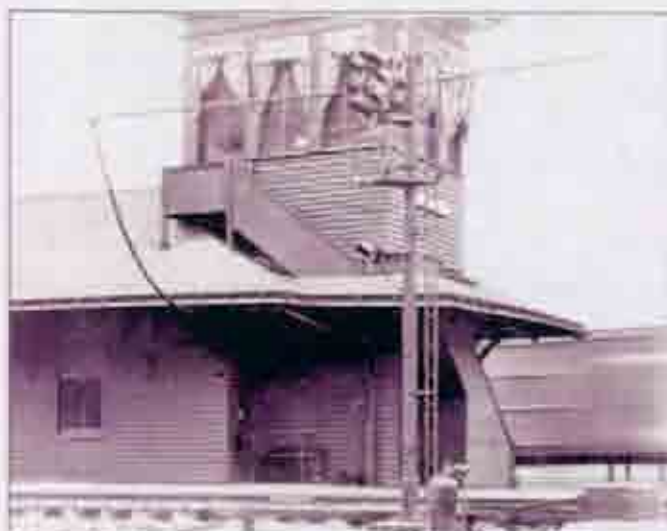
Figure 21. Exterior stairs were added to the tower around 1900. (Henry Freeman collection.)

On the east end of the station was the two-story signal tower (Figure 20). A brick chimney with a flared top was built flush with the edge of the roofline on the west side of the tower. In 1900 a new interlocking switch system was installed for the Valley Branch junction. From that point on trains were controlled from the upper story of the tower.<sup>55</sup> Prior to that, the switching mechanism was operated manually. Entrance to the tower from the outside was initially gained through a door located on the southeast corner of the first floor. Though no documentation has been found, it can be assumed that interior stairs or a ladder led to the upper reaches of the tower. Later, around 1900, exterior stairs were added on the east side that wrapped around the tower, providing access to the upper story through a door on the south side (Figure 21). Photographs of the station around 1910 show a semaphore bracketed on the main line (north) side of the tower (Figure 22). Block tower signs with the telegraph call letters "HF" hung on the east and west sides of the tower. In addition, a station-identifying sign of "Harper's Ferry" hung on the east face of the tower.

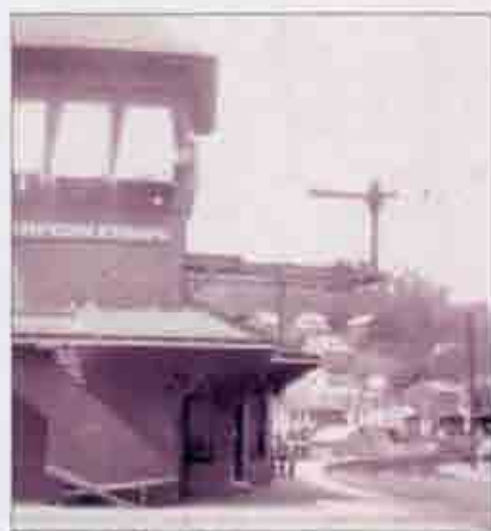
Figure 22. Ca. 1910 view of tower and semaphore. (Henry Freeman collection.)

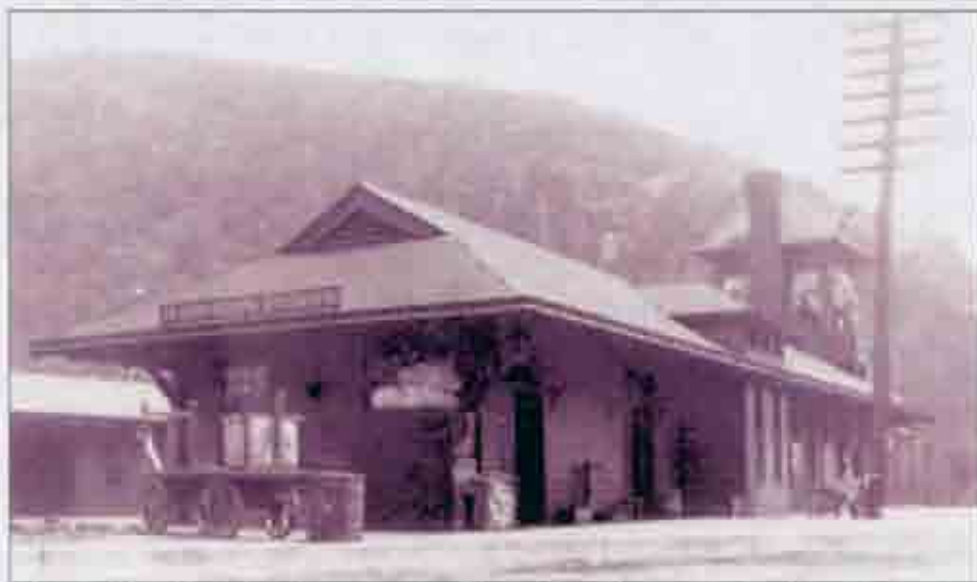
*Figure 24. The men's bathroom, located beneath the dormer, stuck out from the south  
facade. (Henry Freeman collection.)*

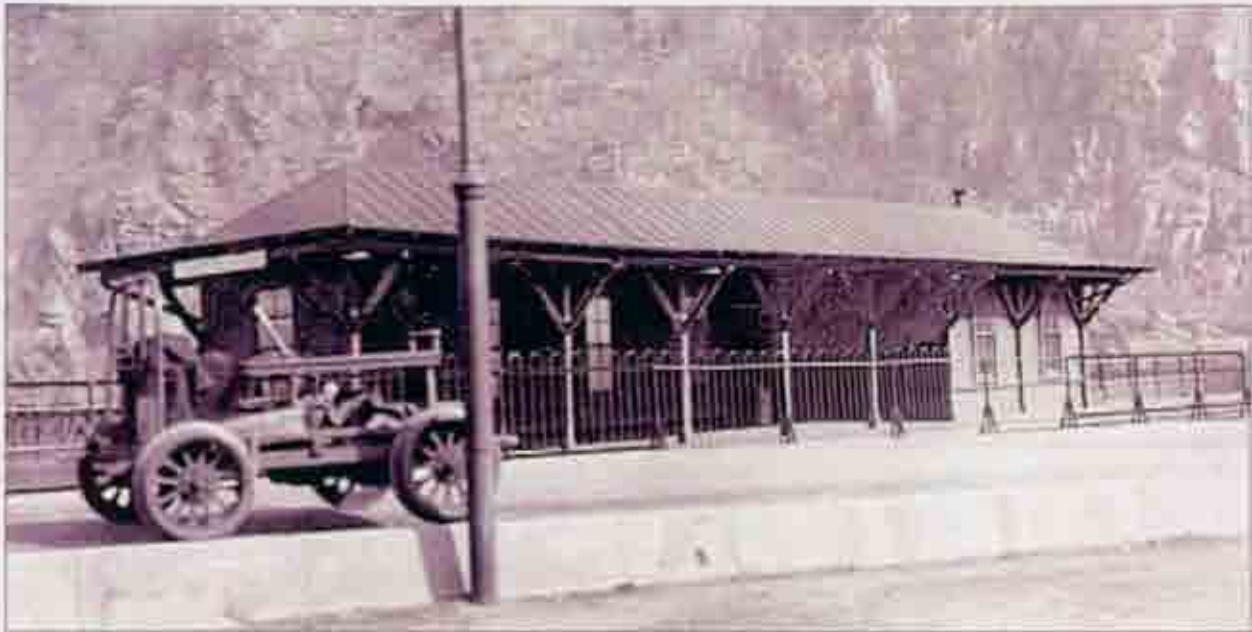
*Figure 26. The westbound waiting shelter. It is pictured here after an enclosure was built on the east end to protect passengers from the elements. (Henry Freeman collection.)*

In October 1898 a three-sided wooden waiting shed was erected on the north side of the tracks for the benefit of westbound passengers.<sup>58</sup> As depicted on a 1902 Sanborn Fire Insurance map, the shed was located directly across the tracks from the freight section (west end) of the station building. The shed was enlarged in 1910 by a 20' addition on its east end and covered with a metal roof. The addition resulted in a small area that was totally enclosed (Figure 26). This enclosed area was referred to as a "winter room."<sup>59</sup> As this name implies, the purpose of the addition was to provide additional shelter against the elements. Photographs show a vent pipe projecting through the waiting shelter roof, indicating the presence of a coal or woodburning stove.

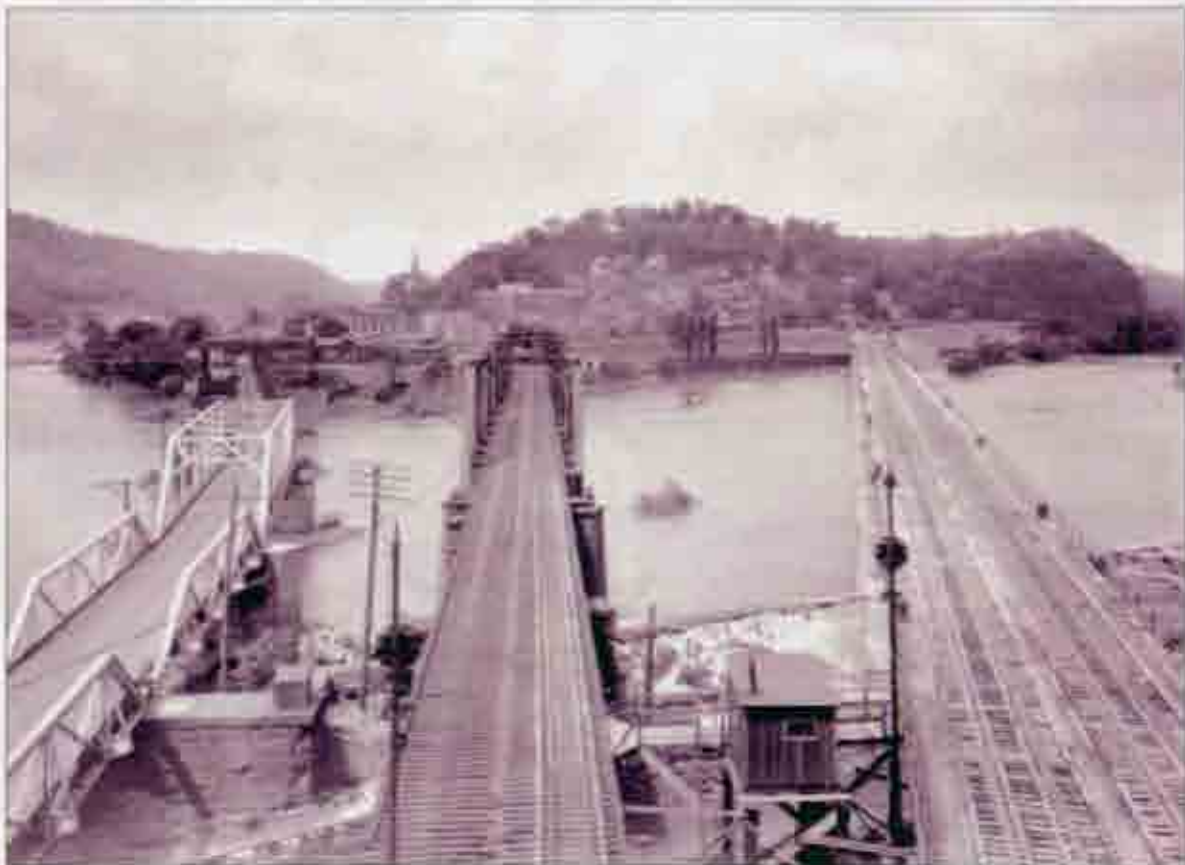
*Figure 30. The angle of the new Potomac River bridge, at far right in this 1911 photograph, helped eliminate the curvature at both approaches. The 1894 bridge is at center and the original span is at left in this view from the Maryland side. (Honey Freeman collection.)*

The principal feature of the improvements was a new double-track bridge, consisting of fourteen deck plate-girder spans. The new bridge was constructed at an angle to the river axis, making it approximately 50 percent longer than the 1894 bridge. The bridge met the West Virginia shore considerably upriver from the landing of the previous one, but still within the old armory grounds (Figure 30). It was also aligned on a tangent in relation to the tunnel, which once and for all eliminated the curvature on the Maryland side. On the West Virginia side, the new alignment resulted in a wide, sweeping curve (a 4 degree curve versus the previous 9 degree one) that permitted nearly unrestricted train speeds. The B&O's engineers finally succeeded in ridding the railroad of its troublesome, curvy track at Harpers Ferry.

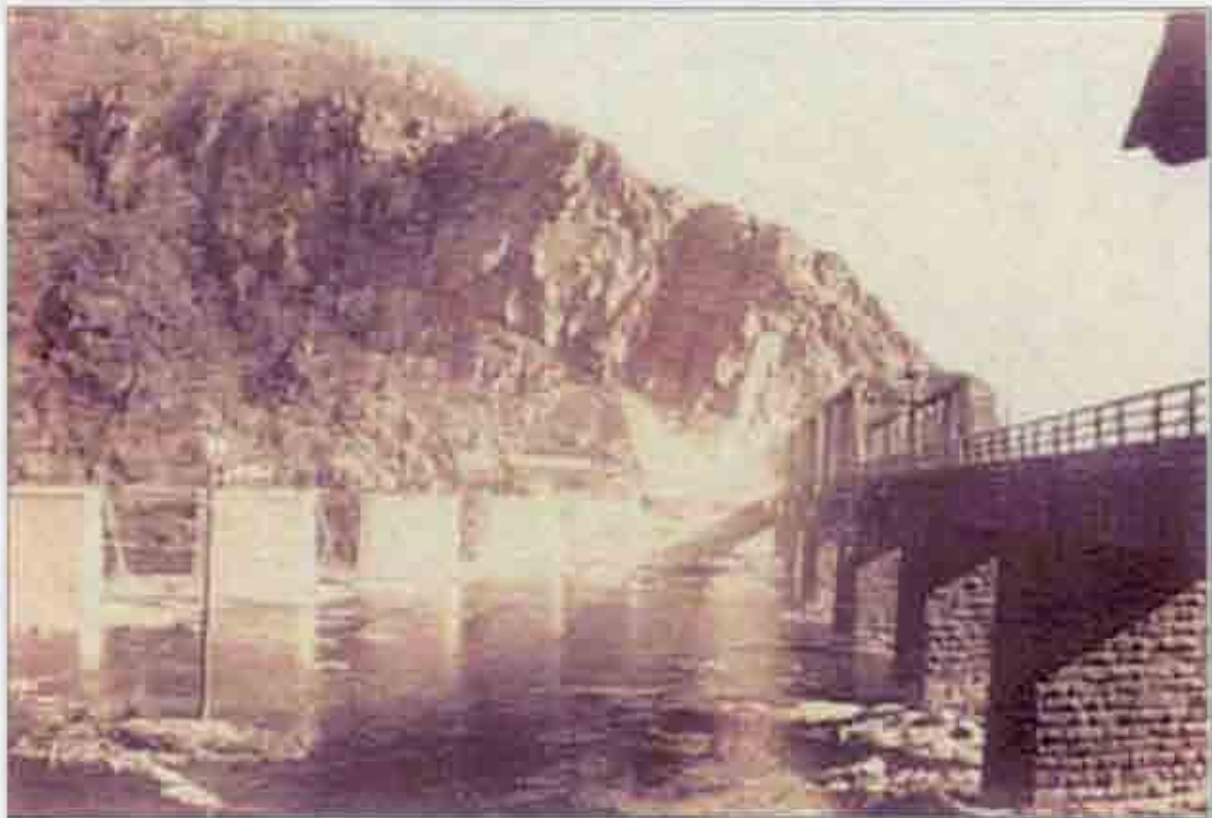
*Figure 31. Maryland Heights towers in the background of this 1930 view of the new bridge piers. Construction of the bridge progressed quickly thanks in part to low water levels. The 1894 bridge is on the right. (Jay Maury collection.)*

Construction of the bridge proceeded rapidly. The Empire Construction Company from Baltimore was contracted to build the abutments and piers and B&O's Engineer of Bridges, Philip G. Lang, supervised the work. Steam shovels arrived on site in October 1930 and within a month, eleven of the thirteen massive bridge piers were completed (Figure 31). Crews constructing the piers took full advantage of a protracted drought that the area was experiencing. Because of the drought, the waters of the Potomac neared record low levels, permitting men and heavy equipment to work in the riverbed with only minimal cofferdams. The conditions were so favorable that the work, originally estimated to take nine months, instead was finished in five. "No grass has tickled the soles of those engaged on this work," Lang wrote of the rapid rate of construction.<sup>72</sup> The bridge piers were set on solid bedrock and rose 35' above the foundations. Four thousand cubic feet of reinforced concrete was used in their construction.<sup>73</sup>

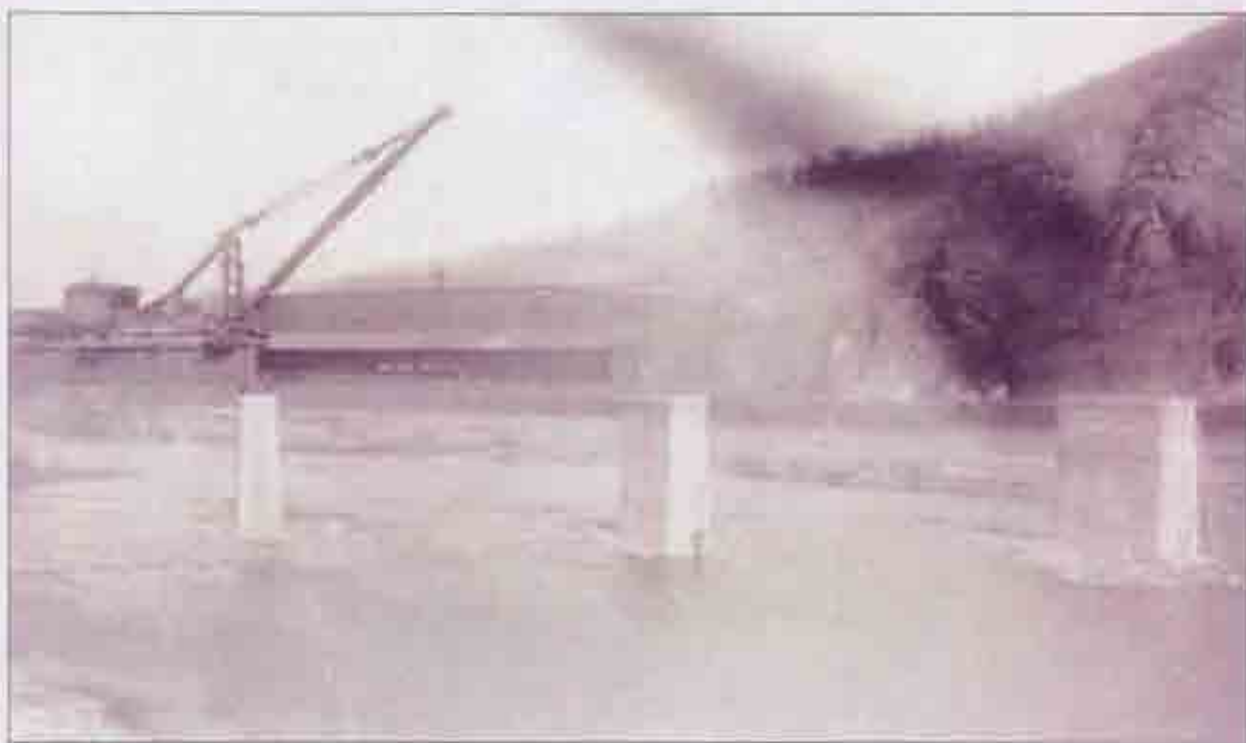
Figure 32. The 1930-31 steel girder bridge. (NPS photo.)

The American Bridge Company was hired to complete the superstructure of the new bridge. They fabricated the steel girders, which were then brought to the site on flatcars and hoisted into place by a rail-mounted crane (Figure 32). The bridge was built using four lines of parallel girders and approximately 4.4 million pounds of structural steel.<sup>74</sup> The rails were placed on wood cross-ties resting directly on top of the girders. The tracks averaged 47' above the river. Wood walkways were built on both sides of the tracks and "goose-neck" light posts lined the West Virginia end of the bridge. Though not nearly as graceful as the B&O's two previous Potomac River bridges, the 1931 bridge was functionally far superior.

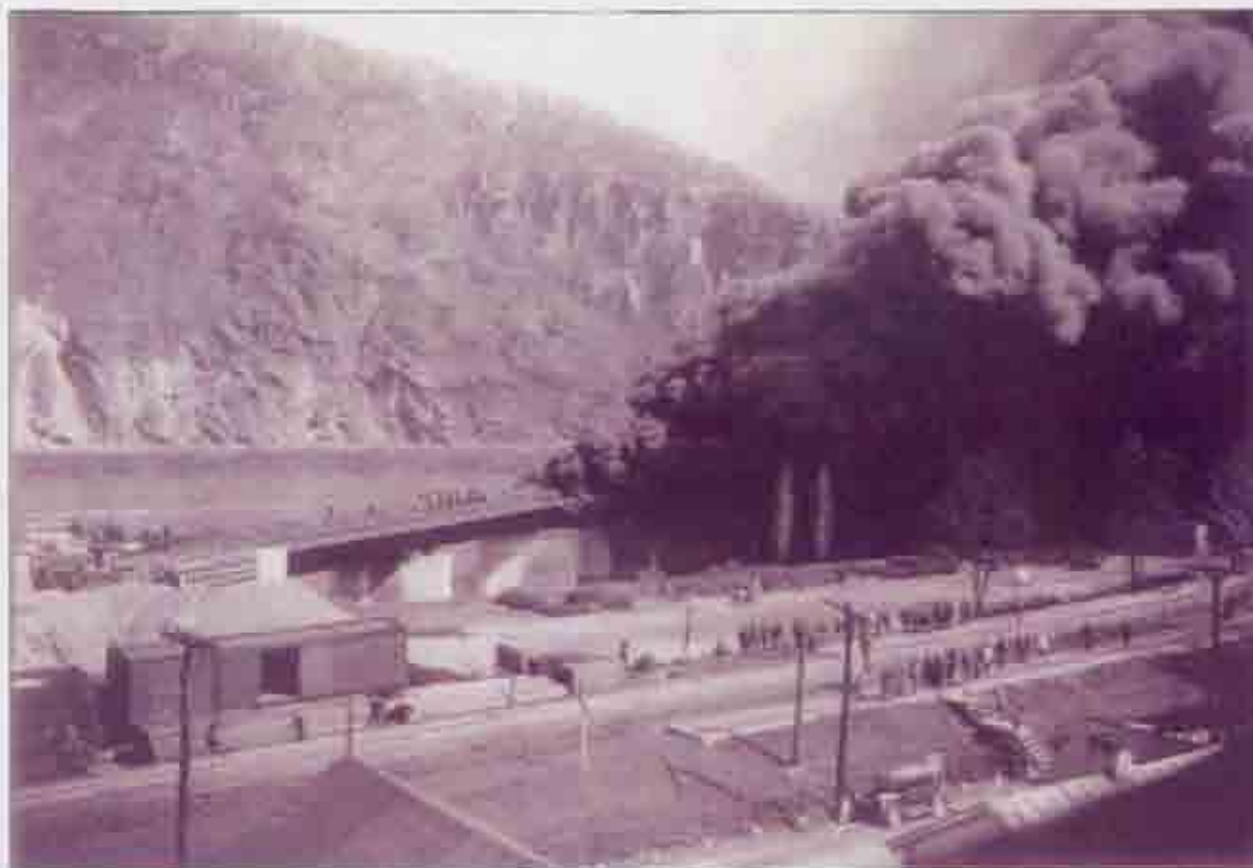
*Figure 33. Fire damaged the new bridge before construction was completed. Fortunately, the cash-strapped B&O was not responsible for the \$200,000 loss. (NPS photo.)*

On March 6, 1931, before construction was even completed, fire swept rapidly from one end of the bridge to the other after a workman accidentally dropped a red-hot rivet into a barrel of creosote (Figure 33). The newly laid cross-ties had been soaked in creosote and burned so fiercely that the steel girders were warped and weakened. Seven and a half of the fourteen spans and thirty of the girders had to be replaced. The damage was estimated at \$200,000. Fortunately, the responsibility for the loss did not fall on the budget-minded B&O. At the time of the fire, employees of the Empire Construction Company were in charge of the work and the

bridge had not yet been turned over to the railroad.<sup>75</sup> The necessary repairs were made quickly and the bridge opened for traffic on June 1, 1931.<sup>76</sup>

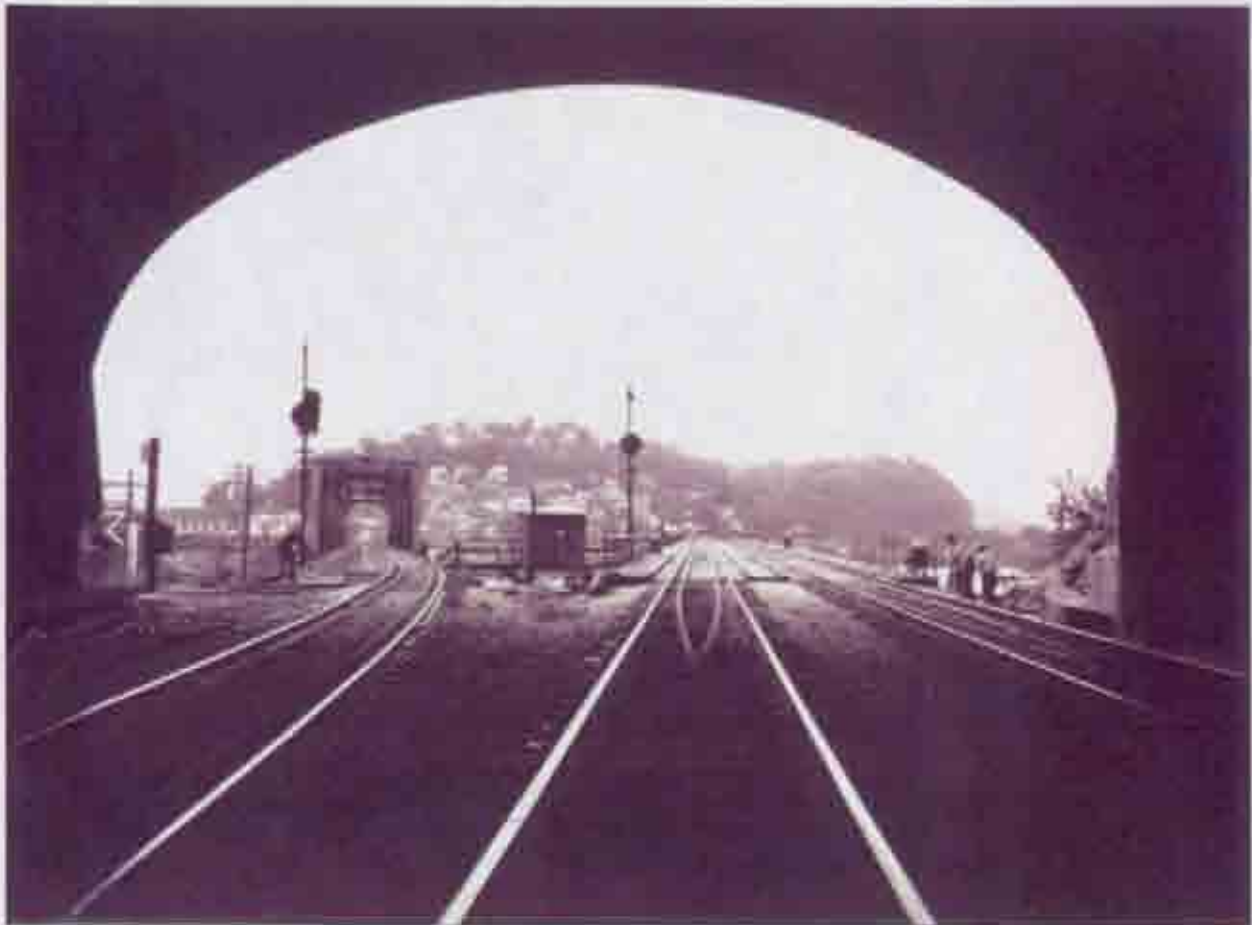
*Figure 34. The B&O modified the Maryland Heights tunnel to allow the convergence of the tracks within. (Henry Freeman collection.)*

widened, or "bell-mouthed," to a width of 45'. This widening also allowed for the convergence of the tracks from the old and new bridges at a location just inside the tunnel (Figure 34). This unusual arrangement is one of the few in-tunnel interlock junctions in the nation.<sup>77</sup> Additional alterations to the tunnel removed clearance restrictions. A new reinforced-concrete lining and portal were also added, giving the tunnel its current appearance.

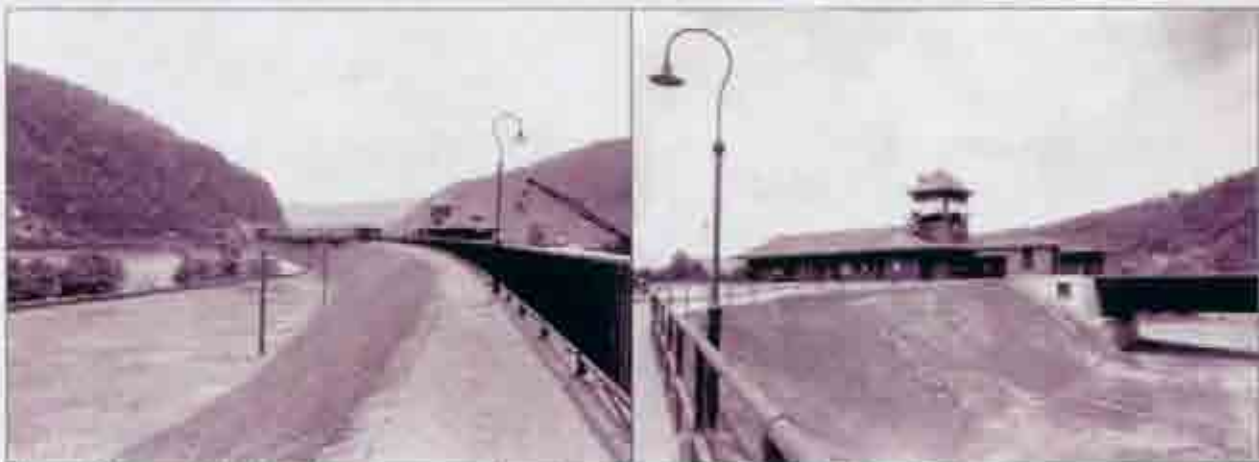
*Figure 35. The 1930-31 realignment required another fill embankment to be placed on the former armory grounds. Note the armory building foundation visible in the photo at right. (both courtesy of Henry Freeman.)*

embankment. Bulldozers prepared a roughly triangular-shaped platform that stretched from the abutment all the way to Potomac Street. The flat area, which would become the new home for the passenger station, was graded and used as a staging area for construction supplies (Figure 36). Access to the new depot grounds was gained via a driveway off Potomac Street. The surfaces of the driveway and new depot lot were left unpaved.

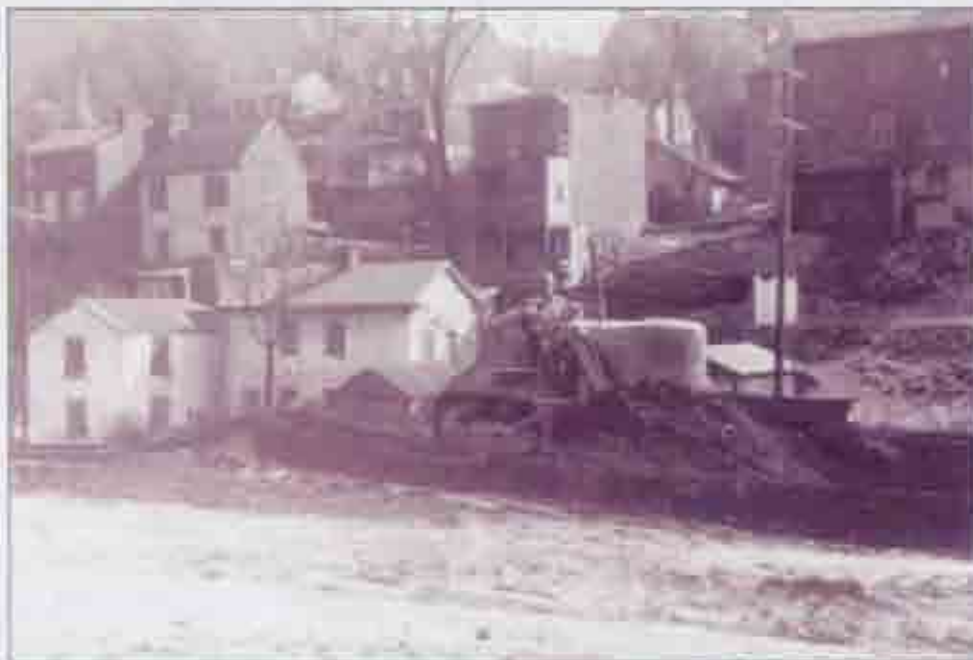
*Figure 36. A workman prepares the site for the relocation of the Harpers Ferry train station. (NPS photo.)*

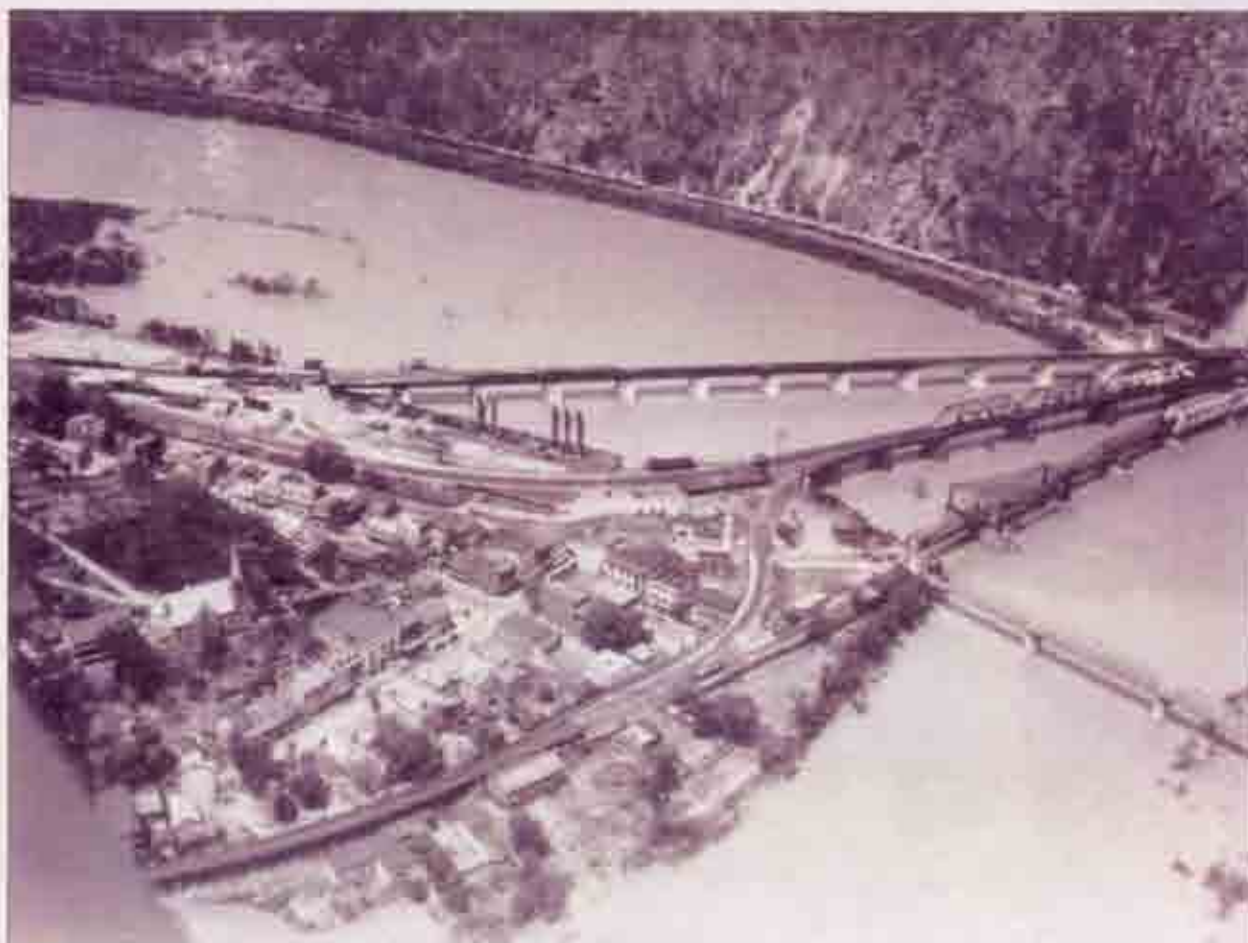
Figure 37. This aerial photograph, taken in 1931 just prior to the relocation of the station, shows all three Potomac River crossings and alignments at Harpers Ferry. (NPS photo.)

Another feature of the new alignment was the rearrangement of the rails for through traffic. After 1931, the 1894 bridge carried only the trains of the Valley Branch. A single track of the old main line was left in place to connect the two bridges on the Harpers Ferry side. This connection between the 1894 alignment and the new main line was maintained as a detour for emergency purposes for several years. It was eventually converted to a nineteen-car siding in 1958.<sup>78</sup> When the 1930-31 improvements were completed, for a period of five years, until the destruction of the Bollman bridge in the 1936 flood, all three of the B&O's Potomac River crossings and alignments could be seen side by side (Figure 37).

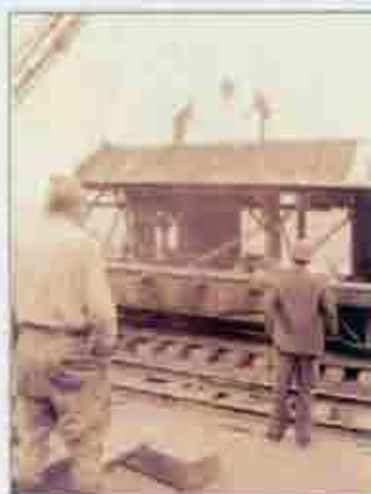
Figure 38. Moving the west bound waiting shelter. (NPS photo.)

The westbound waiting shelter was the first structure relocated. Compared to the station, the shelter's relatively small size and light framing made it the easier of the two tasks to complete. In February 1931, workmen utilized a rail-mounted crane to lift the shelter onto a flat railcar and move it to the new location (Figure 38). The structure was left largely intact, except for a minor change in its river-facing wall. There the sliding door that provided access to the 1913 subway stairs was removed. The resulting opening was then enclosed. The stairs, too, were torn away and the old subway tunnel was filled in prior to the relocation.

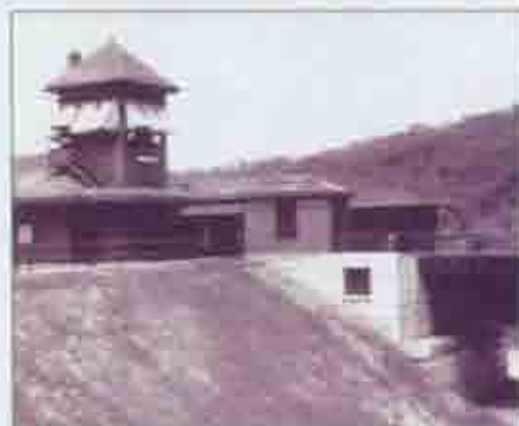
Figure 39. At the new site, the B&O built a subway to provide safe access to the waiting shelter. (B&O Railroad Museum.)

At the new site, pedestrian access to the shelter was once again controlled by means of a cast-iron fence between the two sets of rails. A new concrete subway was built. The tunnel passed below the tracks and through the bridge abutment. On the eastbound side of the tracks, a new subway-covering shed was built. It rested on a concrete foundation and was covered with tongue and groove siding that matched the passenger station building (Figure 39). Later, when the station was relocated, the new subway-covering shed was connected to the main building by a matching slate roof.

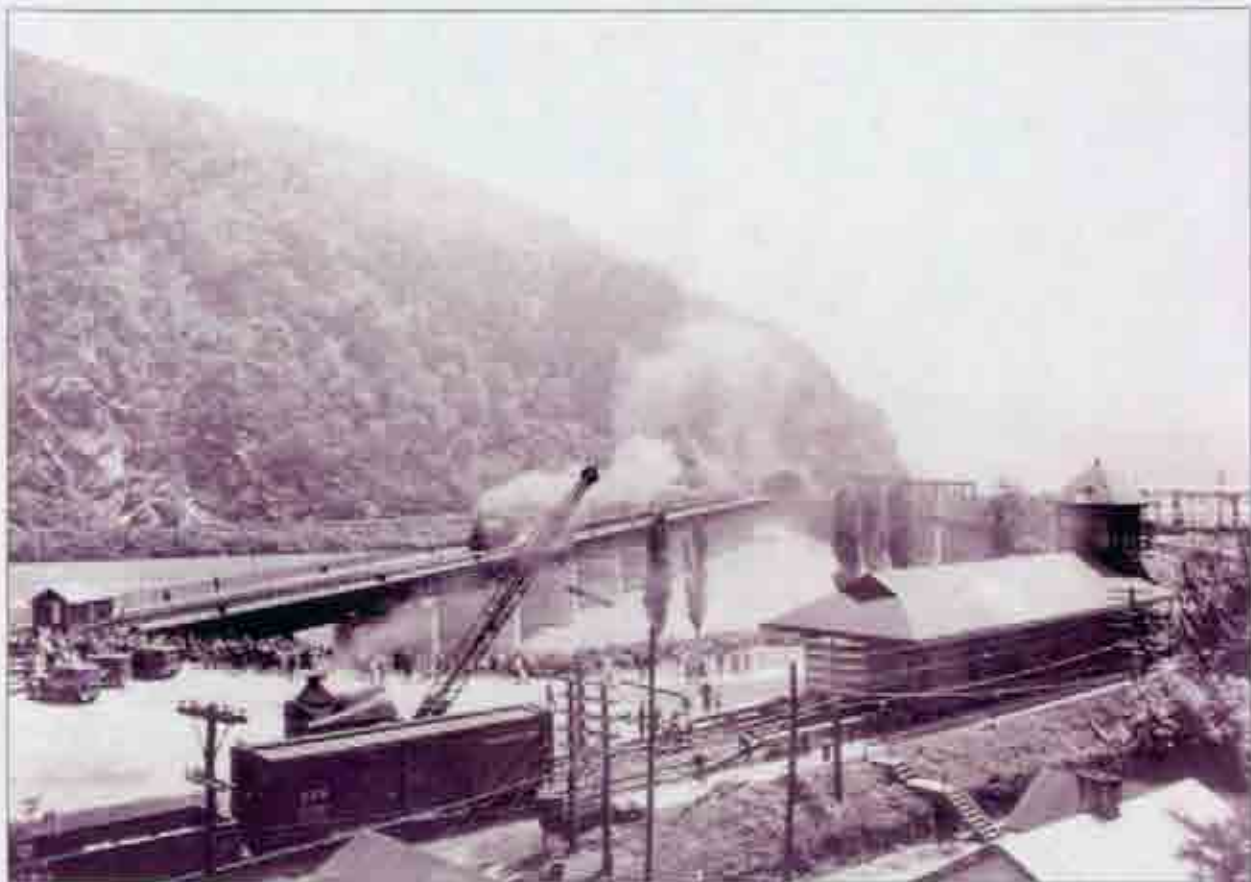
*Figure 41. Hauling the station to its new location, 1931. Notice the chimney and south dormer were removed prior to the move. (NPS photo.)*

The timbers that made up the cribbing functioned as the foundation and were set resting directly on the surface of the fill.
