# Historical Background Report

## Baltimore and Ohio Railroad, Harpers Ferry Station

HAER No. WV-86

Prepared by: Andrew S. Lee, Archeological Technician

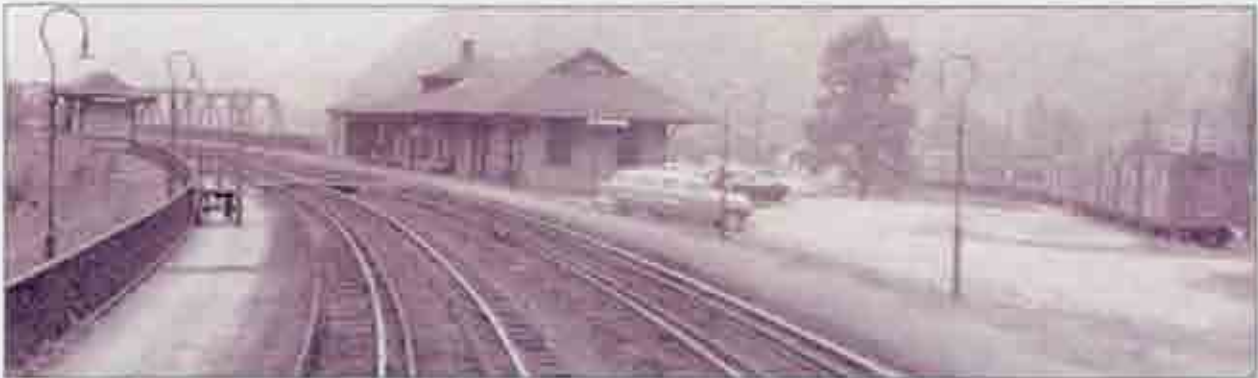
Figure 45. The station as it appeared in the late 1950s, not long after the interlock tower was removed. (B&O Railroad Museum.)

The appearance of the station at Harpers Ferry did change dramatically, however, when it lost its interlock tower. On February 3, 1950, the interlocking controls were moved from the tower to the agent's office. The tower itself was dismantled between August 1950 and March 1951.<sup>96</sup> The removal of the interlocking tower was a typical end result in the railroad's usage of technological developments. Advancements in technology rendered the tower obsolete and it was removed. With the second floor of the two-story tower gone and the subsequent remodeling of that section of the roof, the station looked much as it does today (Figure 45). It did not fully achieve its current configuration, however, until the building's north dormer was removed. Photographic evidence suggests this was done sometime after 1958 but before the mid-1970s.

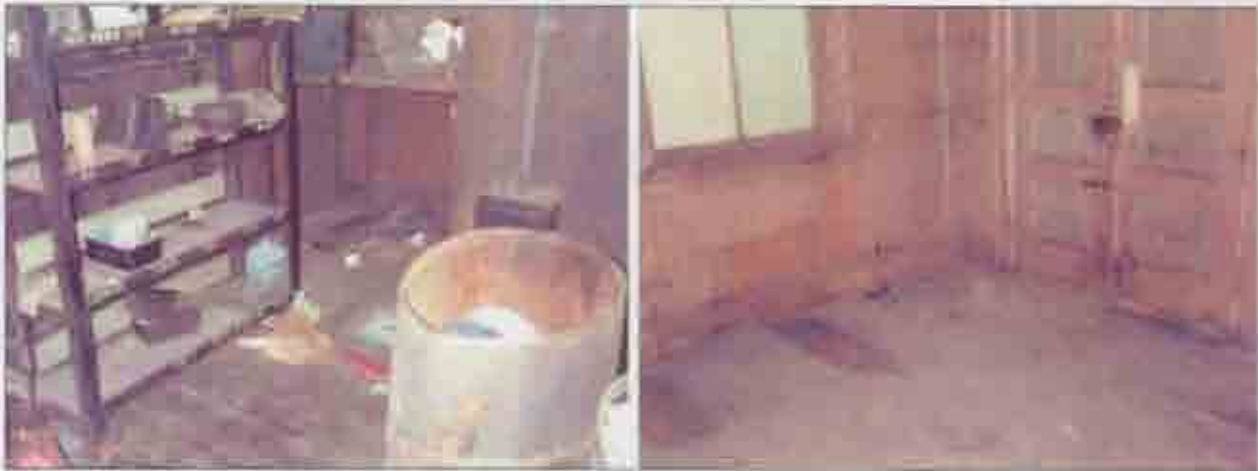
*Figure 46. Preservationists put the station on an "endangered" list 1999. The condition of the station can be seen in these views of the interior. Parts of the station had deteriorated from disuse and neglect. (photos by John W. Ravenhorst.)*

The fact that the Harpers Ferry station remained in active use while other stations in the region were abandoned, did not exempt it from falling into disrepair. Indeed, conditions had deteriorated to the point that in 1999 the National Trust for Historic Preservation and the Great American Station Foundation named the station one of the "Top 10 Most Endangered Stations in America" (Figure 46). The list was designed to highlight historic stations that were in danger of losing their capacity to operate as rail stations due to imminent demolition, destruction by neglect, or plans to terminate station operations. The nomination for the Harpers Ferry station states that "the former B&O Railroad Depot has fallen into disrepair and today faces an endangered future...A revitalized depot," it continues, "can serve as a welcoming front door to the popular community of Harper's Ferry and encourage individuals, families, and groups to use rail service as an easy, safe, and efficient way to visit this historic attraction."<sup>100</sup>
