REPORT OF UNOMIG ON THE INCIDENT OF 20 APRIL INVOLVING THE DOWNING OF A GEORGIAN UNMANNED AERIAL VEHICLE OVER THE ZONE OF CONFLICT

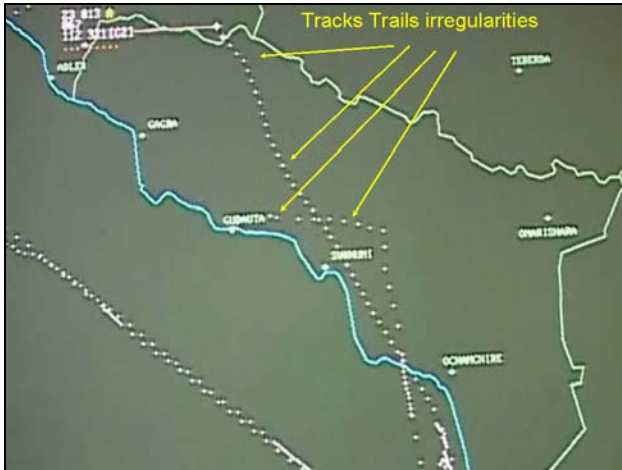
R1

Radar track images

21. The tracks trails of both the UAV and the interceptor are not completely straight, but they have small deviations or curves. The General Air Traffic (GAT) does not have these deviations from a straight track because commercial aircraft are flying with the autopilot engaged. (See annex). If the radar record had been created by a simulator, those kind of small deviations would not have been expected, because simulators normally only create straight tracks.
