PURCELL

WOKING PALACE CONSERVATION MANAGEMENT PLAN

January 2016

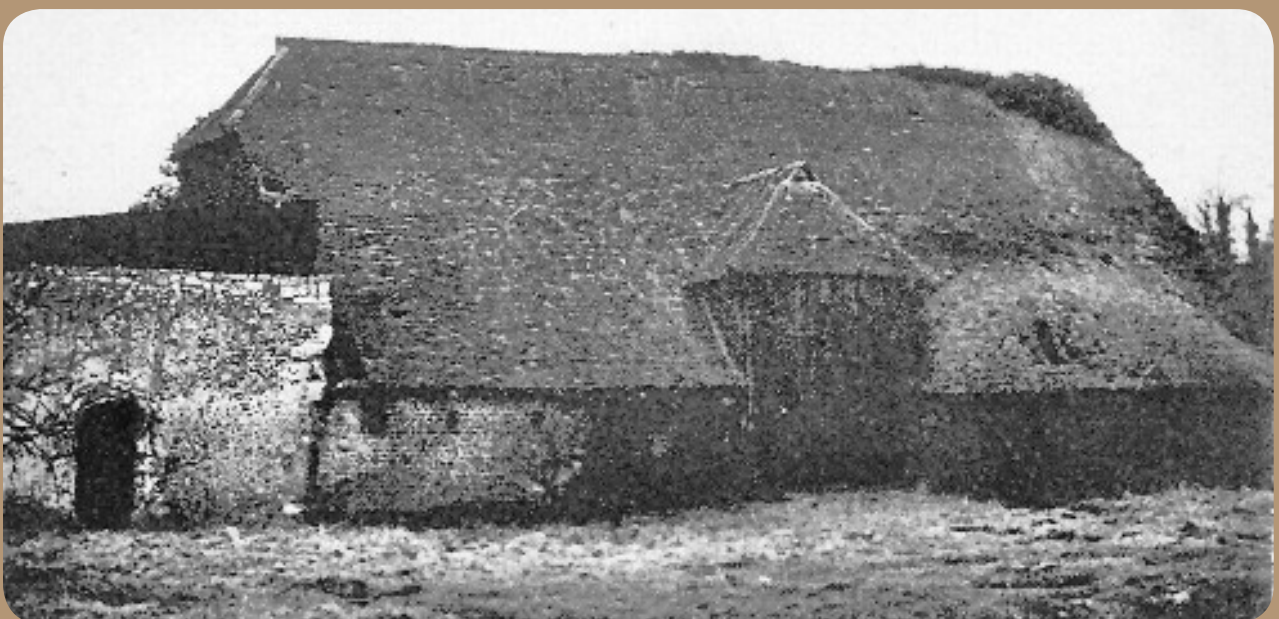
View of barn and vaulted room from north west, believed to be c.1905. Note intact roof to barn building and monopitch roof to vault. (Reproduced by permission of Phillip Moll).

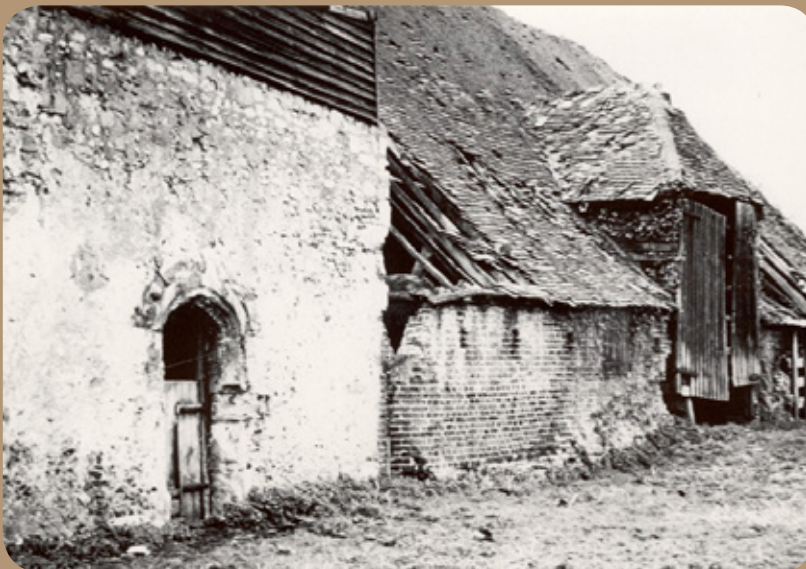
View of barn and vaulted room from south east, c.1945. Note intact roof to barn building and monopitch roof to vault. (Reproduced by permission of Phillip Moll).

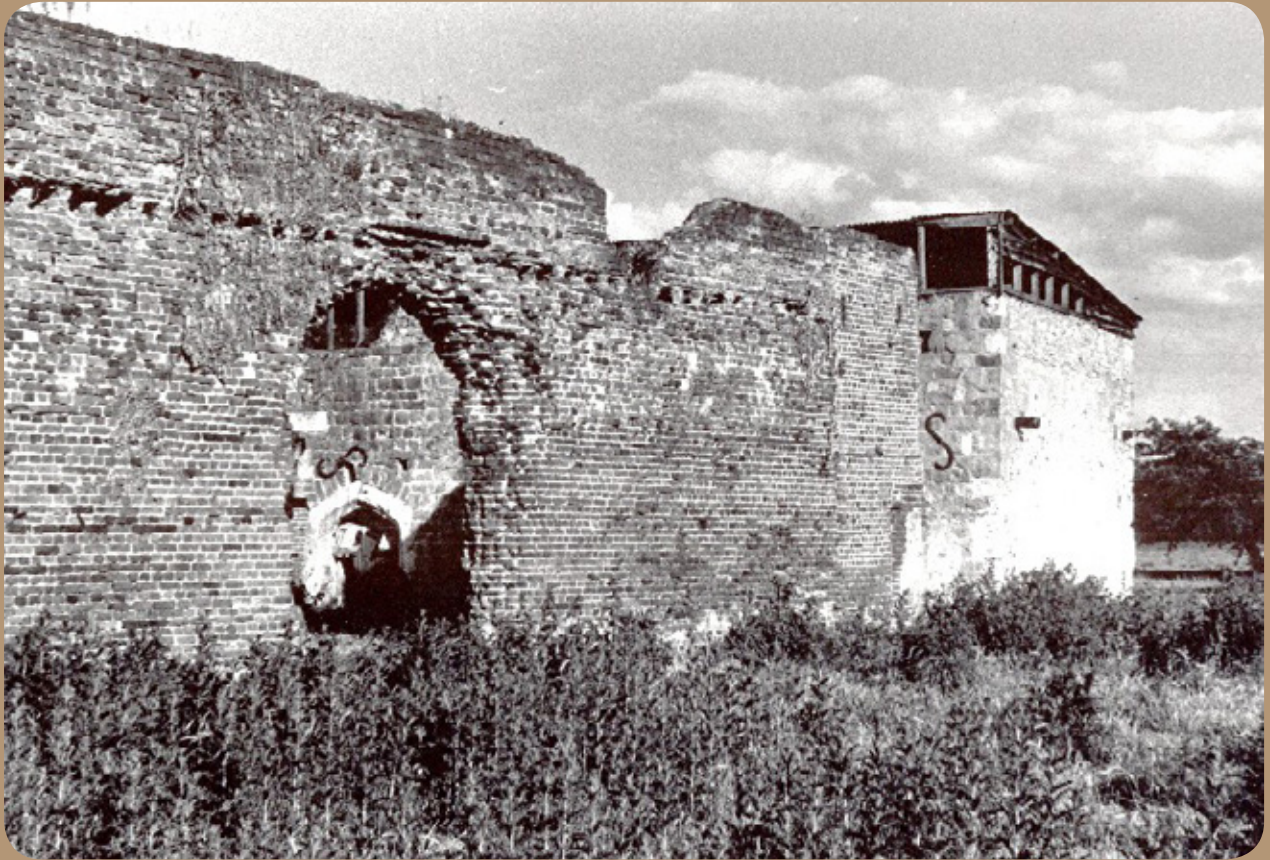
View of Palace from north west. c.1985. Note intact monopitch roof to vault and brick arch. (Reproduced by permission of Phillip Moll).

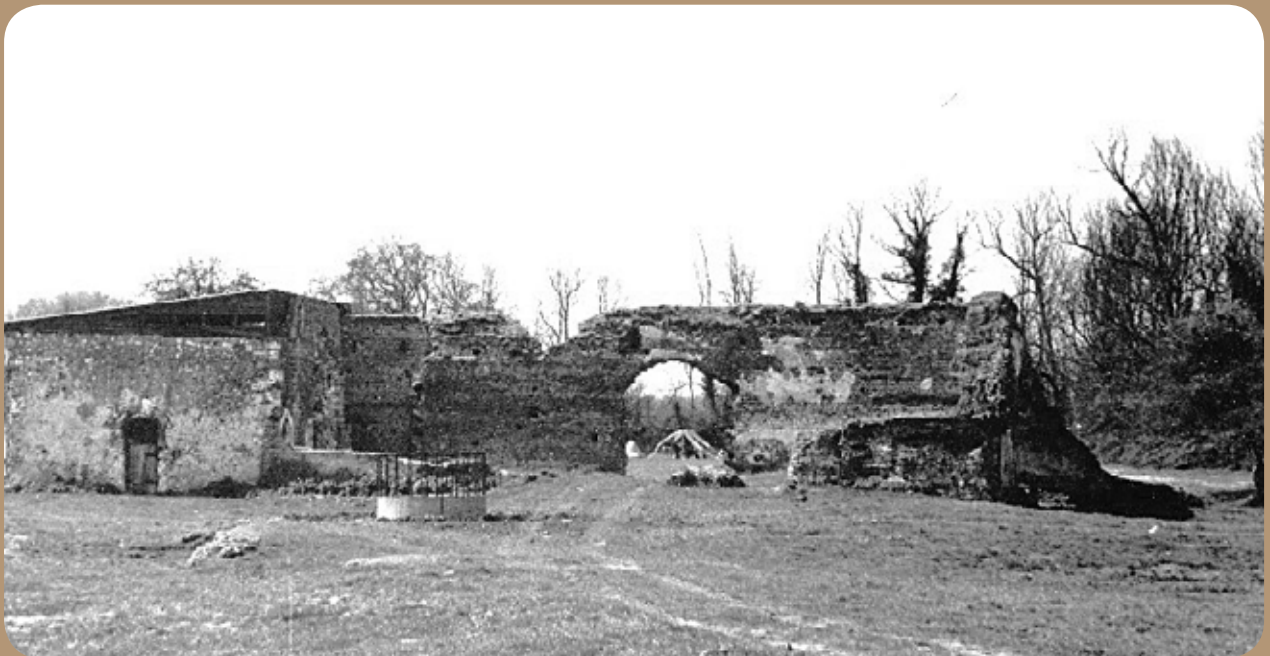
View of Palace from east. c.1985 Note intact monopitch roof to vault and brick arch. (Reproduced by permission of Phillip Moll)

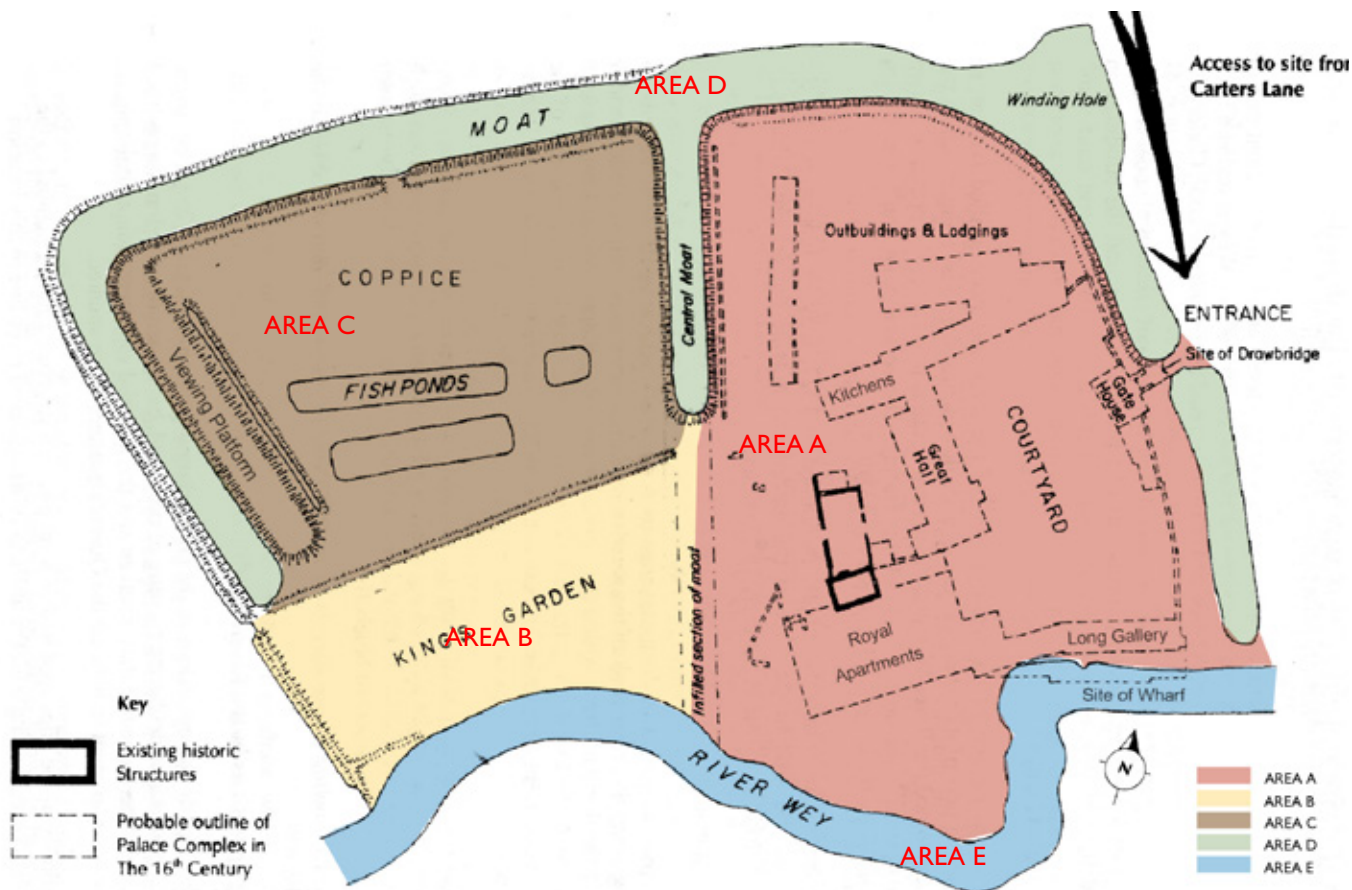
Present day plan of the site

This section provides a description of the site. For ease of understanding the site has been broken down into five areas (A-E) which are illustrated on the plan below. The plan has been reproduced by permission of Woking Borough Council & Richard Savage, with amendments by Purcell.

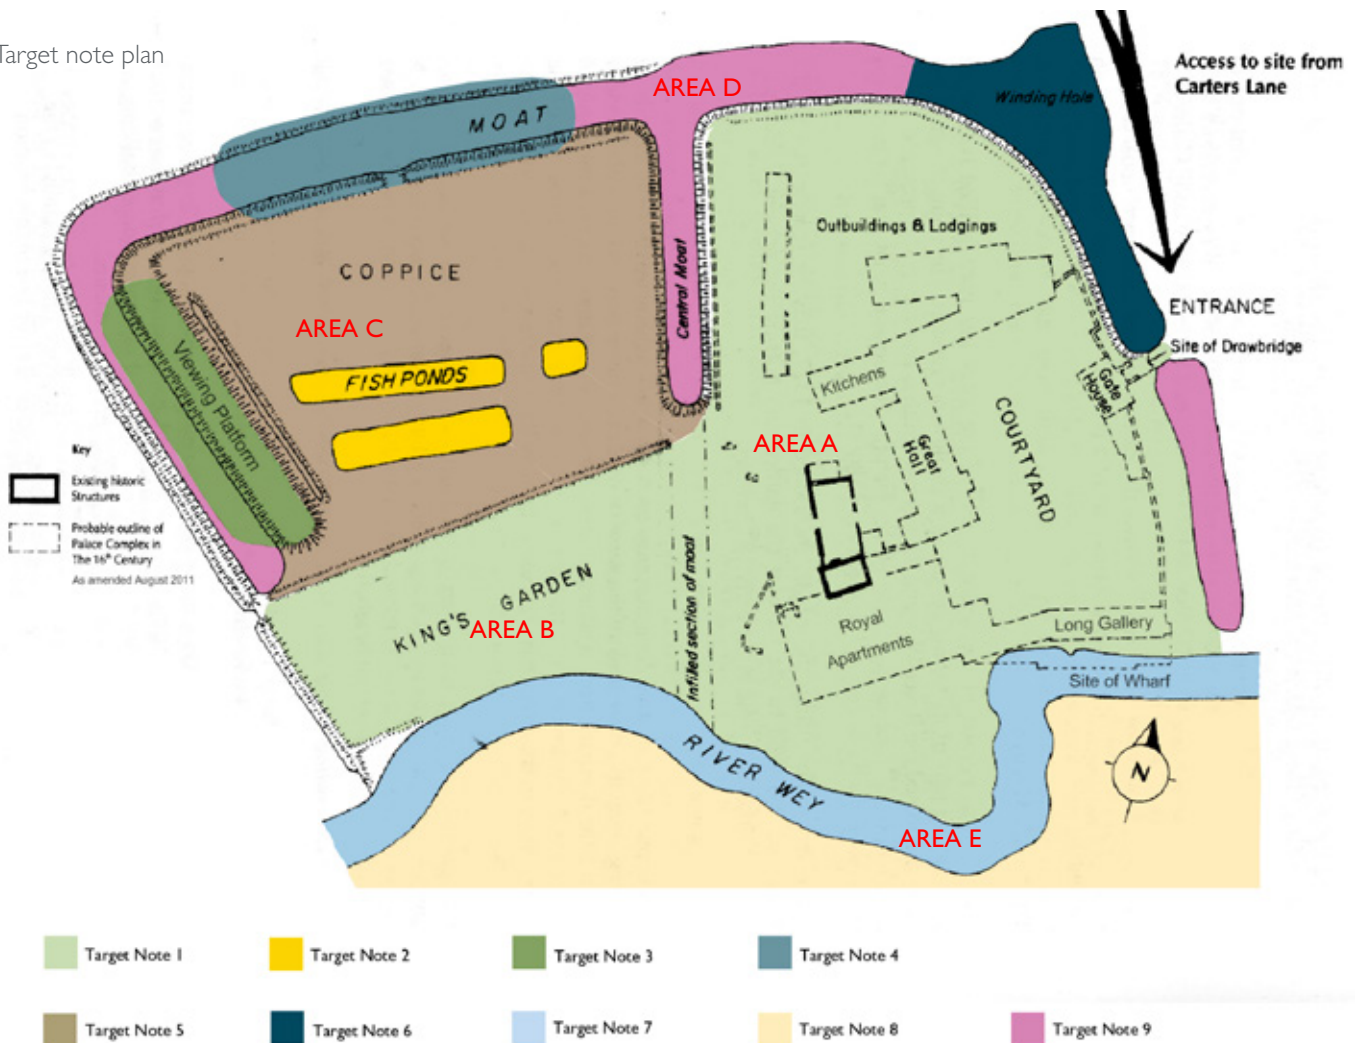
Target note plan

Ecological features of significance have been target noted on the plan opposite, and are described below. A habitat map of the site is also provided below:

Target note 4: A number of willows have encroached into the moat along the northern bank. These have high potential for bat roosting in cracks, crevices and woodpecker holes. A number of log piles, of value for saproxylic invertebrates and reptiles/amphibians are present here as well.

Target note 7: The River Wey shows potential to support water vole, although no evidence was observed during the 2013 survey. Its ecological significance is discussed in the text above. It will provide a corridor for a wide range of species, and was noted as being of particular value for foraging and commuting bats.

Target note 9: The majority of the moat itself consists of shallow choked water, areas of scattered scrub and ephemeral vegetation, and areas of mud. There are no protected or notable species that were observed to be directly associated with this habitat and as such the areas of the moat that have fallen into such disrepair can be considered to be of low significance.

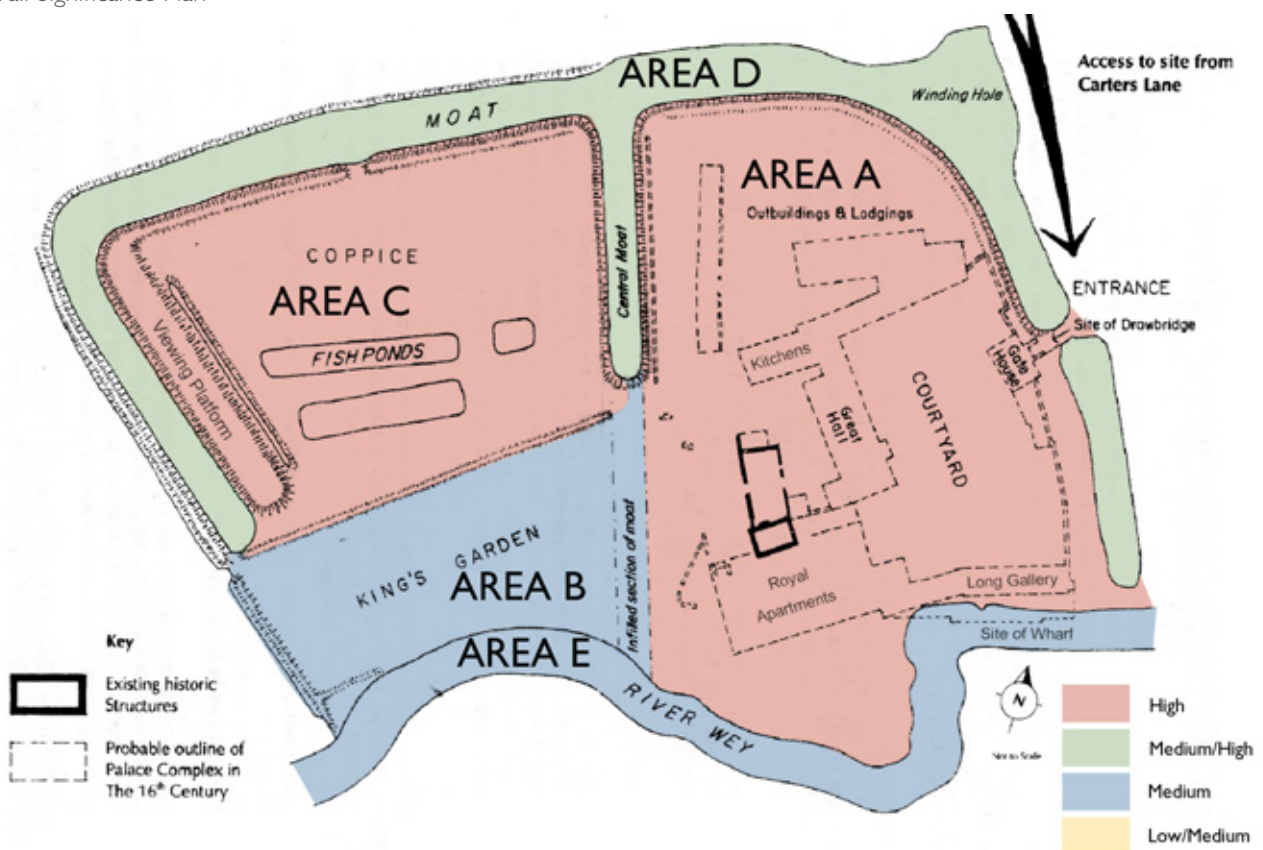
Overall Significance Plan

The table and plans below provide an overview of the heritage and ecological significance of the site by area.

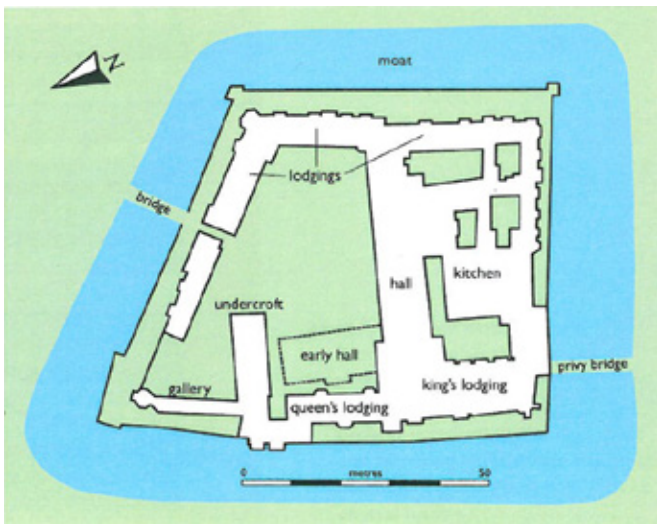
Plan of Eltham Palace (© Rob Poulton)

Eltham Palace, a contemporary Tudor manor is described (by Rob Poulton) to be similar in form and plan to Woking Palace. The plan below is taken from Poulton's 2010 publication. An example of a Palace site which is in similar existing condition as Woking is Clarendon Palace in Wiltshire. Clarendon Palace presents the parallel of a medieval Palace located within a deer park. The Palace is currently in a ruinous state and after decades of archaeological investigation the site has tended to provide access for visitors. Clarendon does not provide comparable historical associations, but provides a useful example of a Palace site in a similar setting and state of survival to Woking.
