## THE GALILEO HIGH GAIN ANTENNA DEPLOYMENT ANOMALY

Michael R. Johnson  
California Institute of Technology  
Jet Propulsion Laboratory  
Pasadena, California

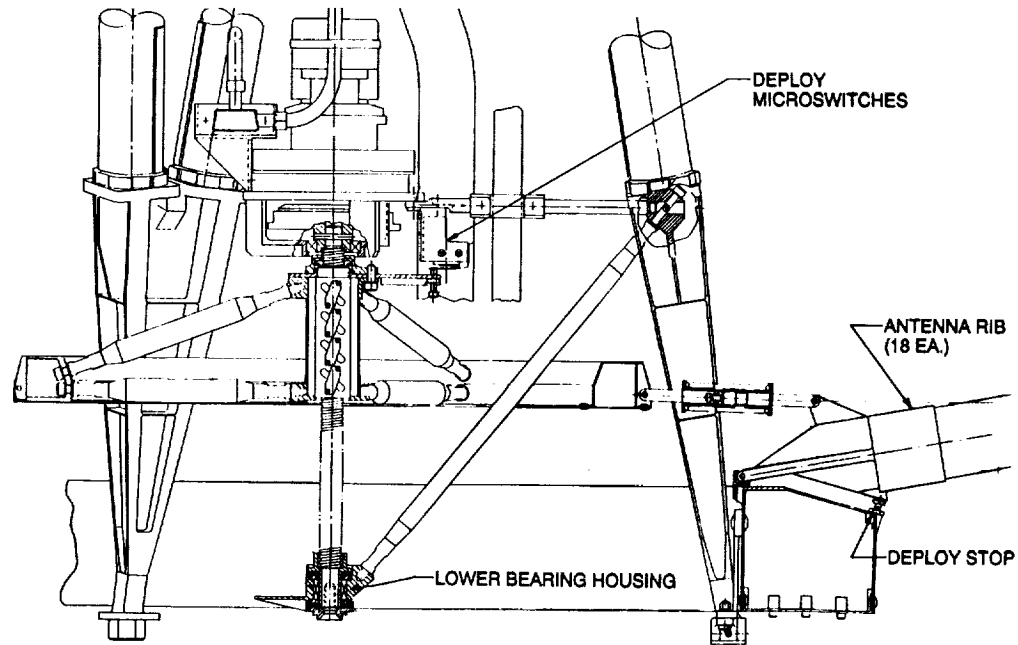
**Figure 5.**  
Galileo High Gain Antenna Mechanical Drive System  
(Deployed)

bearing housing (see Figure 5), due to the sliding contact of the ballscrew with the stationary outer housing. The needle roller bearing in the lower housing is not capable of supporting a large moment load, allowing the ballscrew to rotate relative to the housing and come in contact with it. The result of these torque losses was that very little torque was available to move the ribs against their restraints.

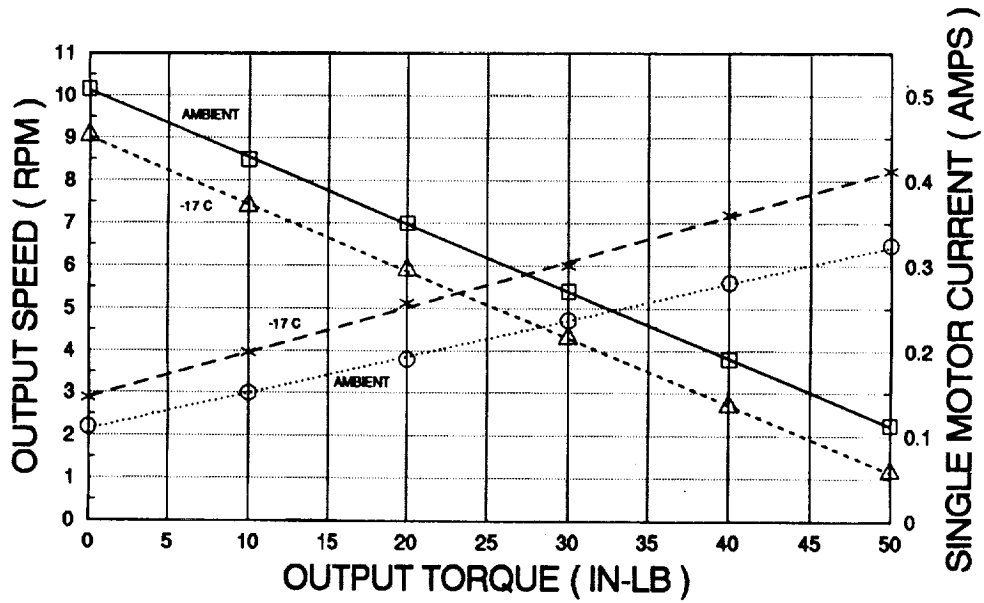
Figure 14.  
Dual Drive Actuator Performance

The motor current telemetry indicated that the motors stalled at 56 seconds after initiation. The telemetry was then used to determine how far the ballscrew in the Mechanical Drive System had rotated from the stowed position. The motors on the DDA are brushless dc motors. The DDA, therefore, has the speed-torque-current relationship shown in Figure 14.

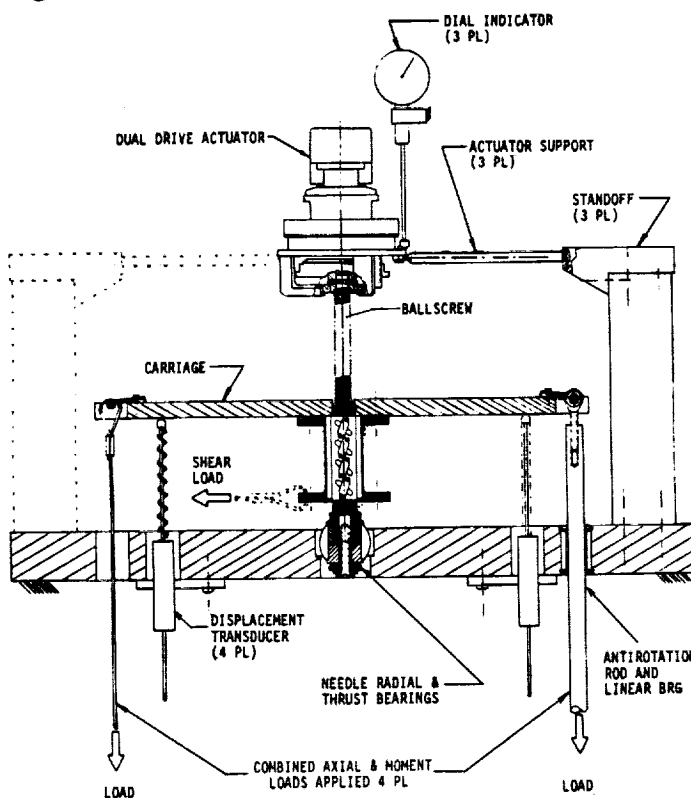
**Figure 17.**  
**Mechanical Drive System**  
**Loading Fixture**

was about 6.33 N-m (56 in-lb). A test was performed on a mock-up of the MDS to determine how it would respond to the odd loading condition created by the antenna. The test fixture shown in Figure 17 was used to apply moment, axial, and shear loads to the "carrier plate" individually and in combination. The results of these tests showed that shear and axial loads do not significantly affect the efficiency of a ballscrew. Moment loads, however, result in very significant losses in a ballscrew/ballnut assembly. The graphs in Figure 18 show that the application of a moment of 339 N-m (3000 in-lb) to a ballnut results in torque losses of 4.18 N-m (37 in-lb), or more than half of the available torque from the DDA. This large amount of torque loss is due to jamming of the balls in the ballnut and sliding contact of the ballscrew with the ballnut body. Also, it was found that further losses occurred at the lower
