EVALUATION OF LANDSLIDE HAZARDS RESULTING FROM  
THE 5-8 OCTOBER 1985, STORM IN PUERTO RICO

Randall W. Jibson  
U.S. Geological Survey  
Reston, Virginia 22092

U.S. Geological Survey Open-File Report 86-26

A report submitted to the Federal Emergency Management Agency  
in fulfillment of a mission assignment to evaluate  
landslide hazards related to disaster FEMA-746-DR-PR

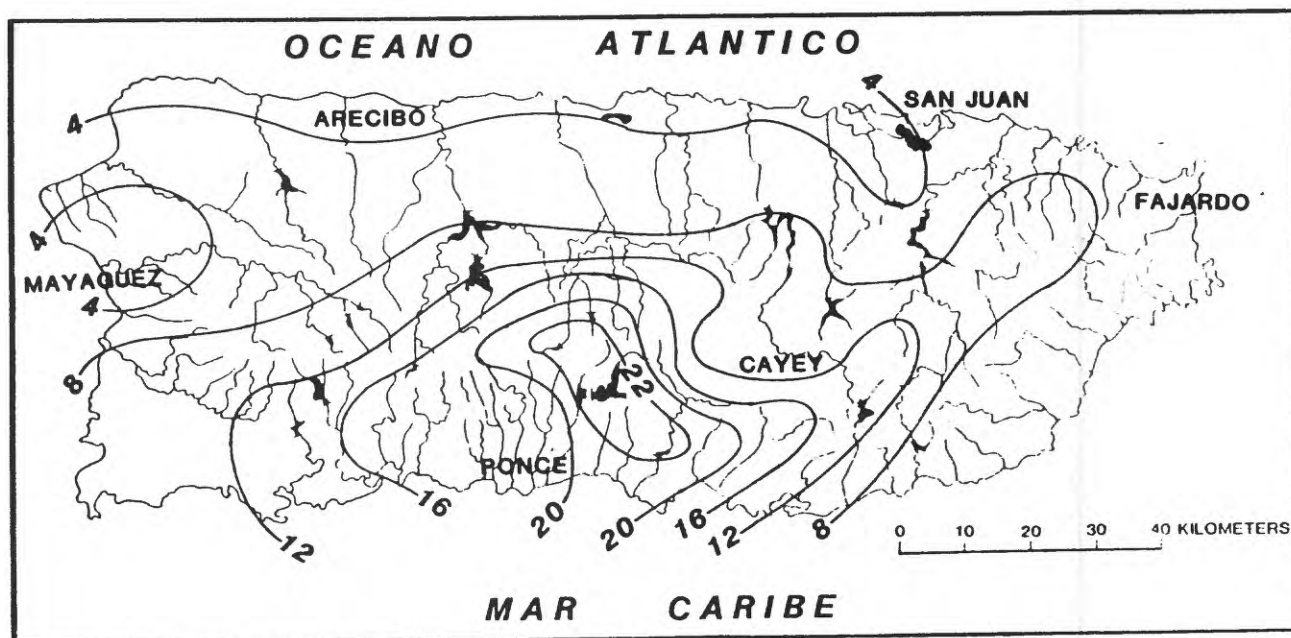
The National Weather Service reported record precipitation totals along a band on the south-central part of Puerto Rico. Precipitation totals during a 24-hour period exceeded historical accumulations and frequencies at several stations in the south coast (fig. 1). North of the towns of Coamo, Santa Isabel, Juana Díaz, and Ponce, the 24-hour totals exceeded 22 inches. The intensity of the precipitation near Tallaboa (west of Ponce) reached values as high as

Figure 1. Total 24-hour rainfall amounts (inches) from 0800 6 October 1985 to 0800 7 October 1985 throughout Puerto Rico.

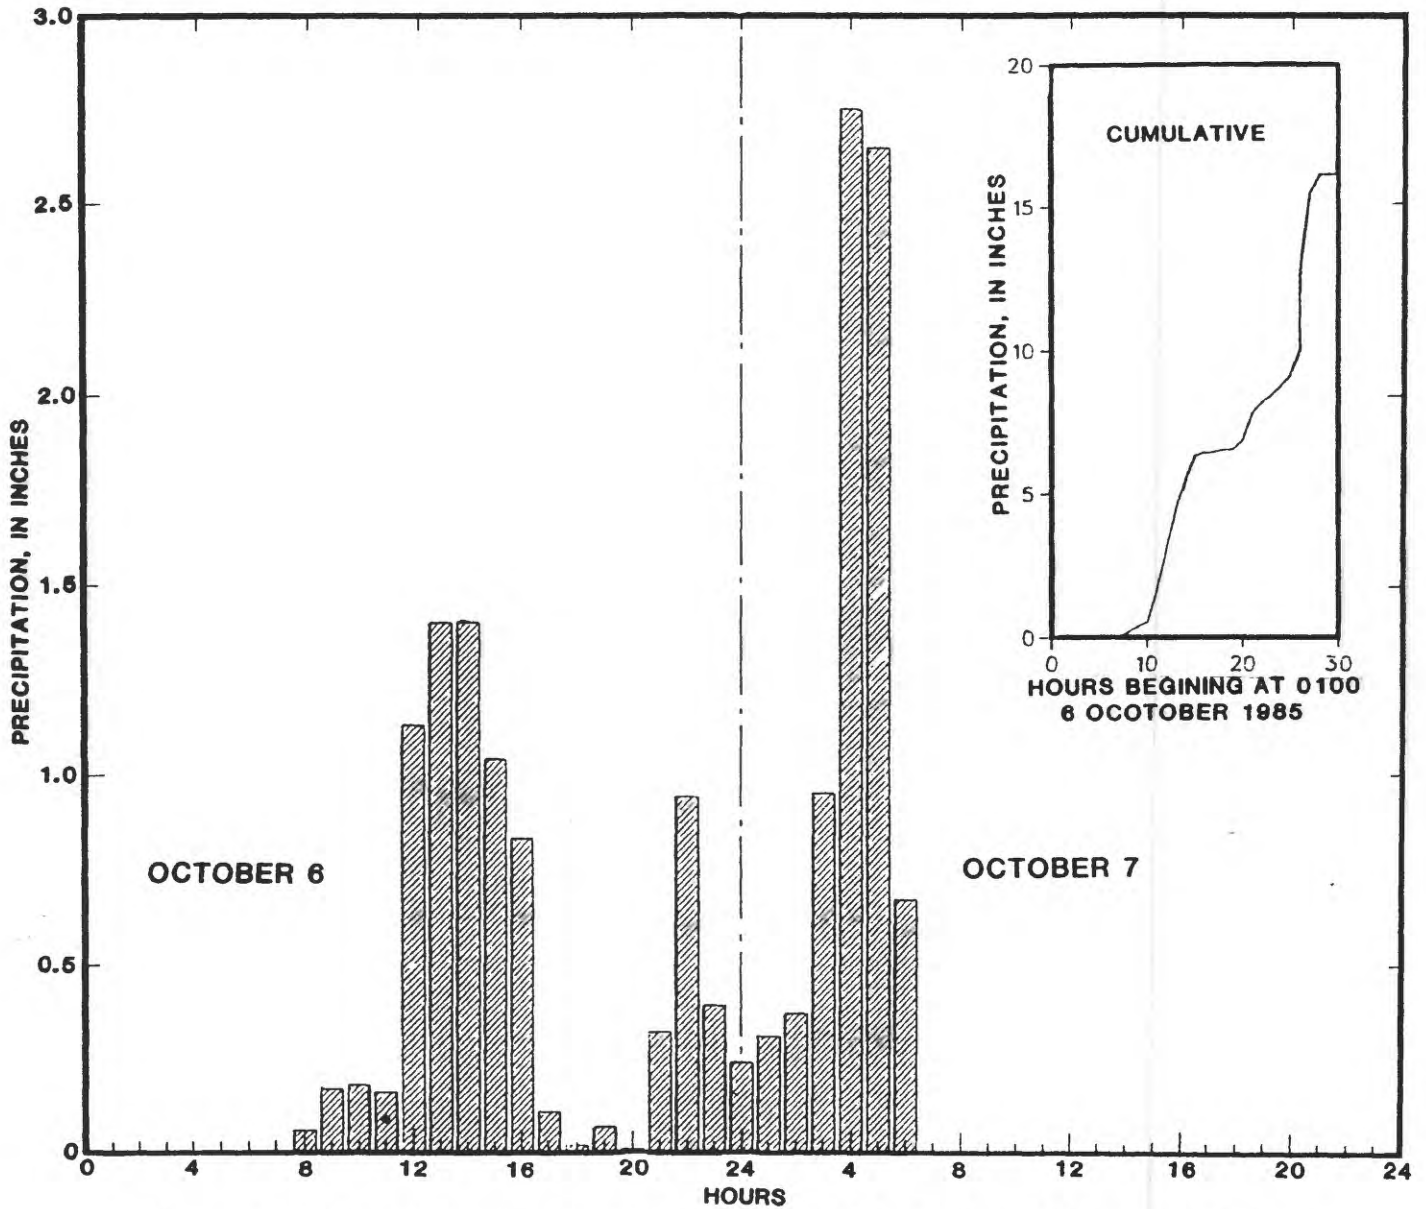
2.75 inches in one hour and about 5.5 inches in two hours. The rainfall was about equally distributed between the afternoon of October 6 and between 0100 and 0300 hours of October 7. Antecedent rainfall during the prior week and on October 6 resulted in the saturation with water of soils throughout the Island. Cumulative precipitation for the period of October 5-8 was as high as 29.85 inches at Cerro Maravilla (table 1). The intensity of the precipitation during the early hours of October 7 induced record runoff and landslides throughout the Island. (See fig.2.)

**Figure 2. Hourly and cumulative rainfall during 6-7 October 1985 near Tallaboa, southern Puerto Rico. (Data courtesy of P.R Energy Power Authority.)**

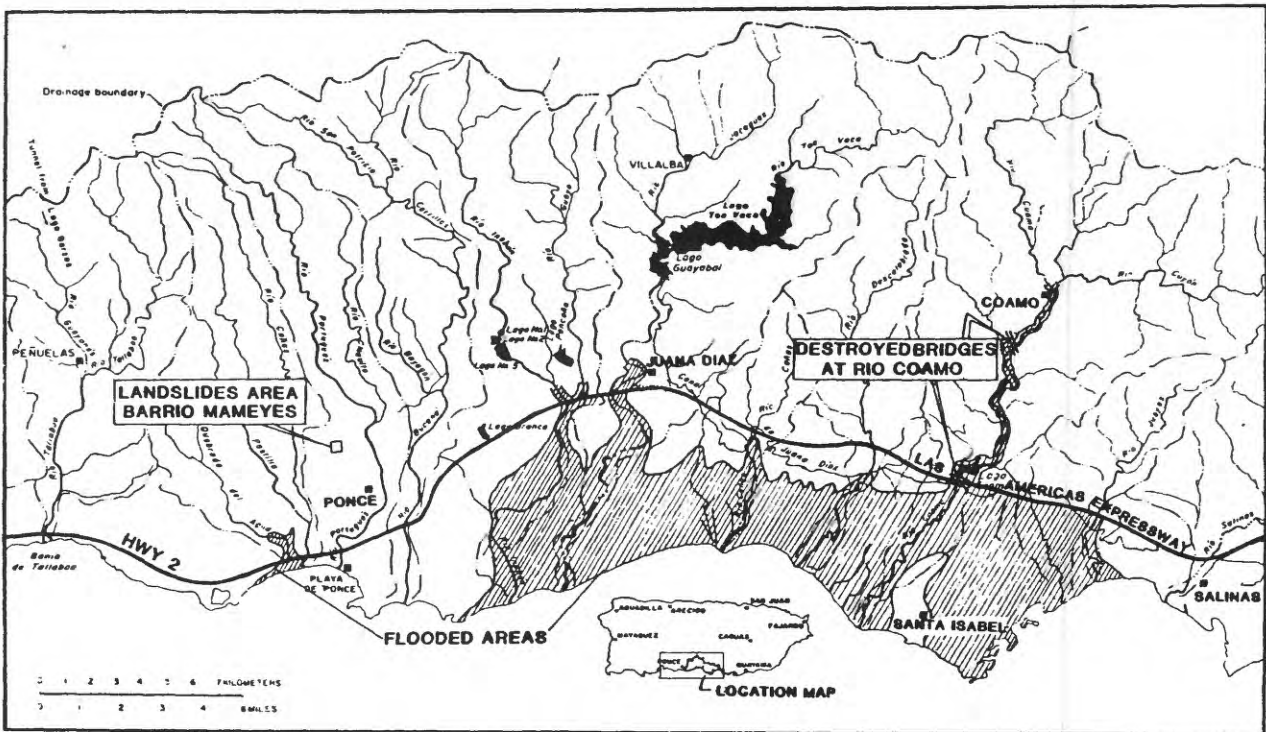
Inundation was most severe in the Santa Isabel to Ponce fans (fig 3). The areas flooded by the streams that overflowed into the valleys exceeded the historical floods of 1975 (Eloísa storm). Flooding in the lower valley of Río Jacaguas was minimized because, for only the second time since its construction, the Toa Vaca reservoir filled-up (original capacity of 44,000 acre-feet). The water works in the Cerrillos and Bucaná area (urban Ponce) also prevented flooding in the area.

Figure 3. Areas flooded in Southern Puerto Rico during the 6-7 October 1985 floods.

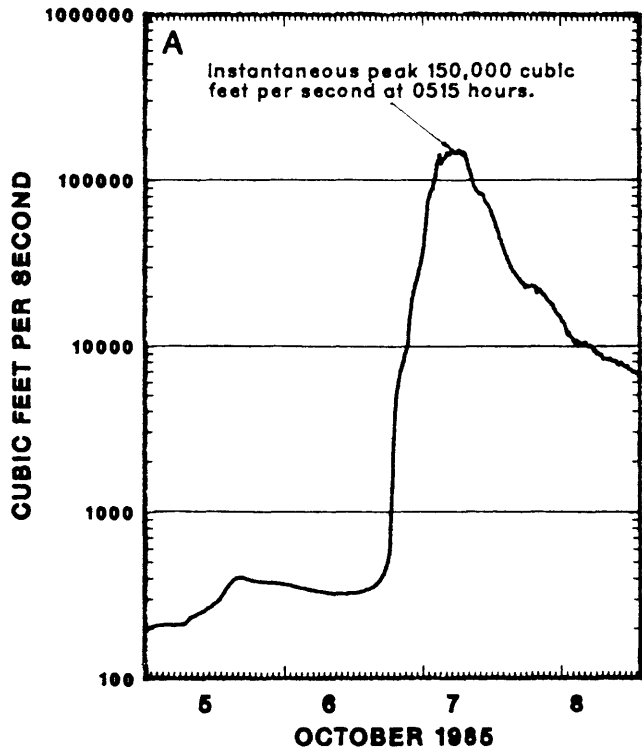
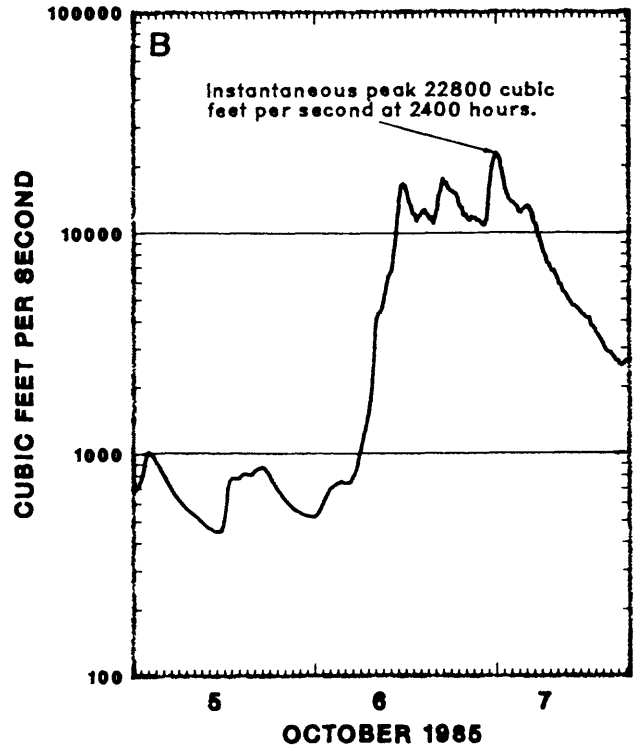
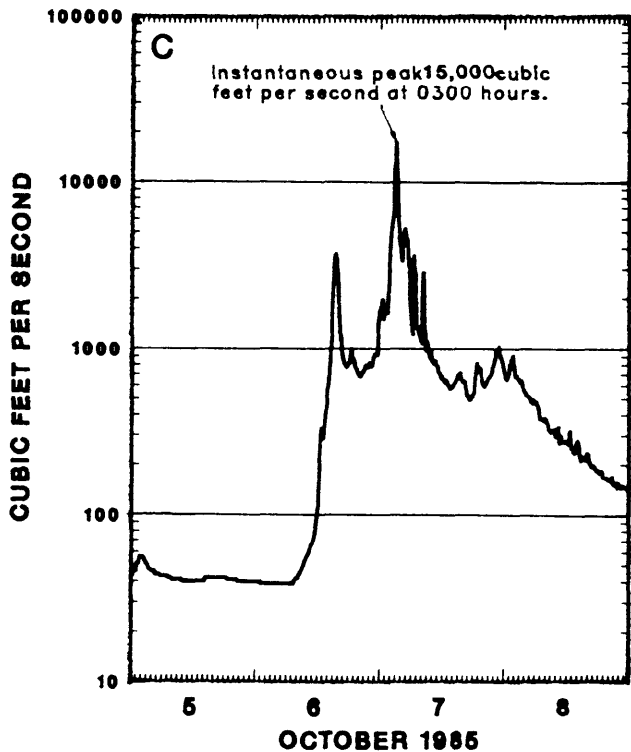
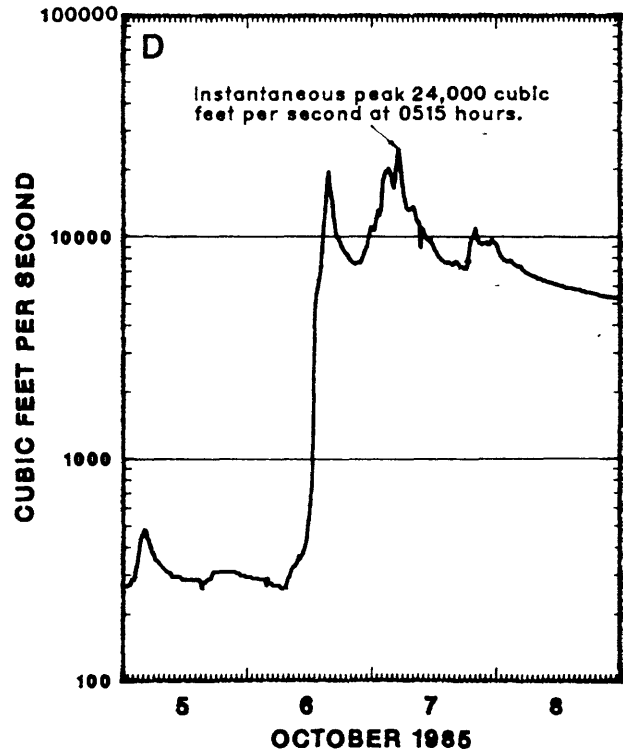
Flood hydrographs at key gaging stations in the headwaters of the areas affected show the intensity and duration of the storm effects (See figs. 4A to 4D).

Figures 4A, 4B, 4C, and 4D. Discharge hydrographs at key streamflow gaging stations during the 6-7 October 1985 floods.
