### **The Cosco Busan**

Allision of Hong Kong-Registered Containership M/V *Cosco Busan*  
with the Delta Tower of the San Francisco–Oakland Bay Bridge  
San Francisco, California  
November 7, 2007

NTSB/MAR-09/01

# **Marine Accident Report**

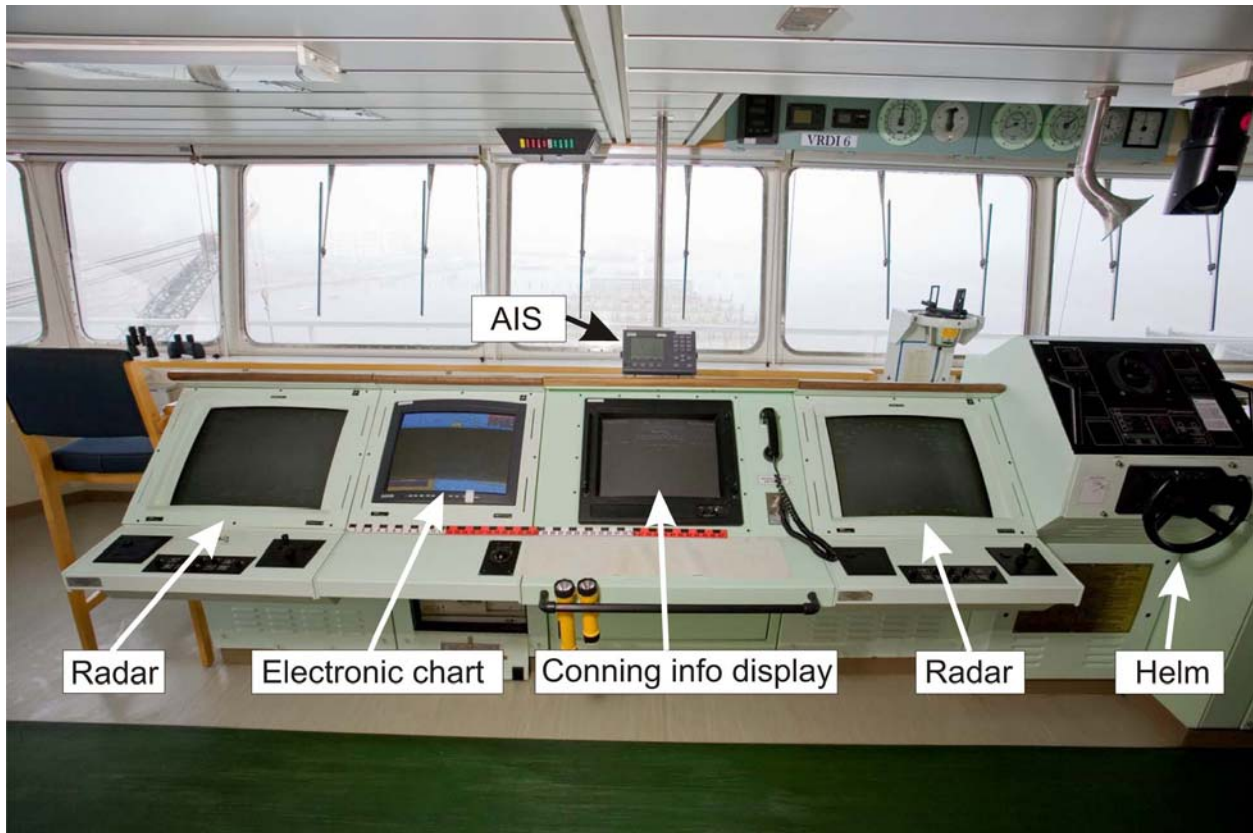
The primary components of the VMS were two radars, an electronic chart system, and a conning information display (figure 7), as described below, as well as an AIS.<sup>47</sup>

**Figure 7.** The bridge of the *Cosco Busan* showing primary navigation displays.

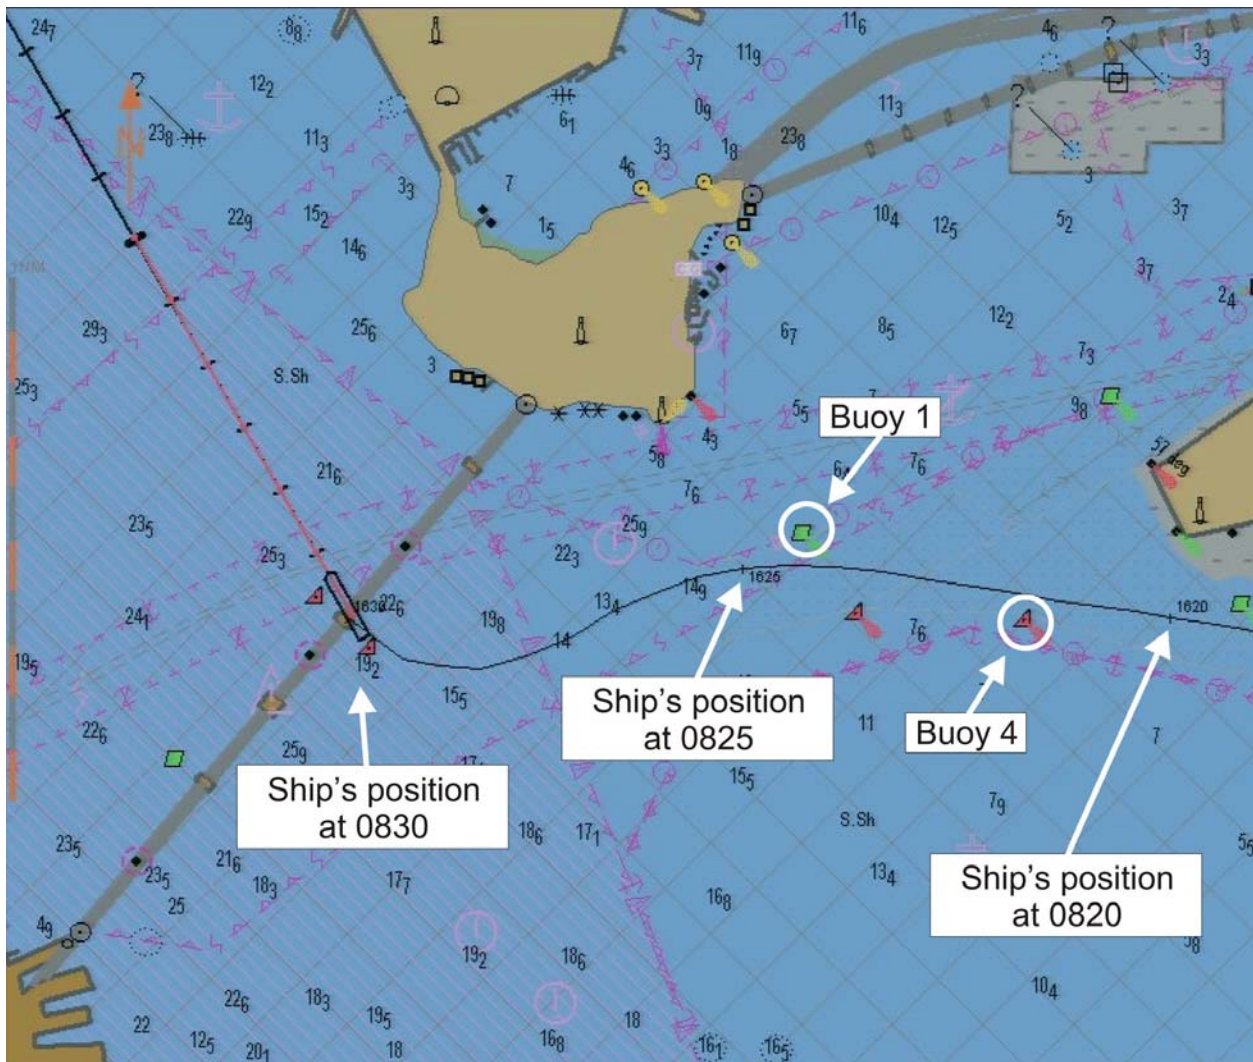
primary and secondary sensors provided a real-time plot of the ship's movement on the electronic chart with time markers at 5-minute intervals (figure 9).

**Figure 9.** Electronic chart from the *Cosco Busan* showing the vessel's track from the entrance channel to the bridge during the accident voyage. The ship's position was marked on the chart at 5-minute intervals.
