# **NATIONAL TRANSPORTATION SAFETY BOARD**

## **AIRCRAFT ACCIDENT REPORT**

**AIR CANADA FLIGHT 797  
McDONNELL DOUGLAS DC-9-32, C-FTLL  
GREATER CINCINNATI  
INTERNATIONAL AIRPORT  
COVINGTON, KENTUCKY  
JUNE 2, 1983**

**NTSB/AAR-86/02  
(SUPERSEDES - - NTSB/AAR-84/09)**

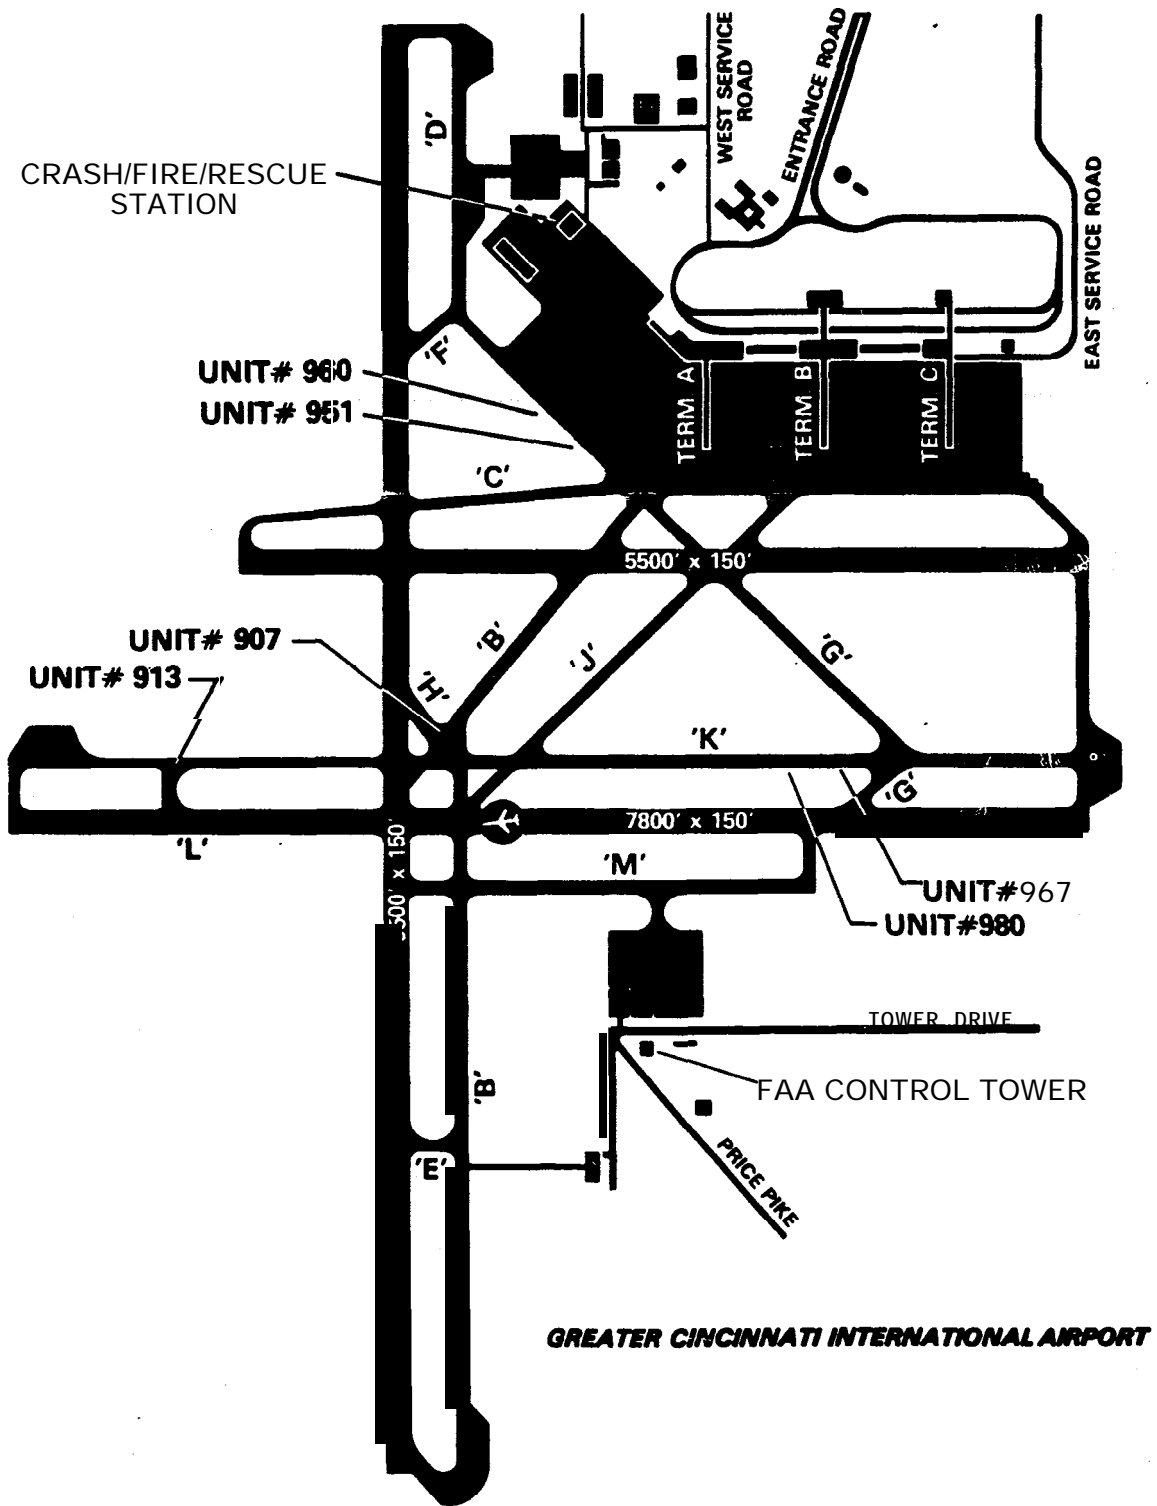
Figure 1.—Standby Positions of Crash/Fire/Rescue Units.

At 1913:38, after Flight 797 was unable to tell him its heading because its heading instruments were inoperative, the approach controller asked the flight to turn left. The controller said that this was an identification turn and that it was also designed to place the airplane closer to the airport. At 1914:03, after observing the target in a left turn, *the* approach controller said that Flight 797's primary target was now \*\*fully identified." He then told the flight that this was a "no gyro" 5/ radar approach for runway two seven left. . ." and cleared it to descend to 3,500 feet. He then told the flight that it was 12 nmi southeast of the Cincinnati Airport, cleared it to land on runway 27L, and informed it that the surface wind was 220° at 4 knots. He informed the tower of the change of landing runways and the tower directed *the* fire department to position its vehicles along runway 27L. (See figure 1.)

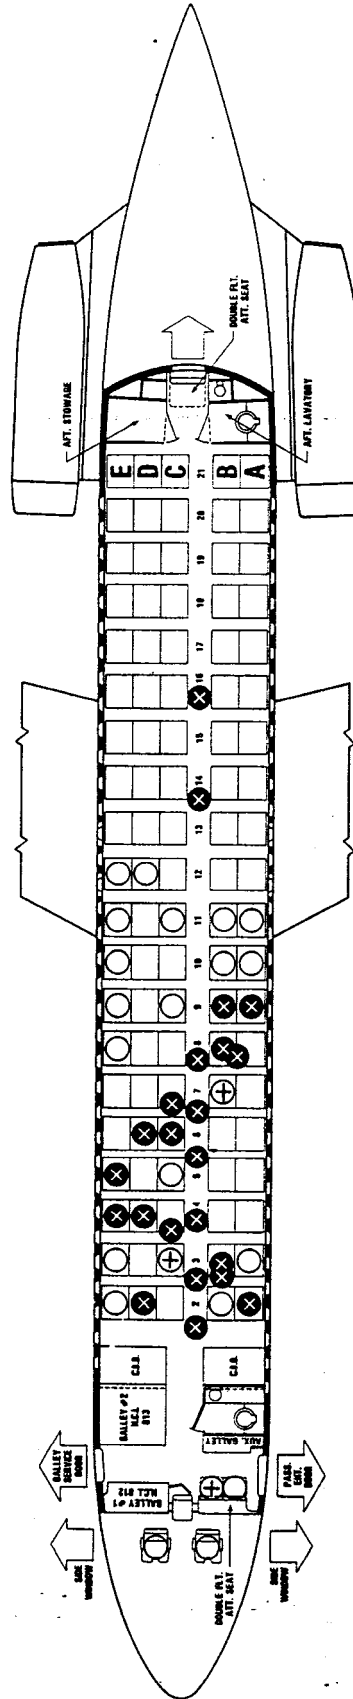
Figure 12.—Diagram of passenger seat locations.

Publication 356 also states, in part, that if excessive smoke and fumes are present in the cabin, the flight attendants should "relocate passengers away from the area of severe smoke and fumes if possible." The passengers had been moved forward in the cabin, and no passenger was seated farther aft than row 12. The two passengers in seats Nos. 12D and 12E refused to move forward because their seats were next to the right forward **overwing** exit window. (See figure 12.)

Except for two fatalities found in the aisle at rows 14 and 16, the majority of the fatalities were found either in the aisle or seated in rows 2 through 9. (See figure 12.) The fatalities at rows 14 and 16 had been seated in seats 8-B and 9-B, respectively.

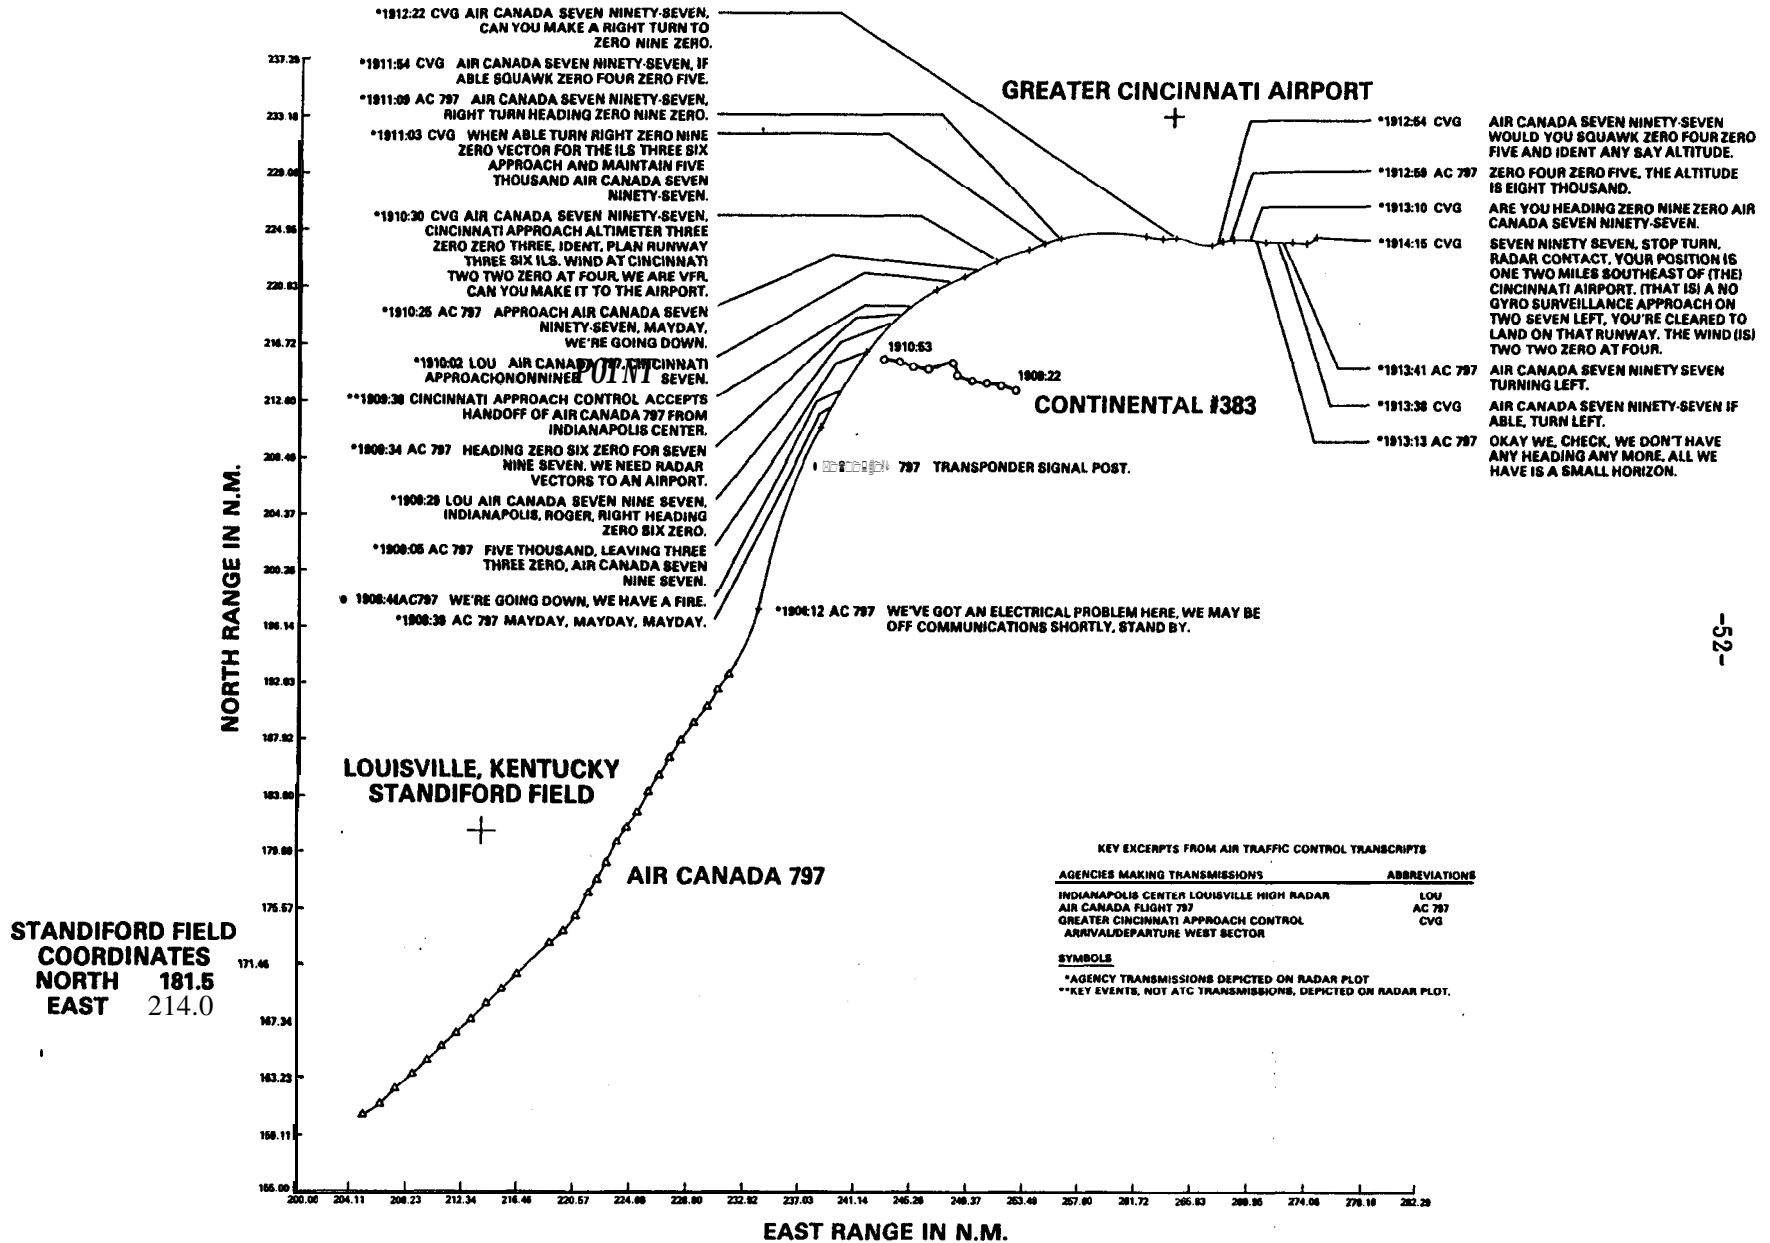
Figure 13.-Ground radar tracks for Flights 797 and 383.

18-36 of the Greater Cincinnati Airport were digitized and plotted with the ground tracks. Times of key transmissions and selected key events were included along Flight 797's radar ground track. The last radar fix retrieved from the DART's data occurred at **1914:15**, and the last transponder information from Flight 797 was received at **1906:12**. (See figure 13.)
