EFFECT OF THE DENALI FAULT RUPTURE ON THE TRANS-ALASKA PIPELINE

Steve P. Sorensen¹ and Keith J. Meyer²

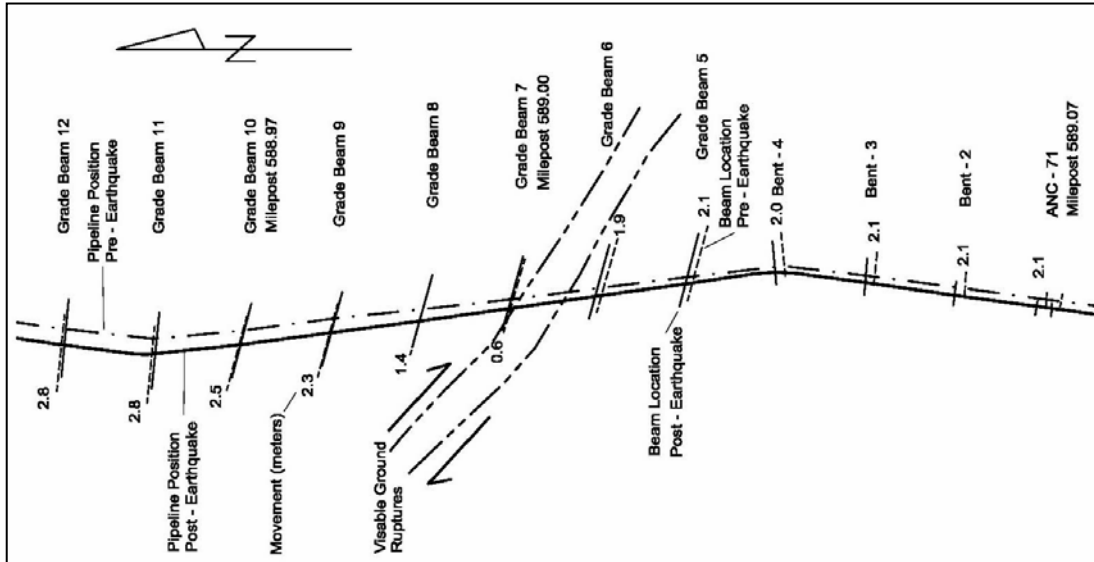
Figure 2. Denali Fault pipeline crossing schematic

As expected, significant pipeline and pipeline support movements occurred during the November 3, 2002 fault rupture. The trace of the rupture was clearly visible between grade beam supports 6 and 7 near the southern end of the special

configuration shown schematically in Figure 2. A range of potential locations of fault surface rupture was analyzed during design. From these design studies, the most severe effect on the pipeline was determined to be when surface rupture was postulated at grade beam 7, which is only one bent away from the observed fault trace. Therefore, this event actually represented the near maximum expected movement for the design, as was indeed the observed result. The relative locations between pre-event and post-event pipeline and beam positions are shown in Figure 4.

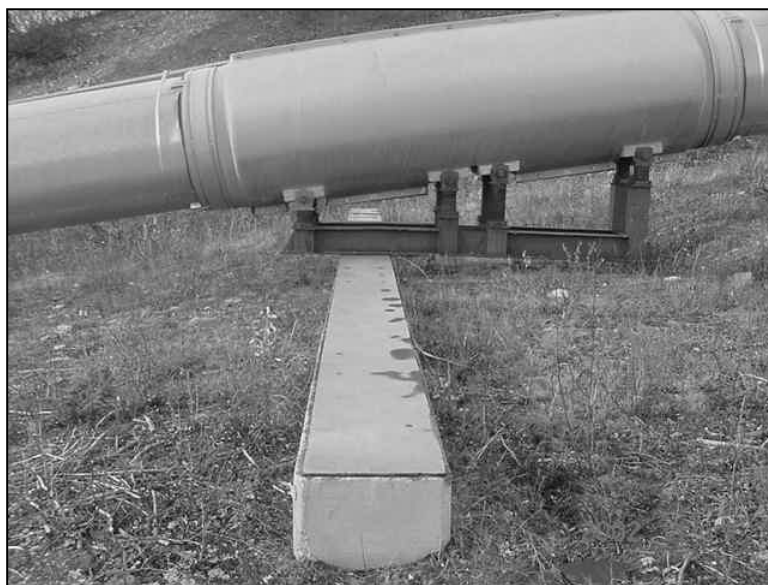
The pipeline shoes were lengthened in the fault zone to accommodate the large longitudinal and lateral pipeline movements anticipated by the largest projected fault displacement and magnitude as shown in Figure 3. Close attention was paid to the sliding surface of the crossbeam and the material lining the bottom of the pipe shoe. The pipe shoe base consisted of a 0.63-cm thick steel plate to which was bonded a

Figure 3. Typical special configuration bent on a concrete grade beam: Note offset shoe position by design to accommodate pipe movement in this case to the left.
