NATIONAL TRANSPORTATION SAFETY BOARD

AIRCRAFT ACCIDENT REPORT

In-flight Breakup Over the Atlantic Ocean
Trans World Airlines Flight 800
Boeing 747-131, N93119
Near East Moriches, New York
July 17, 1996

**NTSB/AAR-00/03
DCA96MA070
PB2000-910403
Notation 6788G
Adopted August 23, 2000**

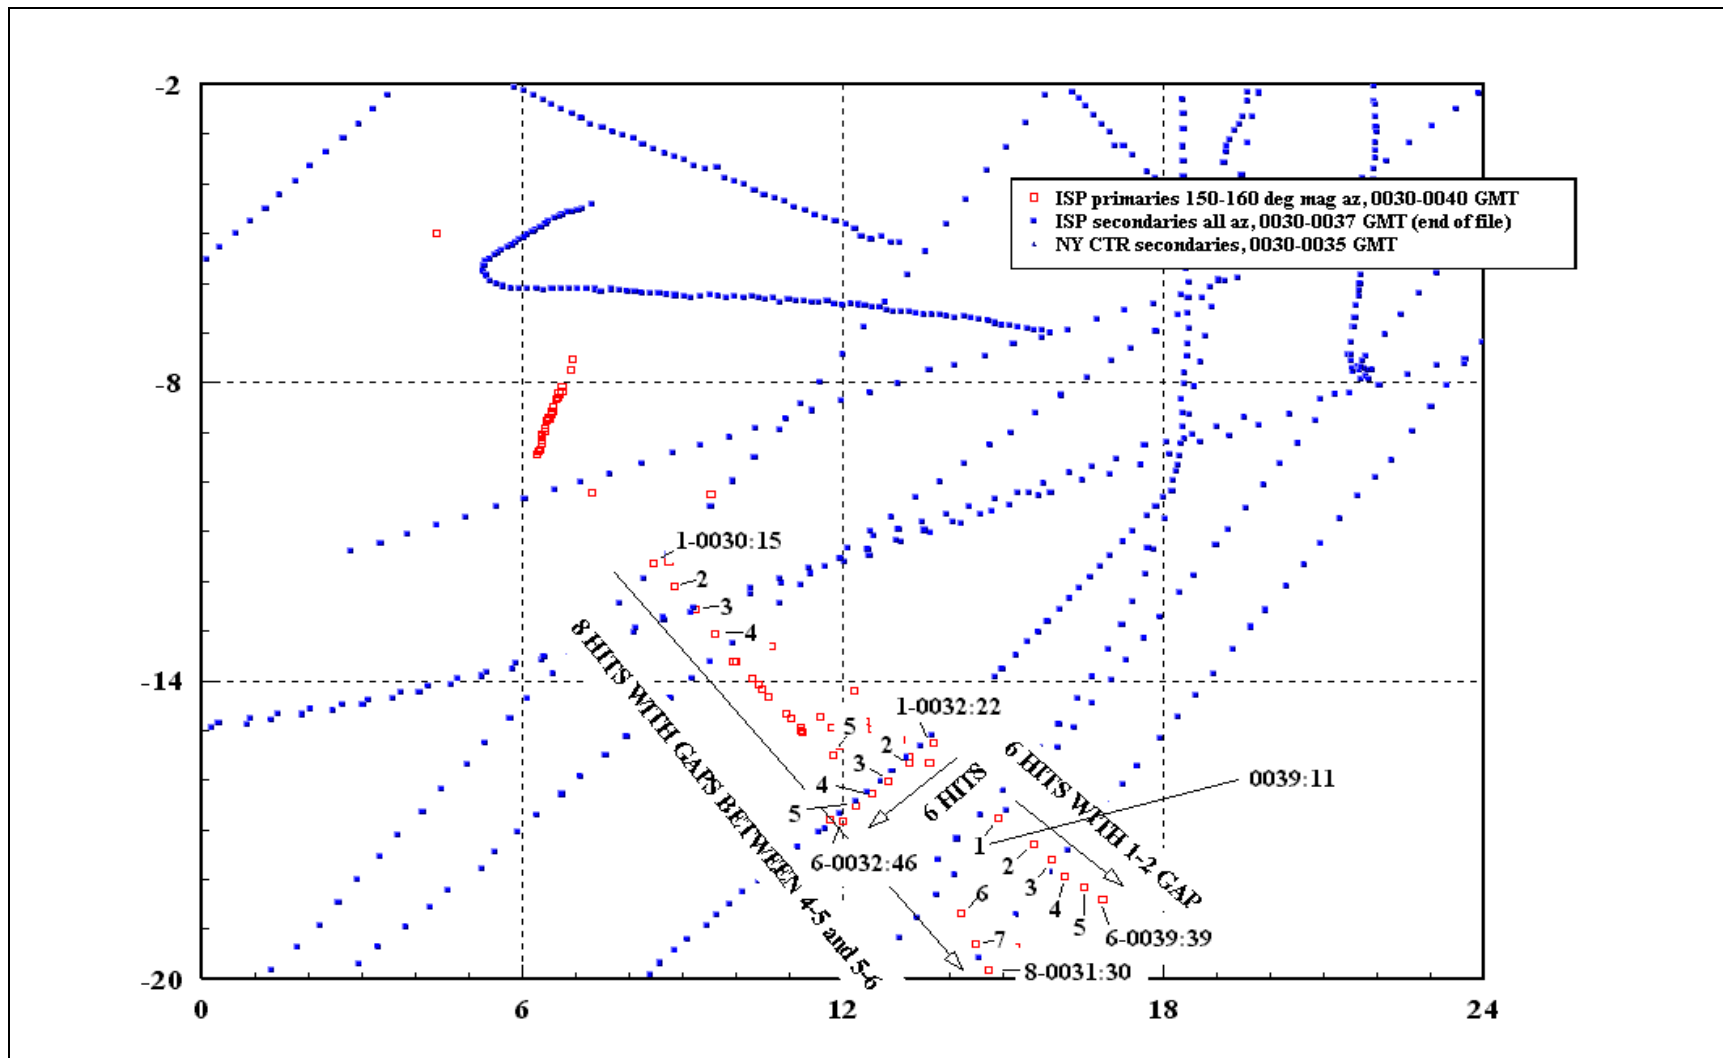
The Islip, New York, radar data showed one particular sequence of eight primary radar returns about the time of the accident (see figure 27) that warranted further review. On the basis of the times of and distances between these primary radar returns, the target appeared to be moving away from TWA flight 800's position at a ground speed of more than 400 knots. The first of the eight radar returns was recorded at 2030:15, more than 6 nm southeast of the accident airplane. The last of these returns was recorded at 2031:30 (18 seconds after TWA flight 800's last secondary return), about 15 miles southeast of TWA flight 800.

Figure 27. Sequence of eight primary radar returns recorded by the Islip, New York, radar site about the time of the accident.

Although most of the radar systems from which the Safety Board obtained data were capable of recording radar targets in the geographic area in which these primary radar returns were recorded, this sequence of eight primary radar returns was only observed in the data from the Islip radar site. Further examination of the returns recorded in that geographic area by the Islip site between about 2030 and 2040 revealed two additional sequences of primary radar tracks with apparent ground speeds greater than 300 knots. One of these sequences indicated a radar target movement away from TWA flight 800 to the southeast, whereas the other sequence indicated a target movement away from TWA flight 800 to the southwest.

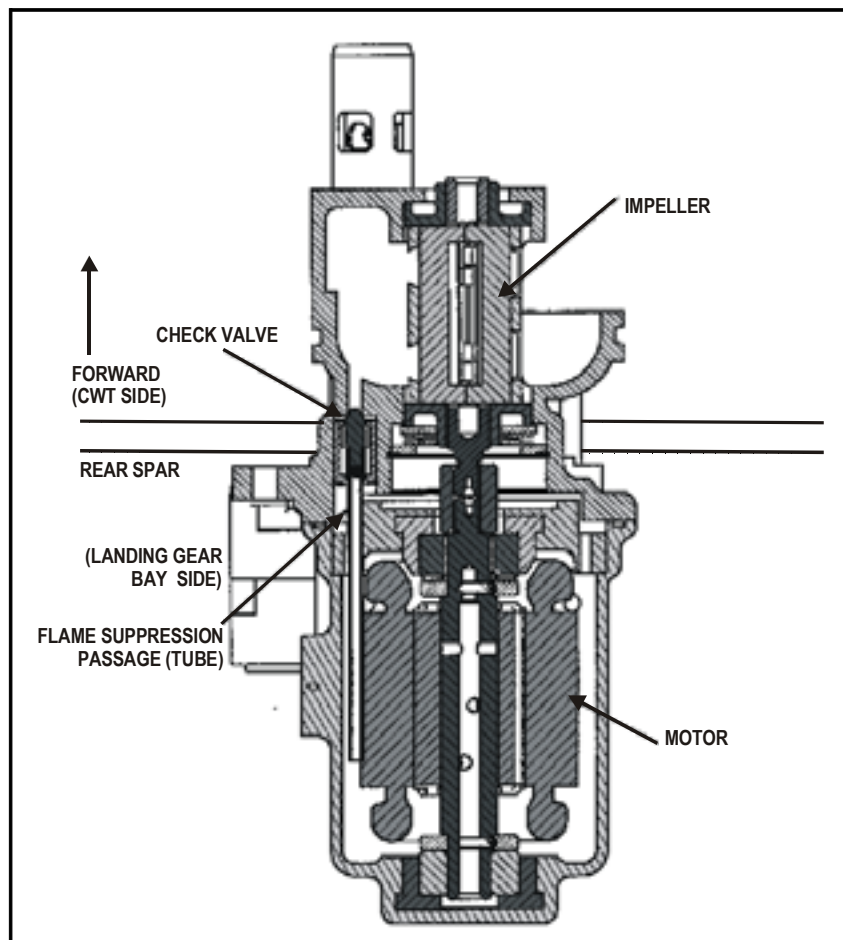
contained multiple explosions that were intentionally ignited within the pump motor cavity, preventing the ignition from transferring to the fuel tank. (Figure 37 is a diagram of a scavenge pump.) Because the Board became aware of instances in which the flame arrestor tube was broken or missing, investigators also conducted a series of tests to determine whether the scavenge pump motor housing would contain explosions with only one of the flame suppression system components (either the flame arrestor tube or the check valve) functioning. In all tests, the scavenge pump housing contained the explosions, and the explosive atmosphere surrounding the test pump did not ignite.

During its postaccident examination of other transport-category airplanes, the Safety Board observed that components in the electrical connector on a scavenge pump in a retired 747 were deteriorated. (Boeing ASBs 747-28A2194 and 747-28A0043, both dated January 18, 1996, “encouraged” operators to inspect for degradation in connectors.) Investigators observed that several scavenge pump electrical connectors had been manufactured of a material that degraded with long-term exposure to fuel. Boeing provided the Board with a service history for the 747 scavenge pump for the 10 years preceding the accident. When queried about the brevity of this history, Boeing indicated that most operators did not return the scavenge pumps to the manufacturer for overhaul.

Figure 37. A diagram of a scavenge pump.

As a result of these findings, Boeing issued ASB 747-28A2206, dated September 25, 1997, and AD 97-25-06, effective December 16, 1997. AD 97-25-06 contained the following summary:

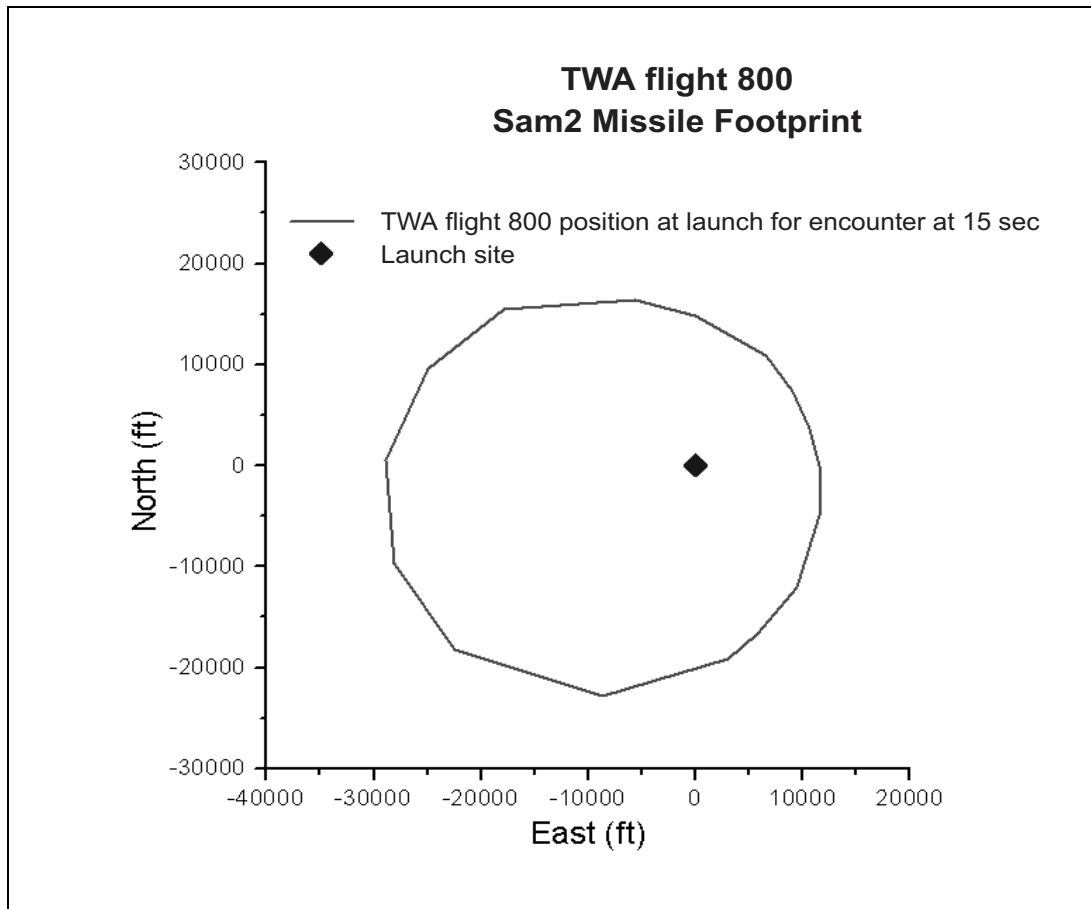
The Safety Board's computer simulations (using this missile performance data and taking into account the winds at the time of the accident) showed that the locations on the surface from which a missile launched at TWA flight 800 would result in selfdestruction within 40 feet of the airplane were extremely limited. Figure 44 shows airplane locations at which, if a high-performance missile were launched at the airplane, the missile would selfdestruct within 40 feet of the airplane. Note that, at the scale shown, the launch area that would result in a selfdestruction within 40 feet of the airplane is not as wide as the line showing the 15-second perimeter in this figure.

Simulations further showed that, because of the pattern in which missile fragments are dispersed after selfdestruction (see figure 43), launches from many of these positions would result in no fragments having a trajectory that would result in penetration of the CWT. For example, because of the nature of missile guidance, a launch from most positions on the perimeter shown in figure 44 would result in the missile catching the aircraft from behind. The area in front of the missile is not in the fragment dispersal area.

Figure 44. Diagram showing airplane and missile launch site locations that could result in missile selfdestruct within 40 feet of the plane.
