OTC 14193

## Failure Analysis of Texas Tower No. 4

Z. Jin, Global Maritime, R. Bea, University of California Berkeley, B.P.M. Sharples, (Formerly with American Bureau of Shipping)

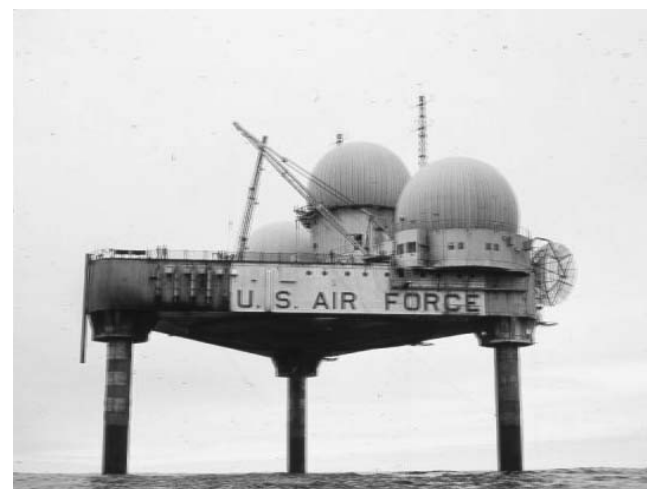
**Fig. 1 – Texas Tower 4 (courtesy TTA)**

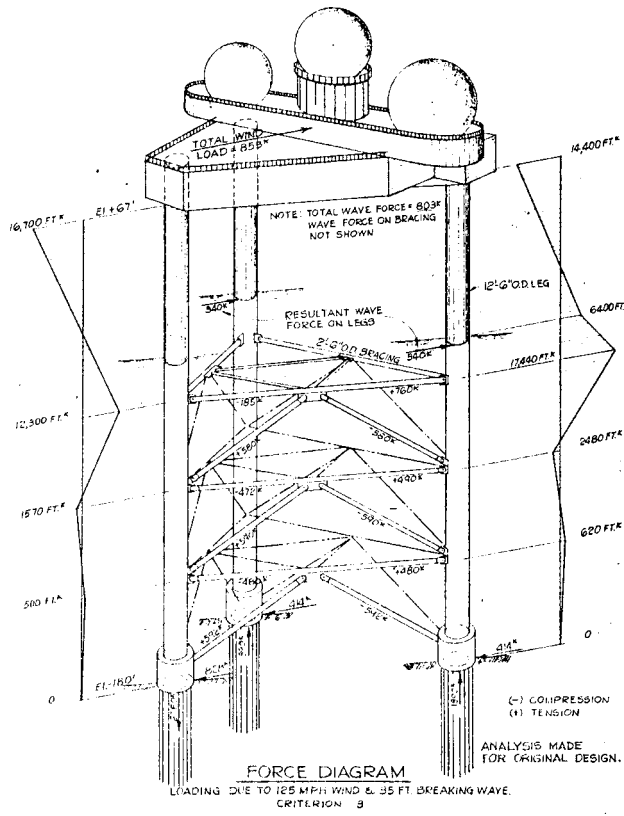
Located in a site where the water depth was about three times that at the sites of TT2 and TT3, TT4 had a completely different 'innovative' design and construction procedure. TT4 had three large diameter (12.5 ft) vertical steel legs interconnected with three tiers of horizontal K-bracing underwater (Fig. 2). Installation of TT4 was based on a self-floating tripod substructure that would be towed to location, upended and attached to the seafloor with large caisson footings, which would provide significant foundation fixity given the site's soil profile. A self-floating deck would be towed to location, maneuvered into the legs, attached to them and then the deck would be raised to the top of the legs where it would be permanently attached to the legs. Another thing unusual about TT4 was the use of pin connections in the underwater bracing system. This decision, made by the design engineers, was based on the grounds that the pin connection would eliminate secondary bending stresses because of its lesser rigidity.

TT4's original configuration is shown in Fig. 2<sup>[5]</sup>. The substructure is an equilateral triangular platform (distance between each leg center is 155 ft, the length of each side of the triangle deck is about 187 ft). The platform topside weighed between 5500 and 6000 tons with all equipment onboard<sup>[5]</sup>. The jacket and footings, comprised of legs, K-bracing and footing caissons, add an additional 1800 tons to the total weight. As installed, the A-B side of the tower was on a bearing of N. 26 degrees E.

Fig. 2 – Configuration of TT4
