**SECOND ADDENDUM TO**  
**UNITED STATES AIR FORCE**  
**AIRCRAFT ACCIDENT INVESTIGATION**  
**BOARD REPORT**

**F-22A, T/N 06-4125**

**525TH FIGHTER SQUADRON**  
**3RD WING**  
**JOINT BASE ELMENDORF-RICHARDSON, ALASKA**

**LOCATION: JOINT BASE ELMENDORF-RICHARDSON, ALASKA**  
**DATE OF ACCIDENT: 16 NOVEMBER 2010**  
**BOARD PRESIDENT: BRIG GEN JAMES S. BROWNE**  
**CONDUCTED IAW AIR FORCE INSTRUCTION 51-503**

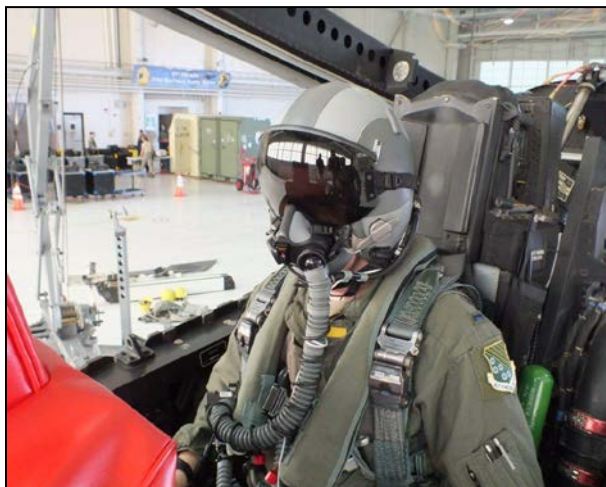
(1) The MP was at high altitude requiring supplemental oxygen when the MA bleed air malfunction occurred. As such, the MP would have had the mask secured to ensure proper oxygen concentration flow. (Tabs J-12, EE-3; Second Addendum Tab B-4, and Figure 12; see also AFI 11-202, Volume 3, *General Flight Rules, Flying Operations*, 5 April 2006, Paragraph 6.4 and Table 6.2);

**Figure 12 -- F-22A Pilot wearing helmet with mask up and secured. (Second Addendum Tab C-4)**

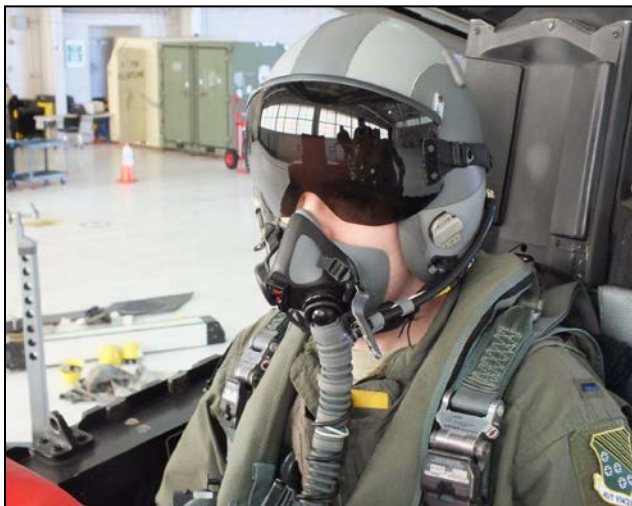
(3) The MP could have lowered the left side of the mask, however, it is not common to do so. (Second Addendum Tab B-4) There are communication and helmet air bladder connections on the left side of the helmet, which would allow for only partial lowering of the oxygen mask. (Second Addendum Tab B-4 and Figures 13 and 14) In addition, if the MP disconnected the left bayonet, EOS oxygen would leak excessively out of the MP's mask once activated. (Second Addendum Tab B-4)

**Figure 13 -- F-22A Pilot wearing helmet with left mask bayonet disconnected. (Second Addendum Tab C-4)**

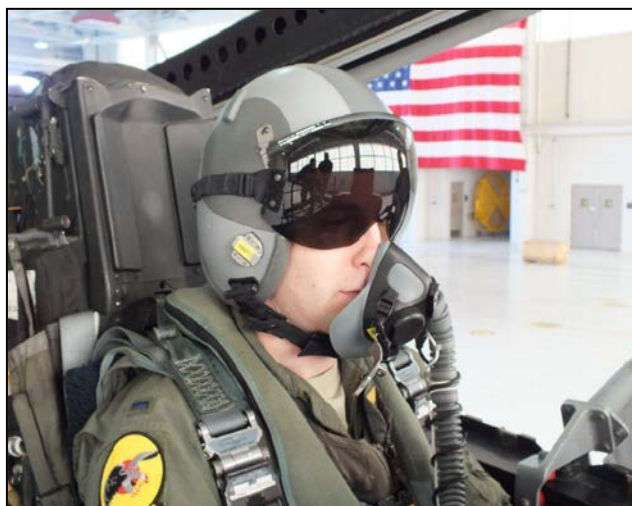
**Figure 14 -- F-22A Pilot wearing helmet with right mask bayonet disconnected. (Second Addendum Tab C-6)**
