WER'WOLF MKII Mine Protected Vehicle

**India Trial Report
January – June 2000**

Deployment in the Jammu Region

Report compiled by: Johan Dippenaar
With assistance from: Hannes Kögl
Amos van Jaarsveld
Marico Wessels
Report published in: October 2000

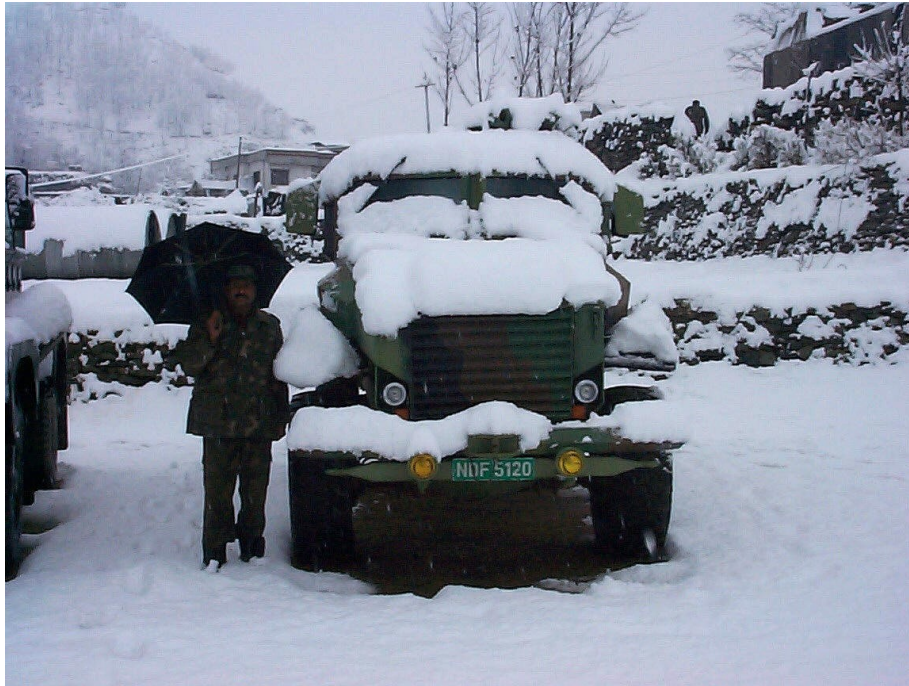
15. **10th February – 07h00**: a heavy snowfall starts at around 04h30 during the night, which by now leaves 8 inches of snow on the ground in the camp. The ambient temperature is 1,1 degrees centigrade and we do a cold starting test. The MKII starts first crank without the use of any cold starting aids.

Cold starting test successfully completed.

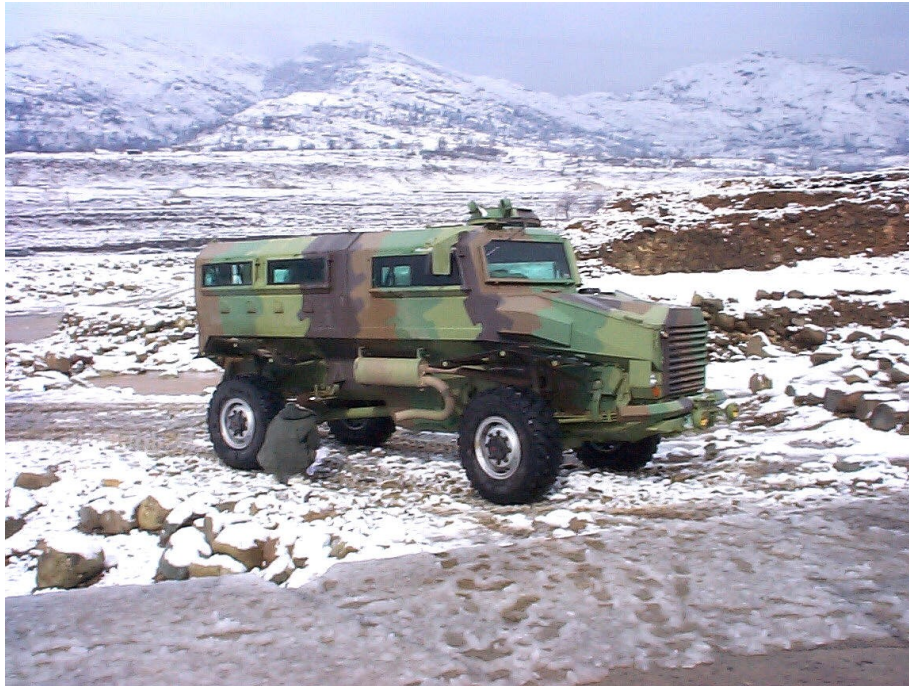
The river crossing is successfully completed.

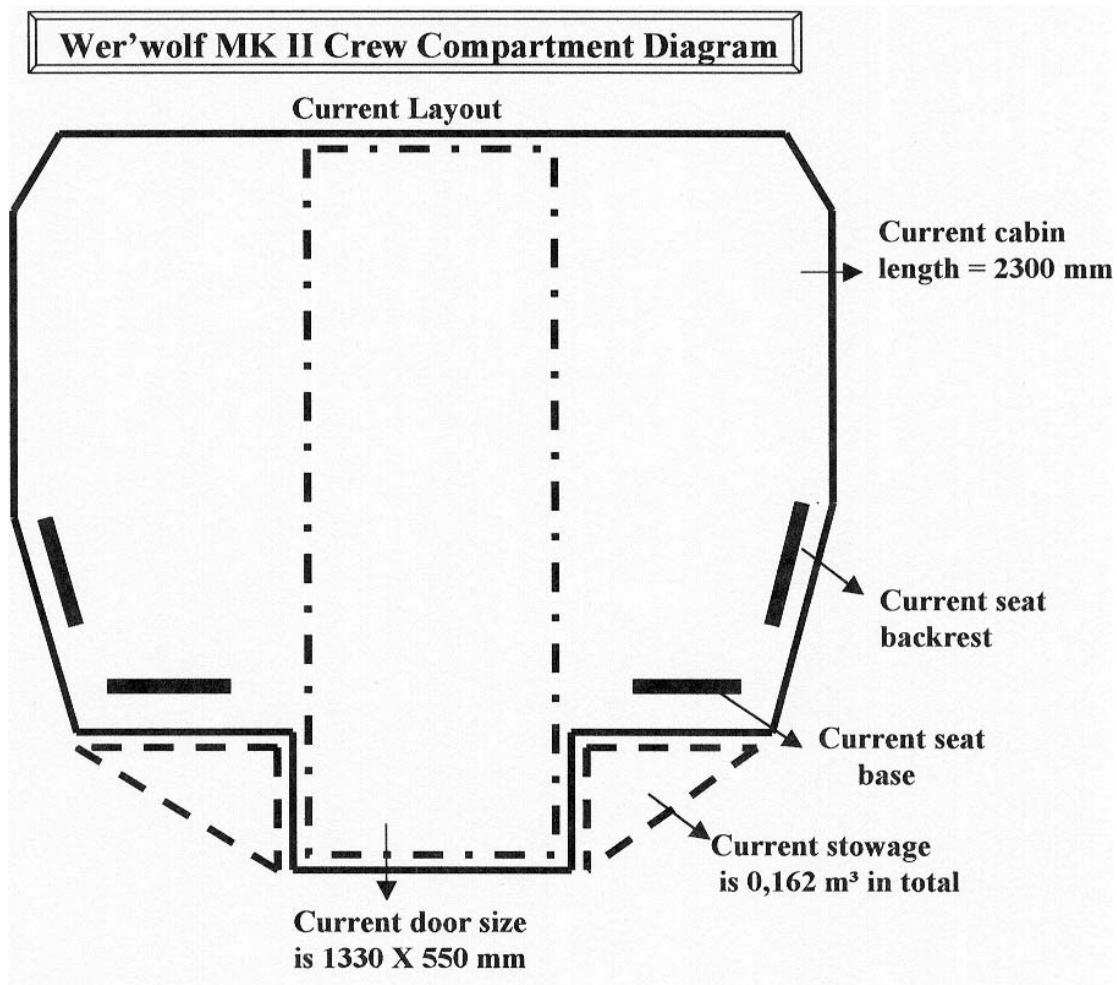
Current crew compartment layout.

23. The following points are noted in terms of Wer'wolf:
 - a. They don't want a modular vehicle with a removable crew compartment. The configuration must be fixed APC with the bulkhead between the compartments removed. They want a back-to-back seat layout for a section size of 2+10 soldiers. The gap between the seats must be stretched for better ease of firing personal weapons.

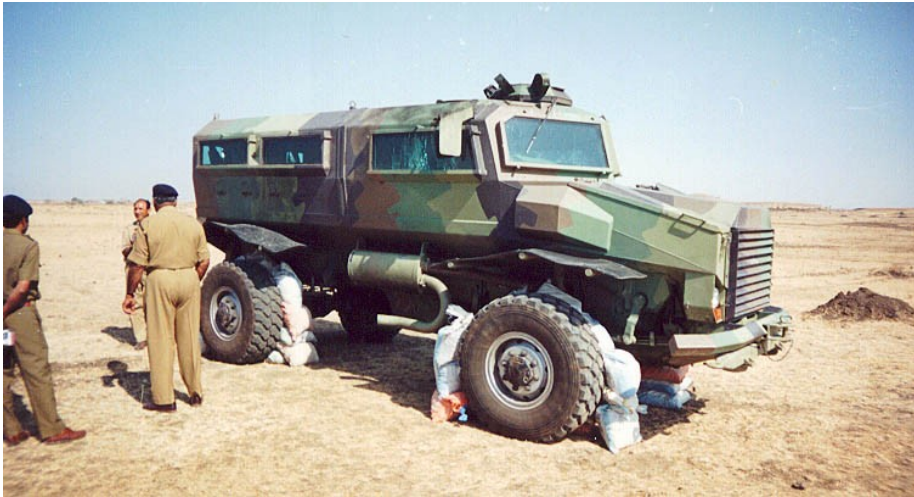
1. Left rear wheel hub and stub axle assembly blows off. The side shaft is intact. The rim and tyre is destroyed. The LH axle tube assembly is severely damaged.
2. All the spring pack hanger mountings on both rear sides shear off, as designed.
3. RH rear shock absorber is destroyed and is replaced.
4. RH rear light bracket bends, but is repairable.
5. LH spring main blade mounting eye is mildly damaged and is repaired by a roadside blacksmith.
6. RH mudguard bottom mounting caps slide to the outside.
7. LH lower shock absorber mounting bracket is damaged, but repairable.
8. U-bolts that fasten the axle bend, but are fully repairable.
9. LH rear swivel hanger plates bends.
10. 4 – way protection valve housing is damaged and is replaced.

The vehicle is set up and ready for the rear wheel blast test.
