EMBRAER E190-100LR

AIR ASTANA / P4-KCJ

ACCIDENT
SAFETY INVESTIGATION
FINAL REPORT

[08/ACCID/2018]

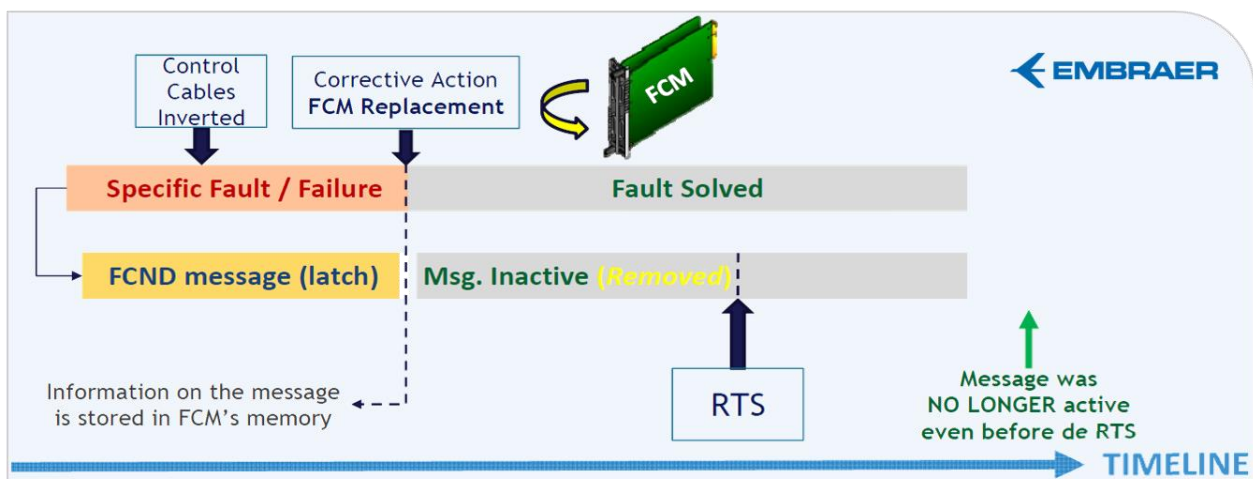
Figura 15 || Figure 15

Having the same pre-conditions of test #3 with the inverted aileron control cables and after performing the corrective actions that latched the FCND message, the related FCM was replaced by an FCM with a cleared NVM and the RTS performed. The FCND was no longer active, even before performing the RTS.

Sequência de ações e resultados do teste #4 || Test #4 event sequence and findings

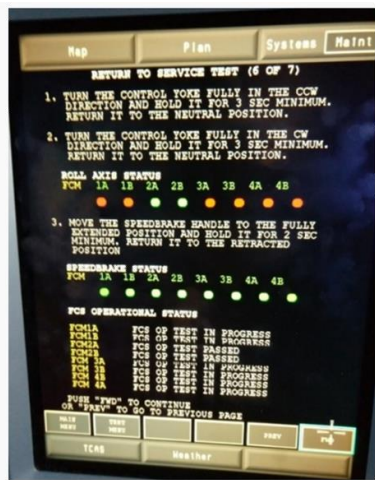
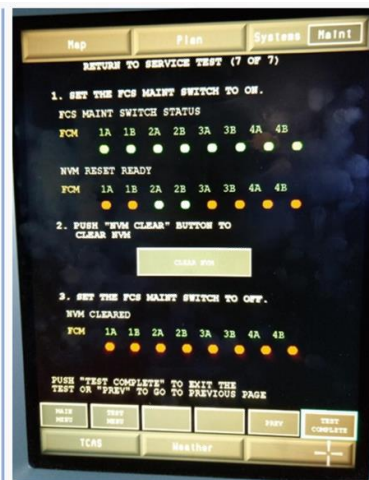
Figura 17

Additionally, it was confirmed that with the FCS (NVM of the FCM) cleared of faults prior to the ailerons control cables inversion, i.e. without conditions to trigger the FLT CTR NO DISPATCH (FCND) message, the cable inversion only will not trigger the message, even following the RTS procedure. In this same RTS procedure after cable inversion, the FCM 1, 3 and 4 status, was shown in red, and it was not possible to clear the NVMs, as shown on the two pages of the test illustrated in figure 17 regarding the accident flight.

- NOV 11th, in the morning of accident day, FCM2 was installed, the last component to be replaced and software loaded.

After six power-down/power-up sequences, the FLT CTR NO DISPATCH message did not reappear following the flight controls system return to service (RTS) procedure.

Ilustração do teste dos FCM e condição das respetivas NVMs antes do voo do acidente

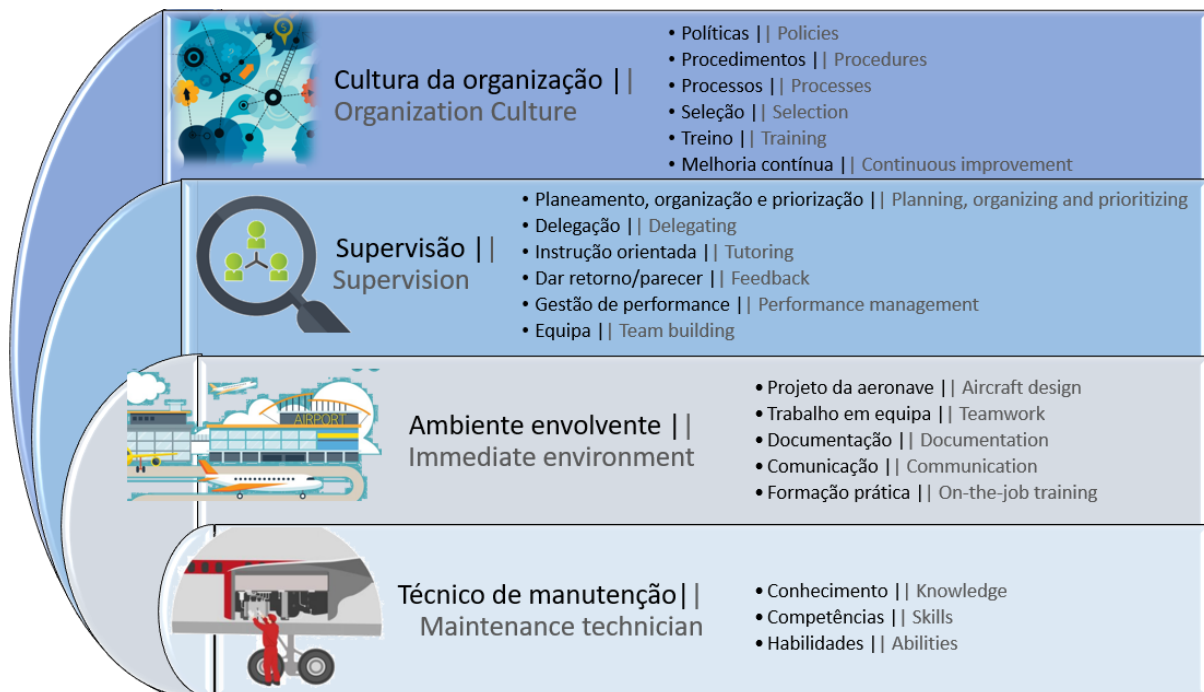
Figura 21 || Figure 21

In this way, the human error that occurred during the cable support replacement, led the investigation to explore the systemic aspects that underlie it.

Cadeia de fatores identificados || Identified involved factors

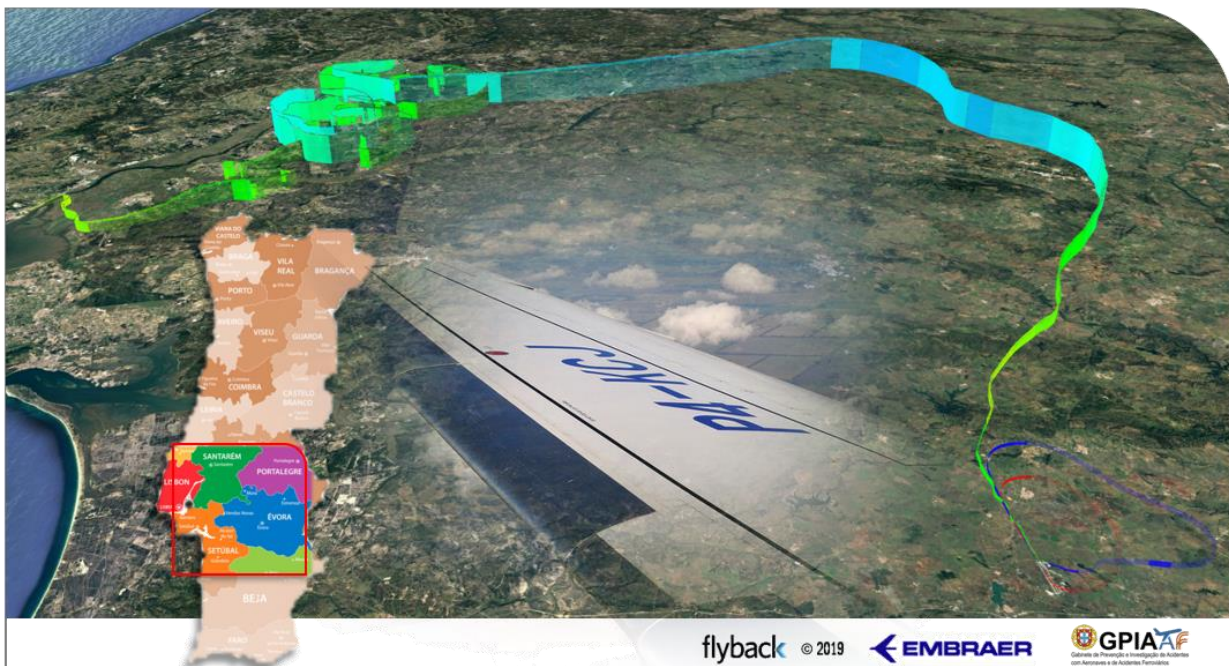
Figura 29 || Figure 29

The use of flight controls in direct mode, as detailed in 1.6.5.1, facilitated the aircraft control mainly by limiting the deflection of the roll spoilers, which, although acting in the correct direction, acted in opposition to the ailerons.

The roll spoilers acting correctly, made it impossible for the crew to apply the reversed controls (yoke), after detecting the discrepancy on the aileron inversion.

Perspetiva geral do trajeto do voo do acidente

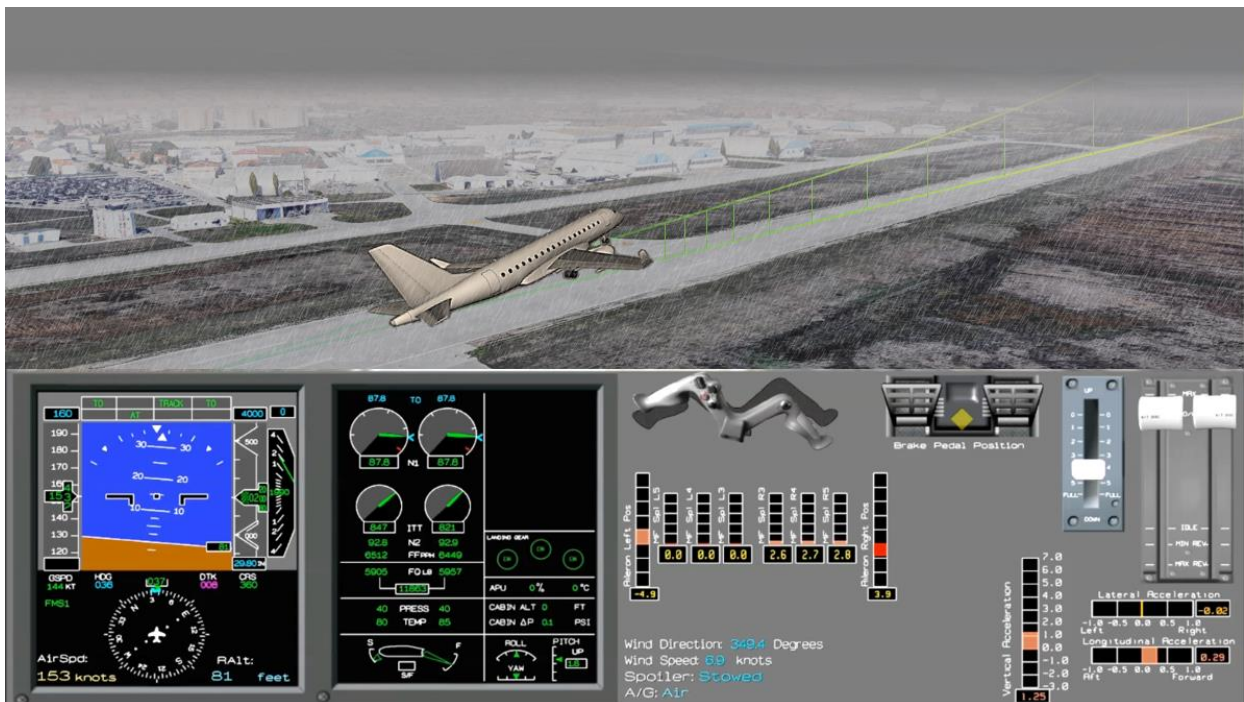
Figura 30 || Figure 30

As described in the meteorological factors, the aircraft took off with a low ceiling, forcing the crew to immediately change to instrument flight rules in IMC and the loss of visual references. Not being a mandatory requirement, carrying out this type of flight with minimum VFR conditions would be good practice.

Simulação das condições meteorológicas à decolagem para o primeiro voo após manutenção
