UNITED STATES COAST GUARD

REPORT OF INVESTIGATION INTO THE ALLISION OF THE COSCO BUSAN WITH THE DELTA TOWER OF THE SAN FRANCISCO-OAKLAND BAY BRIDGE IN SAN FRANCISCO BAY ON NOVEMBER 7, 2007

MISLE ACTIVITY NUMBER: 3095030

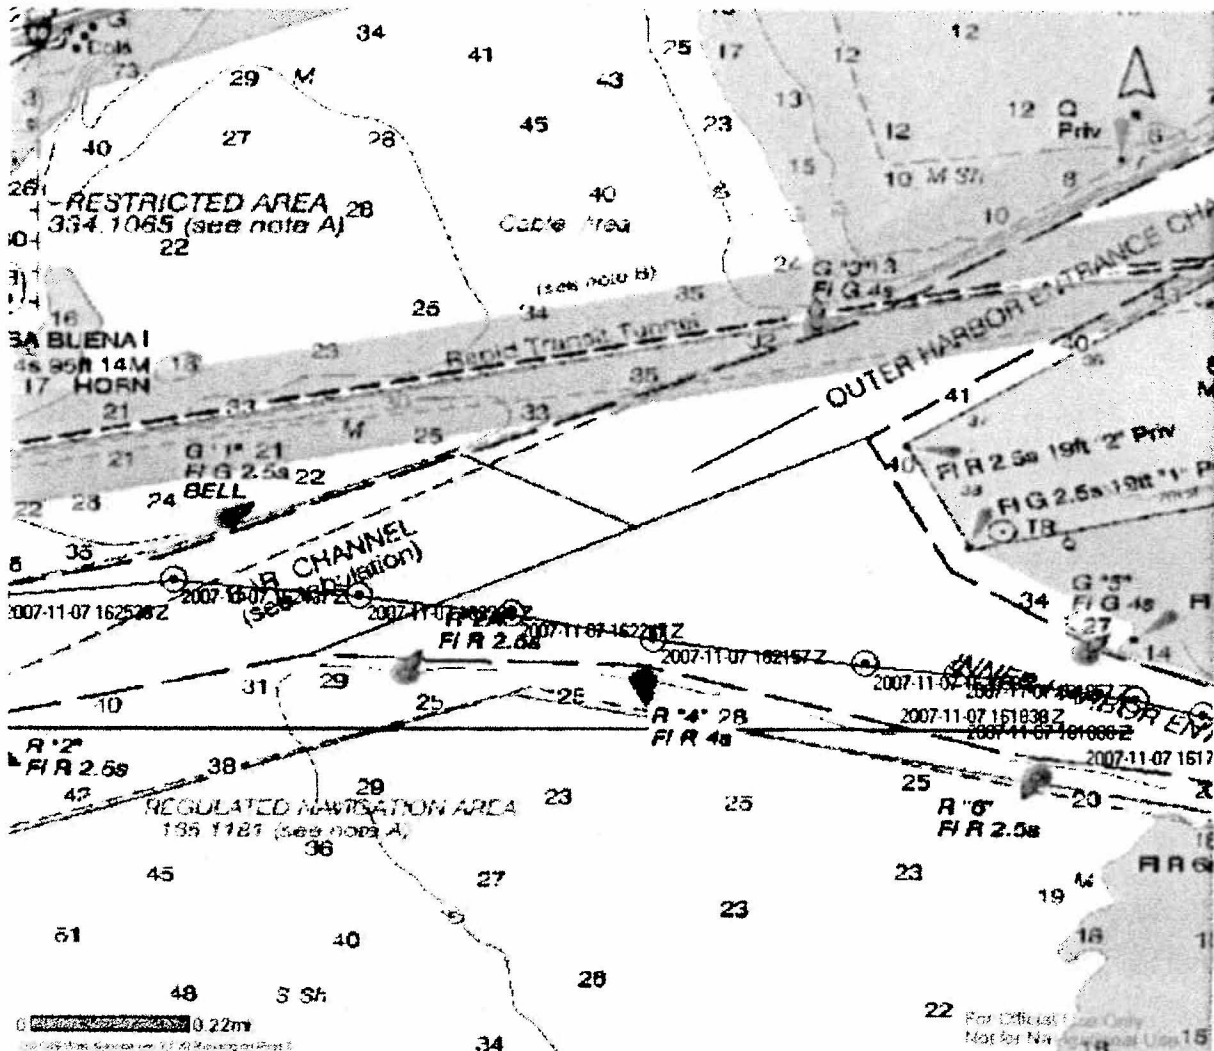
Figure 3. This image was prepared by the Coast Guard Office of Information Resources. Times shown are in Zulu (Greenwich Mean Time (GMT)), which can be converted to local time by deducting eight hours. This image shows the COSCO BUSAN's AIS trackline (indicated in blue) from Lighted Buoys "5" and "6" to Lighted Buoy "1."

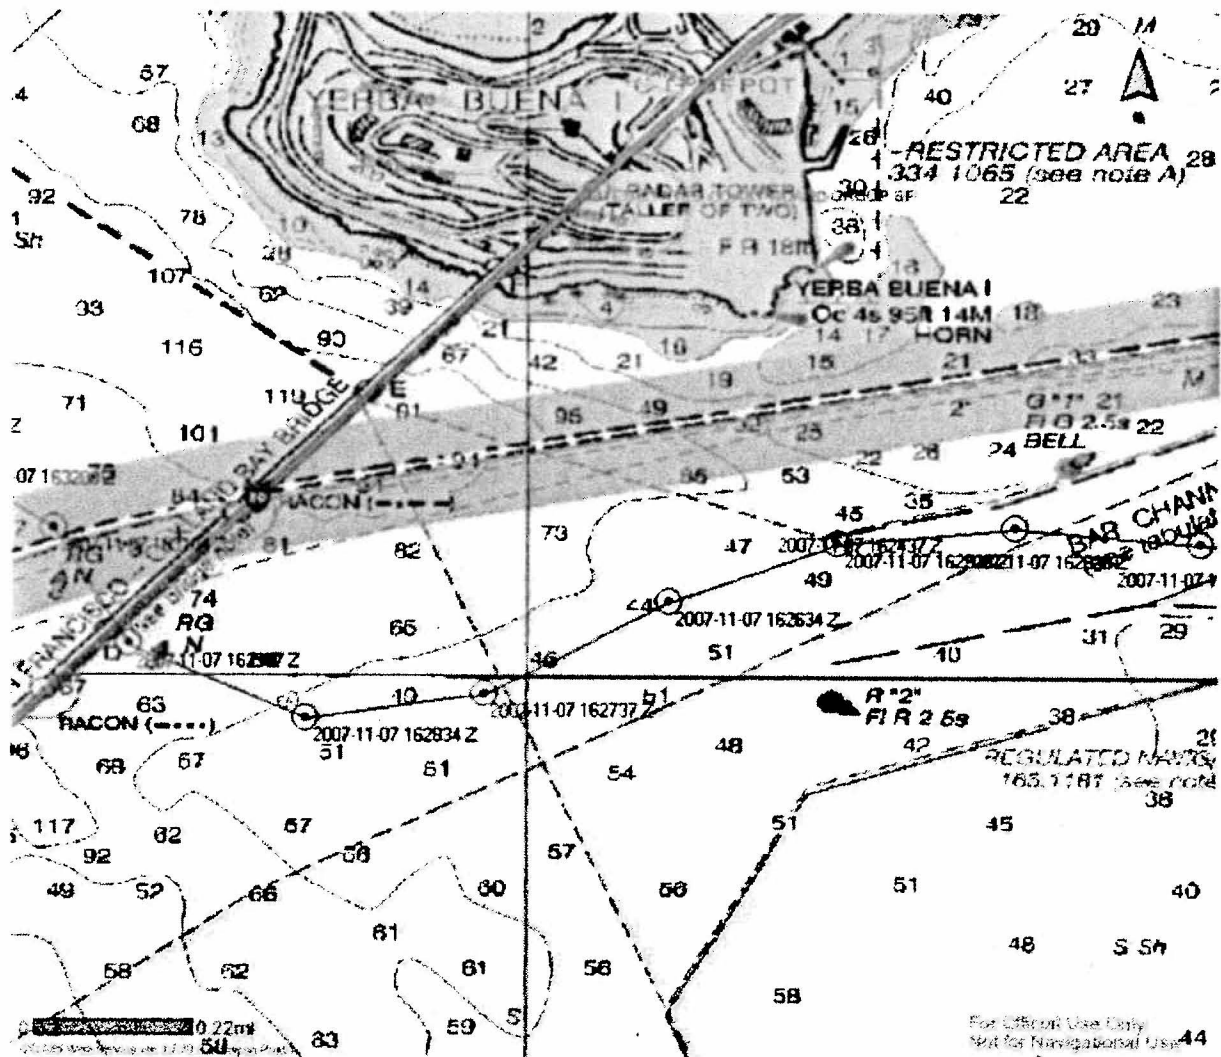
Figure 4. This image was prepared by the Coast Guard Office of Information Resources. Times shown are in Zulu (Greenwich Mean Time (GMT)), which can be converted to local time by deducting eight hours. This image shows the COSCO BUSAN's AIS trackline from Lighted Buoy "1" to a point northwest of the Delta Tower of the Bay Bridge, after the allision.

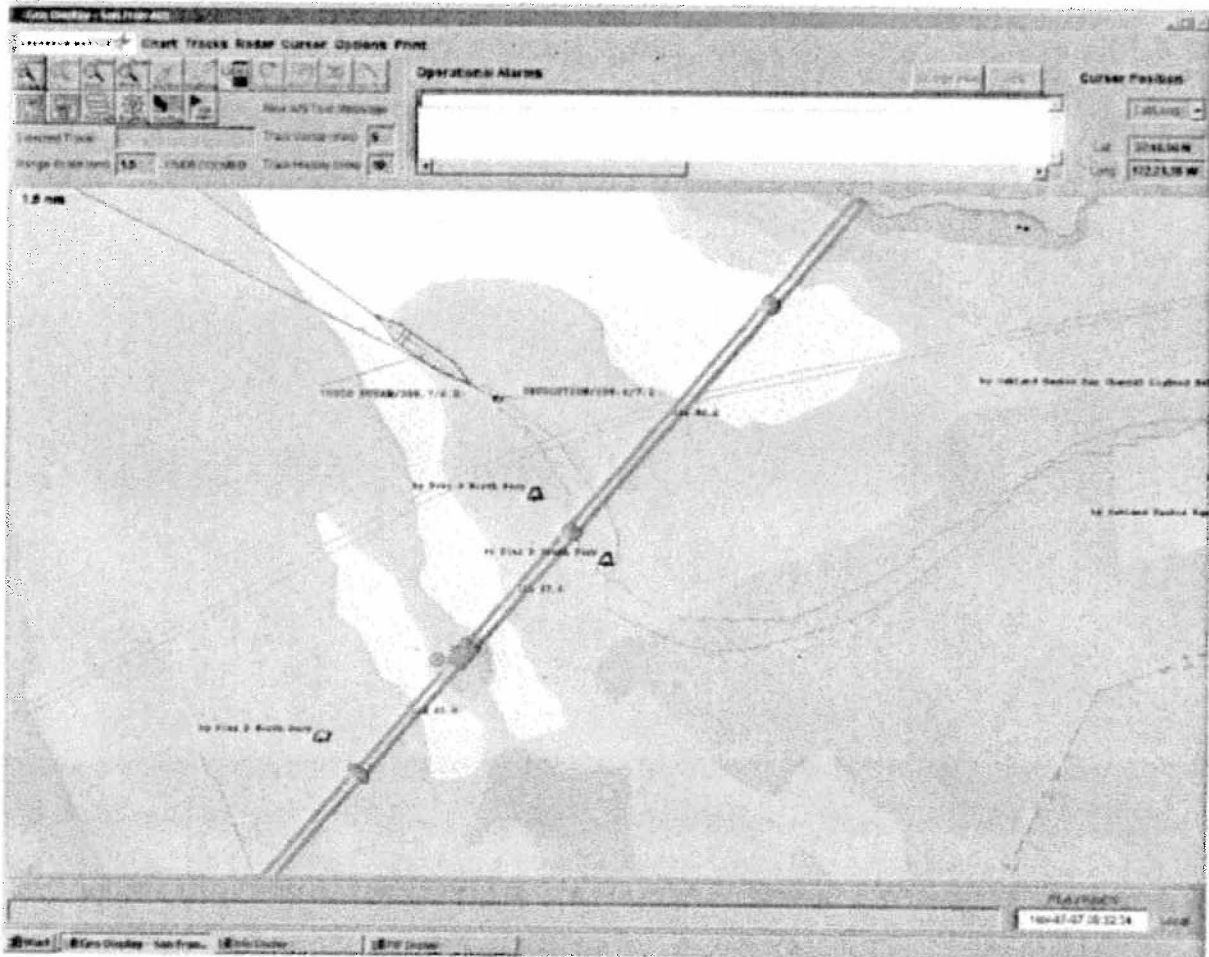
Figure 5. This image was recovered from the Coast Guard Vessel Traffic System (VTS) after the casualty. The green lines are the tracklines of the M/V COSCO BUSAN and the Tug REVOLUTION respectively. Note how the tug crossed the wake of the COSCO BUSAN as the ship maneuvered.

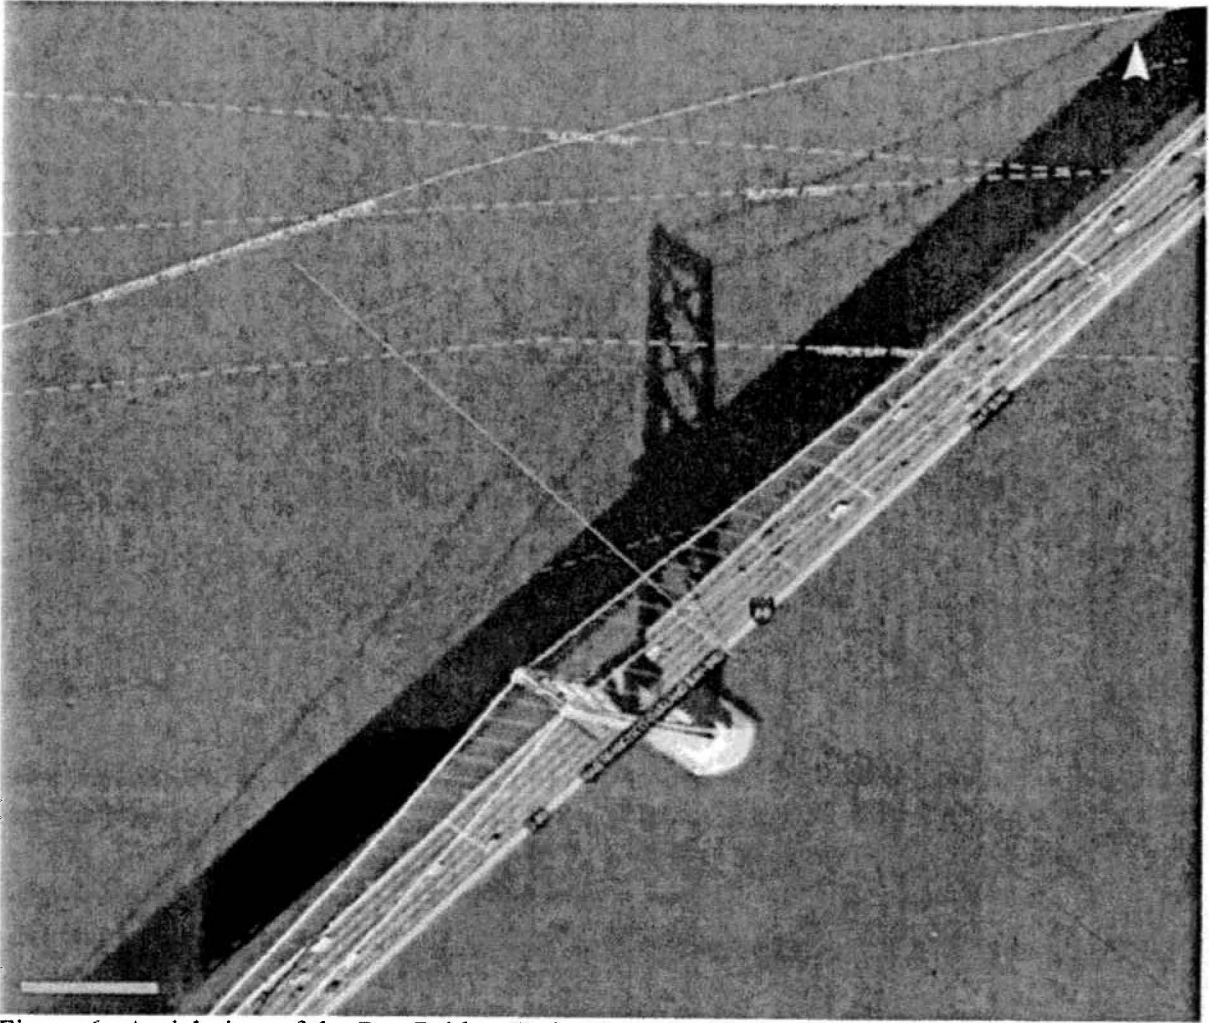
Figure 6. Aerial view of the Bay Bridge (Delta Tower) with the AIS trackline of the M/V COSCO BUSAN in blue.
