NATIONAL TRANSPORTATION SAFETY BOARD

AIRCRAFT ACCIDENT REPORT

EASTERN AIR LINES, INC.,
BOEING 727-225, N8838E
RALEIGH, NORTH CAROLINA
NOVEMBER 12, 1975

NTSB/AAR-83/06
(SUPERSEDES—NTSB-AAR-76-15)

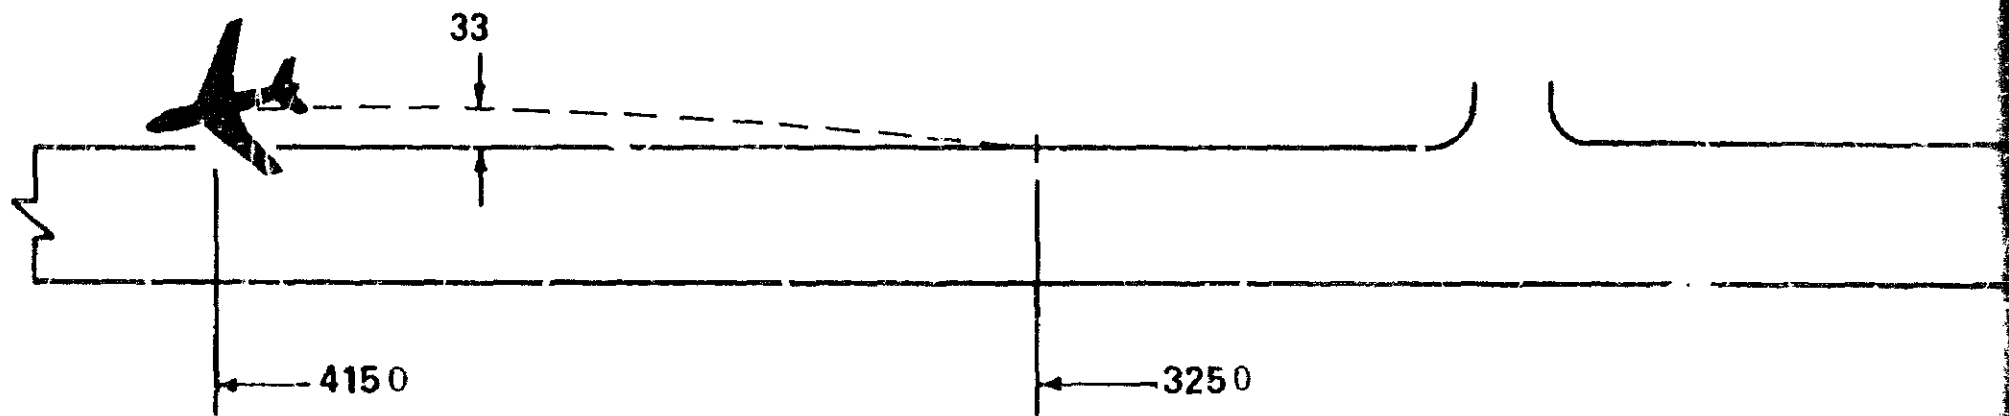
APPENDIX D

- a Support - Main Landing Gear Door to Strut Attach.
- b Left Inboard T.E. Aft Flap (9.5 Ft. Inbd.)
- c Mid Flap - Left T.E. Inbd.
- d Left T.E. Inbd Mid Flap, Outbd Half
- e Portion of Wing T.E. Structure Spoiler and Support Beam
- f Lower Right Wing Access Door Near Main Gear
- g Handrails (10 Ft. Apart) Airstairs
- h Airstair Control Access Panel
- i Right Main Landing Gear Extension Actuator

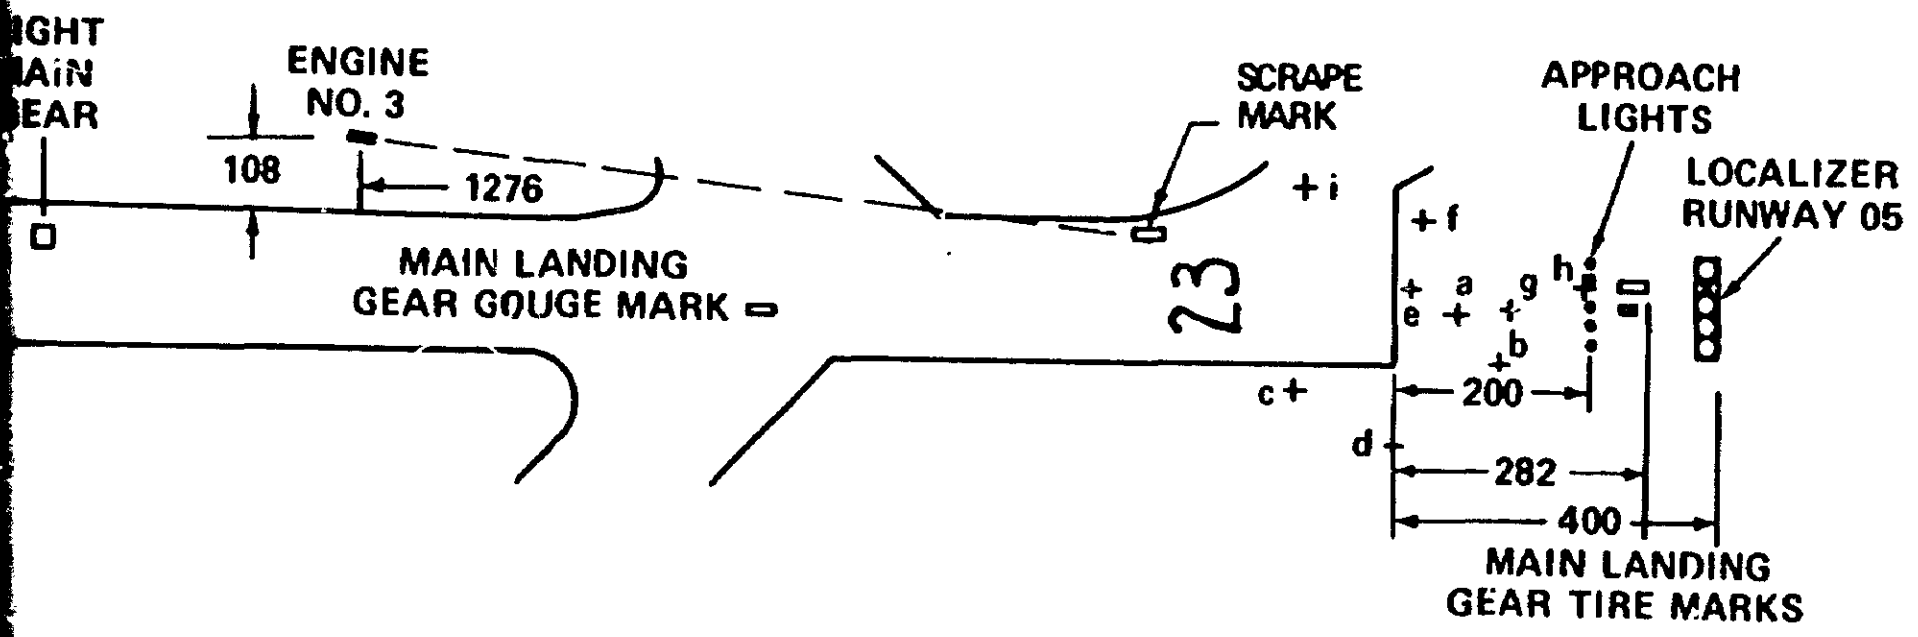
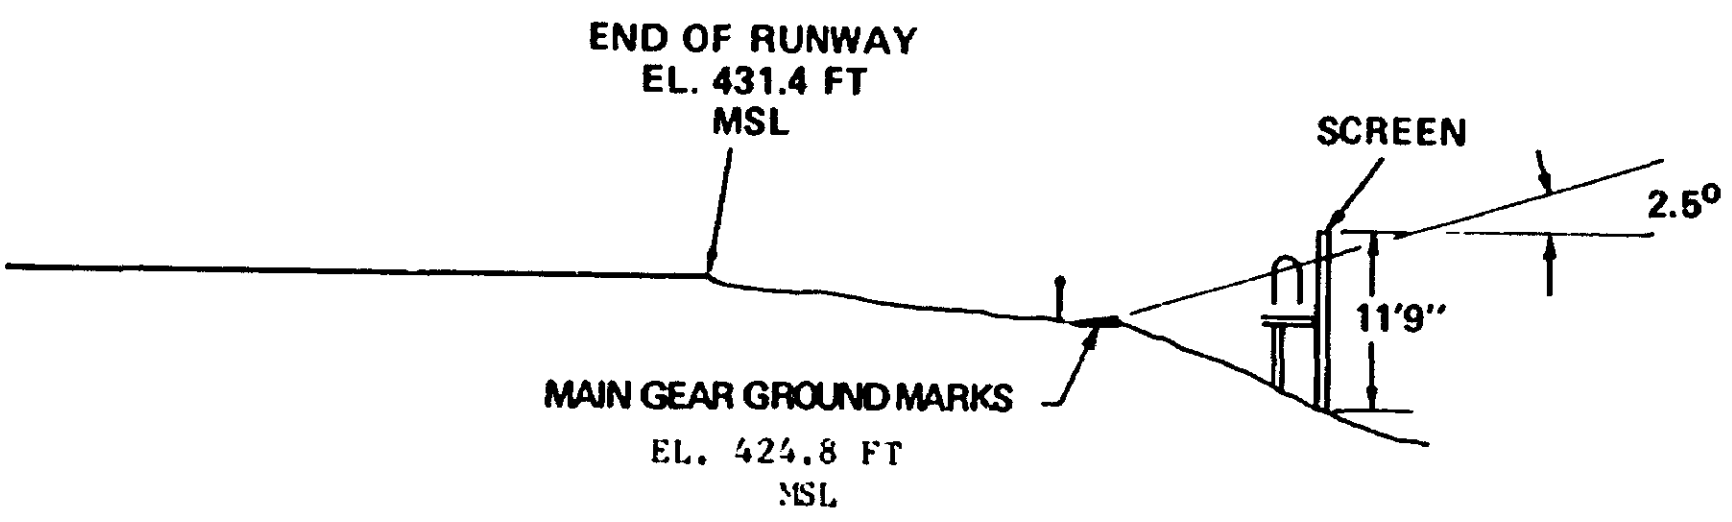
APPENDIX E

WRECKAGE DISTRIBUTION
 EASTERN AIRLINES FLIGHT 401
 Raleigh-Durham N.C.
 12 November 1975
