AIRCRAFT ACCIDENT REPORT

ALOHA AIRLINES, FLIGHT 243
BOEING 737-200, N73711;
NEAR MAUI, HAWAII
APRIL 28, 1988

NTSB/AAR-89/03

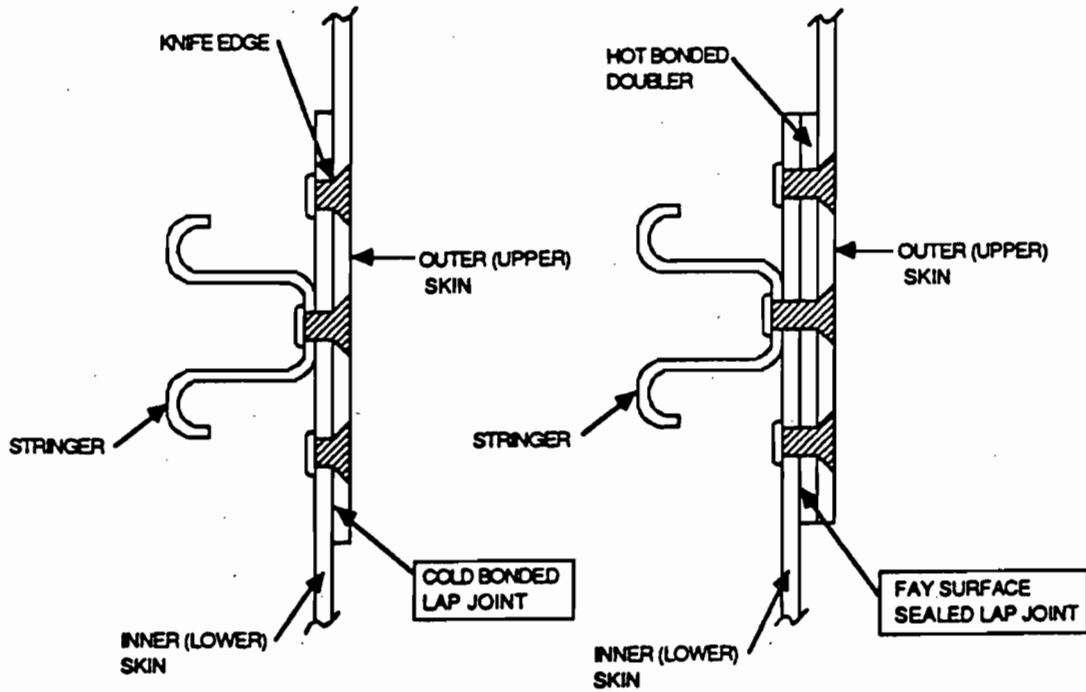
Figure 4a.--Lap joint section between tearstraps

NOTE: SKIN THICKNESS DIMENSION 0.036 in.

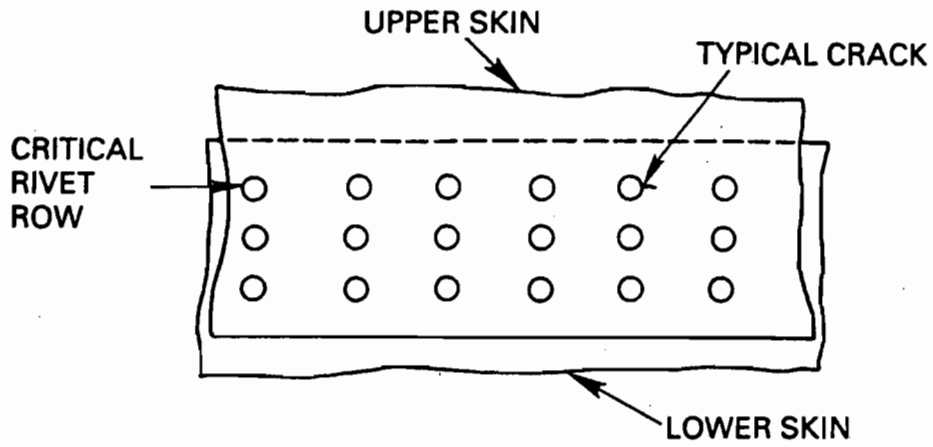
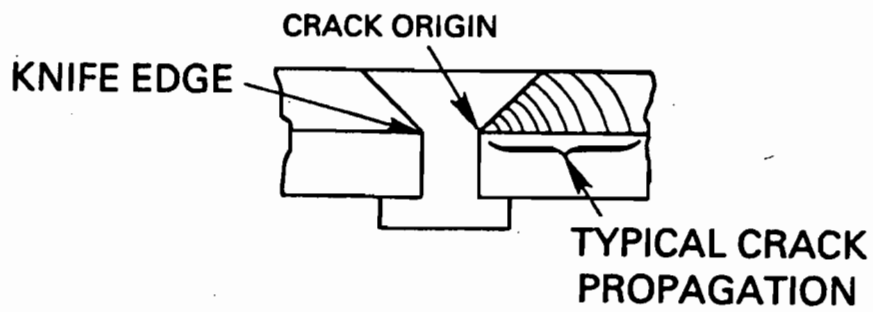
initially is expected to occur in the outer layer of skin along the lap joint because the outer layer contains a knife edge at each of the countersunk rivet holes. Furthermore, the fatigue cracking primarily is found in the upper row of the outer skin panel lap joint rivet holes because this area carries the greatest stress. For the underlying skin of the lap joint, the area of greatest stress is through the lower row of lap joint rivet holes. However, since the rivet holes in this skin panel are not countersunk, fatigue cracking is not as likely to initiate at this location.

The lap joint piece, S-4L, from BS 519 to BS 536, exhibited fatigue cracking from 16 consecutive rivet holes along the upper row of lap joint rivets. The largest single fatigue crack in one direction measured 0.18 inch from the knife edge of the countersink. (See figure 6.) The longest total combined crack length in both directions across a rivet hole (end to end of the crack including the hole) measured 0.53 inch. Both the cold-bonded lap joint and the hot-bonded tear straps in this area had disbonded. Light to moderate corrosion was present on the previously bonded surfaces.

Figure 6a.--Typical lap joint

Figure 6b.--Cross section of a rivet and skin

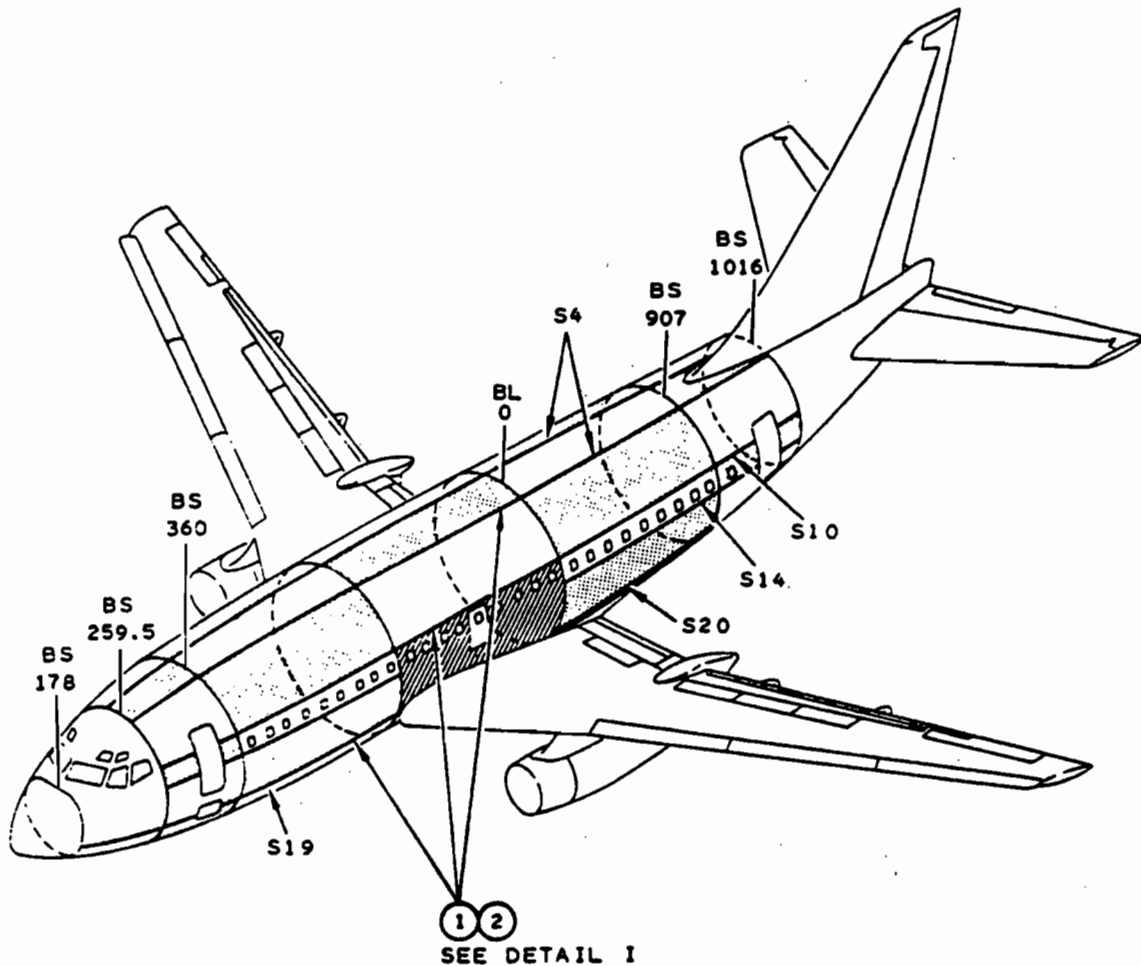
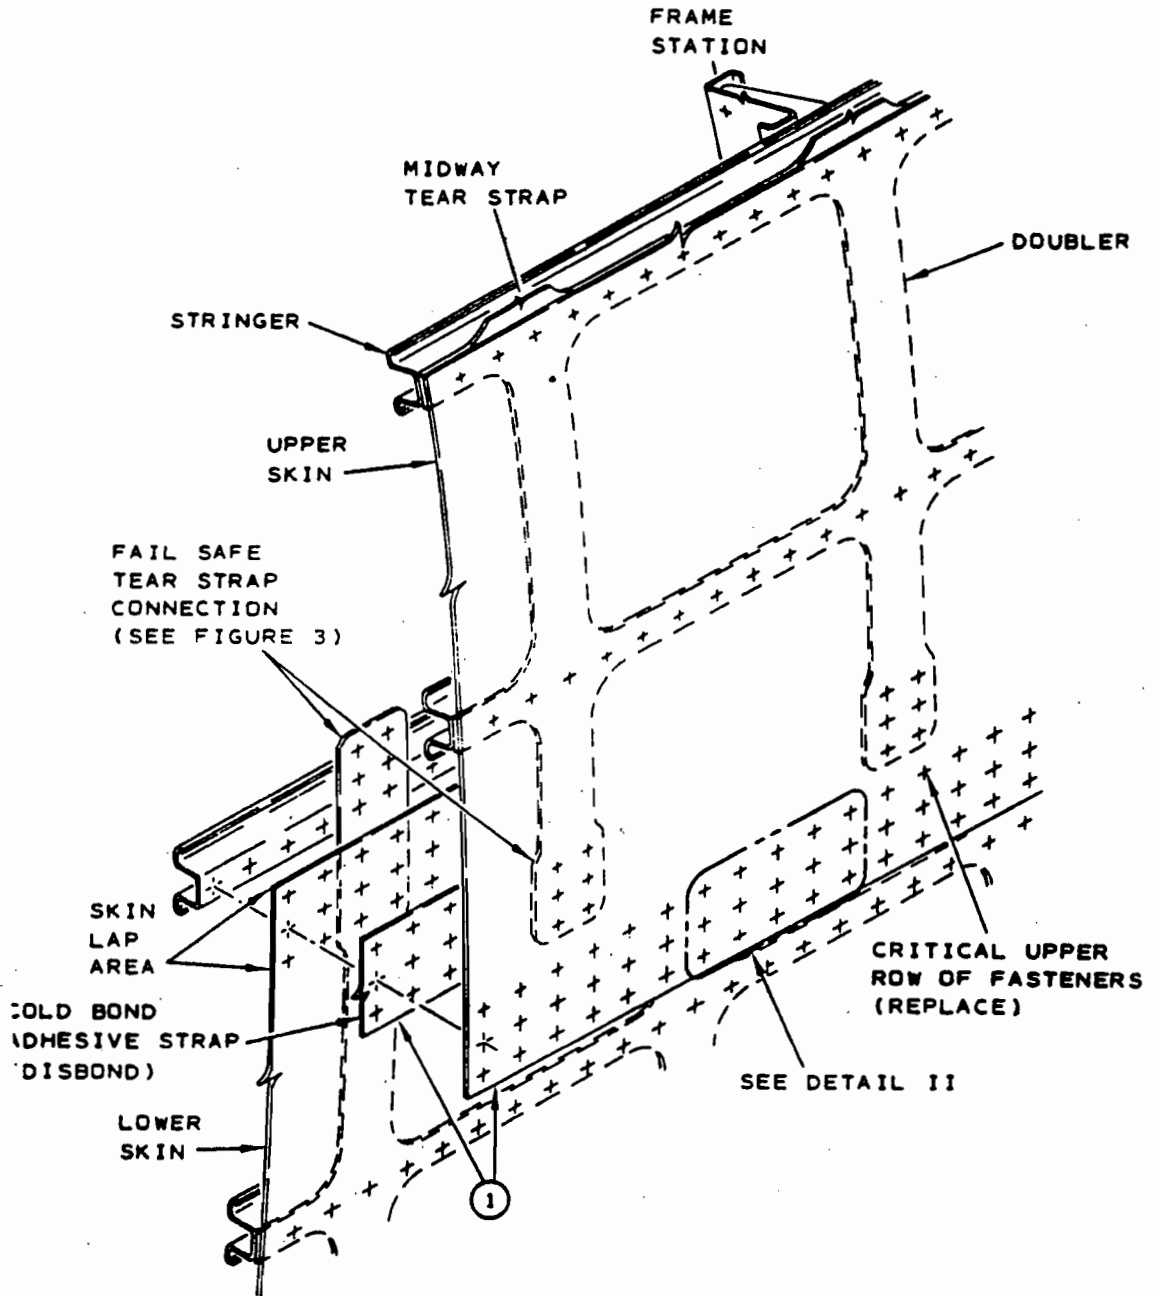
FIGURE 1. LAP JOINT INSPECTION

- A. To find cracks in the critical (upper) row of fasteners of longitudinal skin lap joints using high frequency eddy current, without removal of fasteners.
- B. The cracks usually start on the inner surface of the outer skin at the edge of the countersink. From there they propagate out along the faying surface. See Fig. 3 for an illustration of a typical crack. This inspection can find cracks 0.040 inch or longer beneath the countersunk fastener heads in skin of 0.036 inch and 0.040 inch thick.
