## **AIRCRAFT ACCIDENT REPORT**

**RUNWAY COLLISION INVOLVING  
TRANS WORLD AIRLINES FLIGHT 427  
AND SUPERIOR AVIATION CESSNA 441  
BRIDGETON, MISSOURI  
NOVEMBER 22, 1994**

**Adopted: August 30, 1995  
Notation 6519B**

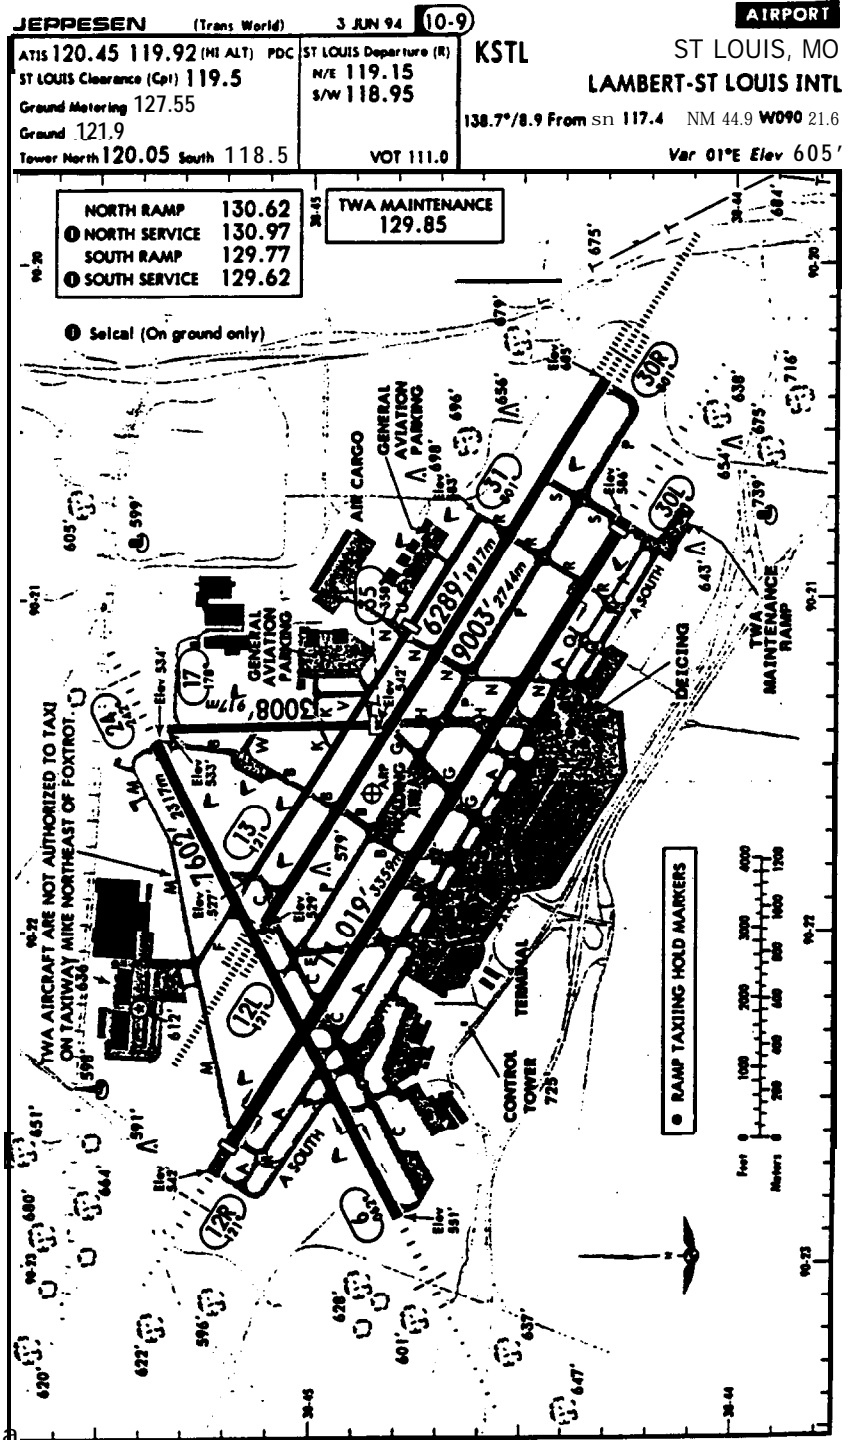
Figure 6-- Lambert-St.Louis International Airport Diagram (Copyright 1994 Jeppesen Sanderson, Inc.)

Components of two headsets were in and around the airplane, and the cords were plugged into their respective receptacles. A pair of eyeglass frames were in the pilot's seat. Several loose pages of Jeppesen approach charts were located in the cockpit area, including the current STL airport diagram (Copyright 1994 Jeppesen Sanderson, Inc.), dated June 3, 1994. (See Figure 6.)
