MARINE ACCIDENT REPORT

**SS EDMUND FITZGERALD
SINKING IN LAKE SUPERIOR**

NOVEMBER 10, 1975

REPORT NUMBER: NTSB-MAR-78-3

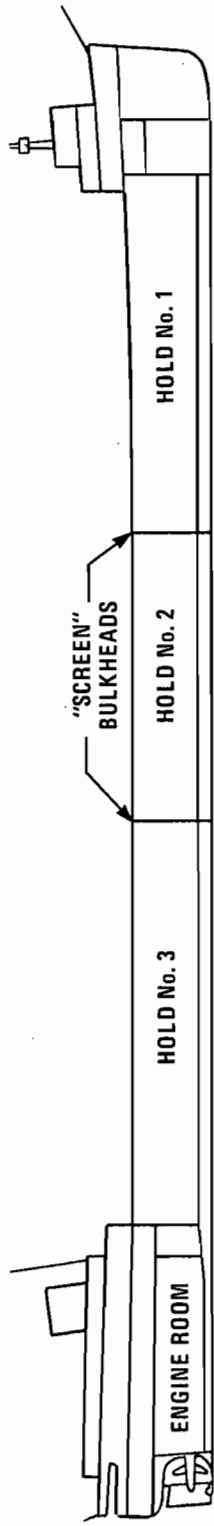
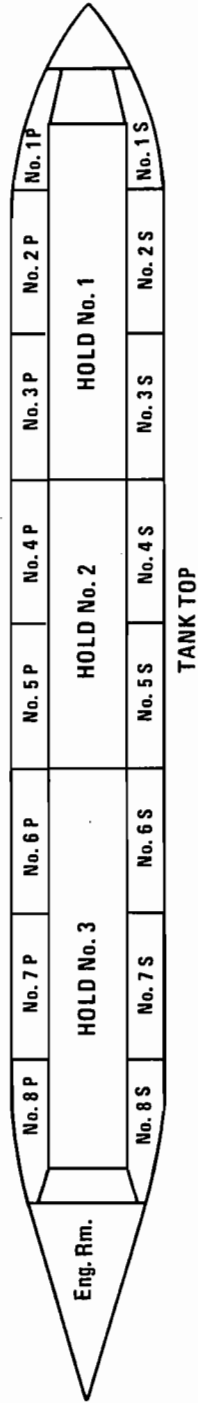
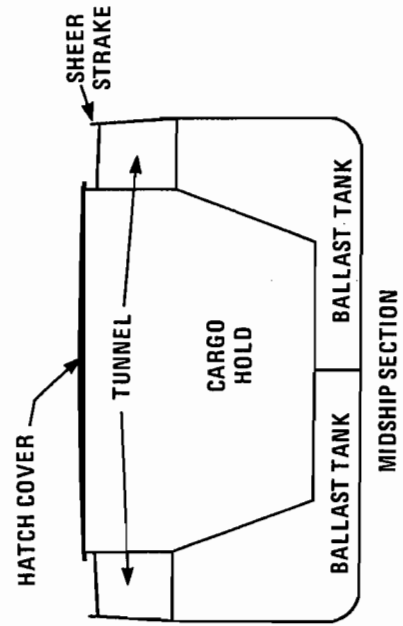
Figure 2. Arrangement of SS EDMUND FITZGERALD.

The FITZGERALD was a conventional "straightdecker" Great Lakes bulk cargo vessel. (See figure 2.) It was 729 feet long, 75 feet in breadth, 39 feet in depth, 13,632 gross tons, and 8,686 net tons. It was propelled by a 7,500-hp, steam turbine and was built as Hull 301 at Great Lakes Engineering Works, River Rouge, Michigan, in 1958. The vessel was owned by Northeastern Mutual Life Insurance Company and operated by the Columbia Transportation Division of the Oglebay Norton Company.

The vessel had a 860,950-cubic-foot cargo hold divided by two nonwatertight transverse "screen" bulkheads. Outboard and below the cargo hold were eight ballast tanks divided at the centerline into port and starboard tanks. (See figure 2.) The forward deckhouse contained the pilot house and accommodations for the deck crew. The engineroom was located aft, above which were the rest of the accommodations and the crew's messing facilities. Below the weather deck and above the ballast tanks were two tunnels, one port and one starboard, used for access between the accommodation areas during adverse weather. The sheer strake extended 15 3/8 inches above the weather deck at side and was connected to the stringer plate by a riveted gunwale bar.
