NATIONAL TRANSPORTATION SAFETY BOARD

MARINE ACCIDENT REPORT

**GROUNDING OF
THE U.S. TANKSHIP EXXON VALDEZ
ON BLIGH REEF, PRINCE WILLIAM SOUND
NEAR VALDEZ, ALASKA
MARCH 24, 1989**

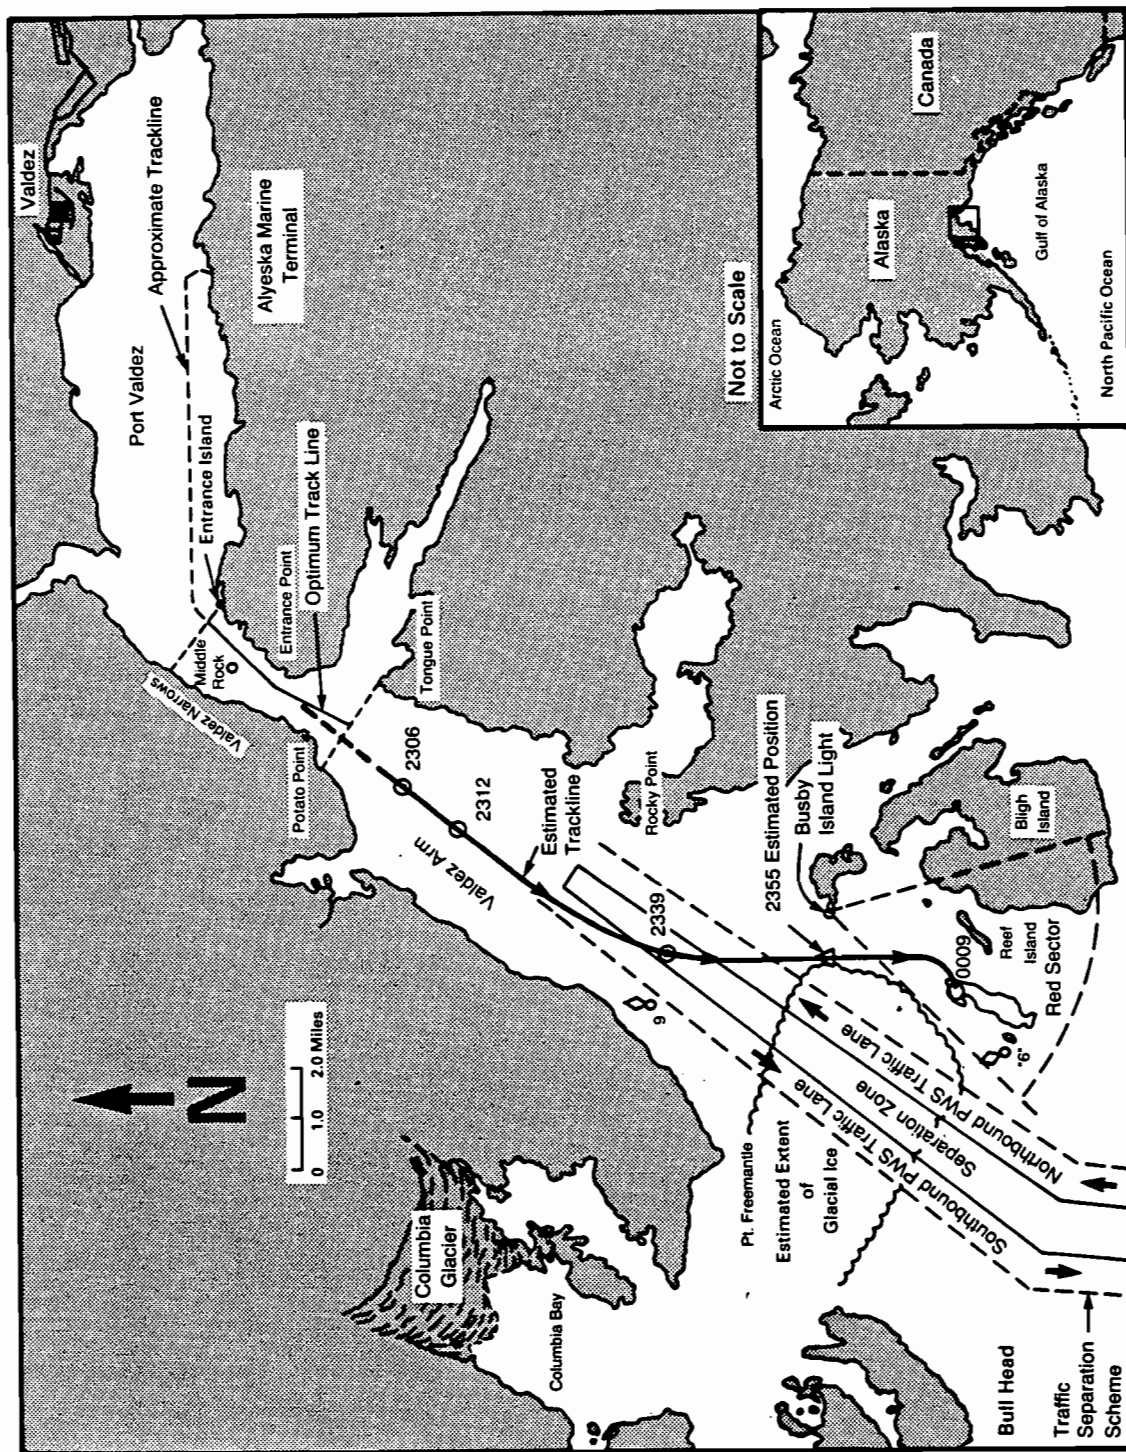
Figure 2.--Location of the accident.

According to the chief mate, when the vessel was a few hundred feet from the pier, the third mate arrived on the bridge to relieve him. The chief mate went to his stateroom to sleep. According to the pilot, about 15 to 20 minutes after the vessel got under way, the master left the bridge. The pilot continued to issue orders to the helmsman, as necessary, to head the vessel toward the harbor entrance and to direct the third mate to make the necessary changes in engine speed. The third mate supervised the helmsman to ensure that all rudder orders from the pilot were correctly followed and also monitored the vessel's progress by logging the time abeam of prominent landmarks and navigation aids. As the vessel approached the Valdez Narrows, the pilot reduced the speed to 6 knots to conform with the established speed limit for loaded tank vessels in the Narrows and then maneuvered the vessel to position it on the optimum trackline.⁵ (See figure 2.)

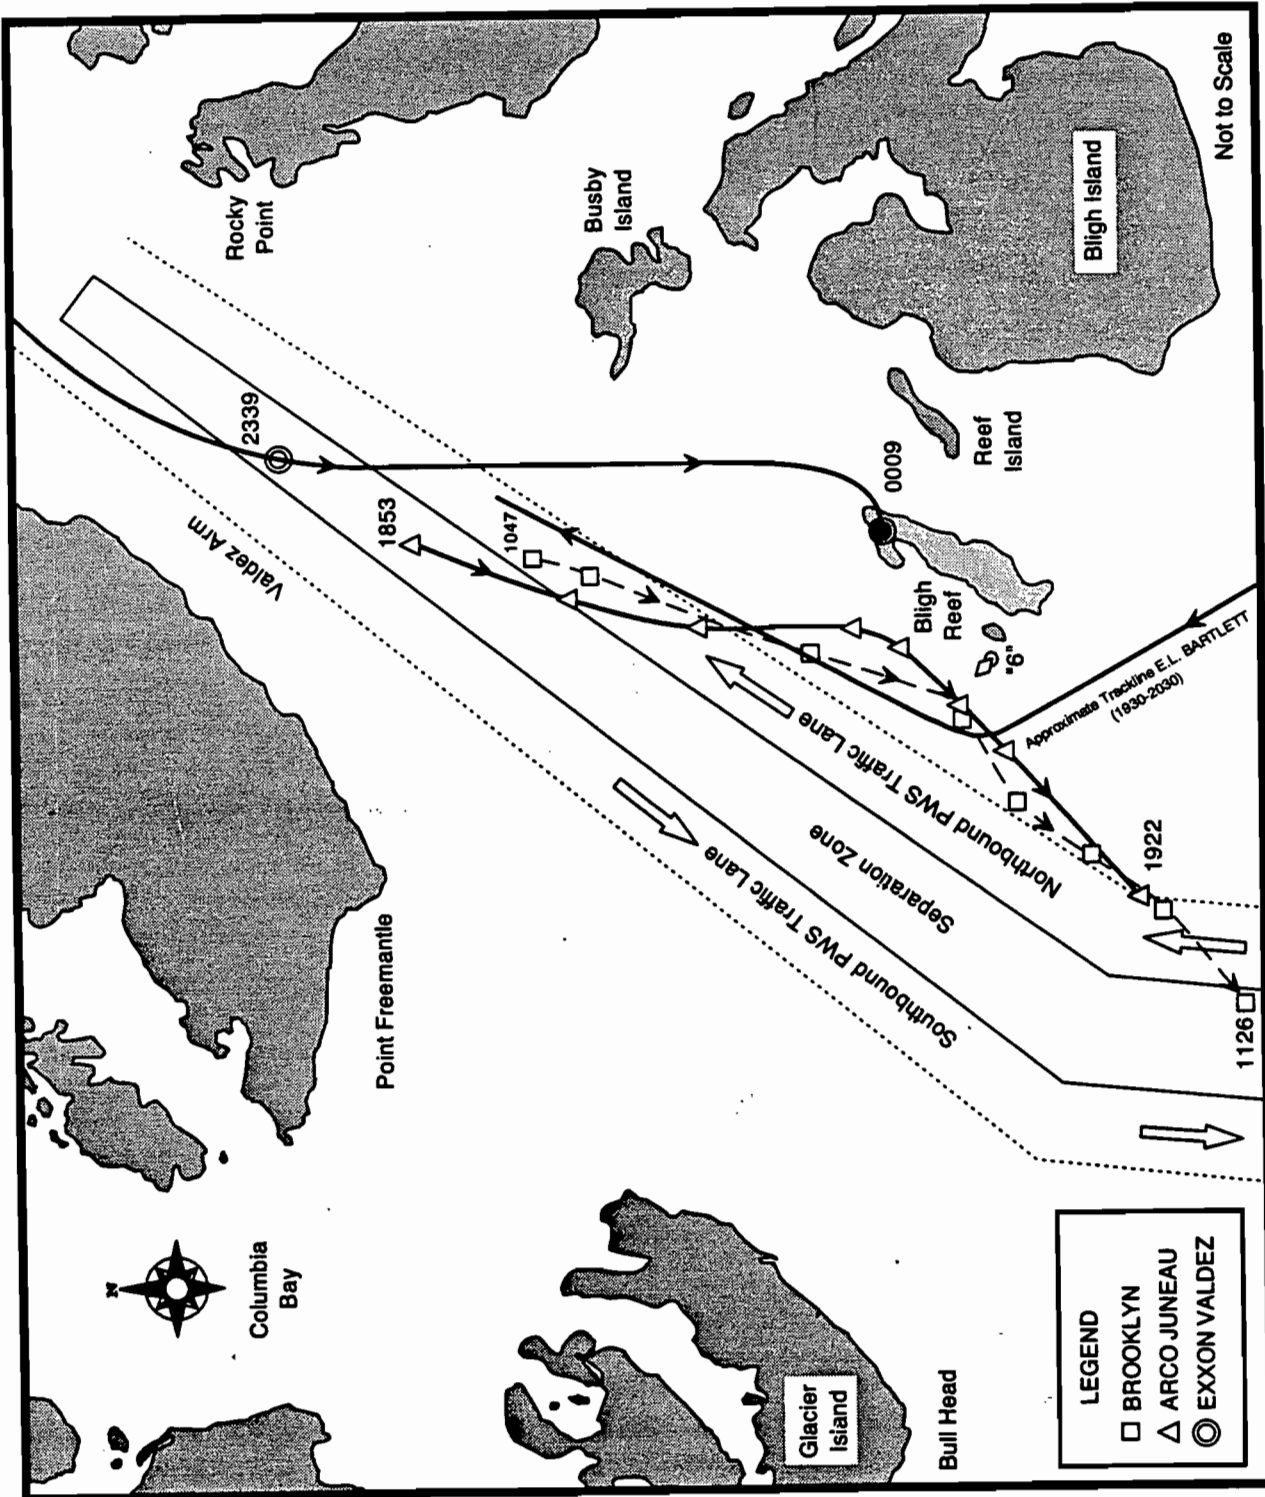
Figure 9.--Vessels departing the TSS.

During the morning of March 23, the tankship BROOKLYN transited the Valdez Arm outbound. (See figure 9.) During that time, the BROOKLYN departed from the TSS to avoid ice and passed within 1.4 miles west of the portion of Bligh Reef where the EXXON VALDEZ later grounded. Shortly thereafter, the vessel passed within 0.35 mile (about 2,100 feet) west of Bligh Reef buoy before returning to the TSS.

About 1904, during the evening before the accident, the ARCO JUNEAU altered course to about 180° and departed from the traffic lanes to avoid the ice. During this time, the vessel passed within 3,900 feet (about 4.5 ship lengths) west of the portion of Bligh Reef where the EXXON VALDEZ later grounded. Shortly thereafter, the vessel passed within 0.4 mile

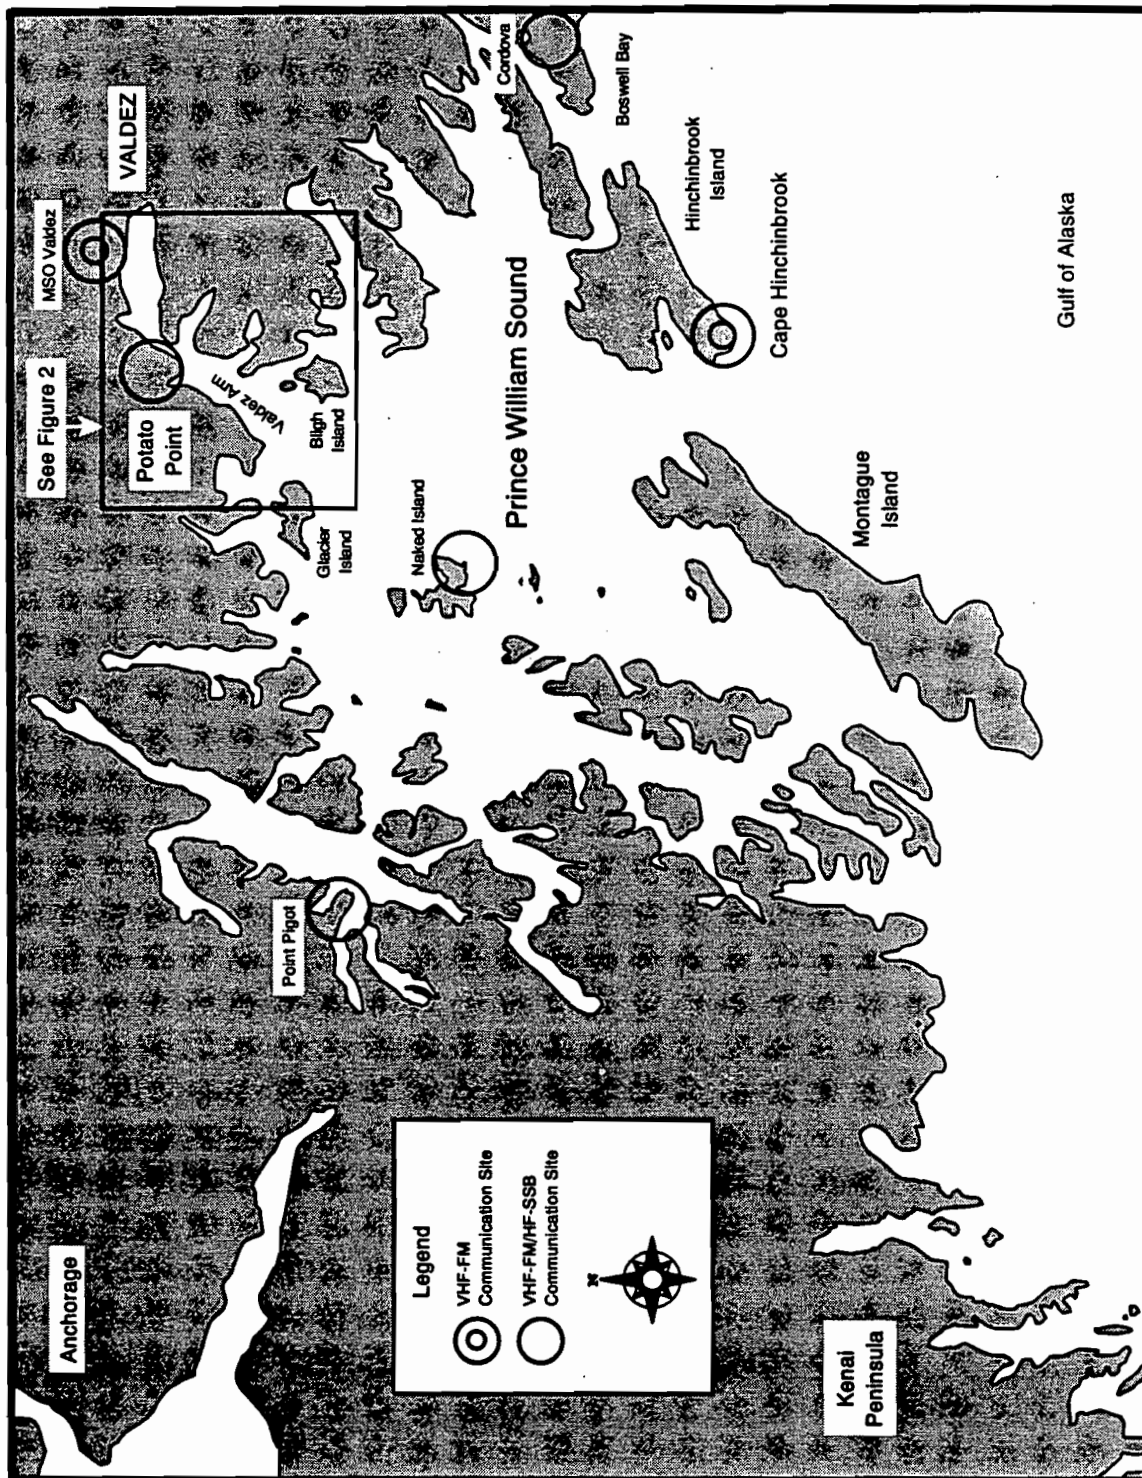
Figure 11.--Communication sites.

The VTC and the communications center were linked to seven remote communication sites located throughout Prince William Sound: Potato Point, Naked Island, Naked Island Tertiary, two at Cordova, Point Peugeot, and Cape Hinchinbrook. (See figure 11.) There was an additional HF-SSB site at Cape Yakataga outside Prince William Sound that was used in the event that the Cape Hinchinbrook remote site became inoperative. According to the VTS Users Manual, VHF-FM Channel 13 (156.65 MHz), the bridge-to-bridge navigation safety frequency, was designated as the radiotelephone frequency for the entire VTS area. The VTC maintained a continuous guard on Channel 13 and used this frequency to transmit and receive vessel movement data and other marine safety information.

According to the 1600-2400 VTC watchstander, because the Naked Island site was inoperative during the evening of March 23, the VTC had difficulty establishing VHF-FM communications between the VTC and vessels south of Naked Island. To maintain communication with those vessels, VHF-FM traffic was rerouted via a remote communication site near Cordova. When the Naked Island site was inoperative, there was no communication link to Cape Hinchinbrook, which meant the loss of the Cape Hinchinbrook communication site. The loss of the Cape Hinchinbrook site forced the VTC to reroute HF-SSB communications between the VTC and vessels en route to Prince William Sound through the Cape Yakataga (HF-SSB) remote communication site.

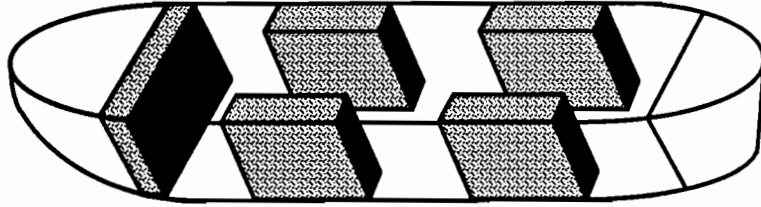
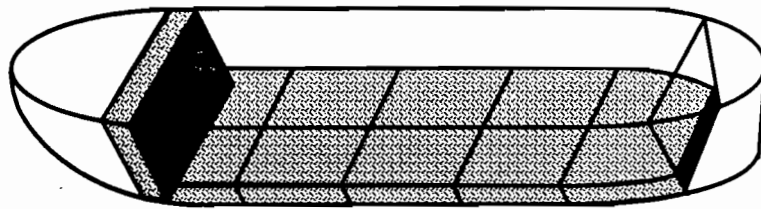
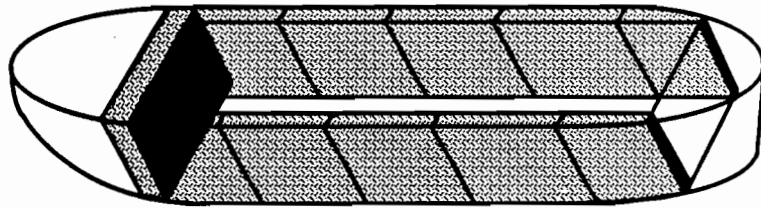
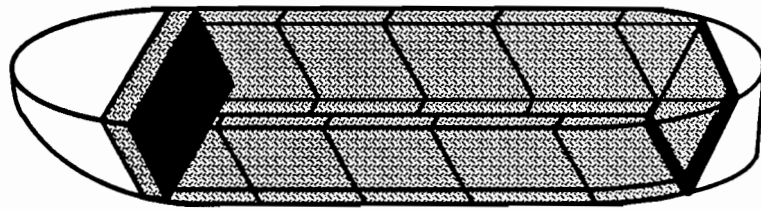
Figure 12.--Tankship design alternatives.

The vessel owner is permitted to meet the regulations by implementing the tank configuration that will result in the lowest cost and least loss of deadweight. For most vessel owners, a staggered wing tank configuration (see figure 12) constitutes the most operationally efficient and cost-effective option. For tank vessels over 20,000 deadweight tons,⁶⁹ a typical staggered wing tank arrangement would consist of four sets of wing tanks, two sets carrying segregated ballast and two sets carrying cargo. This arrangement, however, only provides partial protection against oil outflow owing to collisions because only four wing tanks are ballast tanks, and only minimal protection from grounding is provided because none of the cargo tanks are protected. This method was used in the design and construction of the EXXON VALDEZ.

- (a) Double Bottoms.--Tank vessels can be designed and constructed with various tank arrangements that can reduce the oil outflow if there is an accident. For instance, a tank vessel can be fitted with a double bottom extending along the length of the cargo tank area as shown in figure 12b. (See page 87.)
