# NATIONAL TRANSPORTATION SAFETY BOARD

## RAILROAD ACCIDENT REPORT

DERAILMENT OF  
STEAM EXCURSION TRAIN NORFOLK AND  
WESTERN RAILWAY COMPANY TRAIN  
EXTRA 611 WEST  
SUFFOLK, VIRGINIA  
MAY 18, 1986

NTSB/RAR-87/05

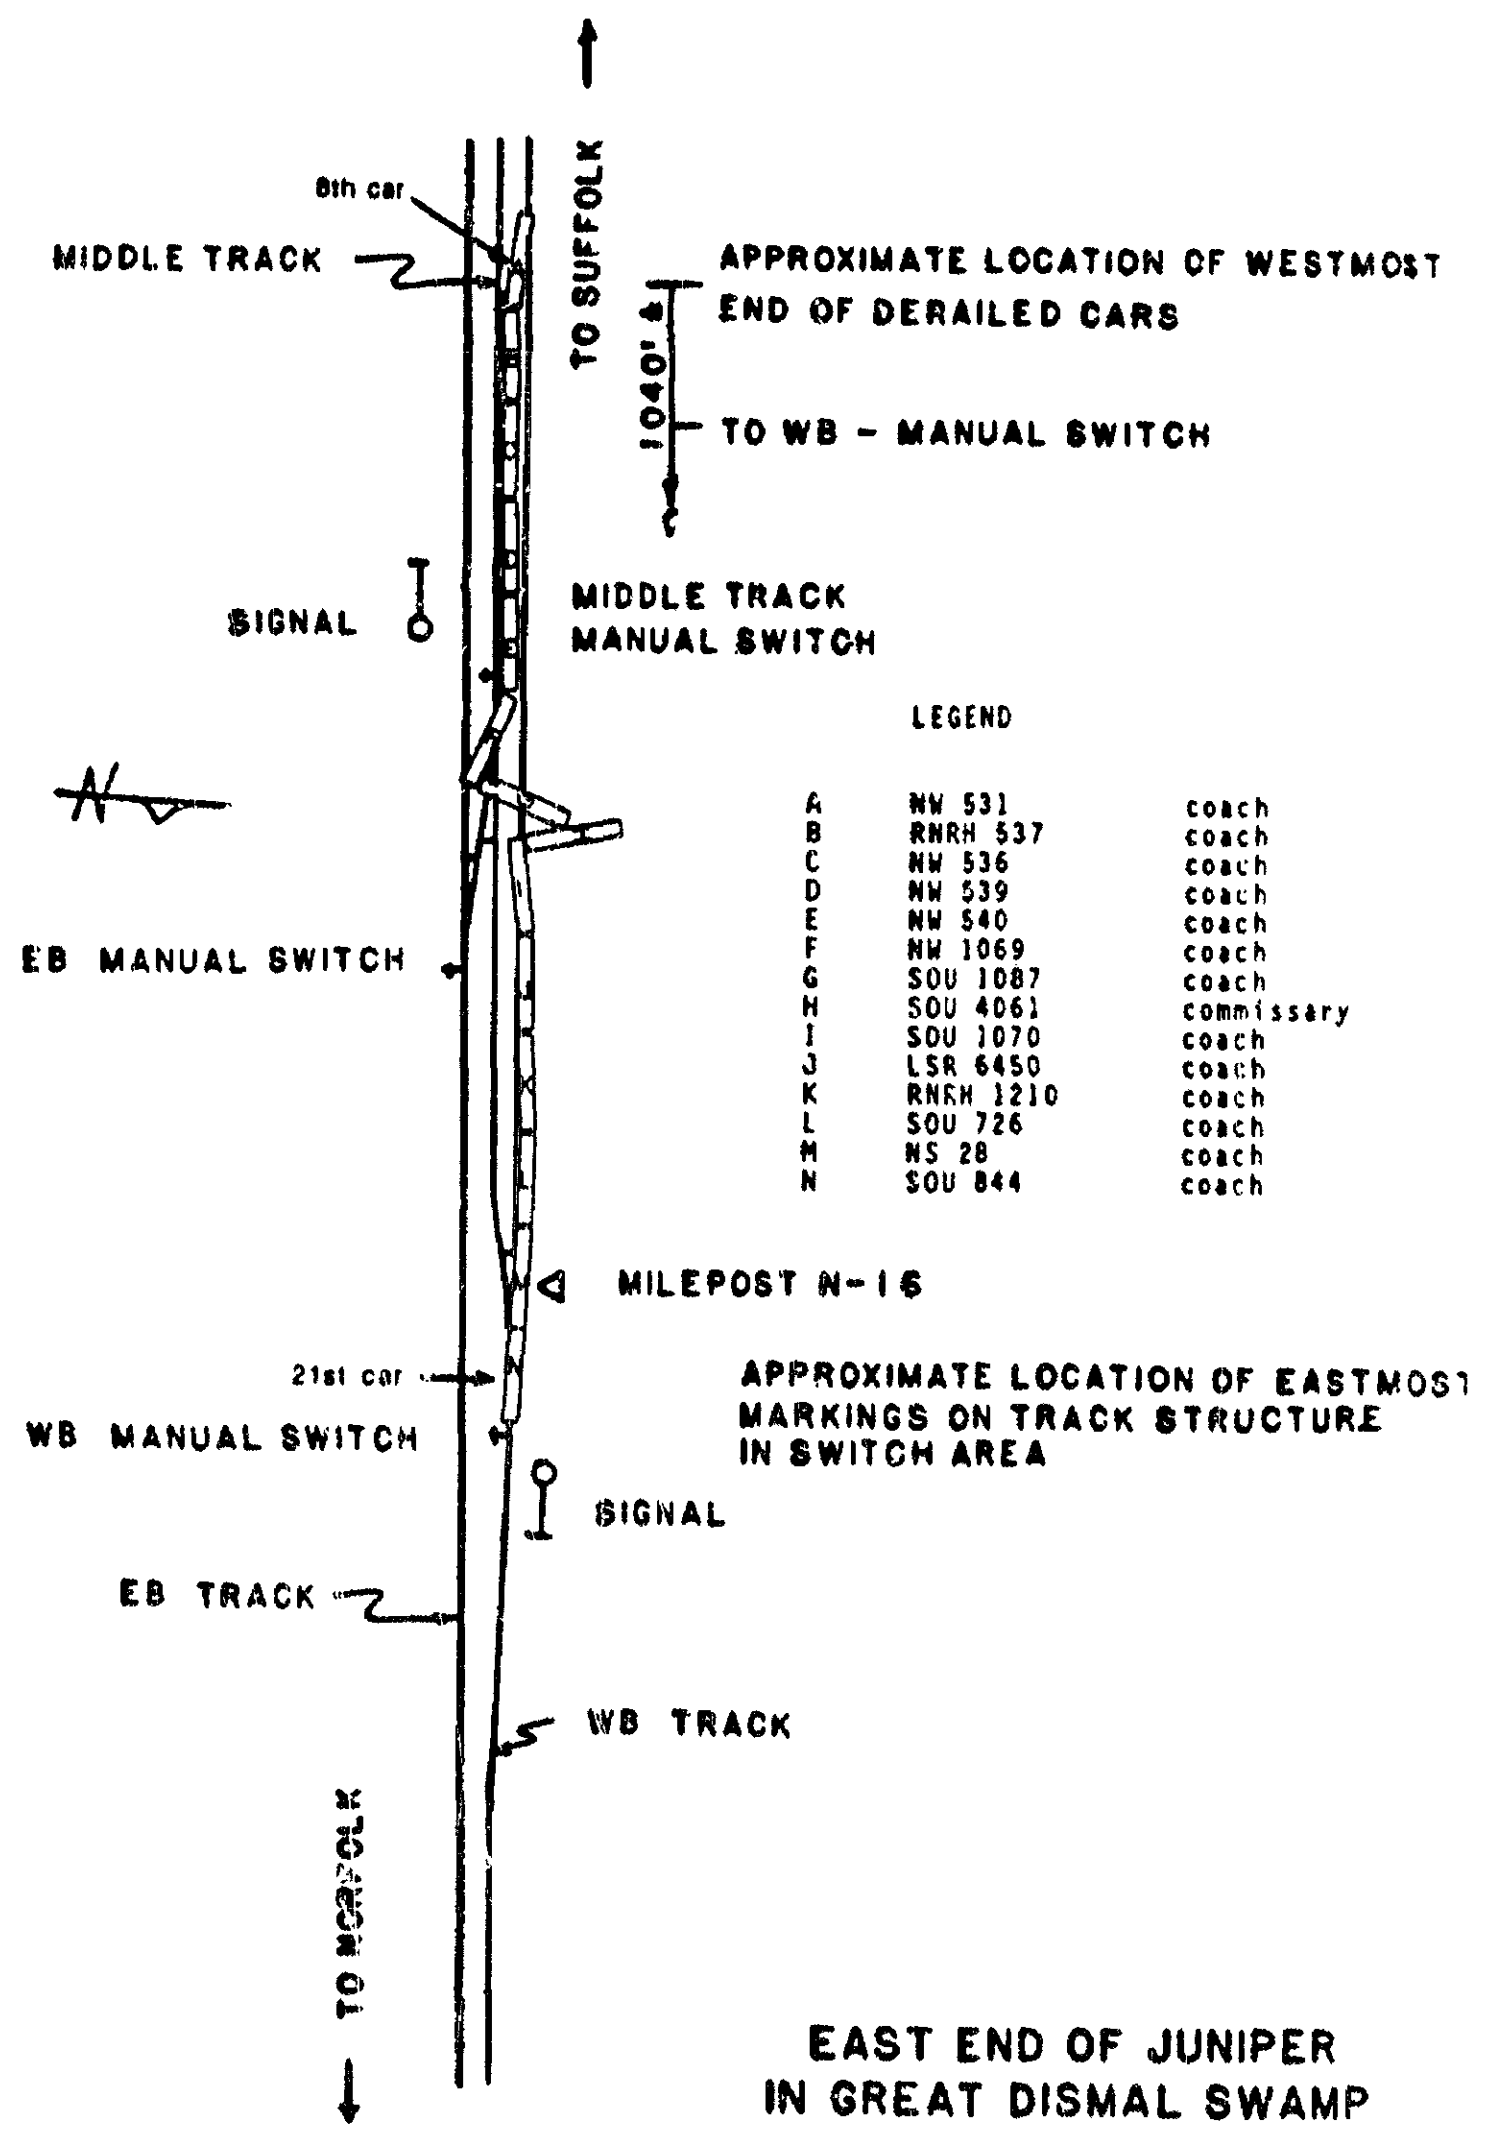
The lead truck (west end) of the eighth car, NW 531, had passed through the turnout correctly, but the trailing truck (east end) proceeded in the direction of the divergent route, skewing the car and breaking off the knuckle 8/ of the seventh car, TWC 1723. All derailed cars remained upright and together except for the 13th through 16th (NW 1069, SOU 1087, SOU 4061, and SOU 1070) which jackknifed and/or overturned. The 13th car (NW 1069) did not stay in line with the five preceding derailed cars. The last two cars of the train remained undamaged on the track. The derailed cars blocked the middle track and the eastbound main track. (See figures 2 and 3.)

The west end of the last car to derail, SOU 844, was near the turnout frog; 9/ the east end of the car remained on the track with its wheels in the switch area. A member of the traincrew reported that the switch points were gapped and that neither switch point was against the stock rails. According to N&W maintenance-of-way officials, the switch stand 10/ was examined immediately after the accident and was found in the reverse position (diverging route into the middle track); the safety block in the stand had rotated 90° counterclockwise. The operating lever had rotated with the safety block remaining locked in its recess in the top collar portion of the safety block. The yellow disc target was facing the east-west direction indicating that it had reversed to show a diverging route into the middle track.
