# PONTIAC

## Service Craftsman News

No. 2 S-280

February, 1956

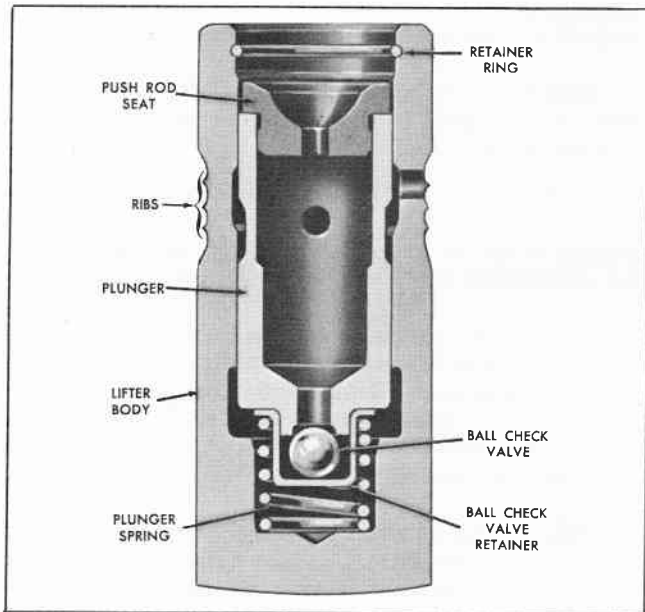
Fig. 4 Regular Production Valve Lifter

The introduction of the 285 horsepower Strato-Flight V-8 engine brings to three the number of different valve lifters now being used in production. These three types are illustrated in Figs. 4, 5 and 6. Figs. 4 and 5 illustrate the valve lifters used interchangeably in regular production. Externally they differ in appearance (note ribs on lifter body shown in Fig. 4 and radial groove on lifter body in Fig. 5), however, internally they are similar. The lifter used in the 285 horsepower engine is similar externally to the

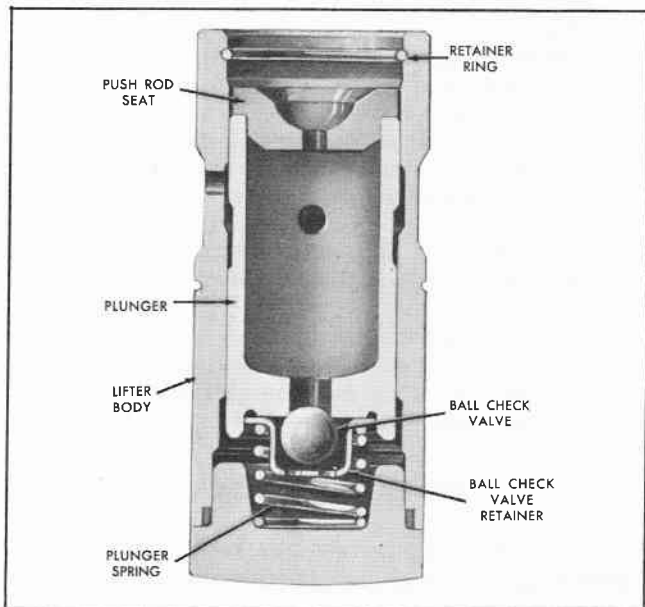
Fig. 5 Regular Production Valve Lifter

standard production lifter shown in Fig. 5. It can be identified from the standard lifter by the letter "A" stamped on the lifter body and by the fact that the area that contacts the cam has a lubrited (blackened) finish. Internally, as shown in the illustration, the new lifter has a spring under the ball check valve and a redesigned ball check valve retainer.
