**05-116 collapse of Bridge 256 over Nuhaka River,
Palmerston North-Gisborne Line**

Report 05-116

collapse of Bridge 256 over Nuhaka River

6 May 2005

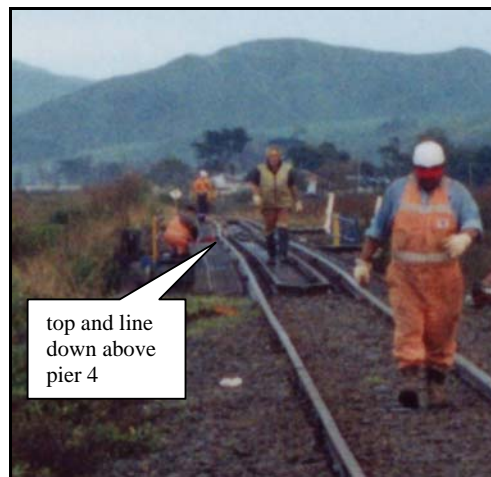
Figure 12
Bridge 256, before arrival of work Train 60
(courtesy of Ontrack)

- 1.11.27 Between Monday 2 May and Thursday 5 May 2005, the bridge gang prepared the bridge for the 2-day occupation. Scaffolding was erected around pier 4 and some bridge and track members were dismantled to permit access for pile driving (see Figure 12). On Thursday 5 May, the structures inspector travelled to Bridge 256 to check on arrangements and saw no movement when a northbound train travelled across.

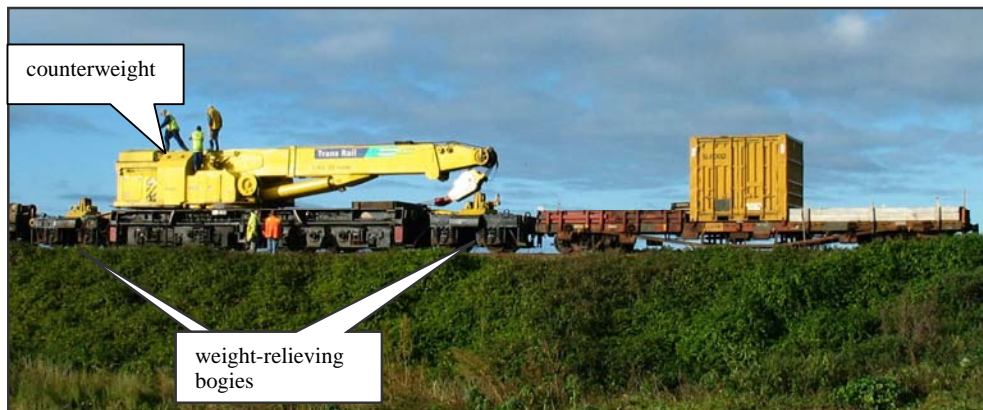
Figure 13
A 60 t rail crane and attendant wagon

1.13.6 Each crane was mounted on two 3-axle bogies with removable weight-relieving bogies positioned at each end of the crane (see Figure 13). In travelling mode, the weight-relieving bogies were attached to reduce axle loads. In working mode they were removed, raising the average axle loads for the whole crane with jib in line and stowed from 14.2 to 20.8 t, and the average for the heavier bogie (at the counterweight end) from 16.0 to 24.1 t. Axle loads of 16.3 t were the maximum normally permitted on the PNGL between Napier and Gisborne.
