# Breaking Secure Bootloaders

# Project One – The SDM660 Android Bootloader

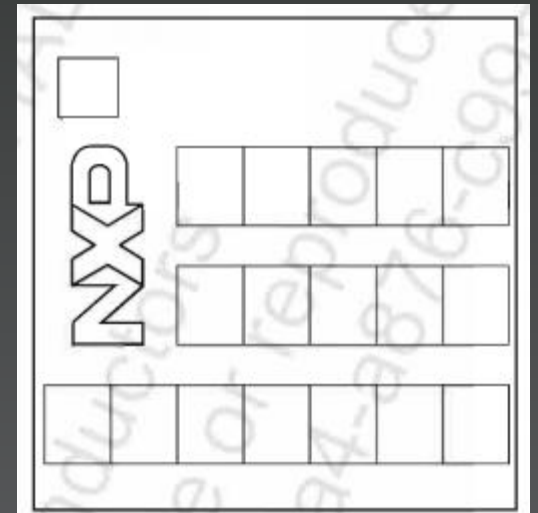
By breaking the firmware protections on these chips, one could add new NFC capabilities

The NXP PN series is extremely popular in smartphones, and any exploits would be transferrable to a large number of devices
