**Republic of the Philippines
Department of Public Works and Highways**

**The Project for Improvement of Quality
Management for Highway and Bridge
Construction and Maintenance, Phase III**

Final Report

Japan International Cooperation Agency

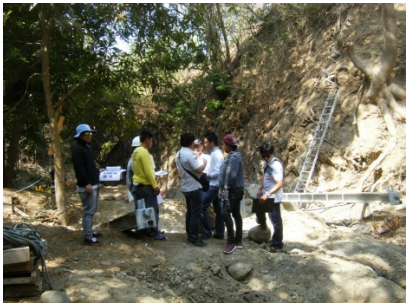
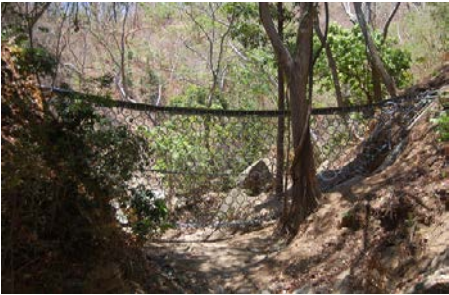
Year 2016					
	Region	Date	Location	Pilot Project Site	Method
1	RO-I	Apr. 19-20,	K0383+950	MNR Santa, Ilocos Sur	Barrier for Debris flow

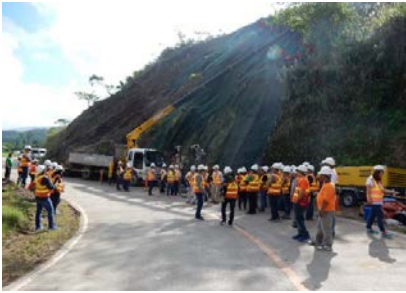
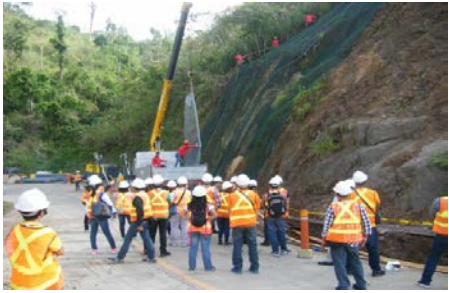
2	RO-II	Nov. 8-10	K0392+900- K0392+963	Cordon-Aurora Road, Quirino Province	Soil nail and Wire mesh

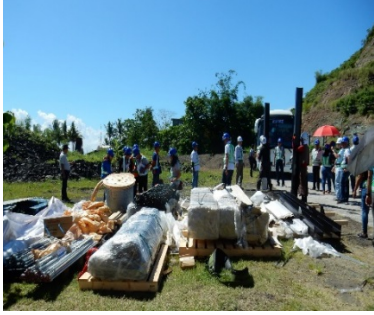
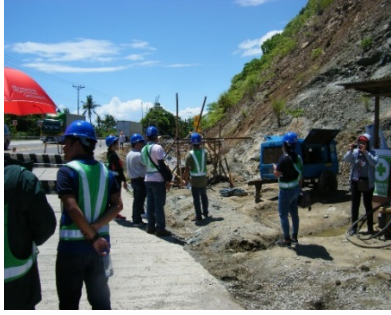
Year 2018					
1	RO-VIII	Mar. 21-23	K0923+000- K0923+350	Cabuynan, Tanauan, Leyte	Rockfall protection fence and Rope net

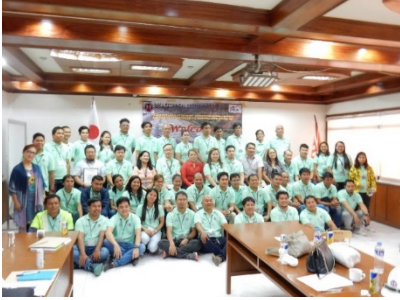
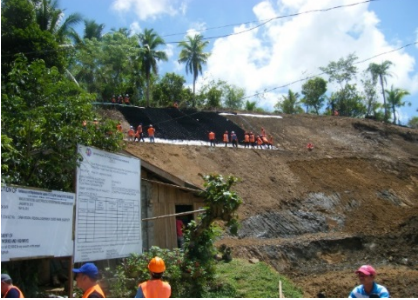
2	RO-V	Apr.4-6	K0500+220- K0500+280	Albay West Coast Road	Slope protection and retaining wall by Geoweb

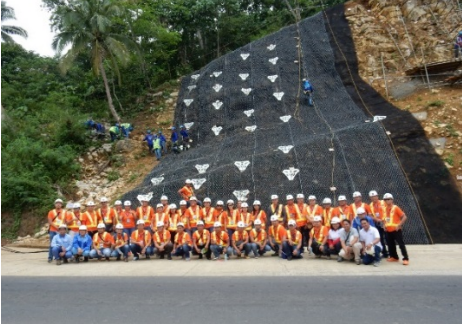
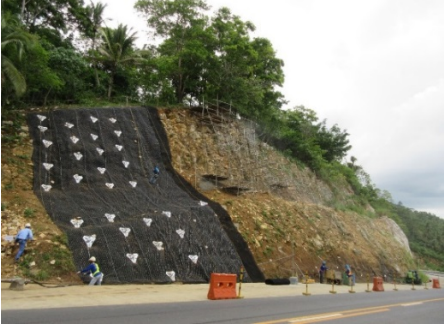
3	RO-XIII	Jun.26-28	K1171+050- K1171+086	Daang Maharlika (Surigao-Agusan Section)	New-Nailing Network System

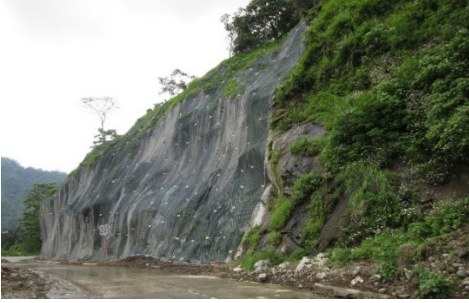
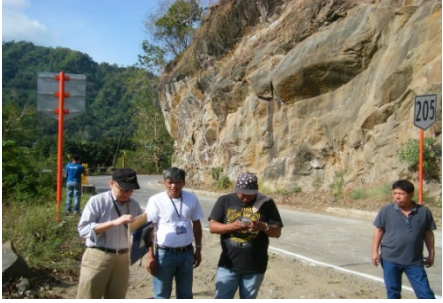
4	RO-I	Jun.27-29	K0337+000	Tagudin-Cervantes Road, Ilocos Sur	Soil nail with mesh

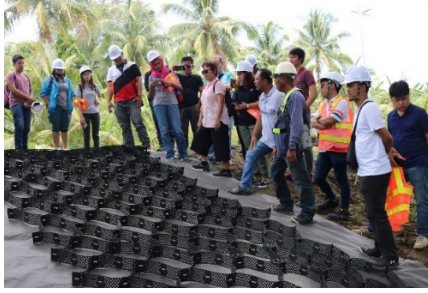
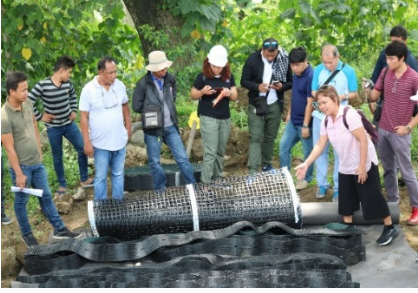
5	RO-XII	Aug. 29-31	K1687+640- K1687+749	Davao-Cotabato Jct. Digos Road, Cotabato	Geotextile, Geogrid, Geoweb

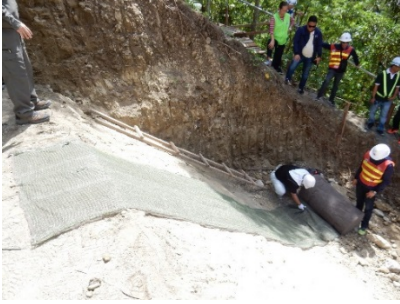
6	RO-XI	Nov. 27-29	K1502+244- K1502+300	Fatima-Malabog Road, Davao del Norte	Web Composite Mat, Geoweb

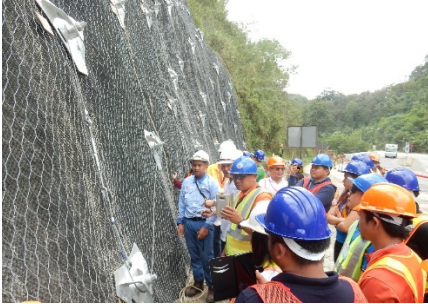
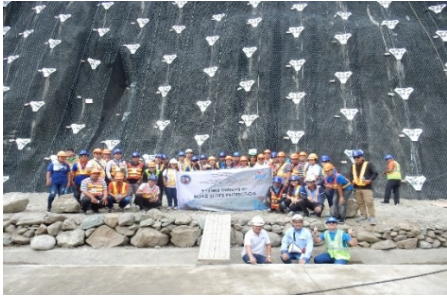
7	RO-X	Dec. 3-5	K1465+97- K1465+147	Sayre Highway, Kulaman Section, Bukidnon	New-Nailing Network System

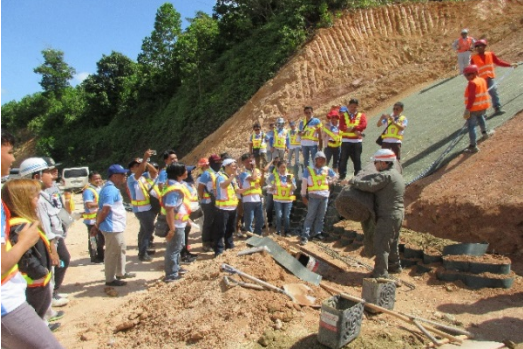
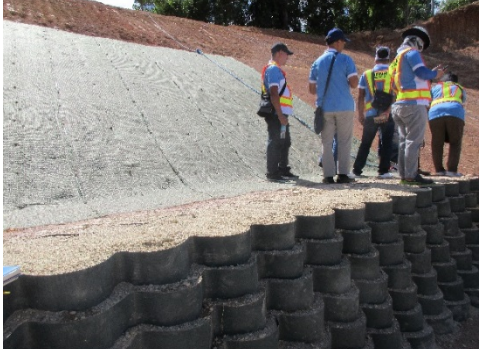
8	RO-IV-B	Dec. 11-13	K0187+280- K0187+357	Paglaum-Baho	Geoweb, Web Composite Mat

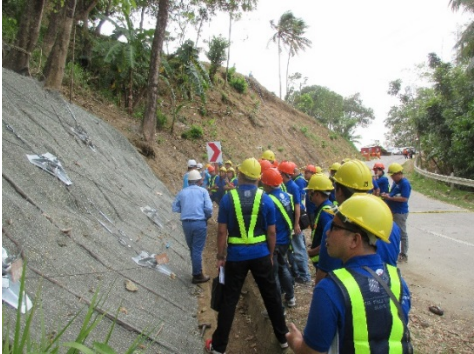
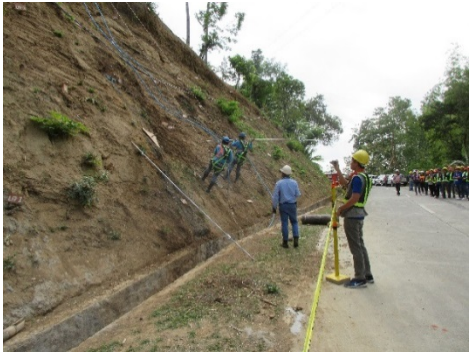
Year 2019					
1	RO-VI	Jan. 16-18	K47+800- K47+950, K49+540- K49+921	Guimbal-Igbaras- Tubungan-Leon Road	New-Nailing Network System, Web Composite Mat

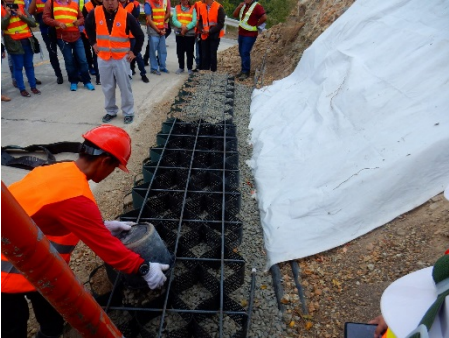
2	RO-IV-A	Jan. 22-24	K0165+200	Bauan-Mabini Road	Geoweb, Web Composite Mat

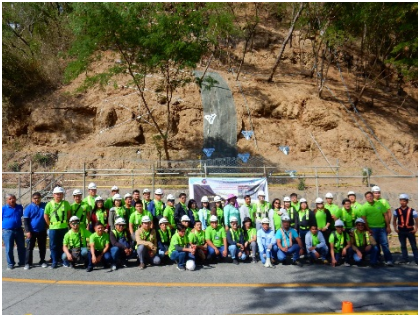
3	RO-III	Jan. 29-31	K0178+370- K0178+436	Pantabangan-Canili- Basal-Baler Road	New-Nailing Network System, Web Composite Mat

Figure 1.3.1.2-2 Field Trainings of the Pilot Projects on Road Slope Protection

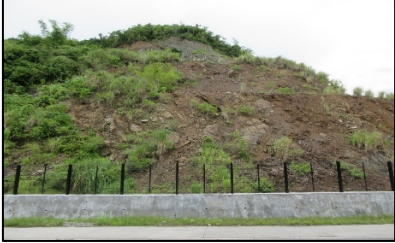
Region	Date	Elapse of time	Pilot Project Site	Method
1	RO-VIII	Jun.20, 2018	4 months after	Cabuynan, Tanauan, Leyte	Rockfall Protection Fence and Rope Net

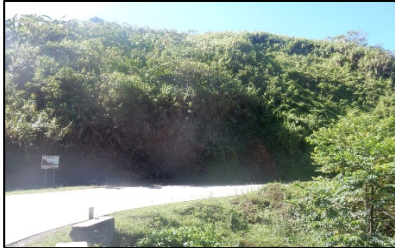
2	RO-II	Jul.4, 2018	1 year and 8 months after	Cordon-Aurora Road, Quirino Province	Soil Nail and Wire Mesh

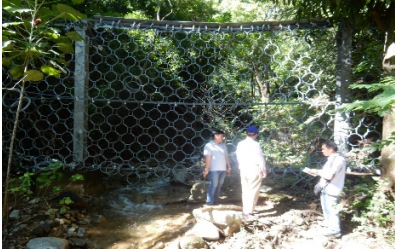
3	RO-I	Sep.12,2018	2 years and 6 months after	MNR Santa, Ilocos Sur	Barrier for Debris Flow

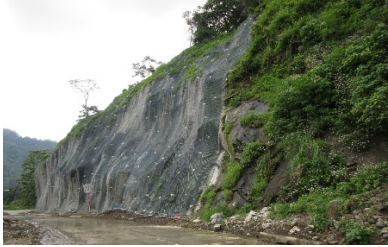
4	RO-1	Sep.12, 2018	3 months after	Tagudin-Cervantes Road, Ilocos Sur	Soil Nail with Mesh

Figure 1.3.1.2-3 Monitoring of the Pilot Projects on Road Slope Protection

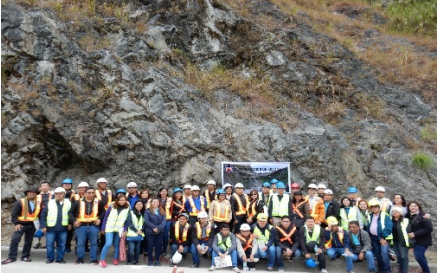
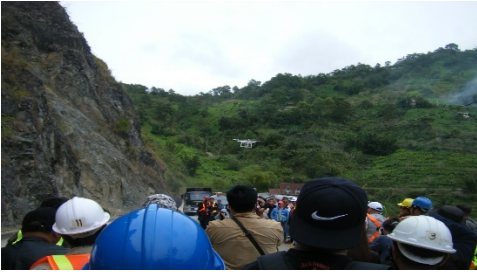
We carried out condition inspection and topographic survey using drone to carry out the pilot project of CAR, and the results of the topographic survey were used for the design of slope protection. Based on the above result, it was confirmed that the surveying work at the site was reduced, and that the 3D model reproduced from the survey results could be adopted for slope protection design.

RO-CAR	Jan. 17	K0266+990- K0267+206	Acop-Kapangan-Kibungan- Bakun Road, Benguet	Survey of road slope by Drone

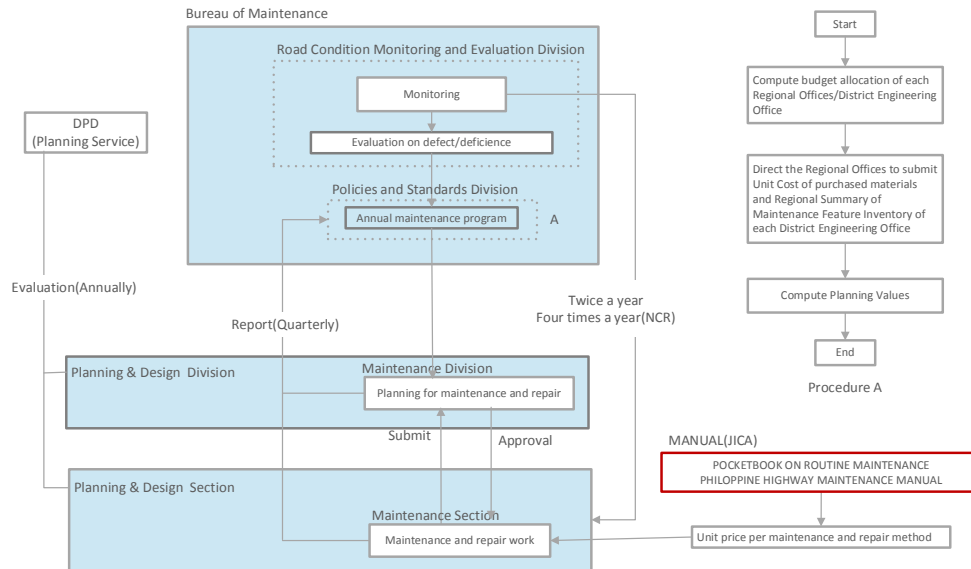
Figure 1.3.1.3-1 Road Maintenance Procedure in Compliance with DO 41 of DPWH

The chart below shows the procedure contained in DO41.

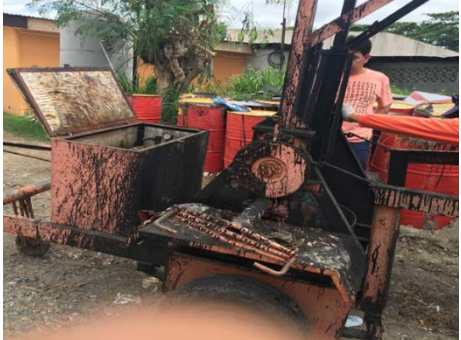
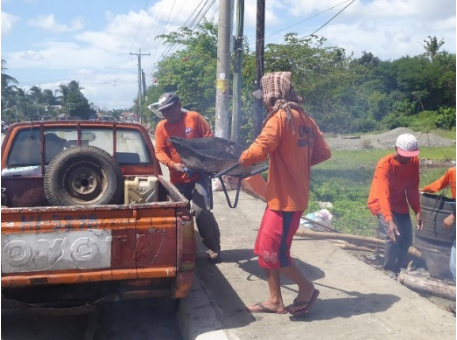
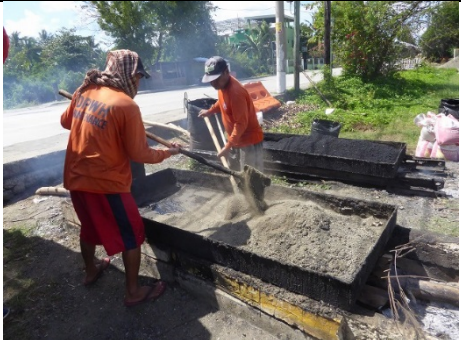
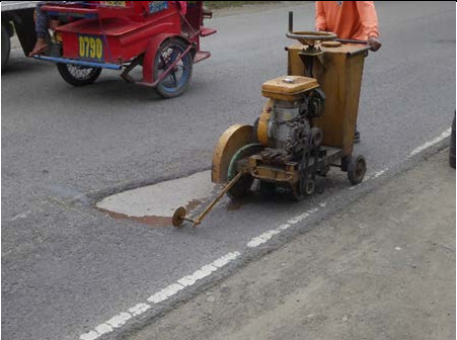
Figure 1.3.1.3-5 Photos of Equipment for Routine Maintenance in DEO

<p>Asphalt Kettle used by the district engineering office in maintenance works is already very old with low efficiency</p>	<p>Dump Truck used for transfer the material is already very old with low efficiency.</p>

<p>Batching plant on where asphalt materials were made by handworks is located near the defect area.</p>	<p>Repair works for asphalt pavement using asphalt cutter.</p>

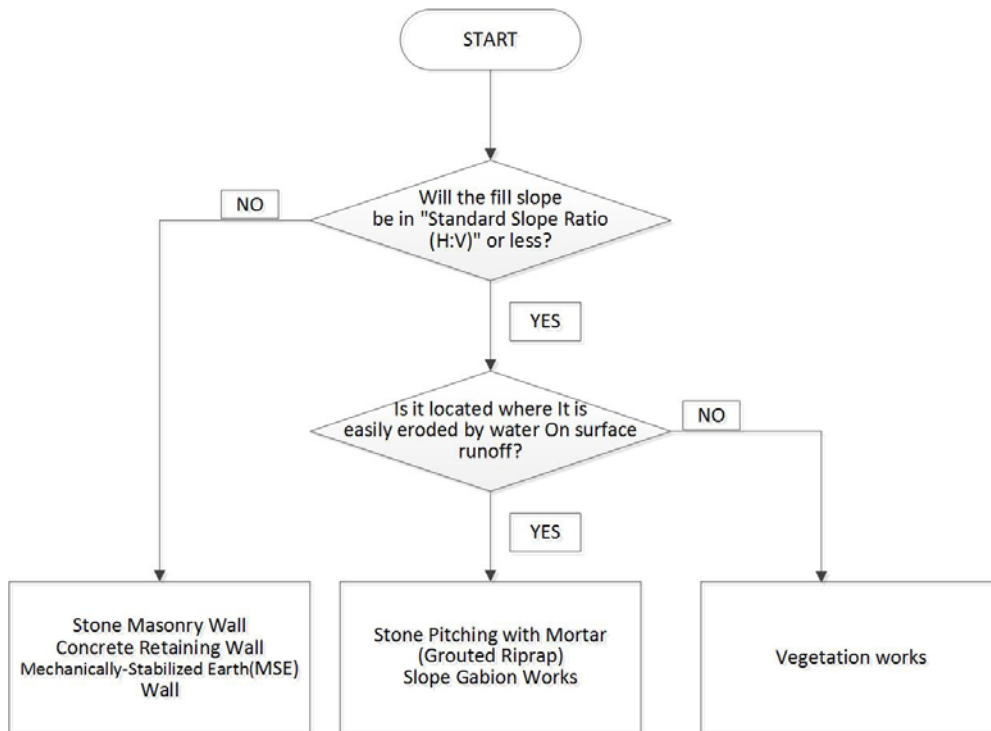
Figure 1.3.1.4-5 Flowchart for Selection of Countermeasure for Road Slip

Developed flowchart for selection of countermeasure for Road slip

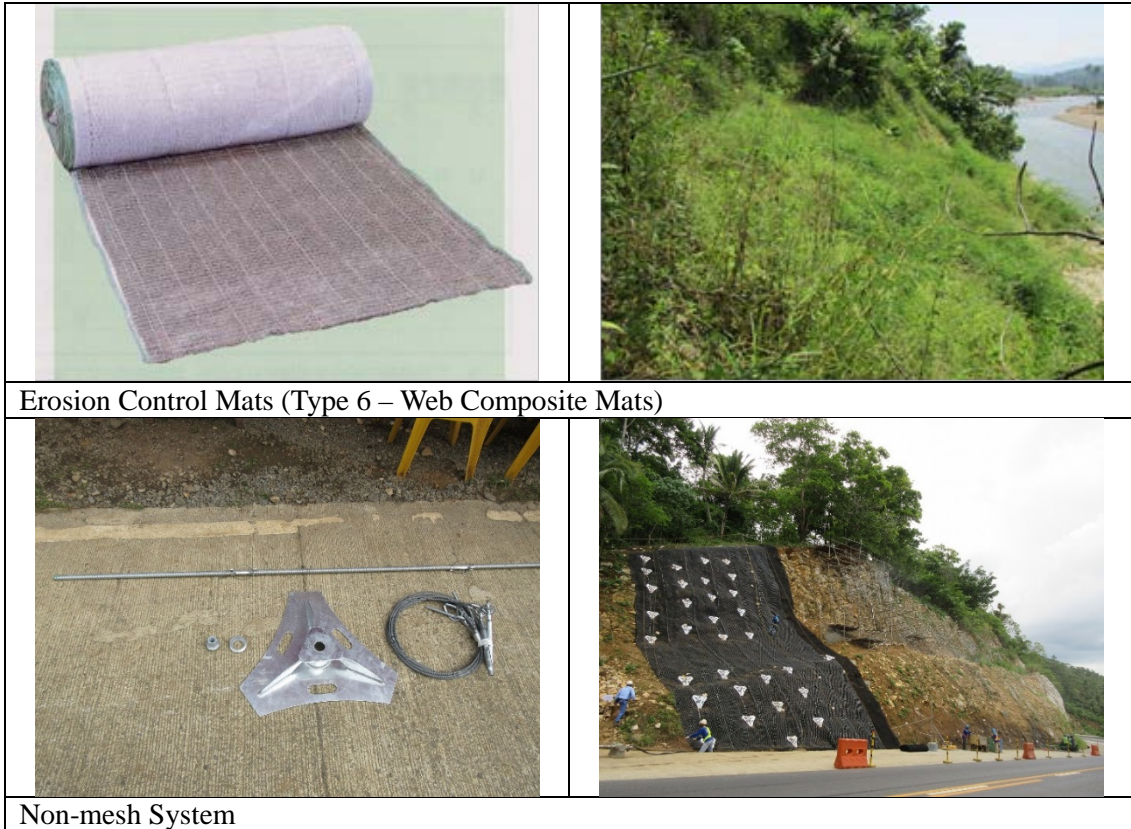
Figure 1.3.1.4-7 Advanced Technology for Soil Collapse

All types of countermeasures for soil slope collapse in the Philippines including some advanced technologies which were conducted in the road pilot project.

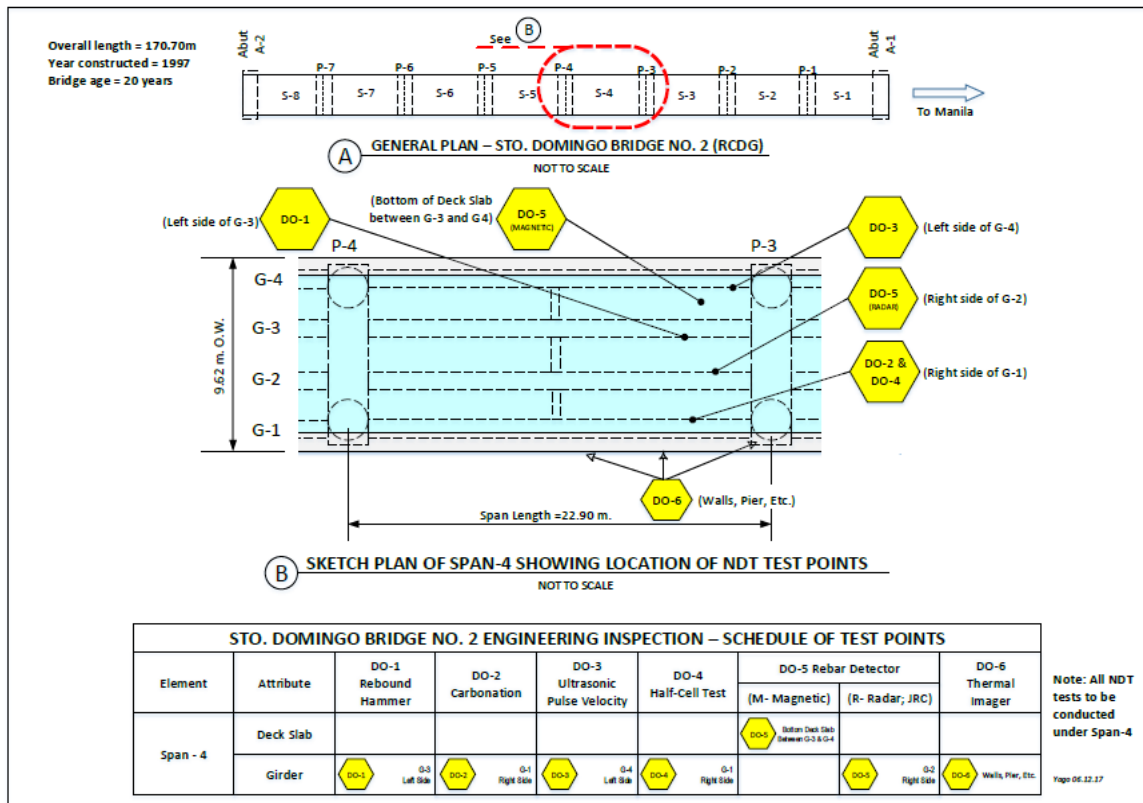
Figure 1.3.2.2-5 Test Point Location Plan (Luzon Area)

The overall condition is Good according to BMS data. However, the actual bridge condition is very severe. JICA Experts & C/Ps verified the overall condition is Bad. So, it became necessary to conduct bridge engineering inspection using NDT.

Test Point Location Plan is as follows;

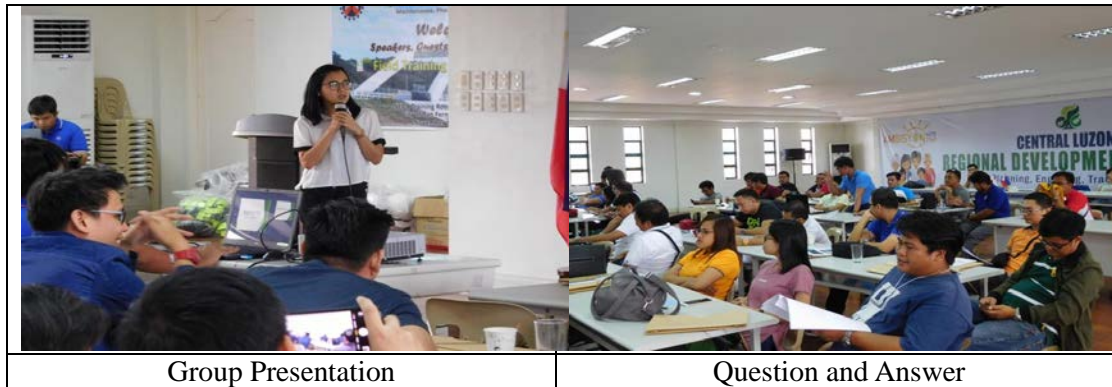
Demo of surface preparation of CFS	Demo of pull off test of epoxy adhesive

Application of CFS	Application of Asphaltic Plug Joint

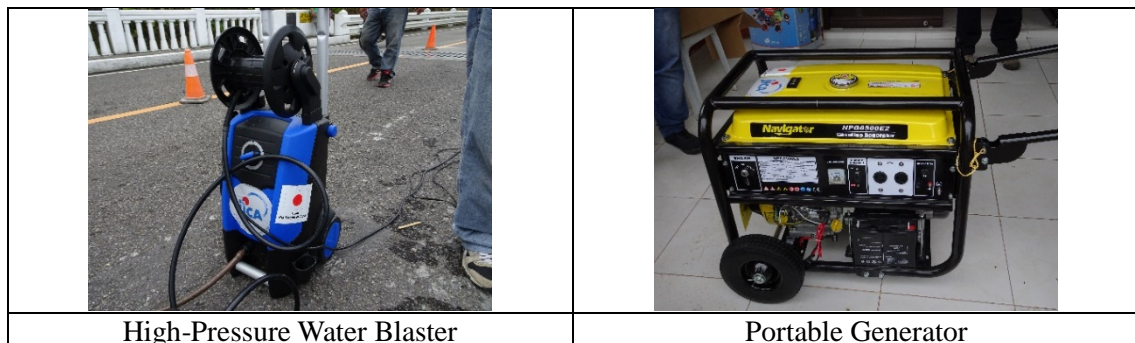
Figure 1.3.3.2-2 Equipment for the OJT

High Pressure Water Blaster, Portable Generator (refer to photo) and some other miscellaneous tools were purchased by JICA and donated to the Regions (RO-II, RO-III, RO-VII, RO-VIII) at the occasion of each OJT on Routine Maintenance Manual for Special Bridge.

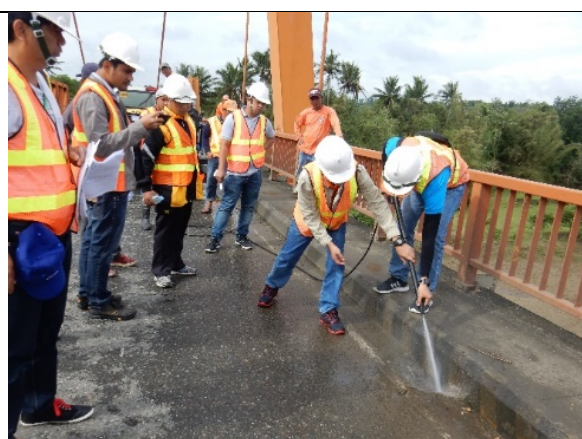
3rd OJT on Routine Maintenance Manual
Mar. 02, 2017
Cleaning of Drainage using High Pressure Water Blaster at RO-II Magapit Bridge

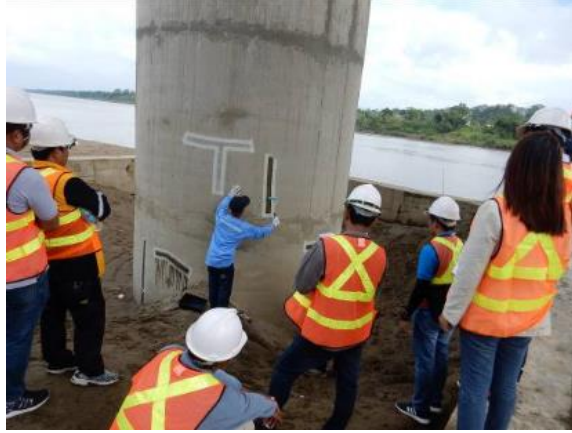
<p>3rd OJT on Routine Maintenance Manual Mar. 02, 2017 Touch-up painting on the Hunger Rope at RO-II Magapit Bridge</p>	<p>3rd OJT on Routine Maintenance Manual Mar. 02, 2017 Epoxy coating on concrete pier at RO-II Magapit Bridge</p>

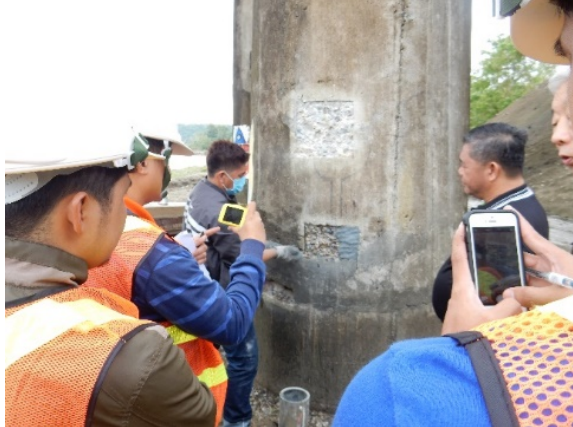
Figure 1.3.3.2-3 Photos of Activities

<p>3rd OJT on Routine Maintenance Manual Mar. 02, 2017 Patching to concrete pier at RO-II Magapit Bridge</p>	<p>3rd OJT on Routine Maintenance Manual Mar. 02, 2017 Discussion at RO-II Regional Office</p>

Patch repair is performed to restore small areas where sound concrete is damaged by spalling, scaling and impact. Polymer cement mortar is used for patching. Fresh mortar is spread by trowel over the damaged area.

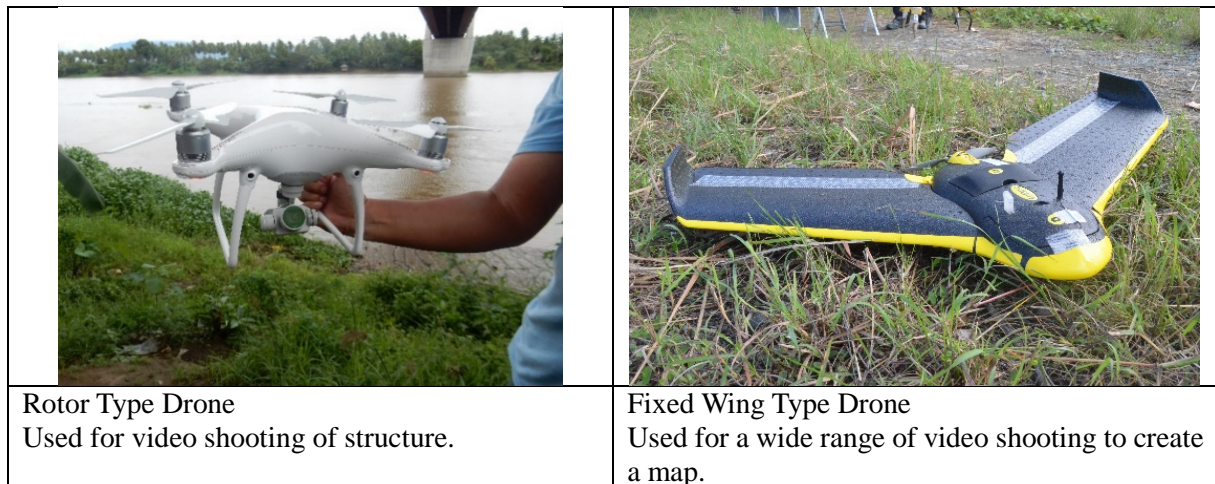
Figure 1.3.3.3-1 Drones used for Inspection

Both rotor type and fixed type drones were used. Photos are shown below.

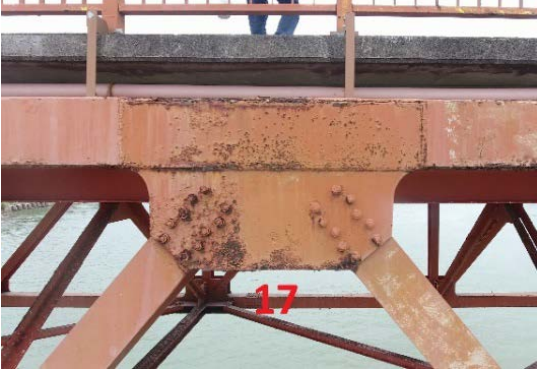
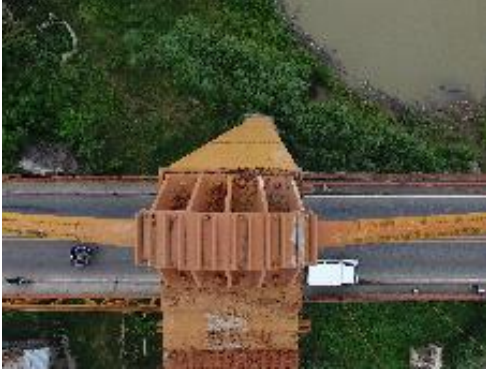
Figure 1.3.3.3-2 Point of Interest Photos

The video photography is processed and Point of Interest Photos (still photographs of defective portion) are extracted from the video.

<p>Defect on the side of Stiffening Girder of Magapit Bridge. It is difficult to find out these defects in this position by inspection above the deck.</p>	<p>One of the Saddle of the Tower of Magapit Bridge. It is difficult to inspect attribute in such high position without scaffolding.</p>

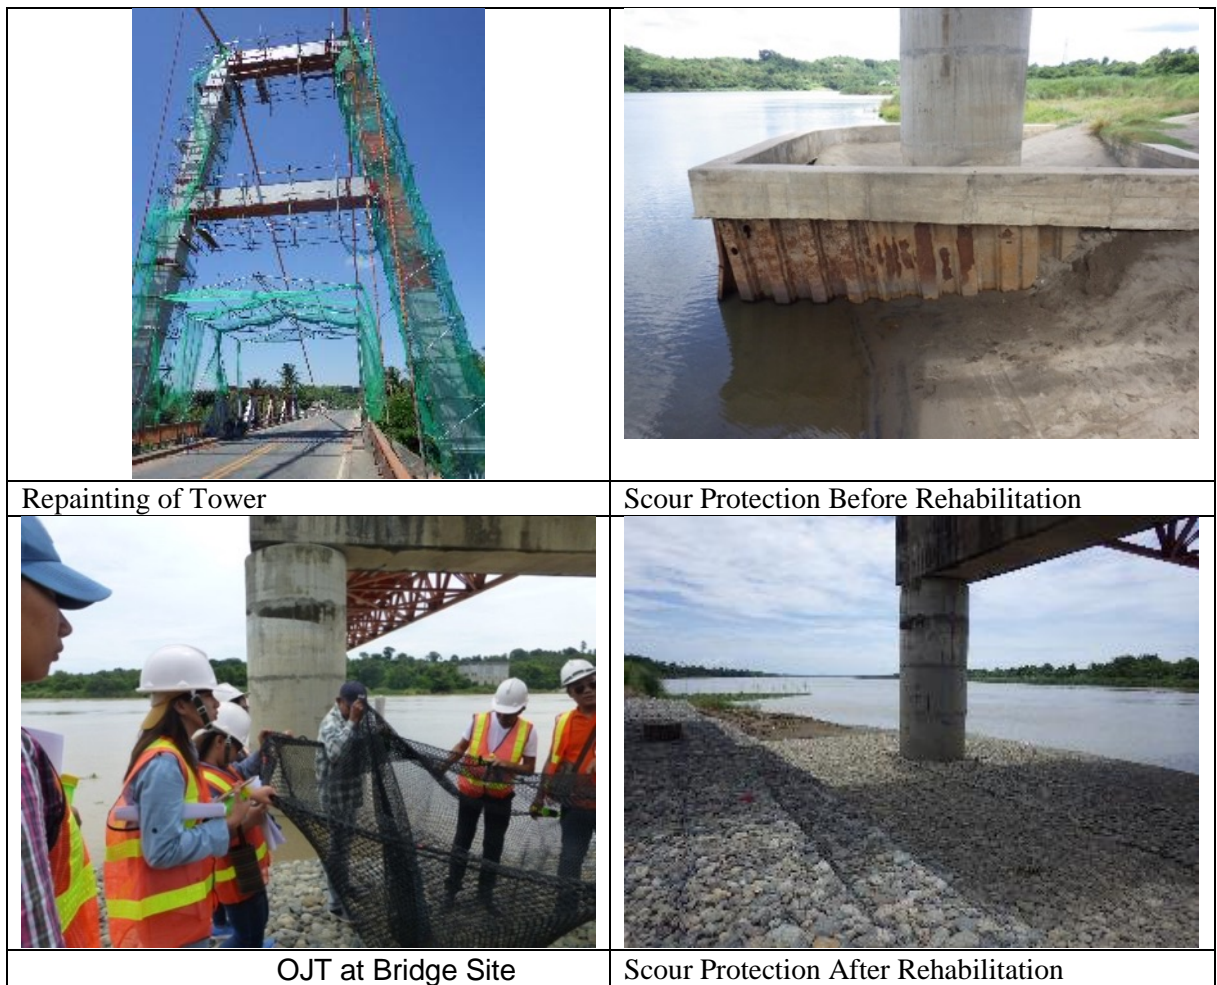
Figure 1.3.3.4-3 Activities in Stage-2

OJT on the Magapit Bridge repair pilot project was held on July 23-24, 2018 at the RO-II training room and at the bridge site. A total of 34 young engineers from RO-II and DEOs participated in the OJT. The OJT was carried out under C/P's initiative and the expert gave suggestion/assistance in preparation of the OJT. The expert also served a lecturer at on-the desk training and at field training. As prime works in Phase-1 rehabilitation work were underway at the time of the field training, trainees witnessed the actual rehabilitation works as well as the structure of the suspension bridge.

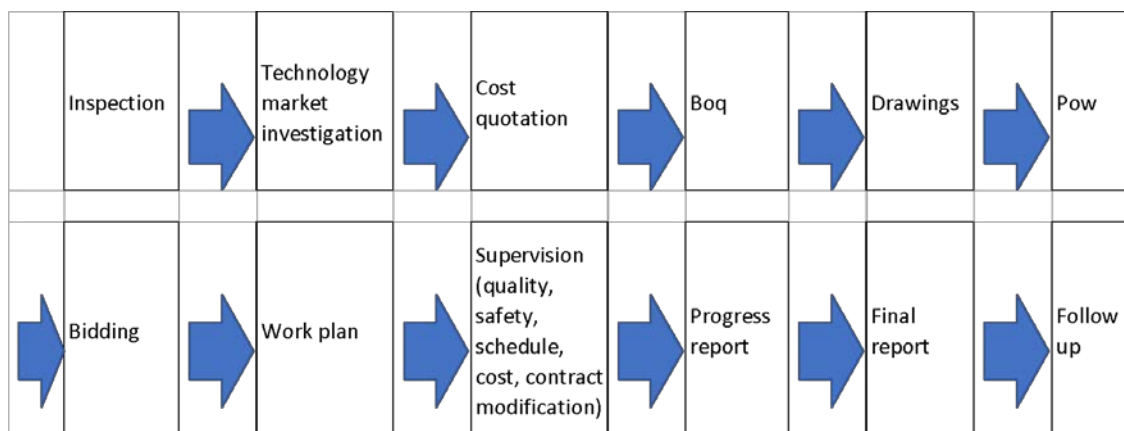
Figure 1.3.3.4-6 Work Flow of Maintenance

Design flow or maintenance work follows next.

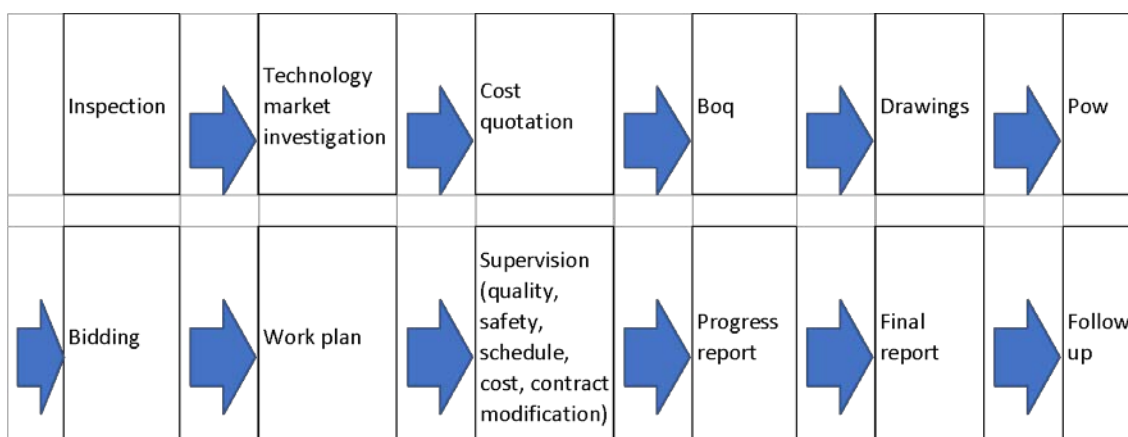
Figure 1.3.3.4-9 Work Flow of Maintenance

Design flow follows next.

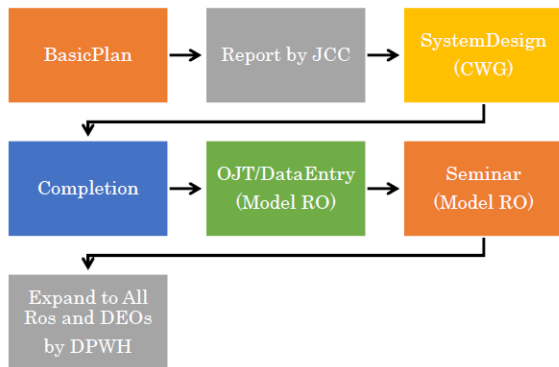
Procedure of Development of MIRB is shown in the flowchart below (Extract from Basic Plan)

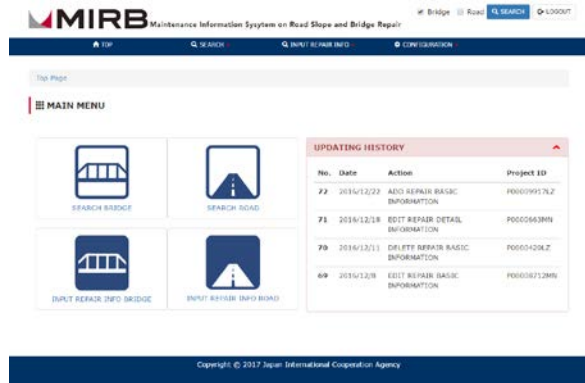
Top Page design of MIRB (Extract from Basic Design Document)

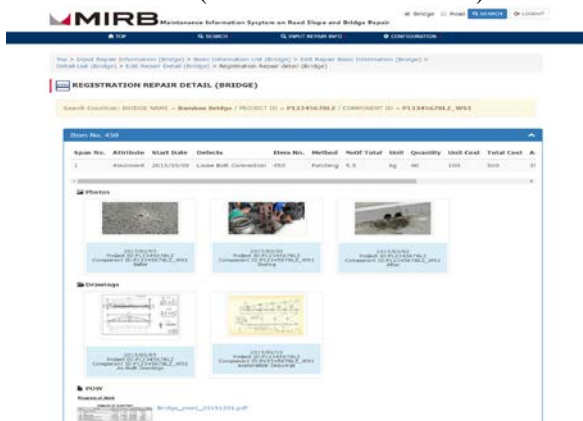
Data input Screen of MIRB (Extract from Basic Design Document)

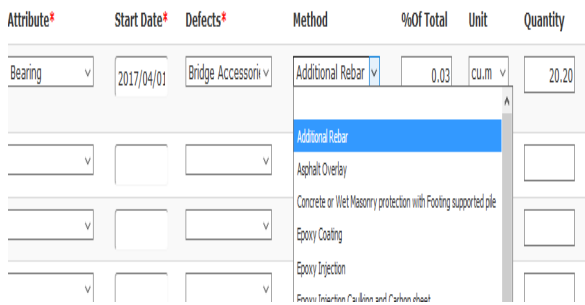
Figure 1.3.4.3-1 Image of System

Input Detailed Repair Information for Bridge Defect
