(12) **EUROPEAN PATENT APPLICATION**

(71) Applicant: **United Technologies Corporation**
Hartford, CT 06101 (US)

(54) **Inspection and repair process using thermal acoustic imaging**

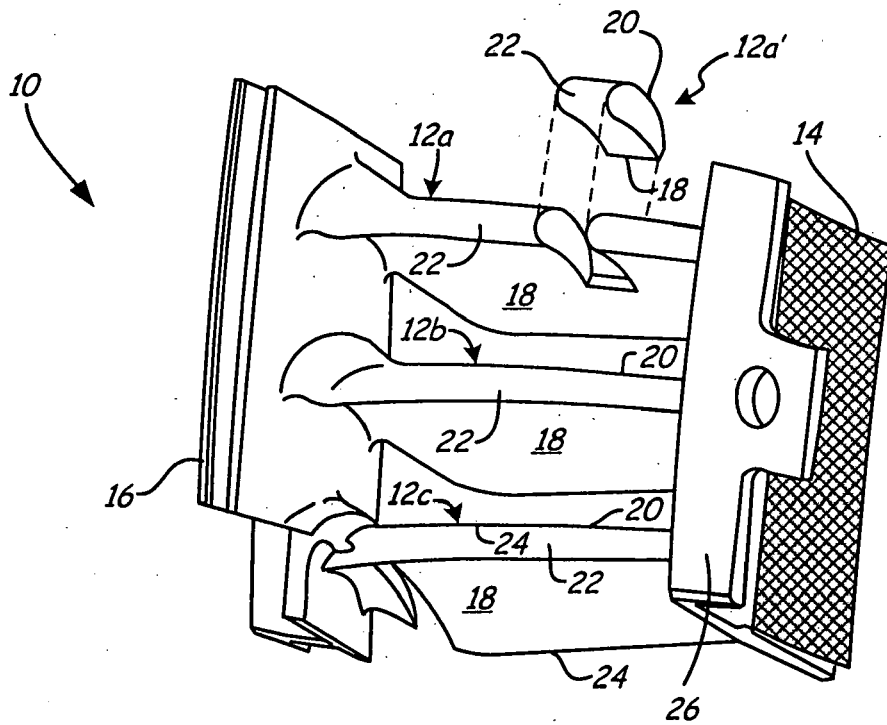
Fig. 1

[0006] FIG. 1 is a perspective view of a vane assembly for use in a gas turbine engine.

density, depth, and severity of the surface attack. Following cleaning, the component is inspected for defects. The prior art method of inspection consists of destructively removing portion, 12a', for instance from the leading edge of vane 12a as illustrated in FIG. 1 and examining the cross-section metallographically to determine the extent of IGA, thermal fatigue cracking, and other service induced damage. Following inspection, a replacement part needs to be fabricated, inserted and joined in. Destructive testing for IGA is expensive and time consuming. Although a replacement piece is welded or brazed to the component to repair the part following the analysis, the component was subjected to destructive cutting to achieve such analysis.

[0008] In FIG. 1, the vanes 12a, 12b, 12c typically have protective environmental barrier coatings (EBC) to protect them from thermal and erosive conditions in the hot gas flow path of the turbine engine. The coatings include at least a high aluminum alloy overlay such as a nickel aluminide, a platinum modified nickel aluminide or MCrAlY where M is Ni, Co, Fe or mixtures thereof. Upon exposure to a high temperature oxidative environment, a
