(12) **Patent Application Publication**
Boletis et al.

(10) **Pub. No.: US 2012/0301286 A1**

(54) **METHOD FOR REPAIRING A FLANGE OF A HOUSING**

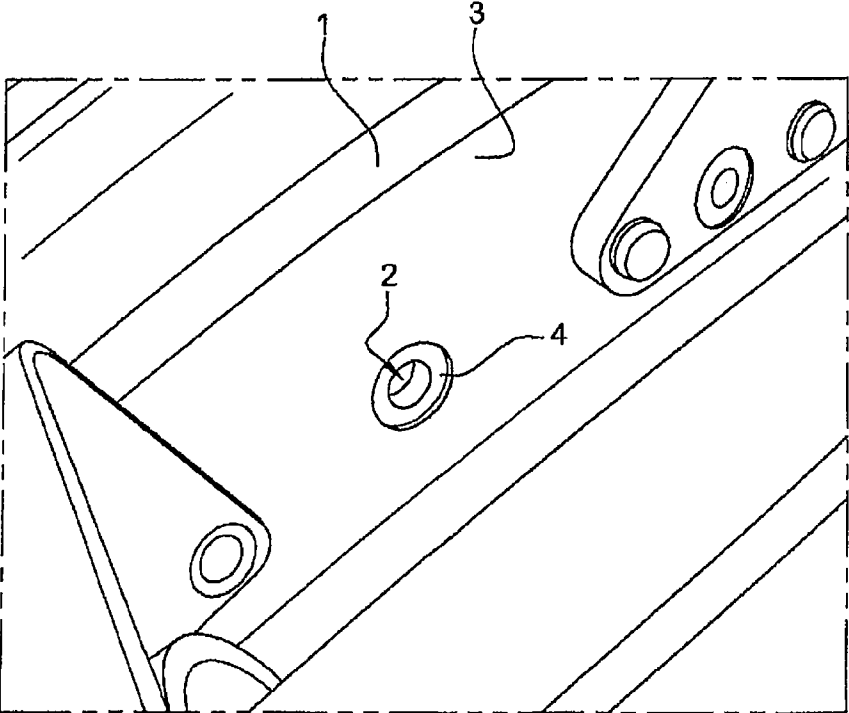
Fig. 1

[0032] FIG. 1 is a perspective view of a portion of a damaged flange;

[0036] FIGS. 1 and 2 show an annular flange 1 of an aluminum casing of a high-pressure compressor of a turbojet that has been damaged by mechanical stresses generated while the turbojet was in operation.

[0037] The flange 1 has holes 2 formed near its circumference and regularly spaced apart from one another, the holes opening out at both ends into annular side surfaces 3. The holes 2 are used for passing bolts, for bolting stiffeners or pieces of equipment. In the example of FIGS. 1 and 2, the equipment (not shown) has a face of circular section that, when in use, bears against the corresponding side face 3 around the bolt-passing hole 2.

[0038] In operation, vibration of the casing can give rise to bruising damage 4 of the inside surfaces of the holes 2 and of the side surface 3 of the flange 1. There can thus be seen a localized indentation in the surface 3 of the flange 1 in the zone where contact is made between the flange and the piece of equipment, together with an increase in the diameter of the hole 2 and/or ovalizing of the section of the hole 2. All of these kinds of damage can clearly be seen in FIGS. 1 and 2.

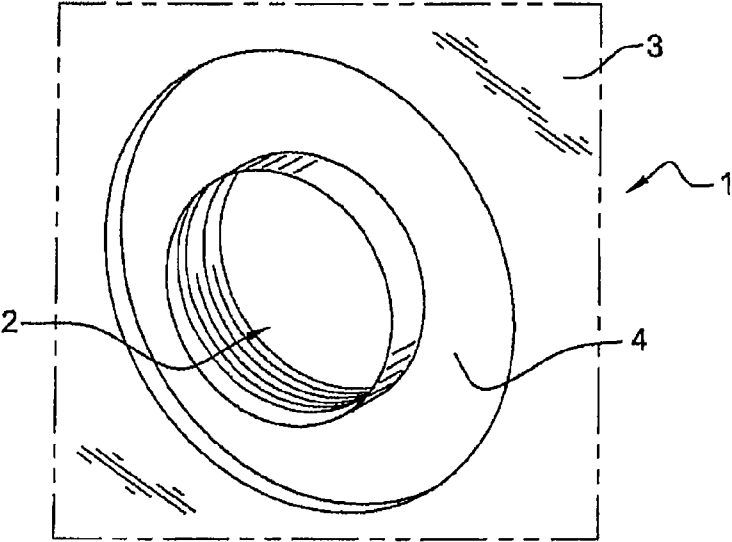
Fig. 2

[0033] FIG. 2 is a view on a larger scale of the through hole in the damaged flange;

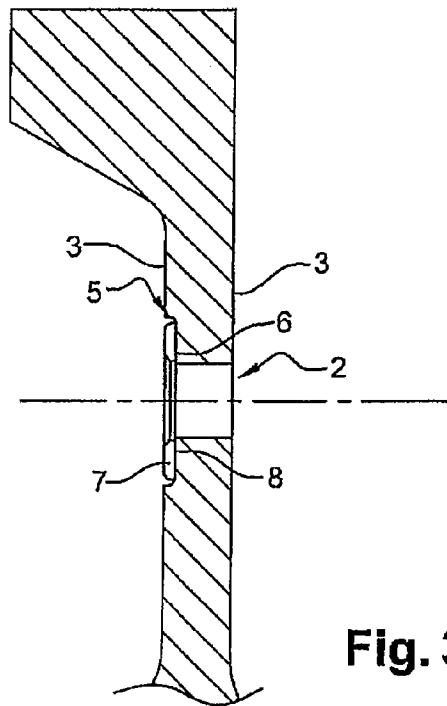
Fig. 3

[0034] FIG. 3 is an axial section view through a flange portion that has been repaired by the method of the invention; and

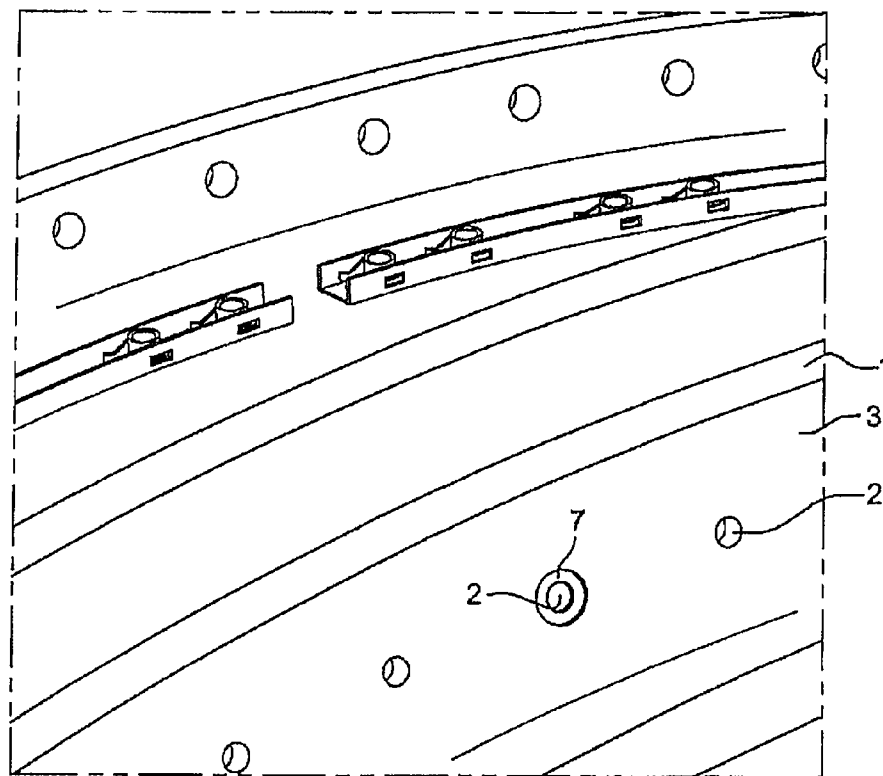
Fig. 4

[0035] FIG. 4 is a fragmentary perspective view of the FIG. 3 flange.
