(10) **Patent No.:** **US 8,864,472 B2**

(54) **METHOD OF REPAIRING OR REWORKING A TURBOMACHINE DISK AND REPAIRED OR REWORKED TURBOMACHINE DISK**

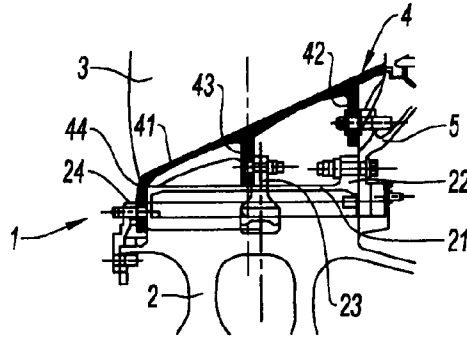
Fig. 1

FIG. 1 is a partial axial cross section through a fan disk according to one way of attaching platforms according to the prior art and without repair or rework;

FIG. 1 illustrates a setup as currently used on engines in operation at the present time. The fan rotor 1 comprises a disk 2 on the rim of which the roots of the fan blades 3 are housed. The housings consist of cavities of slightly curved shape oriented in the axial direction. The disk 2 is secured by bolting to the drum 5 of the booster compressor. Together these form the low-pressure compressor module. Between the cavities, the rim forms ribs 21 which comprises outwardly facing radial tabs situated in a plane that is transverse with respect to the axis of the machine: a downstream tab 22 via which the disk 2 is bolted to the drum 5, a radial tab 23, between an upstream face 24 of the disk and the downstream edge, and termed the central tab. This part of the rim of the fan disk can be seen in perspective in FIG. 2.

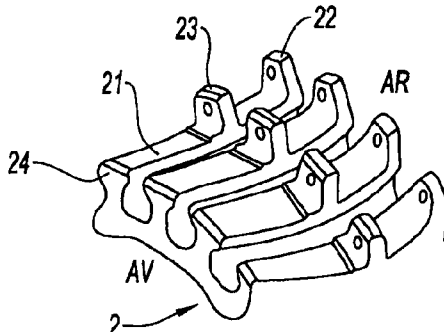
Fig. 2

FIG. 2 is a partial perspective view of the disk of FIG. 1, alone, without the platforms and the blades;

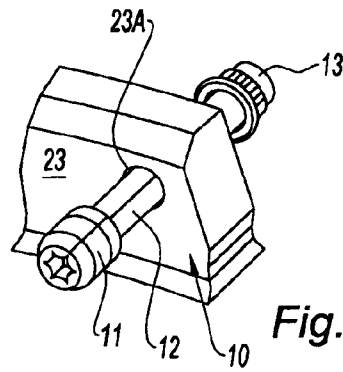
Fig. 3

FIG. 3 is a perspective depiction of the fitting of a conventional retaining pin;

Between the two, upstream and downstream, tabs, the central tab 23 is held radially by an axial pin 10 which is itself fixed by screw-fastening. FIG. 3 shows a conventional pin such as this in the process of being fitted to the central tab 23 of the disk rim. The pin 10 comprises a head 11 and a shank with a threaded portion 12 which is slipped into an axial bore 23A machined in the central tab 23. To fix the pin, the nut 13 is screwed, downstream, onto the shank having a threaded portion until the shoulder of the head 11 comes to press against the upstream face of the tab 23. When the platform is being mounted, the tab 23 is positioned facing the head 11 of the pin and is engaged over and slipped onto this head via its orifice at the same time as the downstream tab is being fitted onto the downstream pin.

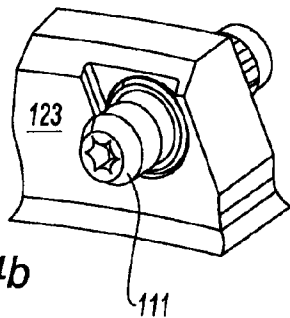
Fig. 4b

FIGS. 4a and 4b show the implementation of the repair according to the invention;

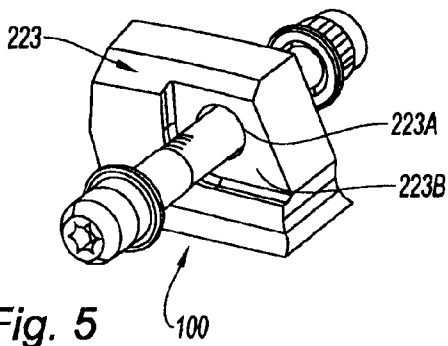
Fig. 5

FIG. 5 shows an alternative embodiment of the spot face according to the invention; and

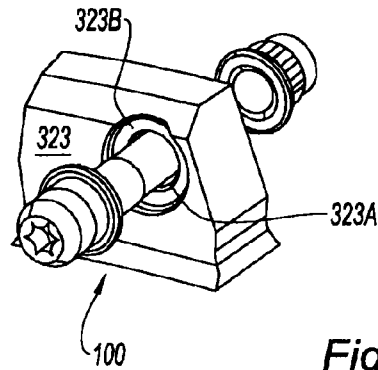
Fig. 6

FIG. 6 shows another alternative form of embodiment of the spot face according to the invention.
