[54] **REPAIR OF TURBINE EXHAUST CASE**

A process is provided for repairing the horizontal mount area of a JT9D turbine exhaust case having two mounting flanges by inspecting the horizontal mount area, weld repairing any defects found in the case wall and installing a reinforcement brace onto the inside of the case wall in the horizontal mount area, wherein the reinforcement brace overlaps an area under one mounting flange and extends to and overlaps the area under the second mounting flange.

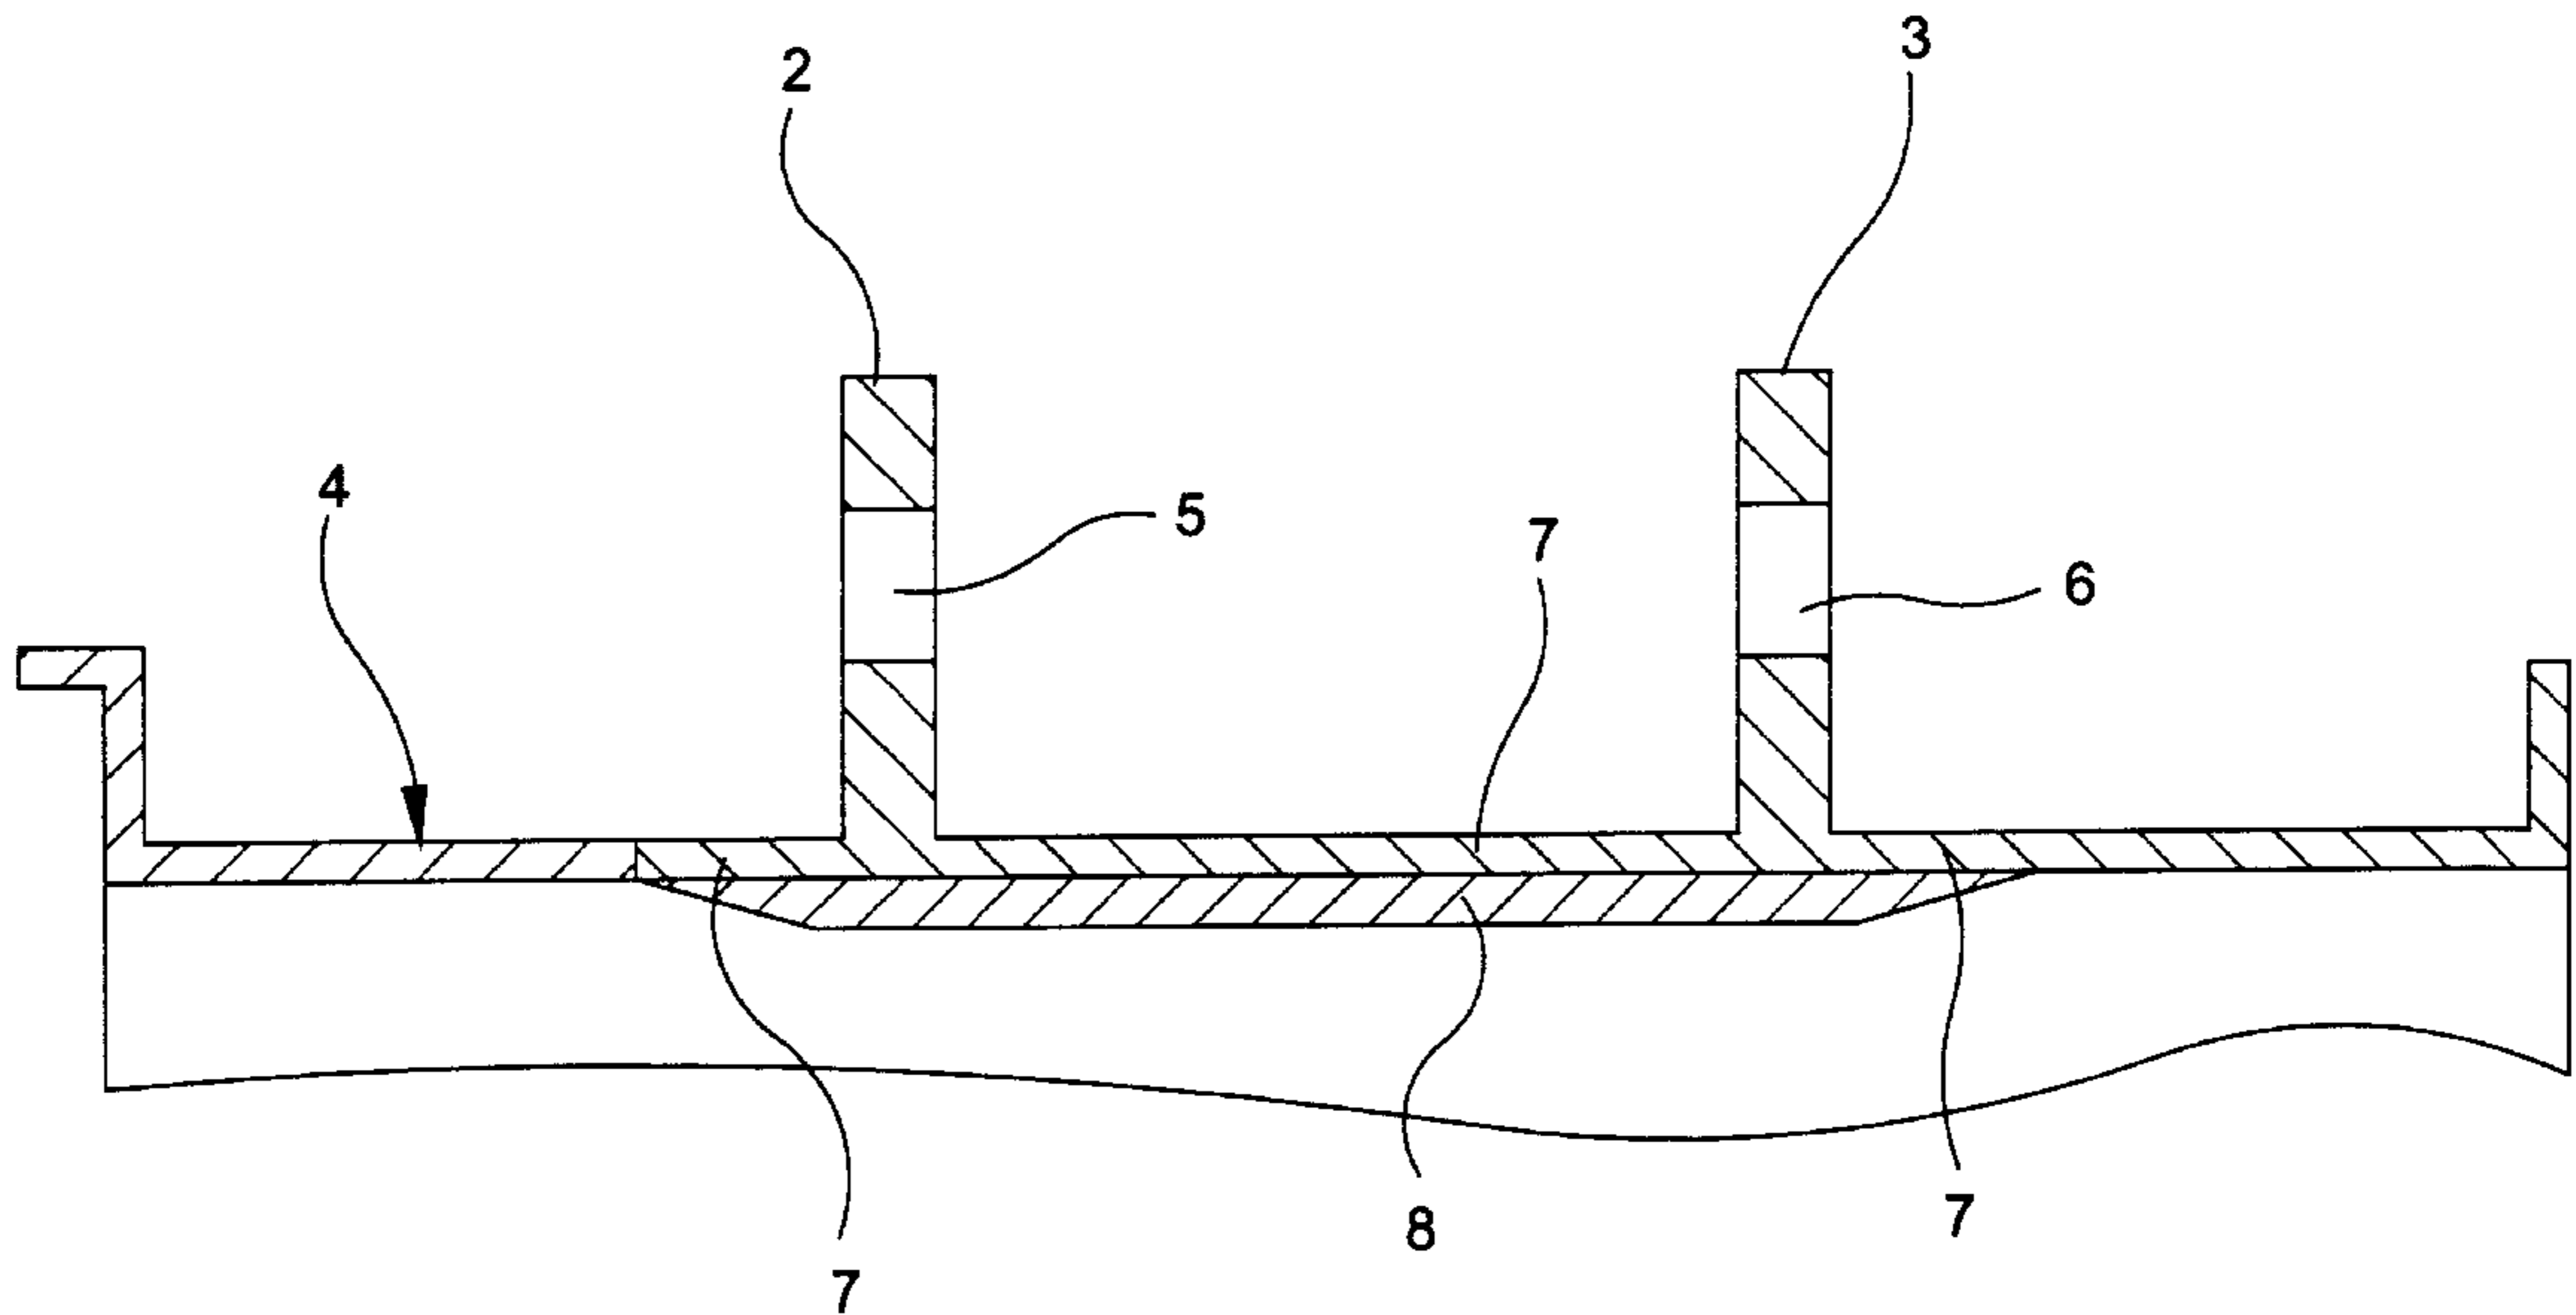
FIG-1

FIG. 1 is a perspective view of a turbine exhaust case;

FIG. 1 shows a turbine exhaust case 1 of a JT9D gas turbine engine having two mounting flanges 2 and 3 on the outside of the case wall 4 which are used for attaching the turbine exhaust case to a rear engine mount (not shown). FIG. 2 is a partial top view of FIG. 1 showing the mounting flanges 2 and 3 with the mount lugs 10 secured through the mounting flanges. FIG. 3 is a sectional view along line 3—3 from FIG. 2. FIG. 3 shows the R-Rail mounting flange 2 and S-Rail mounting flange 3 each having therein horizontal mount pinholes 5 and 6 respectively, for insertion of the mount lugs 10 shown in FIG. 2. The horizontal mount area 7 is the area of the case wall 4 adjacent to and between the horizontal mount pinholes 5 and 6 in the two mounting flanges 2 and 3.

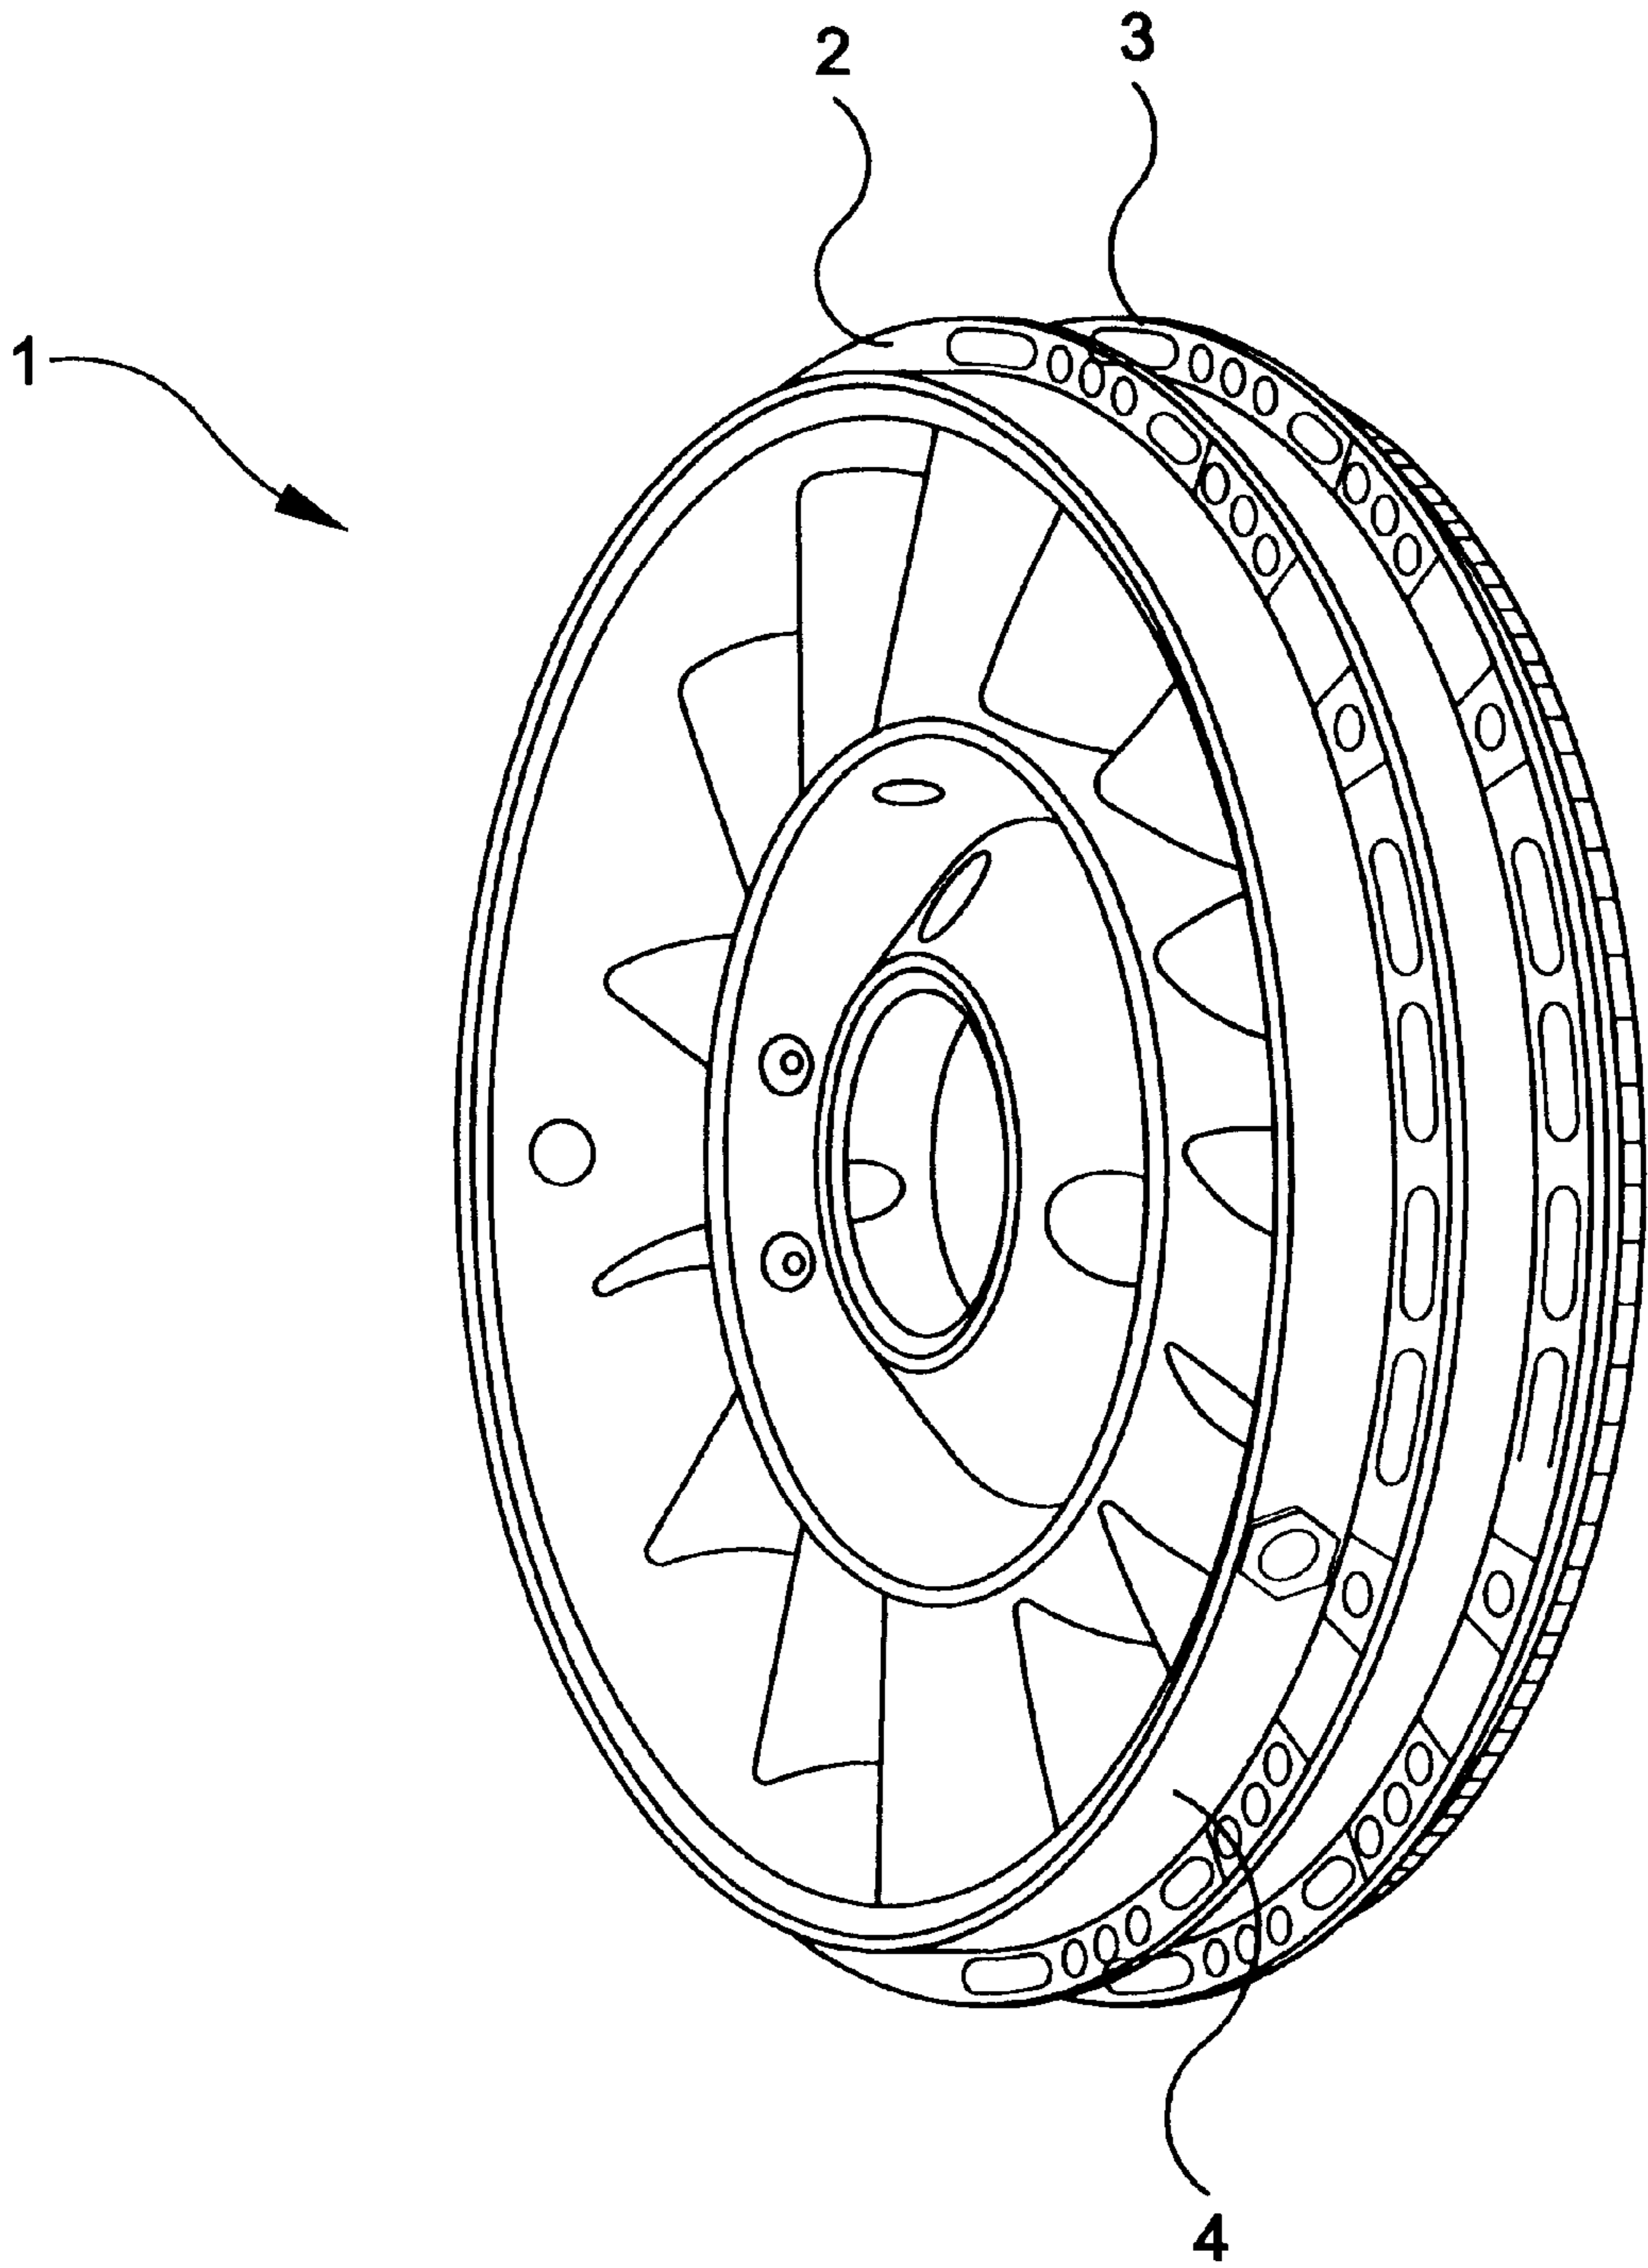
FIG-2

FIG. 2 is a partial top view of the exhaust case of FIG. 1; and

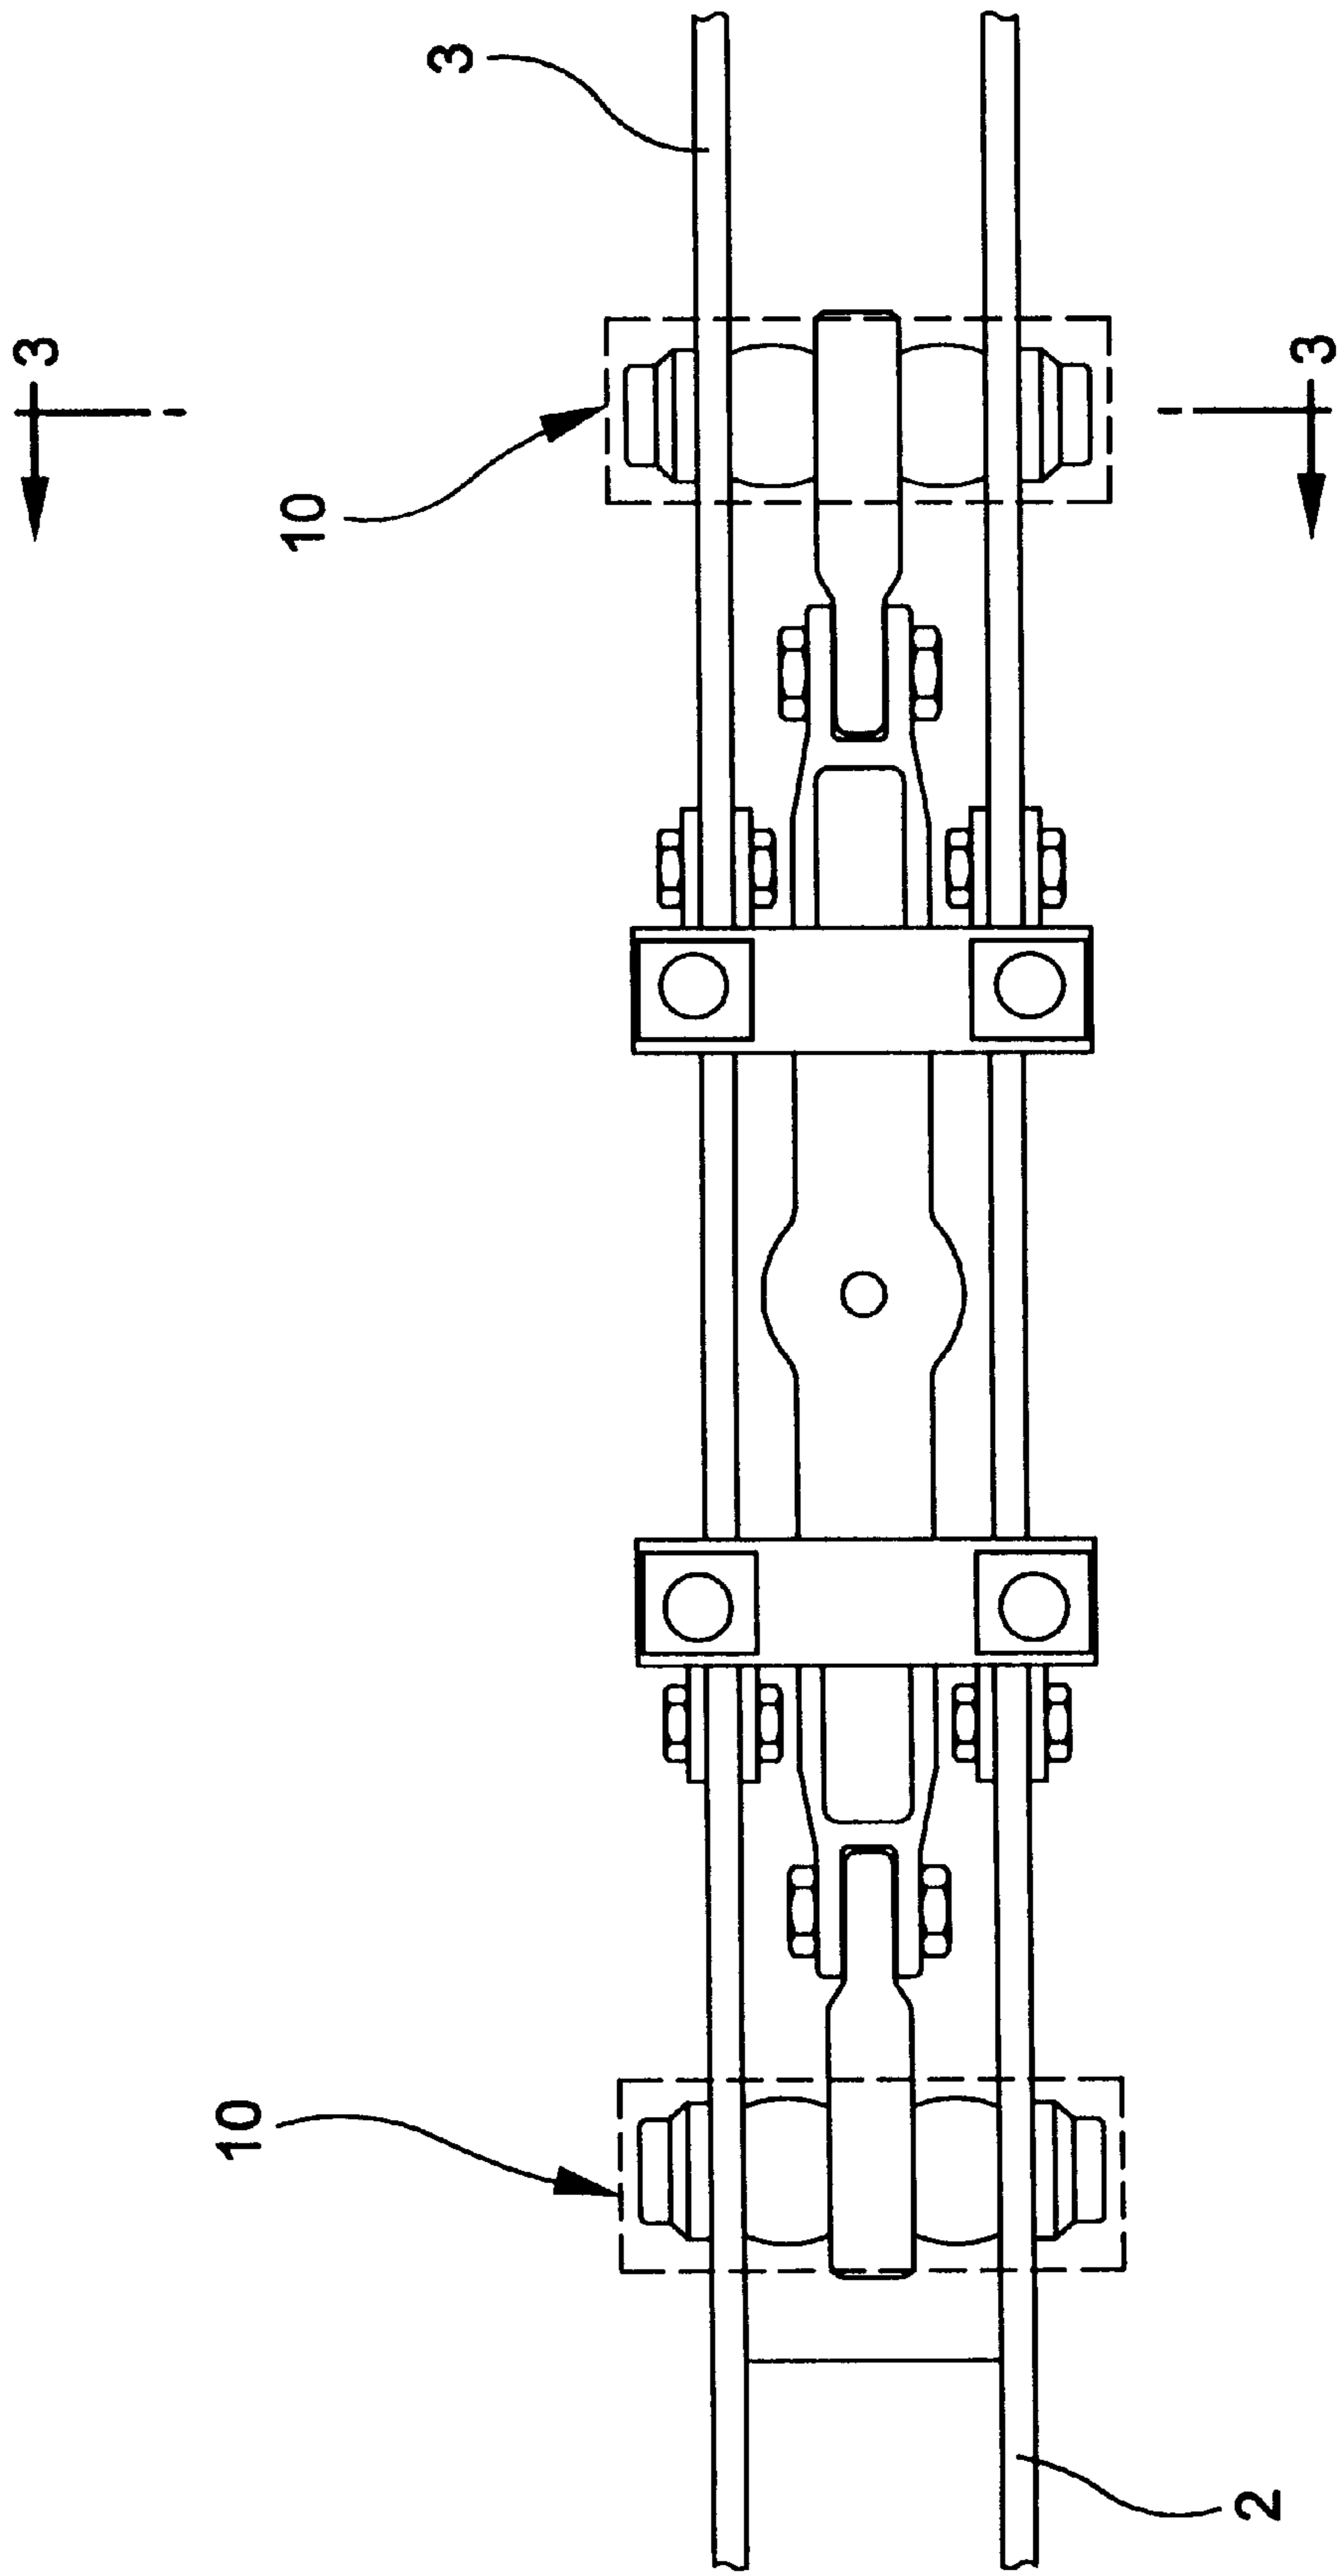
FIG-3

FIG. 3 is a sectional view along line 3—3 of FIG. 2 with the mounting lug deleted.

The process of this invention involves first inspecting the horizontal mount area 7 of the turbine exhaust case 1. Any defects found in the inspection are weld repaired, typically by TIG welding, preferably using a filler metal of the same composition as the turbine exhaust case, which can be a martensitic steel, e.g. AMS 5616. Then a reinforcement brace 8 is installed onto the inside of the case wall 4 in the horizontal mount area 7. The brace 8 overlaps an area under
