(12) UK Patent Application (19) GB (11) 2 108 065 A

(54) **Rotor blade shaft integrity monitoring system**

5 This invention relates to helicopter rotors and more particularly to an improved blade retention apparatus including a redundant tension member and an indicator system to monitor the reliability of the primary member.

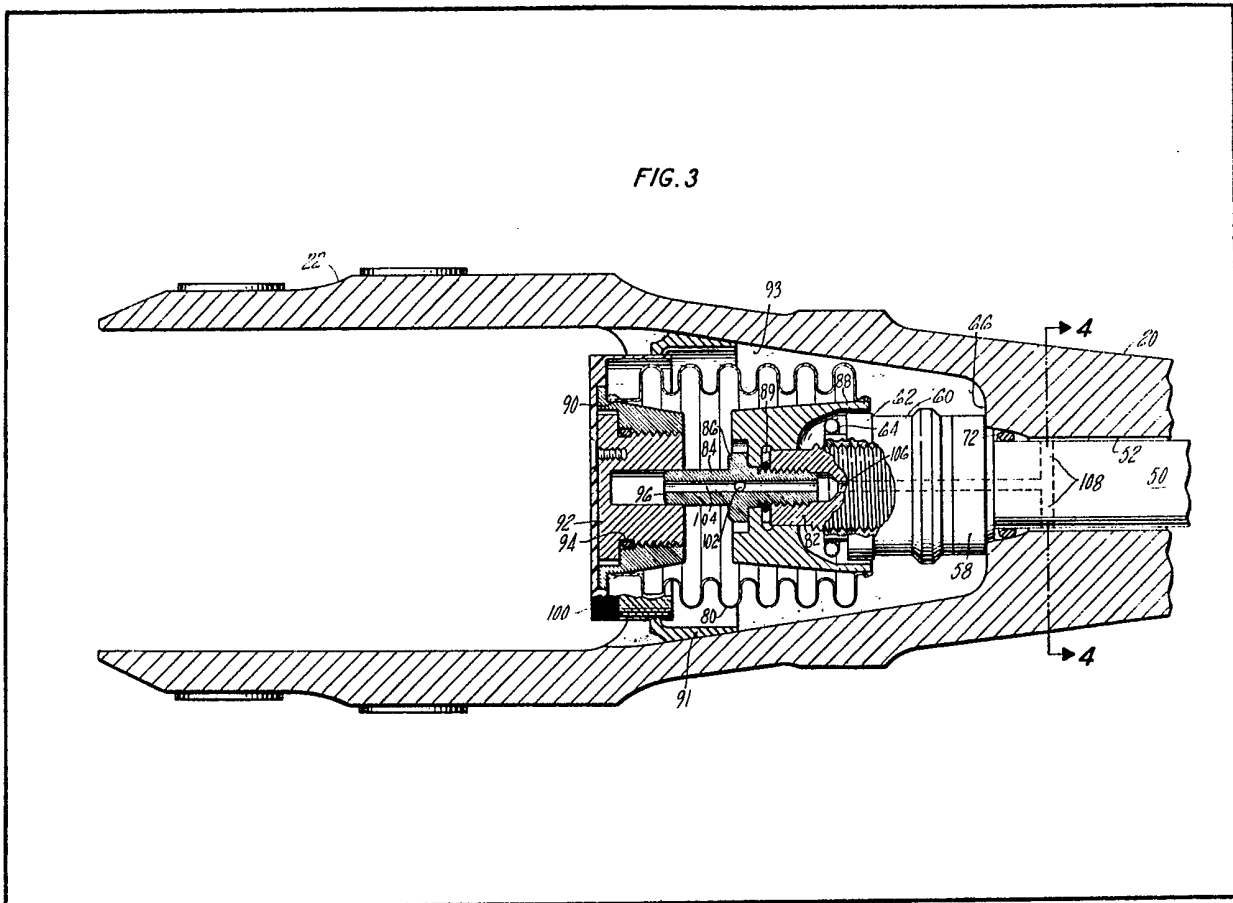
(57) A helicopter rotor blade to hub arm attachment configured to react centrifugal loads from the blade through a blade cuff 22, spindle 20,

and elastomeric bearings utilizes a pre-loaded bolt 50 through the spindle for load sharing therewith and a spindle integrity monitoring indicator 100 to provide a visual showing of a deviation from the normal load sharing proportion. The space between the spindle bore 52 and the bolt 50 is filled with a low viscosity dye pressurized by a bellows 80 in tensions, the dye leaking through any cracks in the spindle to indicate the fault. Loss of dye allows the bellows to contract, moving the indicator 100 secured to its outer end inwardly until the brightly coloured skirt portion of the indicator is hidden in a sleeve 91, only a dull black outer band being visible when a preset minimum dye pressure is reached, to indicate loss of pressure.
