(10) **Patent No.:** **US 9,533,383 B2**  
(45) **Date of Patent:** **Jan. 3, 2017**

(54) **METHOD FOR REPAIRING A FLANGE OF A HOUSING**

(73) Assignee: **SNECMA**, Paris (FR)

The present invention relates to a method of repairing a flange of a casing, e.g. made of aluminum, for a turbine engine such as an airplane turboprop or turbojet.

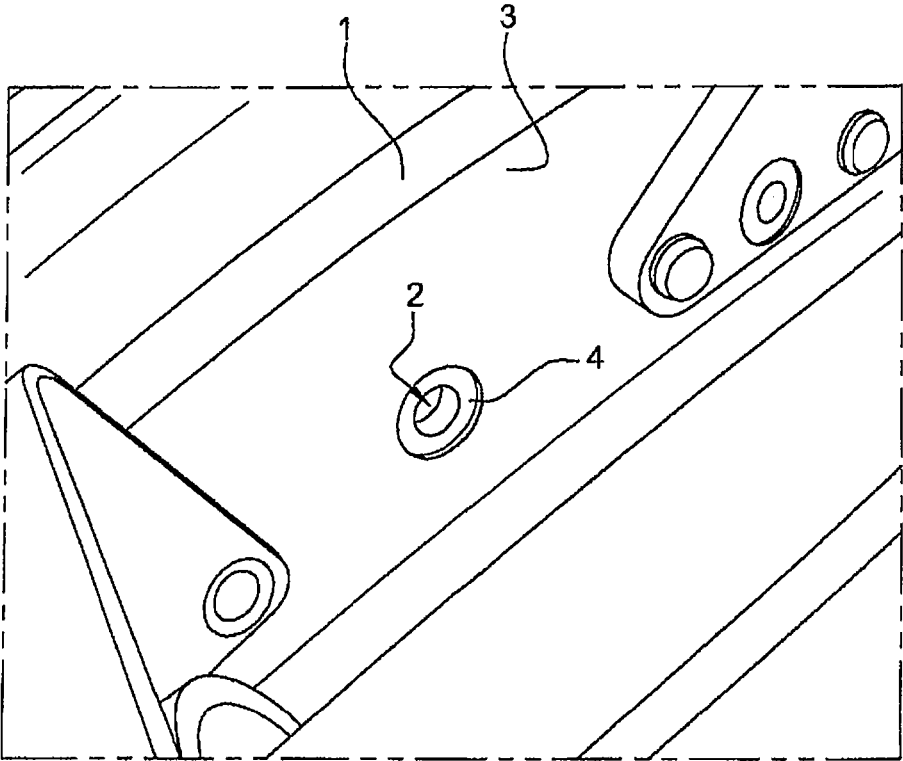
Fig. 1

FIG. 1 is a perspective view of a portion of a damaged flange;

FIGS. 1 and 2 show an annular flange 1 of an aluminum casing of a high-pressure compressor of a turbojet that has been damaged by mechanical stresses generated while the turbojet was in operation.

The flange 1 has holes 2 formed near its circumference and regularly spaced apart from one another, the holes opening out at both ends into annular side surfaces 3. The holes 2 are used for passing bolts, for bolting stiffeners or pieces of equipment. In the example of FIGS. 1 and 2, the equipment (not shown) has a face of circular section that, when in use, bears against the corresponding side face 3 around the bolt-passing hole 2.

In operation, vibration of the casing can give rise to bruising damage 4 of the inside surfaces of the holes 2 and of the side surface 3 of the flange 1. There can thus be seen a localized indentation in the surface 3 of the flange 1 in the zone where contact is made between the flange and the piece of equipment, together with an increase in the diameter of the hole 2 and/or ovalizing of the section of the hole 2. All of these kinds of damage can clearly be seen in FIGS. 1 and 2.

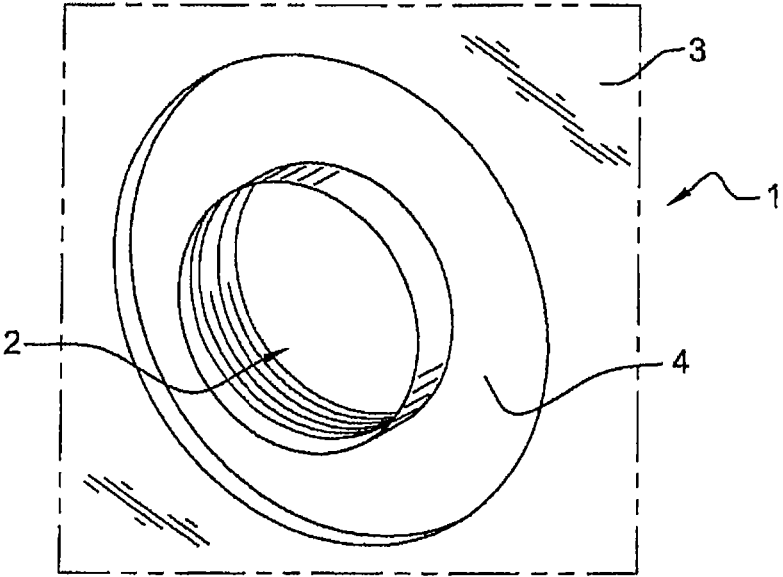
Fig. 2

FIG. 2 is a view on a larger scale of the through hole in the damaged flange;

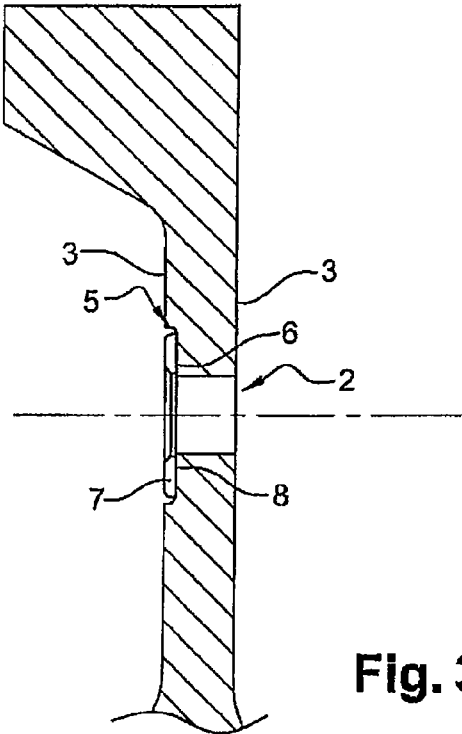
Fig. 3

FIG. 3 is an axial section view through a flange portion that has been repaired by the method of the invention; and

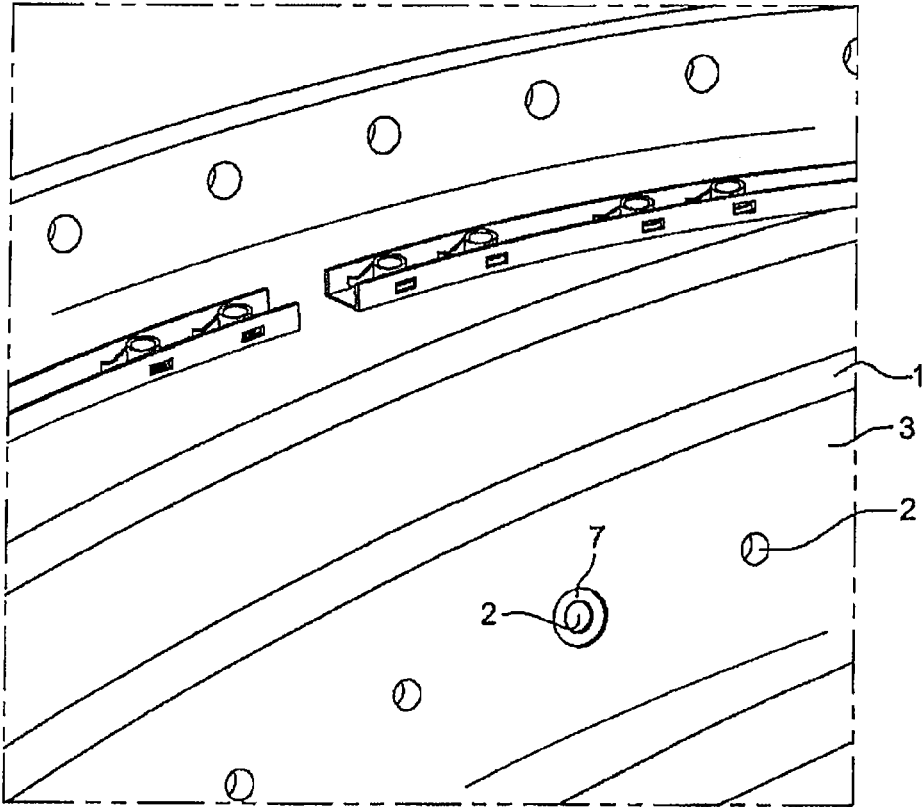
Fig. 4

FIG. 4 is a fragmentary perspective view of the FIG. 3 flange.
